UNDERWATER BRIDGE INSPECTION REPORT

STRUCTURE NO. 92253

CSAH 88

ARMSTRONG CREEK

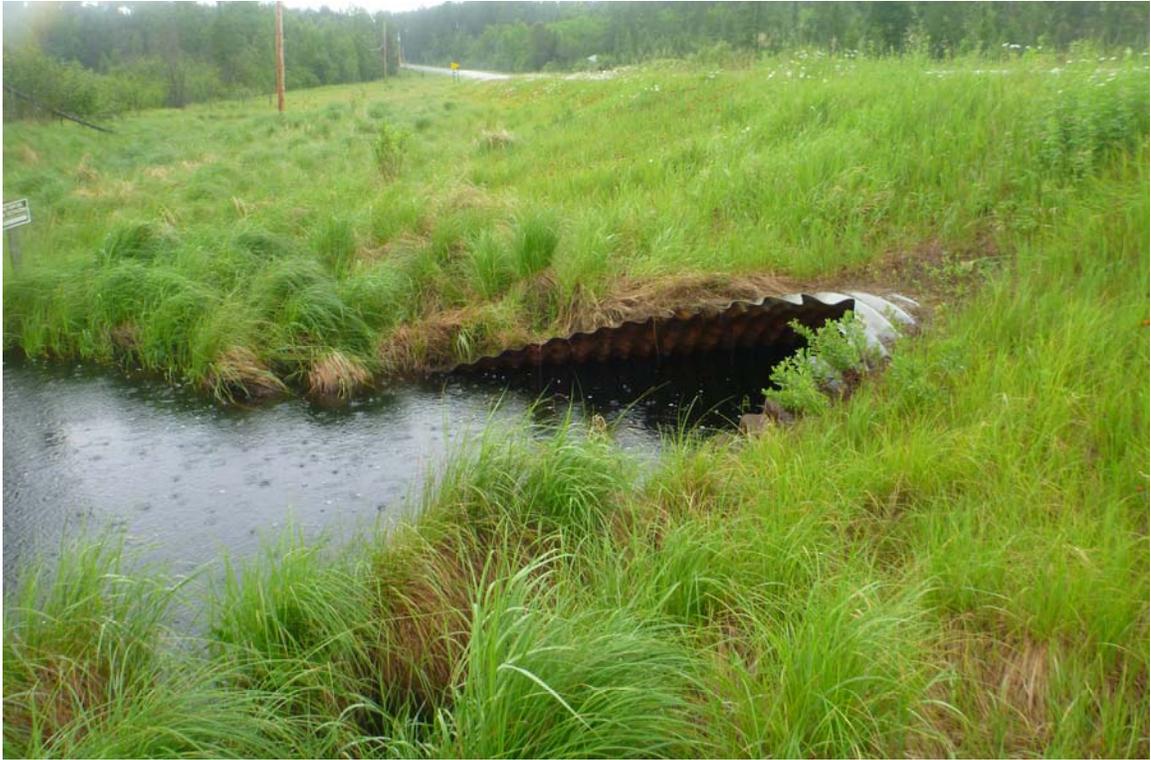
Photograph 1. View of Upstream Opening, Looking North.

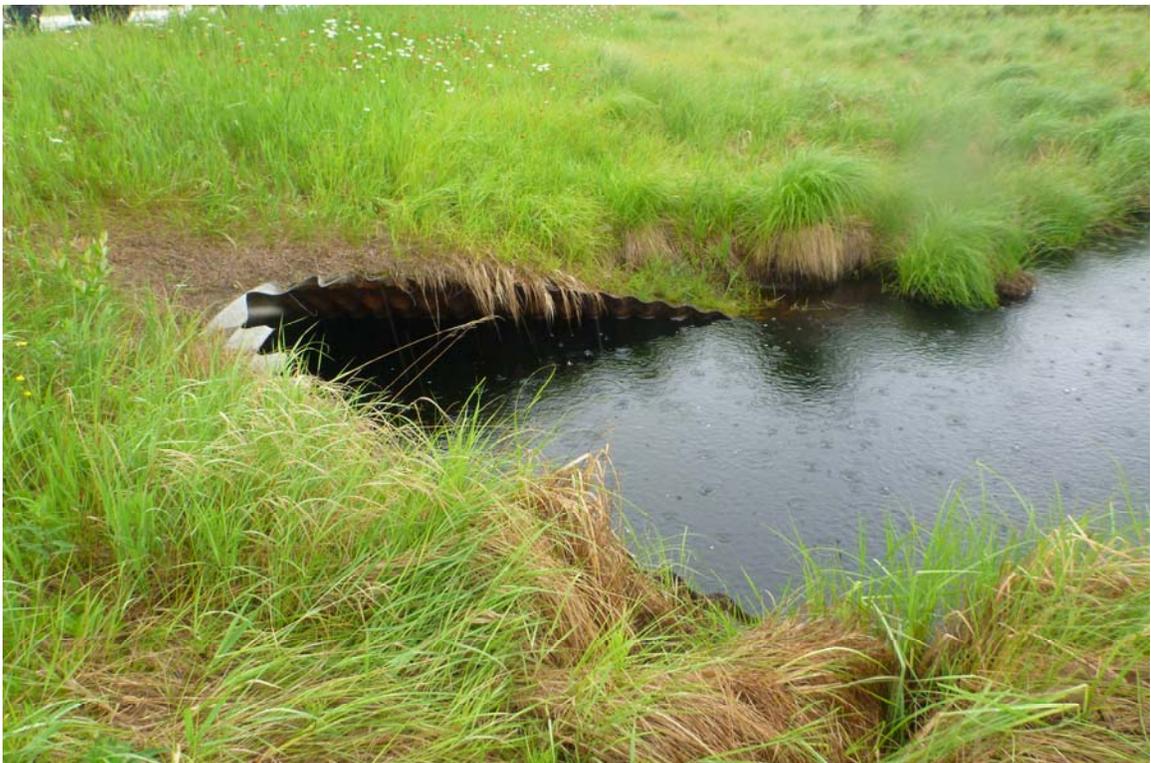
Photograph 2. View of Downstream Opening, Looking West.

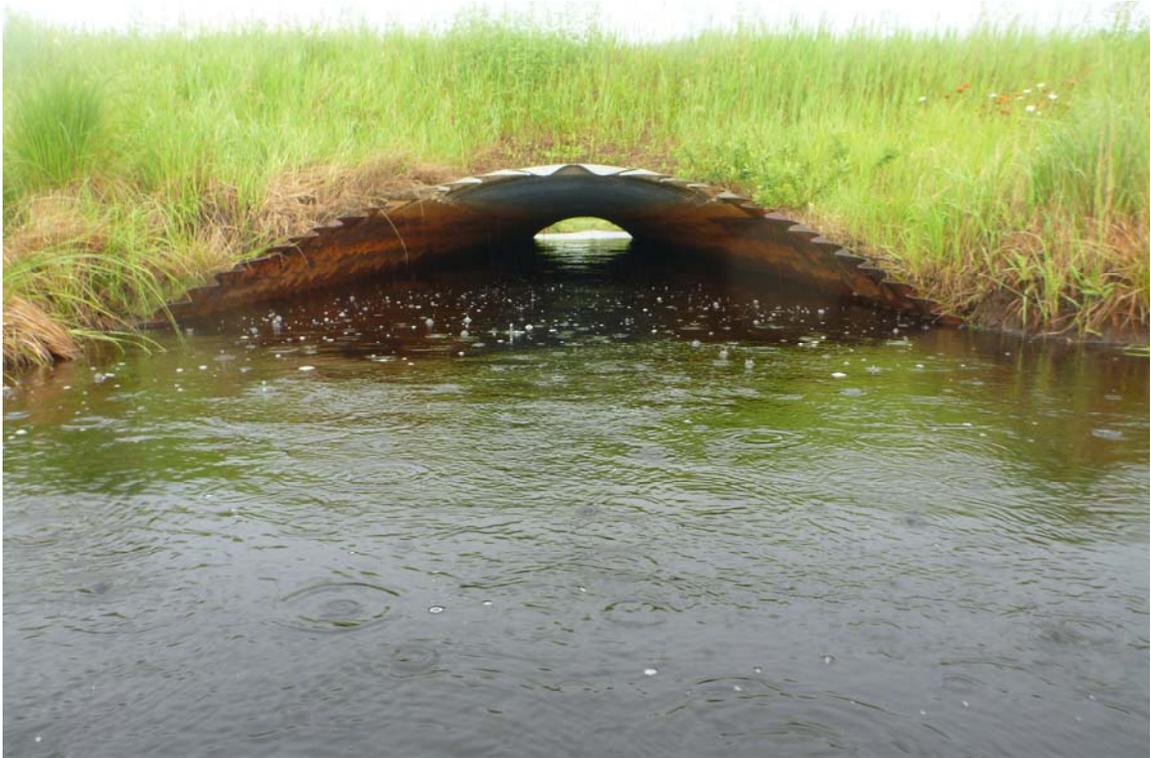
Photograph 3. View of Upstream Opening Along Length of Pipe, Looking Northeast.

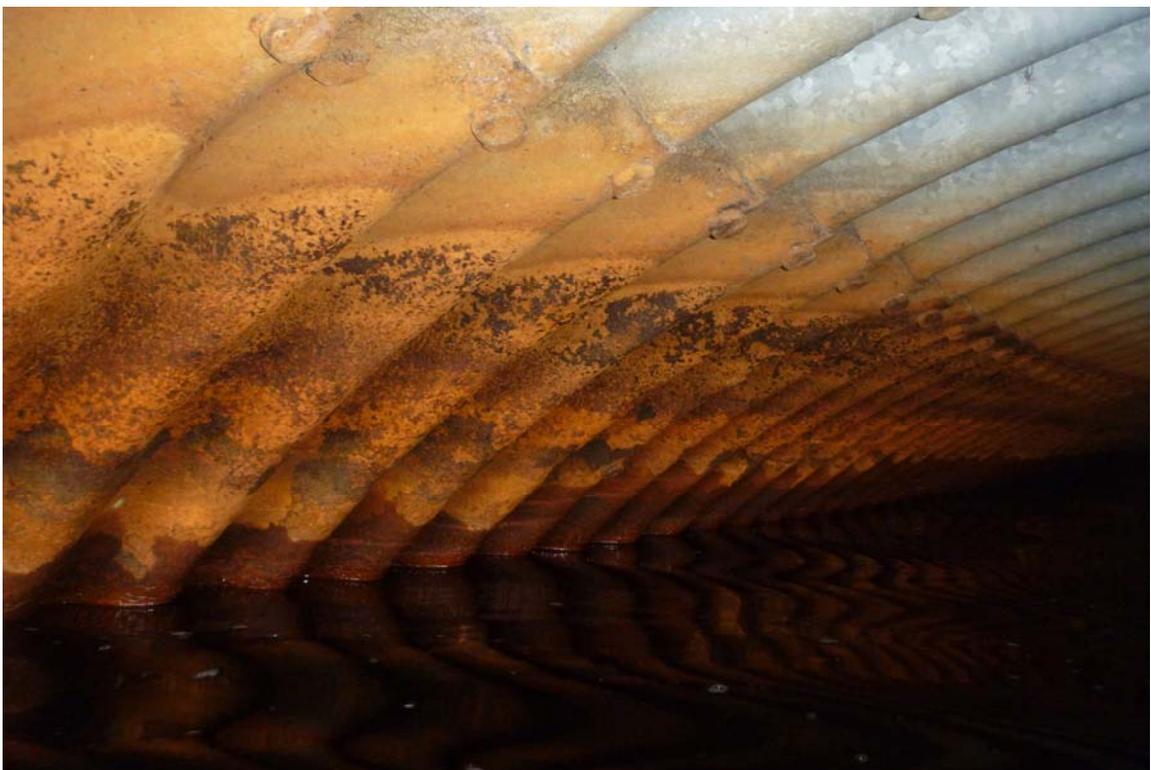
- (A) The corrugated metal pipe exhibited light surface corrosion from 1 foot below to 1 foot above the waterline with no significant loss of section.
- (B) No observed displacement or distortion of the culvert ceiling was observed. The pipe was well aligned and had an overall good shape.
- (C) The channel bottom material consisted of medium silt mixed with sand and gravel allowing a maximum probe rod penetration of 4 inches. Typically a 2 inch thick layer of silt covered the bottom of the corrugated metal pipe. Towards the openings the silt layer increased to a minimum of 6 inches and a maximum of 1 foot thick.

Photograph 4. View of Typical Steel Condition at the Waterline, Looking North.

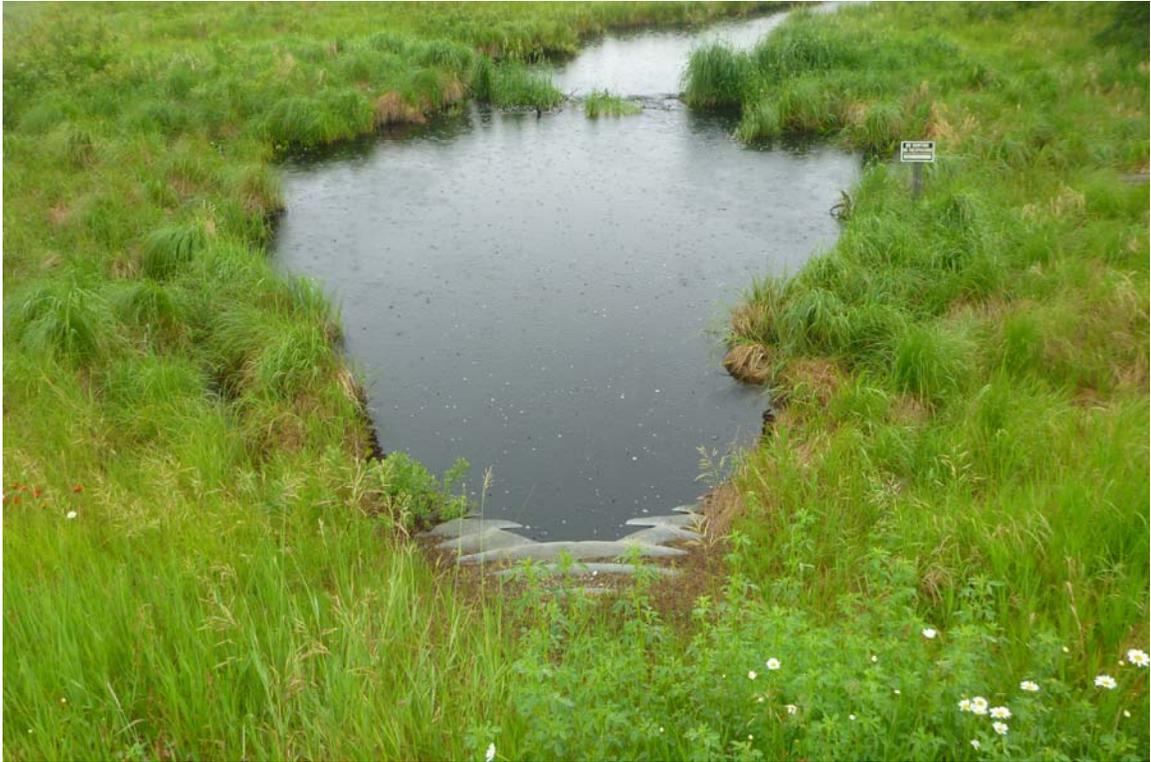
Photograph 5. View of Upstream Channel, Looking Southwest.

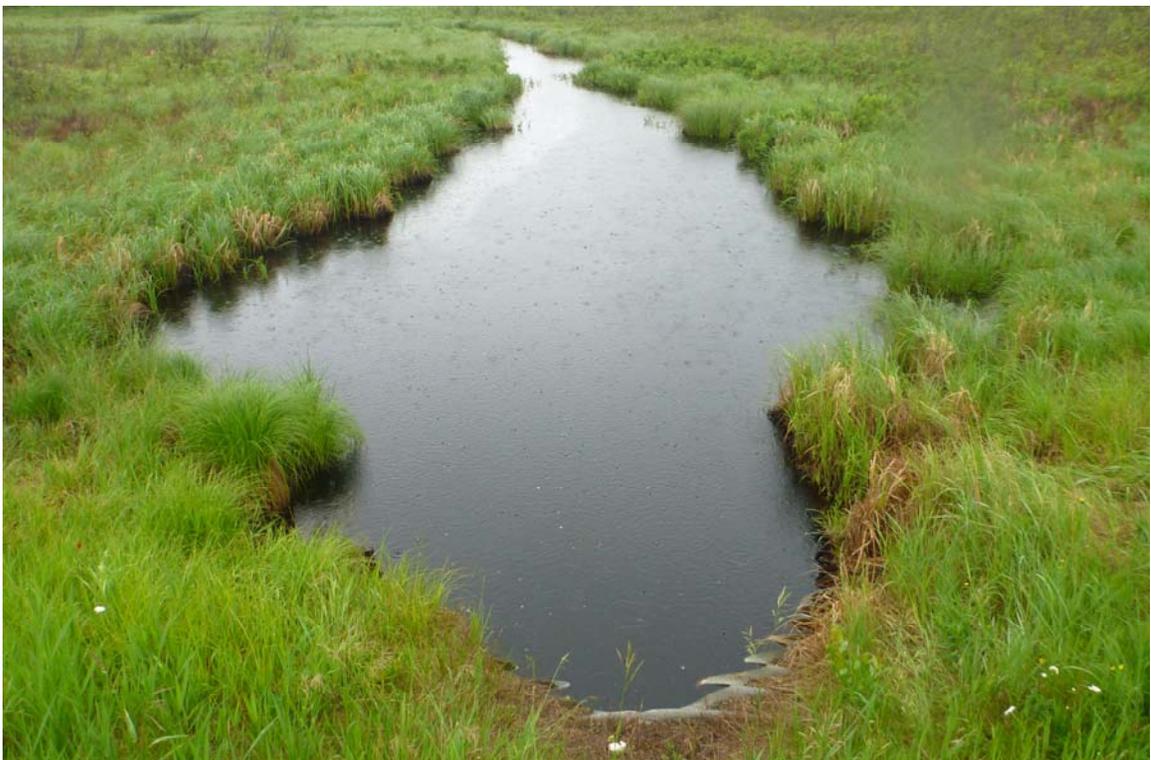
Photograph 6. View of Downstream Channel, Looking Northeast.

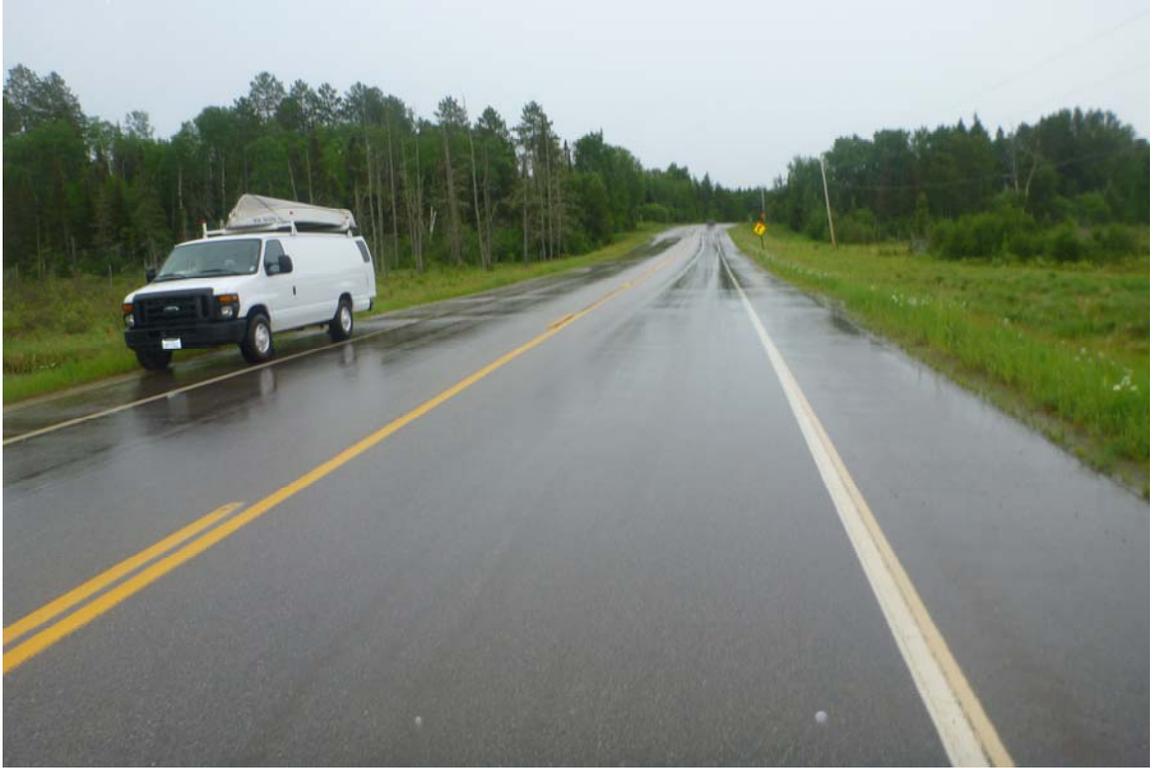
Photograph 7. View of CSAH 88 Over Culvert, Looking Southeast.

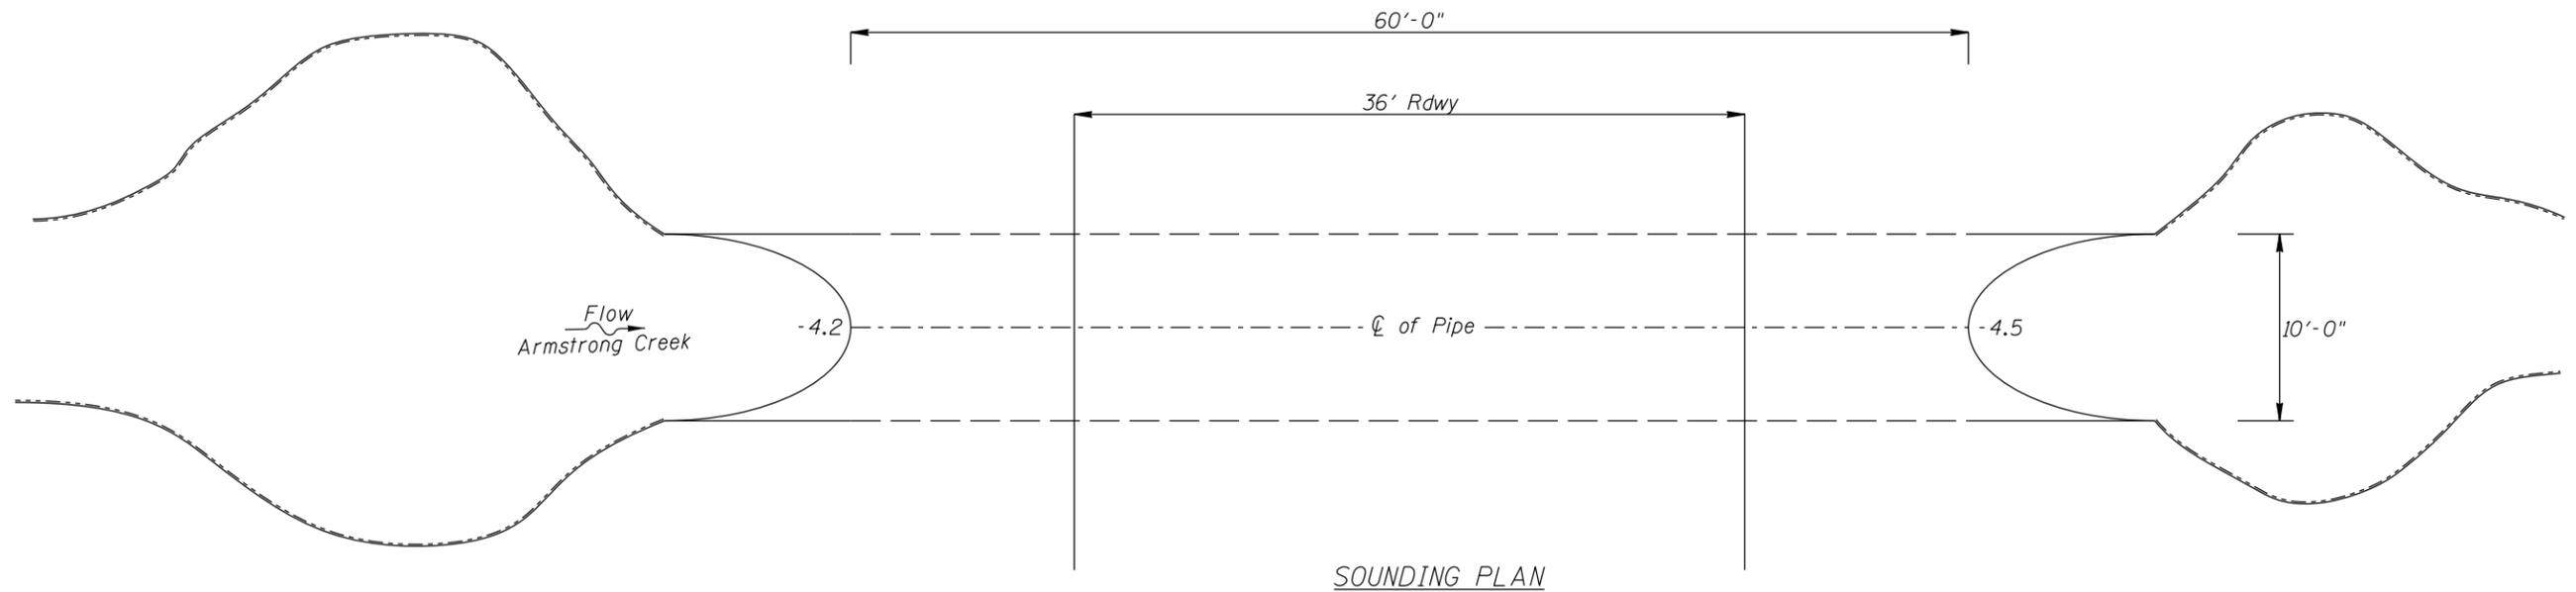
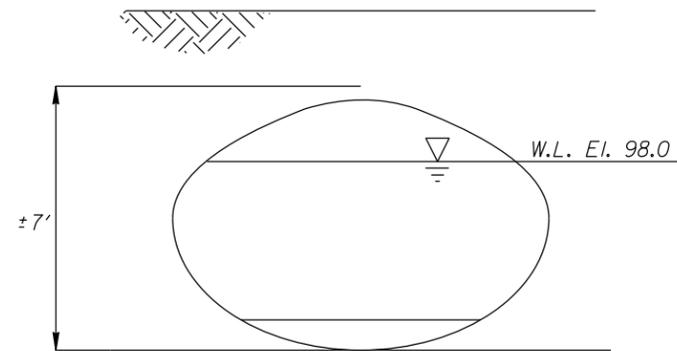
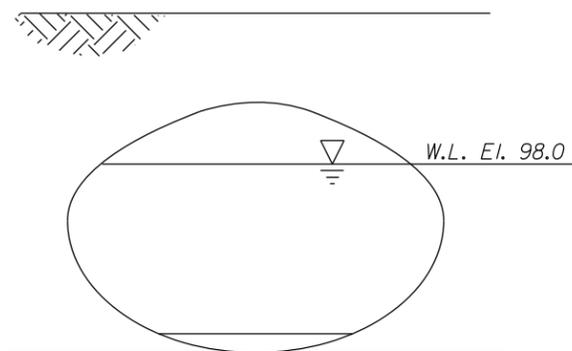
- ① The corrugated metal pipe exhibited light surface corrosion from 1 foot below to 1 foot above the waterline with no significant loss of section.
- ② No observed displacement or distortion of the culvert ceiling was observed. The pipe was well aligned and had an overall good shape.
- ③ The channel bottom material consisted of medium silt mixed with sand and gravel allowing a maximum probe rod penetration of 4 inches. Typically a 2 inch thick layer of silt covered the bottom of the corrugated metal pipe. Towards the openings the silt layer increased to a minimum of 6 inches and a maximum of 1 foot thick.
