UNDERWATER BRIDGE INSPECTION REPORT

STRUCTURE NO. 92628

COOLIDGE CREEK

MINNESOTA DEPARTMENT OF TRANSPORTATION
UNDERWATER BRIDGE INSPECTION

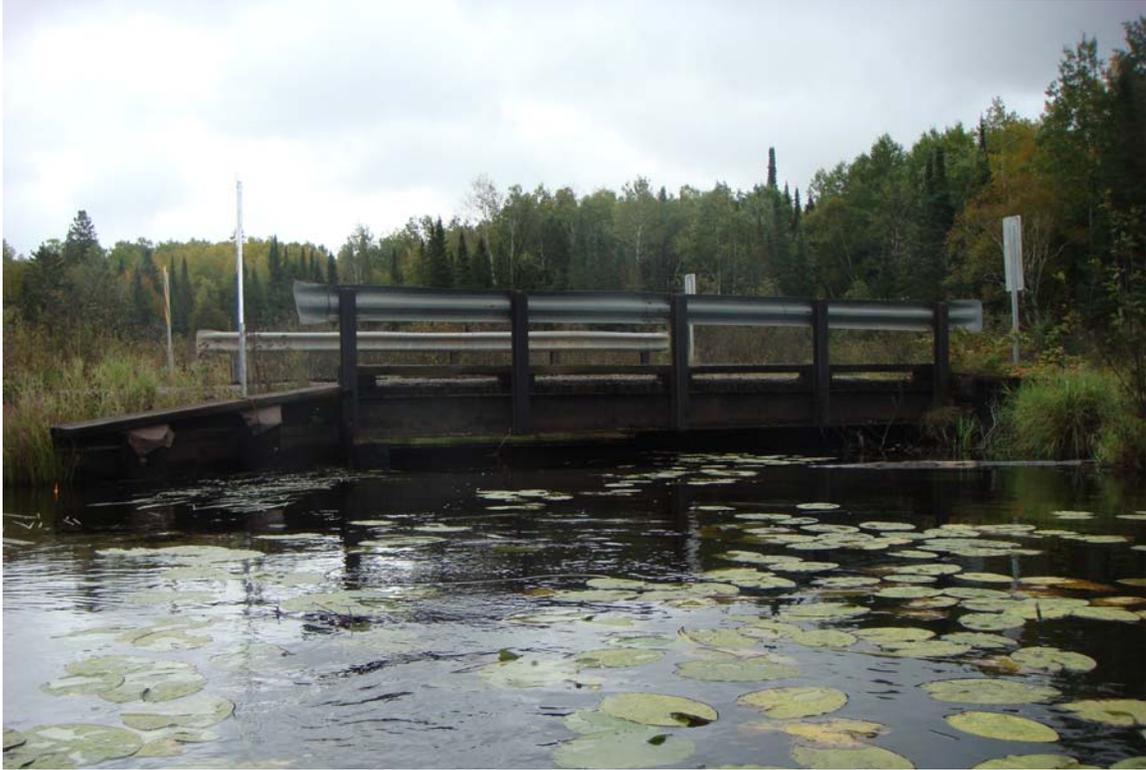
Photograph 1. Overall View of Structure, Looking East

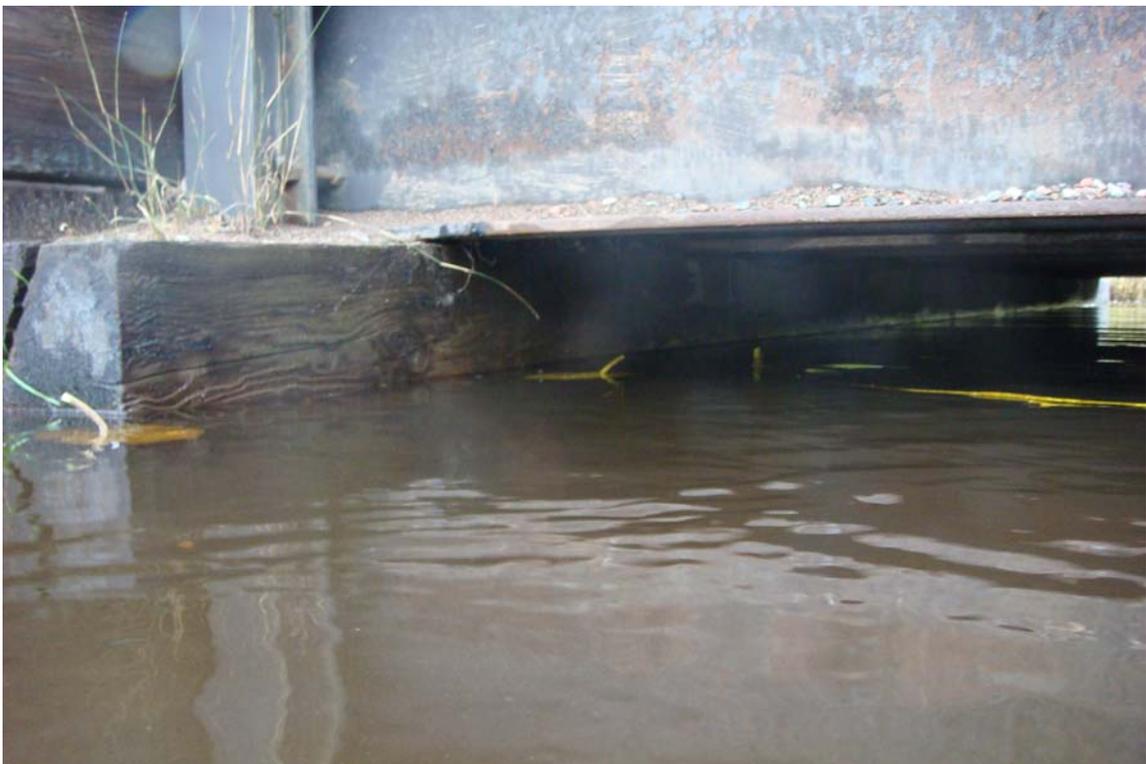
Photograph 2. View of the North Abutment, Looking Northeast.

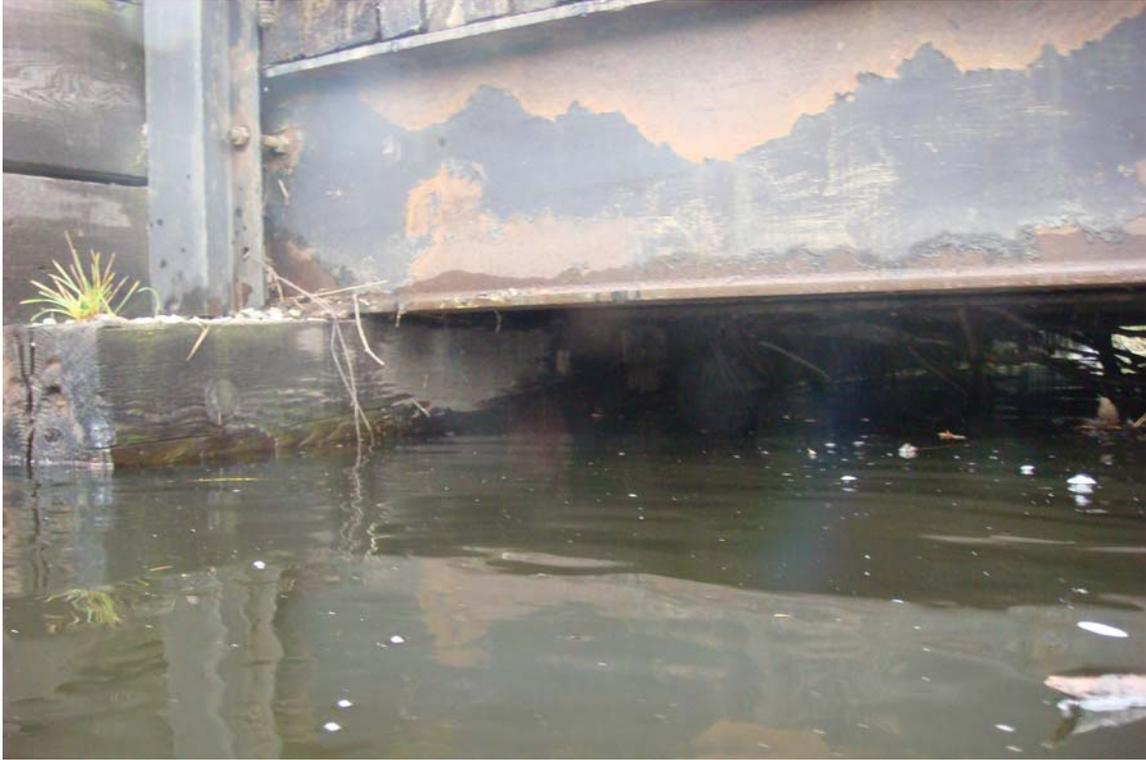
Photograph 3. View of the South Abutment, Looking Southwest.

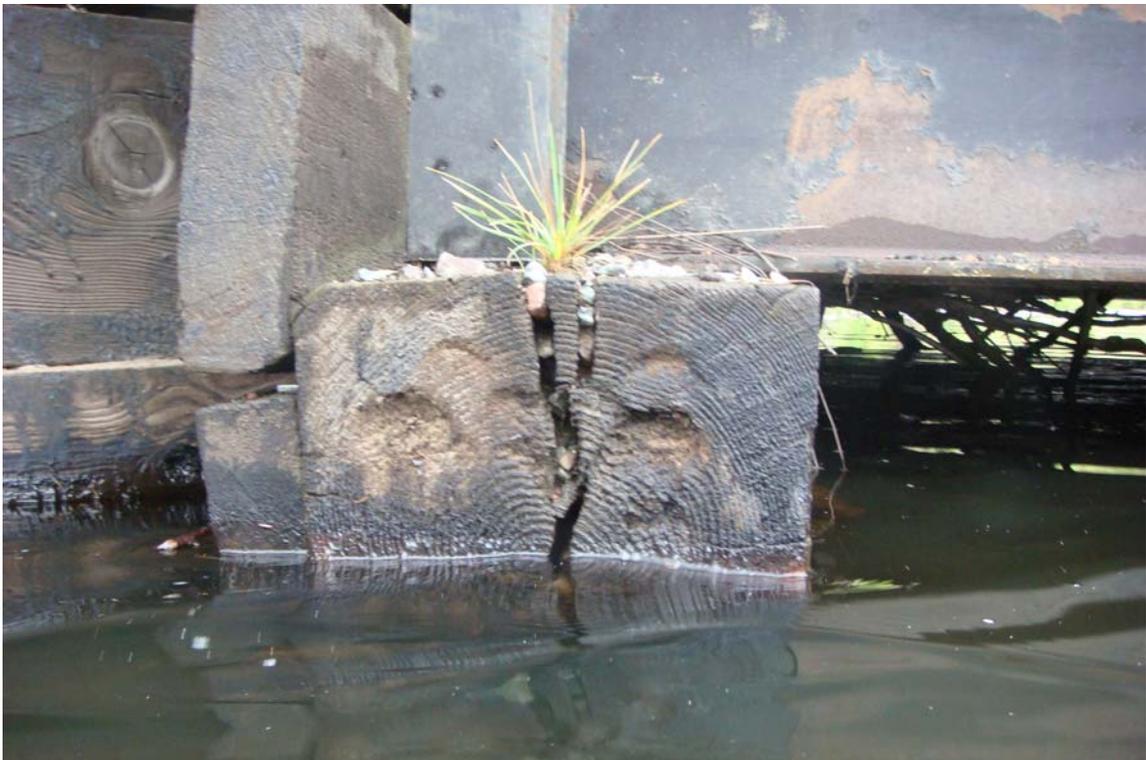
- (C) A split through the full height of the North and South Abutment pile caps was observed running the entire length of the caps. The splits were typically 1/8 inch wide and up to 1 inch wide at the last 5 feet of the upstream and downstream ends. Both pile caps exhibited minor rotation (less than 3°) as a result of the split.

Photograph 4. View of the Split in the South Abutment Pile Cap, Looking West.

Monitor the split in the North and South Abutment pile caps. If noticeable settlement or rotation is found to be developing, consideration should be given to repairing or replacing the timber pile caps.

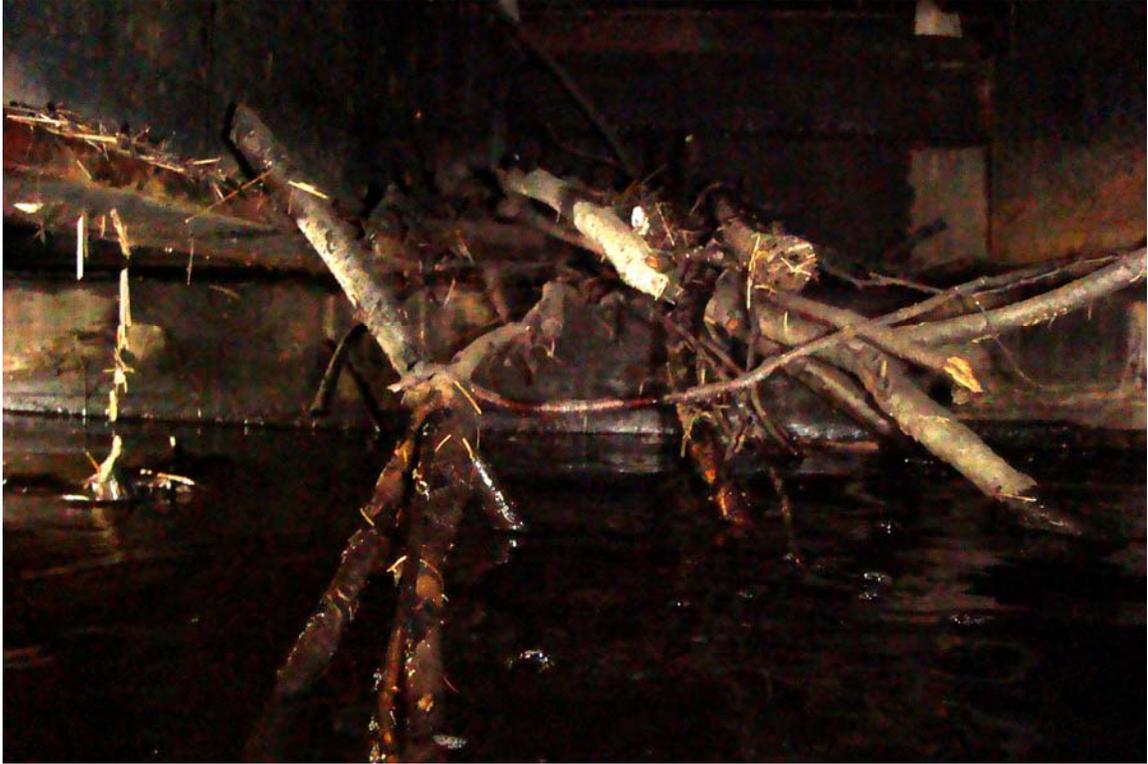
- (D) The timber backwall was typically sound and tight with no noticeable loss of backfill or defects of structural significance.
- (E) A moderate accumulation of timber debris was observed at the South Abutment, consisting of 4 inch diameter and smaller branches extending from the channel bottom to the deck underside and up to 10 feet off the face of the South Abutment.

Photograph 5. View of the Timber Debris Accumulation at the South Abutment, Looking South

The timber debris accumulation at the South Abutment did not appear to significantly affect the channel flow, and as a result, does not require removal at this time. If the debris accumulation increases in size or density, it may be necessary to remove the debris to reduce excessive lateral loads on the abutment, limit further debris accumulation, and reduce the likelihood of channel bottom degradation resulting from obstructed flow.

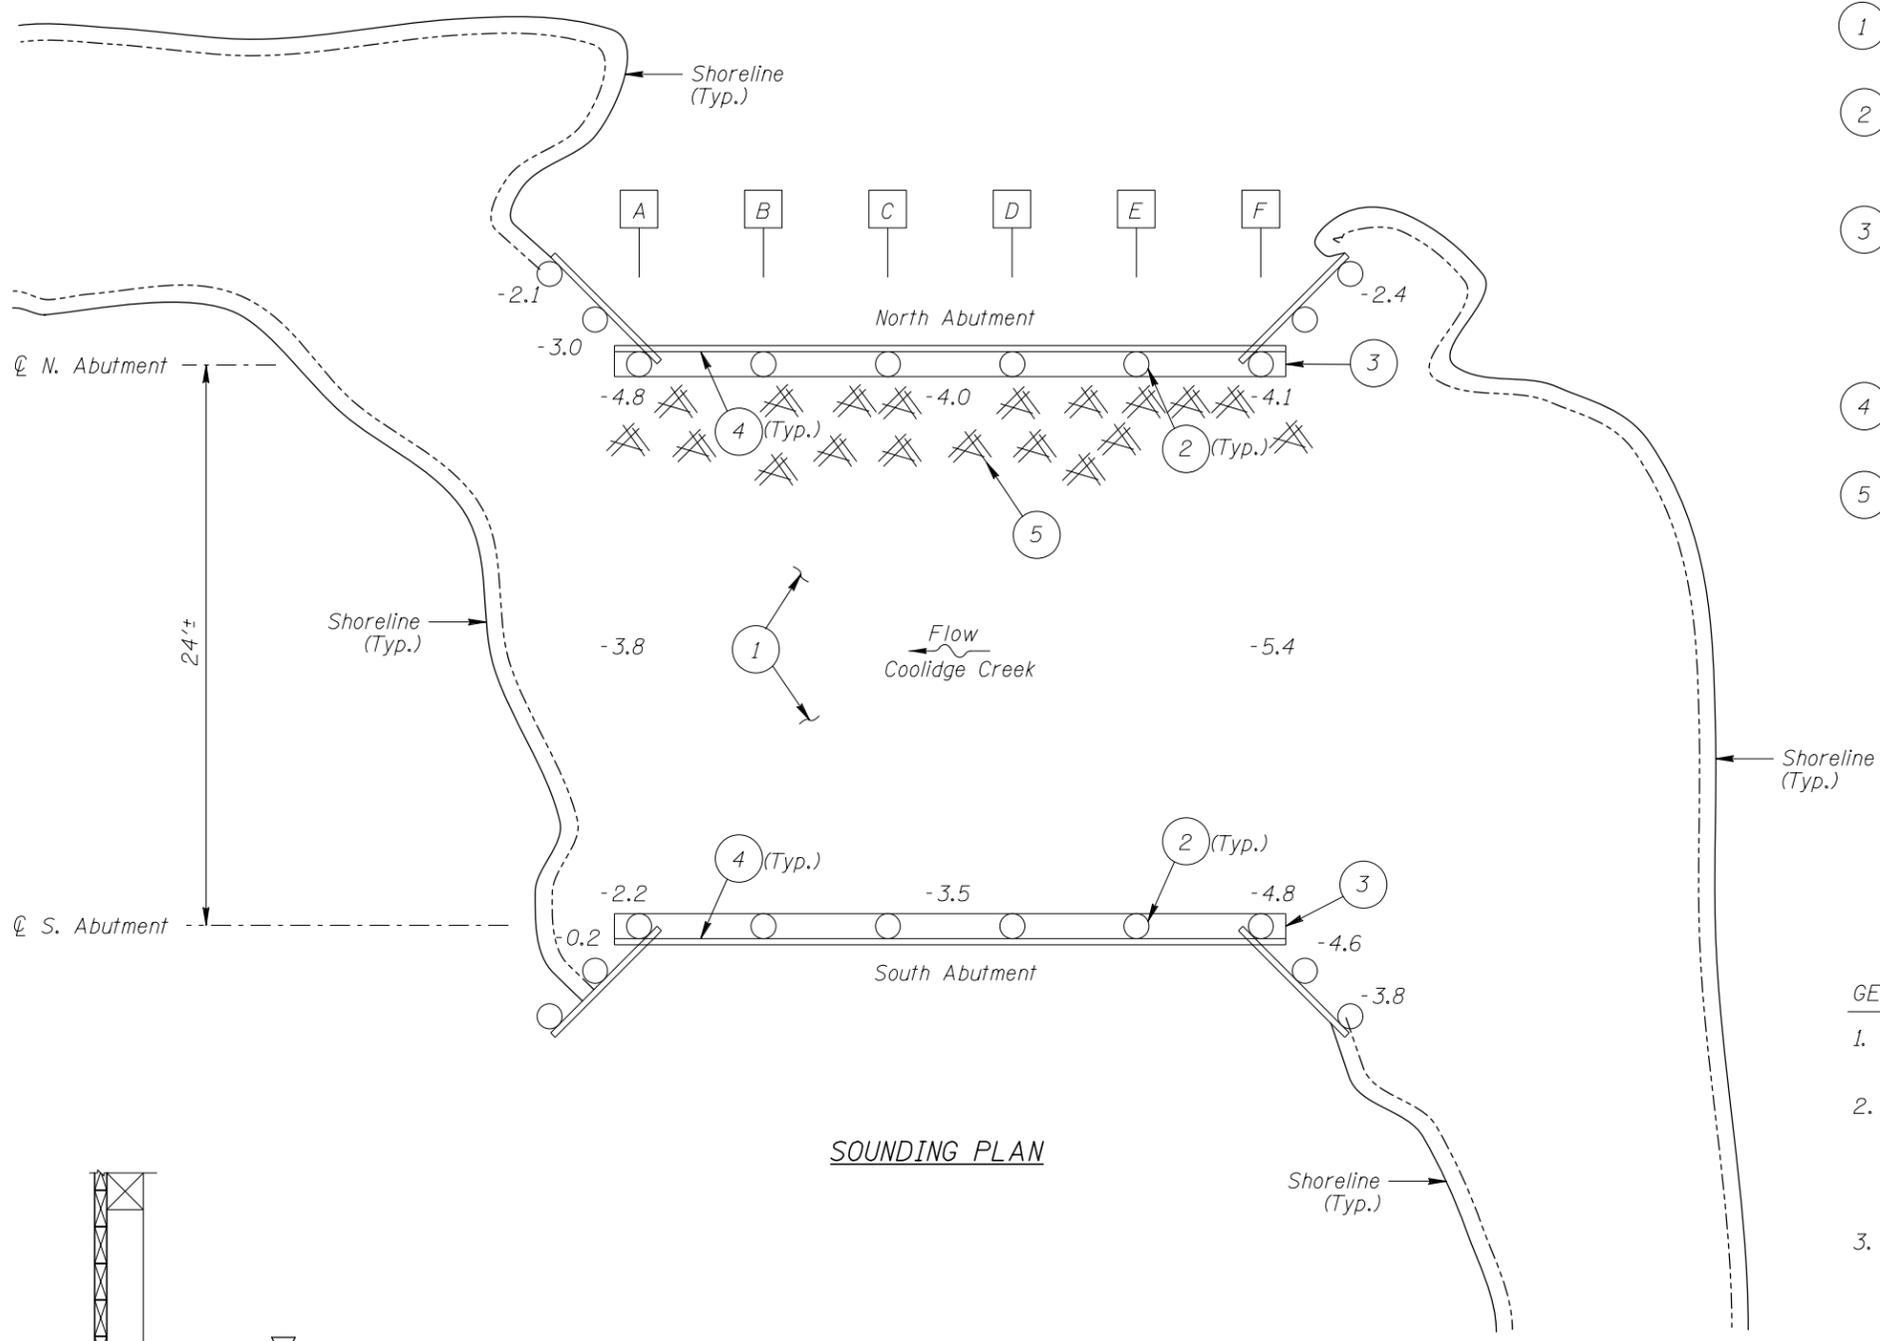
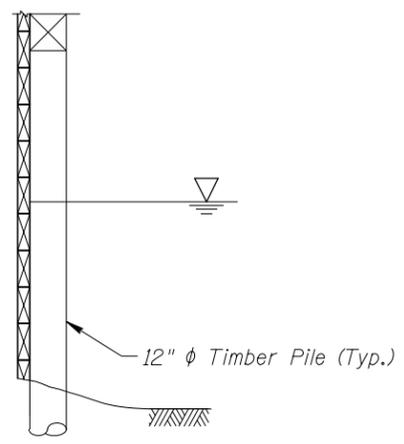
SOUNDING PLAN

- 1 The channel bottom material typically consisted rocks, gravel, and silt with up to 6 inches of probe rod penetration.
- 2 The timber piles were typically sound allowing typical awl penetration of 1/16 inch and exhibiting random splits or checks up to 1/16 inch wide and 1 inch deep.

- 3 A split through the full height of the North and South Abutment pile cap was observed running the entire length of the cap. The split was typically 1/8 inch wide and up to 1 inch wide at the last 5 feet of the upstream and downstream ends. Both pile caps exhibited a minor rotation (less than 3°) as a result of the split.

- 4 The timber backwall was typically sound and tight with no noticeable loss of backfill or defects of structural significance.
- 5 A moderate accumulation of timber debris was observed at the South Abutment consisting of 4 inch diameter and smaller branches extending from the channel bottom to the deck underside and up to 10 feet off the face of the South Abutment.
