UNDERWATER BRIDGE INSPECTION REPORT

STRUCTURE NO. 92698

CR 769

WILLOW RIVER

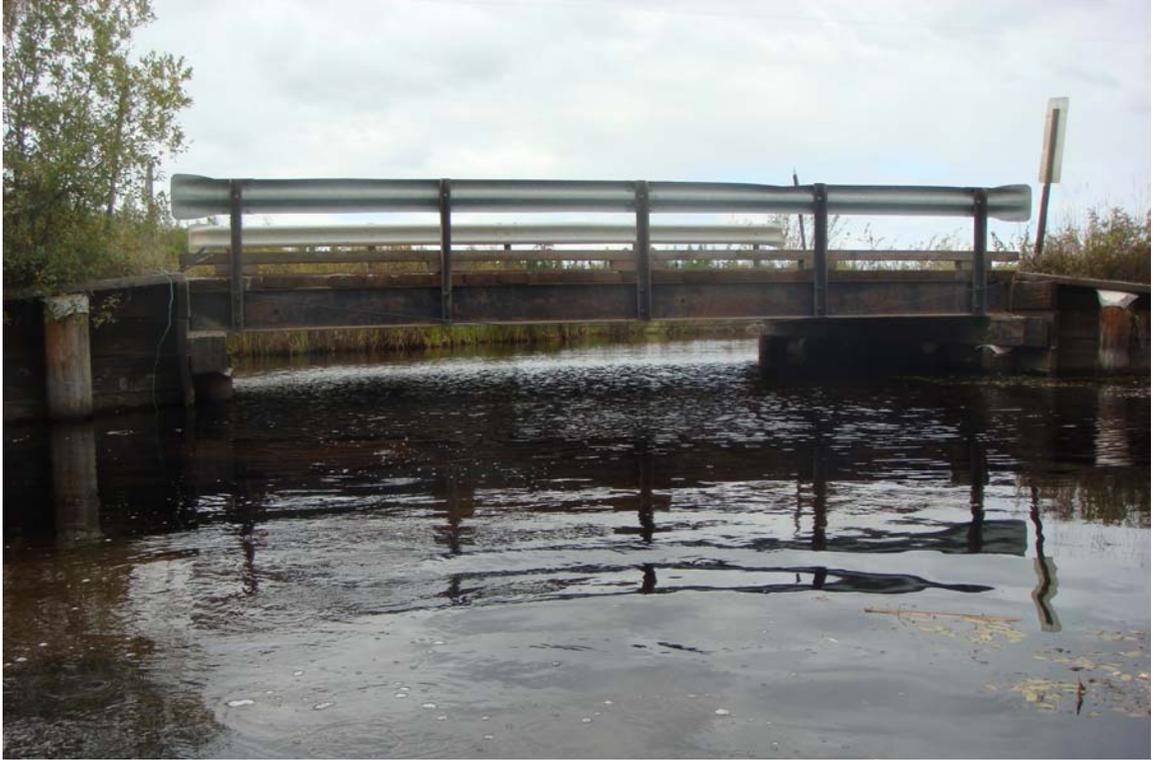
Photograph 1. Overall View of Structure, Looking West

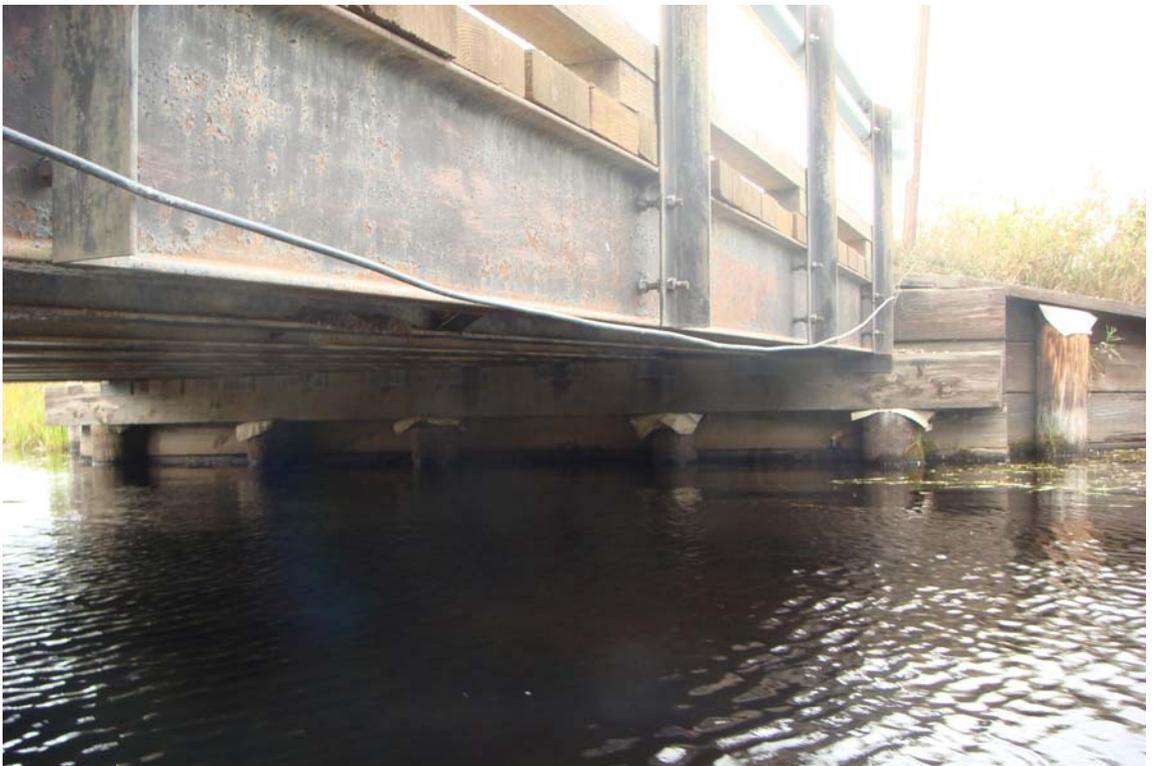
- (C) The timber backwall at the North Abutment was typically sound. The first two backwall boards above the waterline were displaced 2 inches away from the channel. As a result of that displacement, both wingwalls had a gap, up to 2 inches wide, at the backwall.

Photograph 2. View of the North Abutment, Looking North.

- (A) Monitor the timber pile splitting and/or checking and the gaps between the backwall and wingwall boards during future inspections, and if found to be increasing, consideration should be given to repairing these conditions.
- (B) Reinspect the submerged substructure at the normal maximum recommended (NBIS) interval of sixty (60) months.

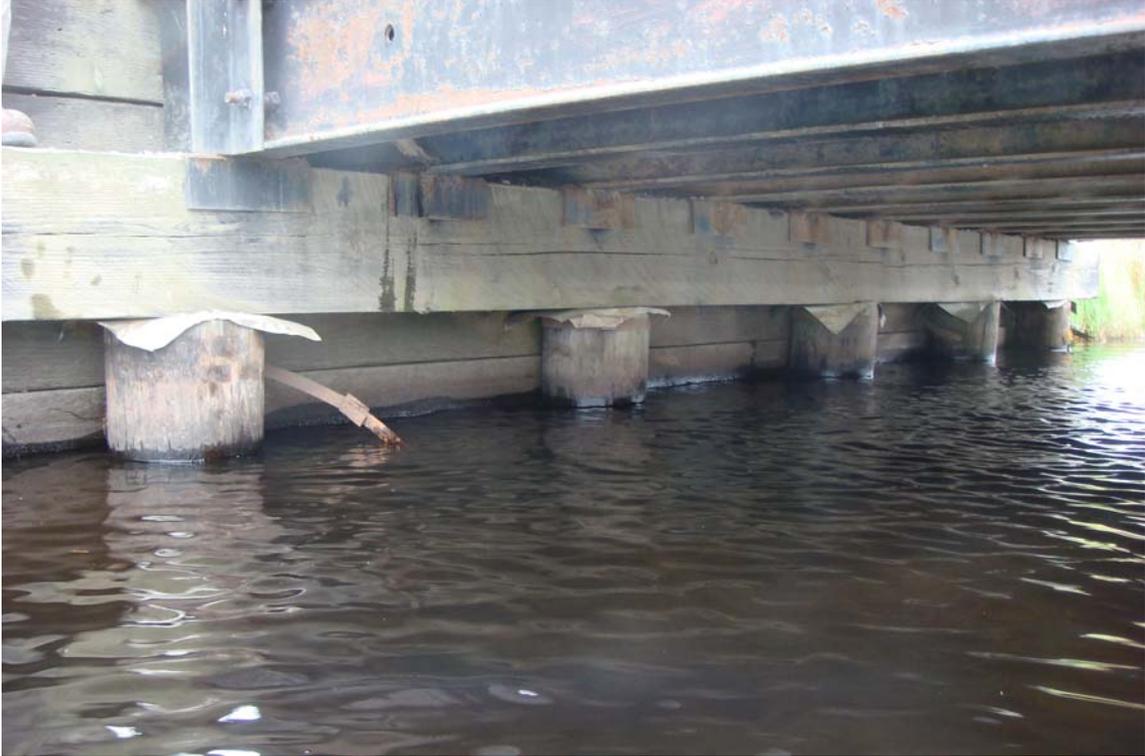
- (D) The timber backwall at the South Abutment was typically sound. The first two backwall boards above the waterline were displaced 1 inch away from the channel. As a result of that displacement, both wingwalls had a gap, up to 1 inch wide, at the backwall.

Photograph 3. View of the South Abutment, Looking Southwest.

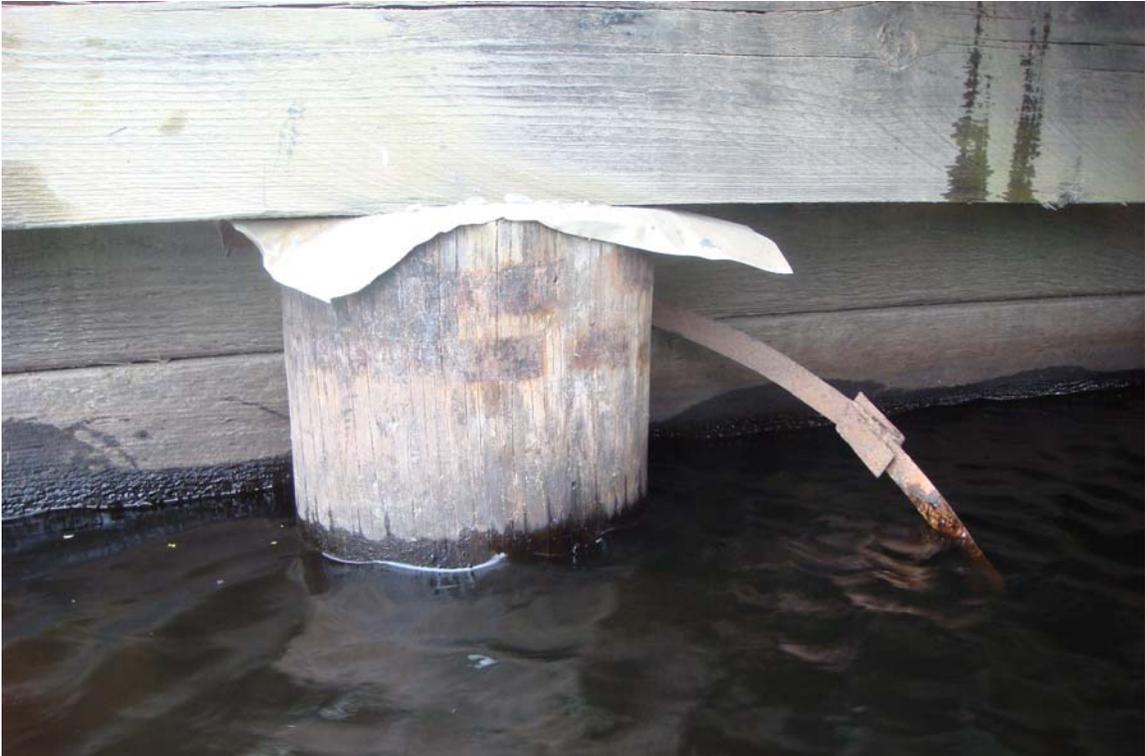
- (A) The channel bottom material typically consisted of sand, gravel, and cobbles with up to 6 inches of probe rod penetration.
- (B) The timber piles were typically sound with random splitting or checking up to 3/8 inches wide and 2 inches deep.

- (E) The metal straps holding the tin flashing in place on top of the piles have come loose. The flashing, however, is still all in place and still effectively protecting the tops of the piles.

Photograph 4. View of the Typical Timber Condition at the Waterline and Loose Tin Cap Strap, Looking South.

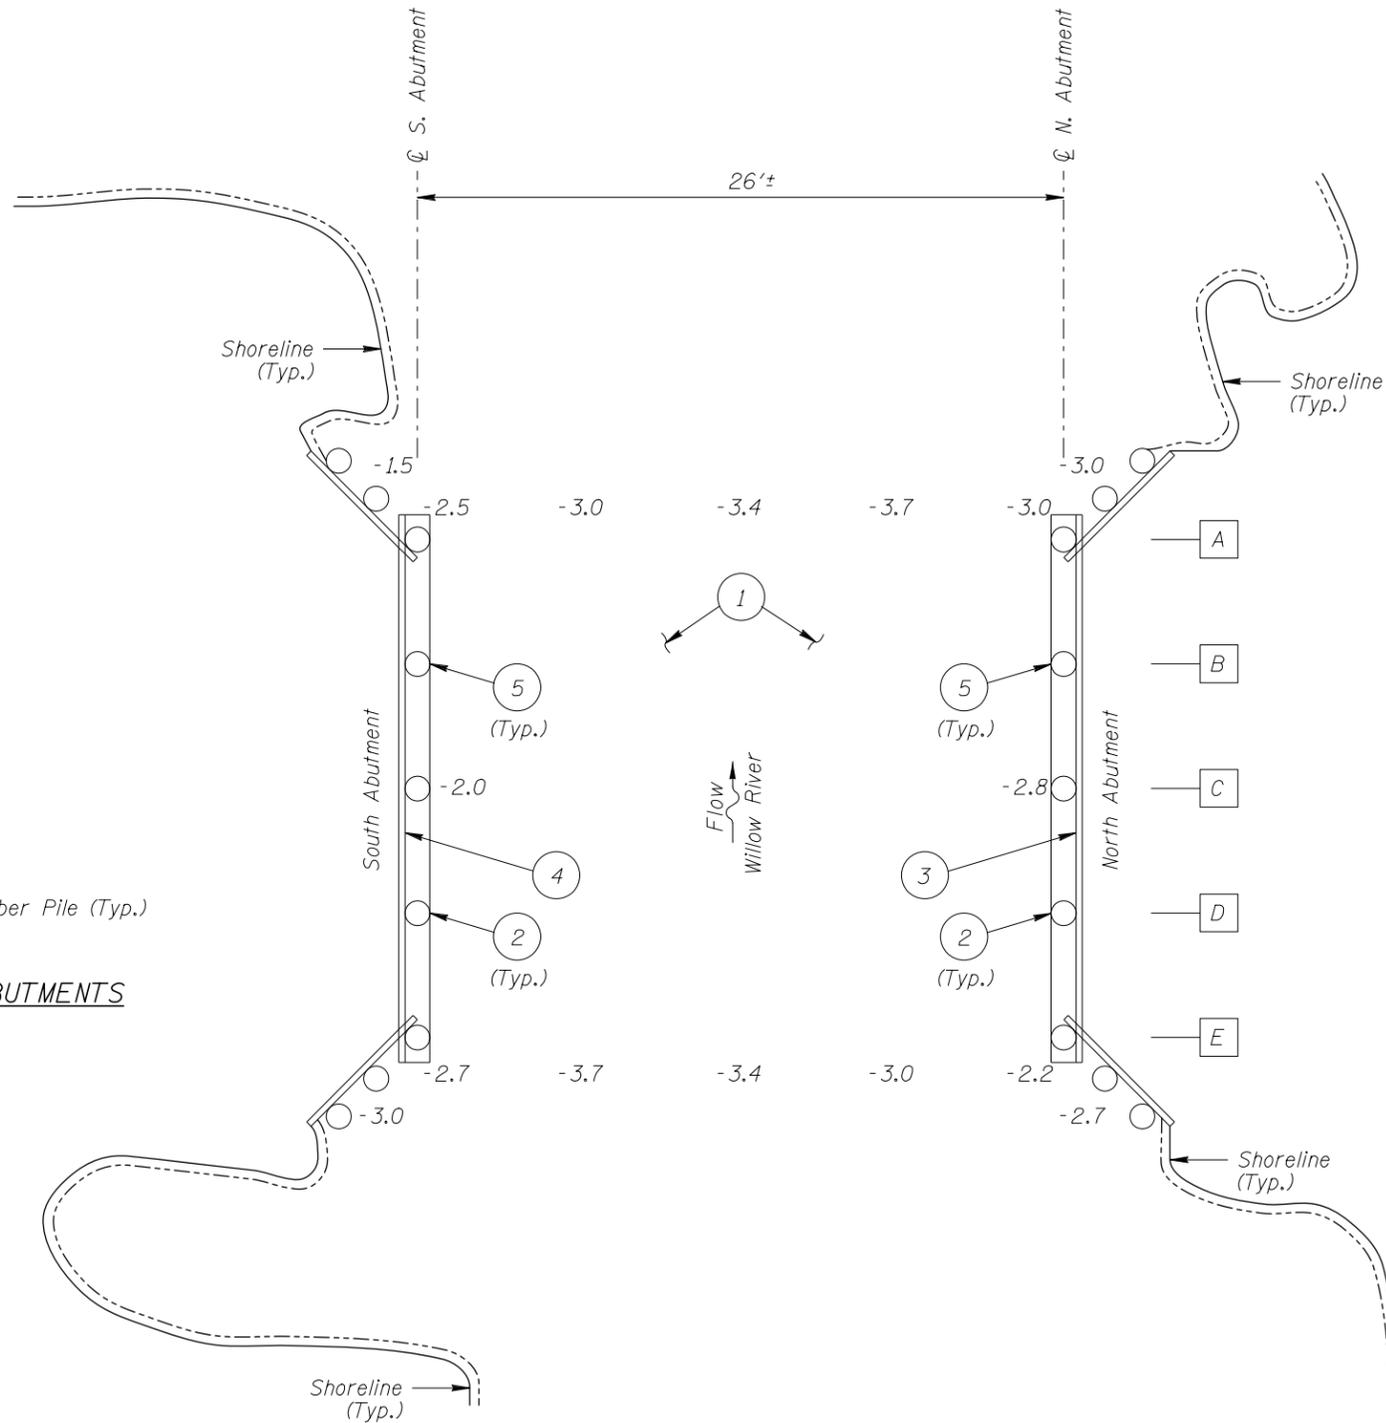
SOUNDING PLAN

- ① The channel bottom material typically consisted of sand, gravel, and cobbles with up to 6 inches of probe rod penetration.
- ② The timber piles were typically sound with random splitting or checking up to  $\frac{3}{8}$  inches wide and 2 inches deep.

- ③ The timber backwall at the North Abutment was typically sound. The first two backwall boards above the waterline were displaced 2 inches away from the channel. As a result of that displacement both wingwalls had a gap, up to 2 inches wide, at the backwall.

- ④ The timber backwall at the South Abutment was typically sound. The first two backwall boards above the waterline were displaced 1 inch away from the channel. As a result of that displacement, both wingwalls had a gap, up to 1 inch wide, at the backwall.

- ⑤ The metal straps holding the tin flashing in place on top of the piles have come loose. The flashing, however, is still all in place and still effectively protecting the tops of the piles.
