UNDERWATER BRIDGE INSPECTION REPORT

STRUCTURE NO. 93020

CR 916

MINNESOTA DEPARTMENT OF TRANSPORTATION
UNDERWATER BRIDGE INSPECTION

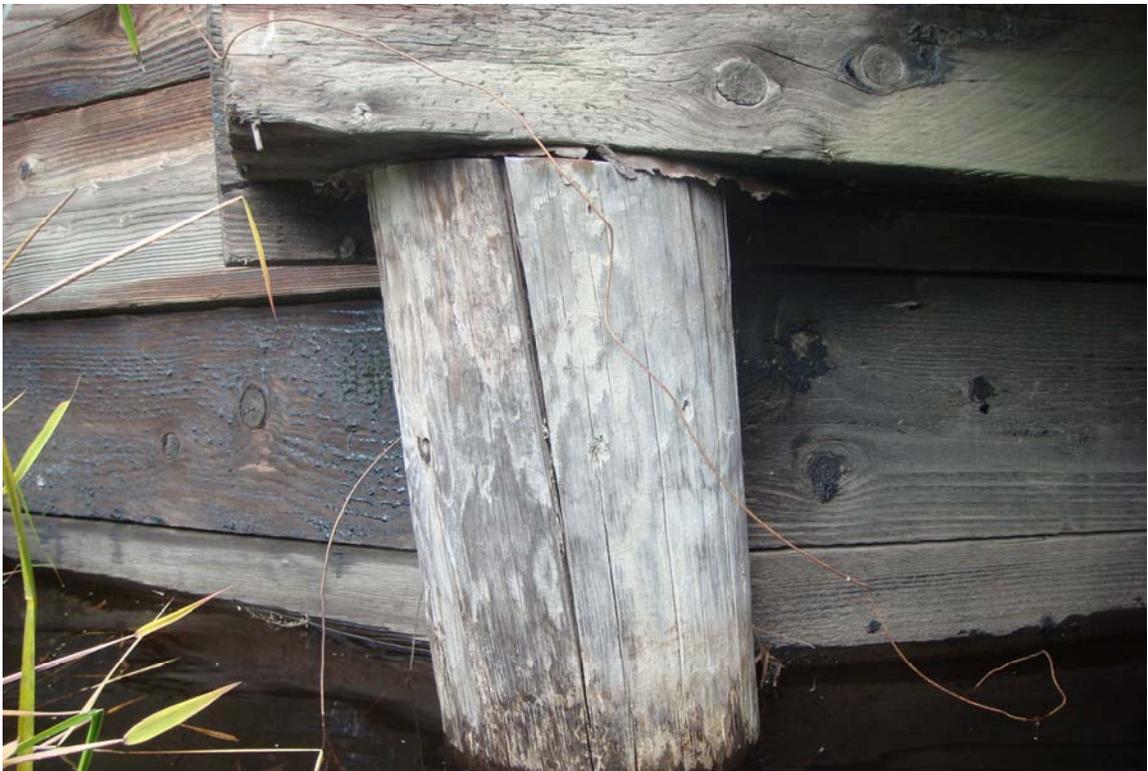
- (A) The channel bottom material typically consisted of rocks up to 1 foot in diameter with no appreciable probe rod penetration.
- (B) The timber piles were typically sound with random splitting or checking up to 1/2 inch wide and 1/2 to 1 inch deep.
- (C) Pile C of the North Abutment had no bearing. There was a 1 inch gap between the top of the pile and the bottom of the pile cap. The pile cap above the pile was deflected downward approximately 1 inch.
- (D) The backwall boards were typically sound with random gaps between the boards of up to 1 inch wide. No appreciable loss of backfill was observed.
- (E) The second backwall board up from the waterline at the South Abutment was displaced 2 inches away from the channel.

Photograph 4. View of the Typical Timber Pile Splitting, Looking North.

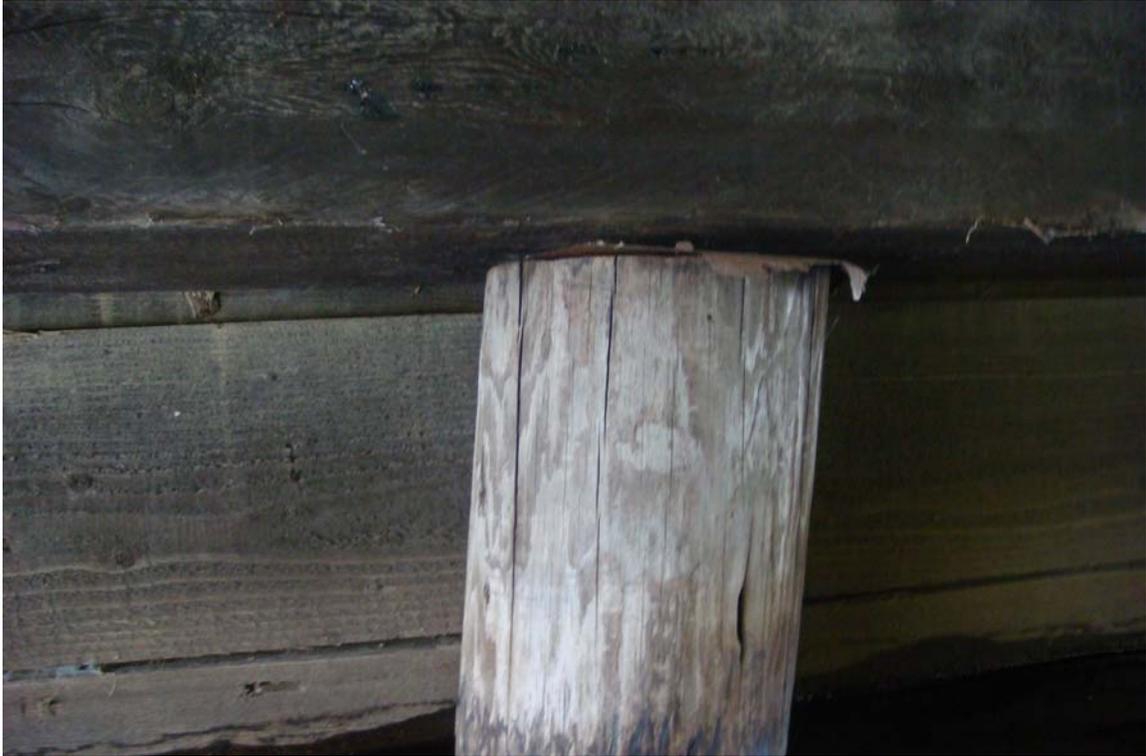
Photograph 5. View of the Gap between the Pile Cap and Pile C at the North Abutment, Looking Northeast.

Place shims between the top of Pile C of the North Abutment and the pile cap to restore full bearing to the pile.

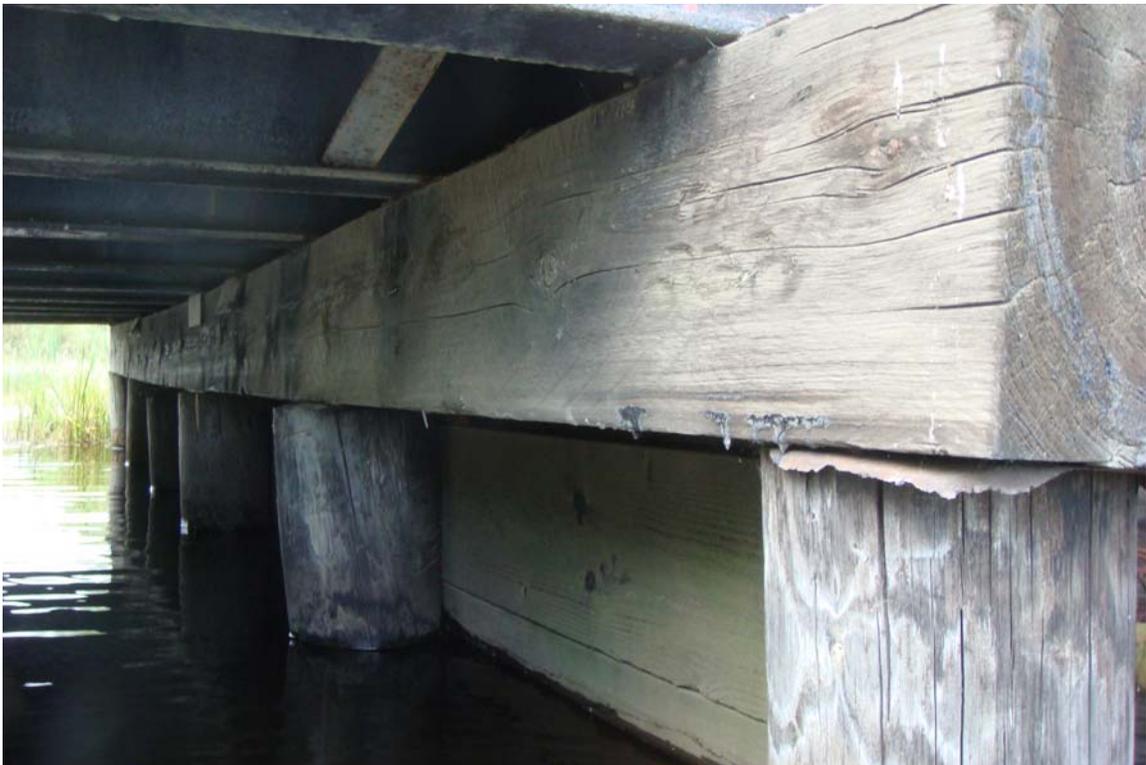
Photograph 6. View of the Deflection of the North Abutment Pile Cap, Looking West.

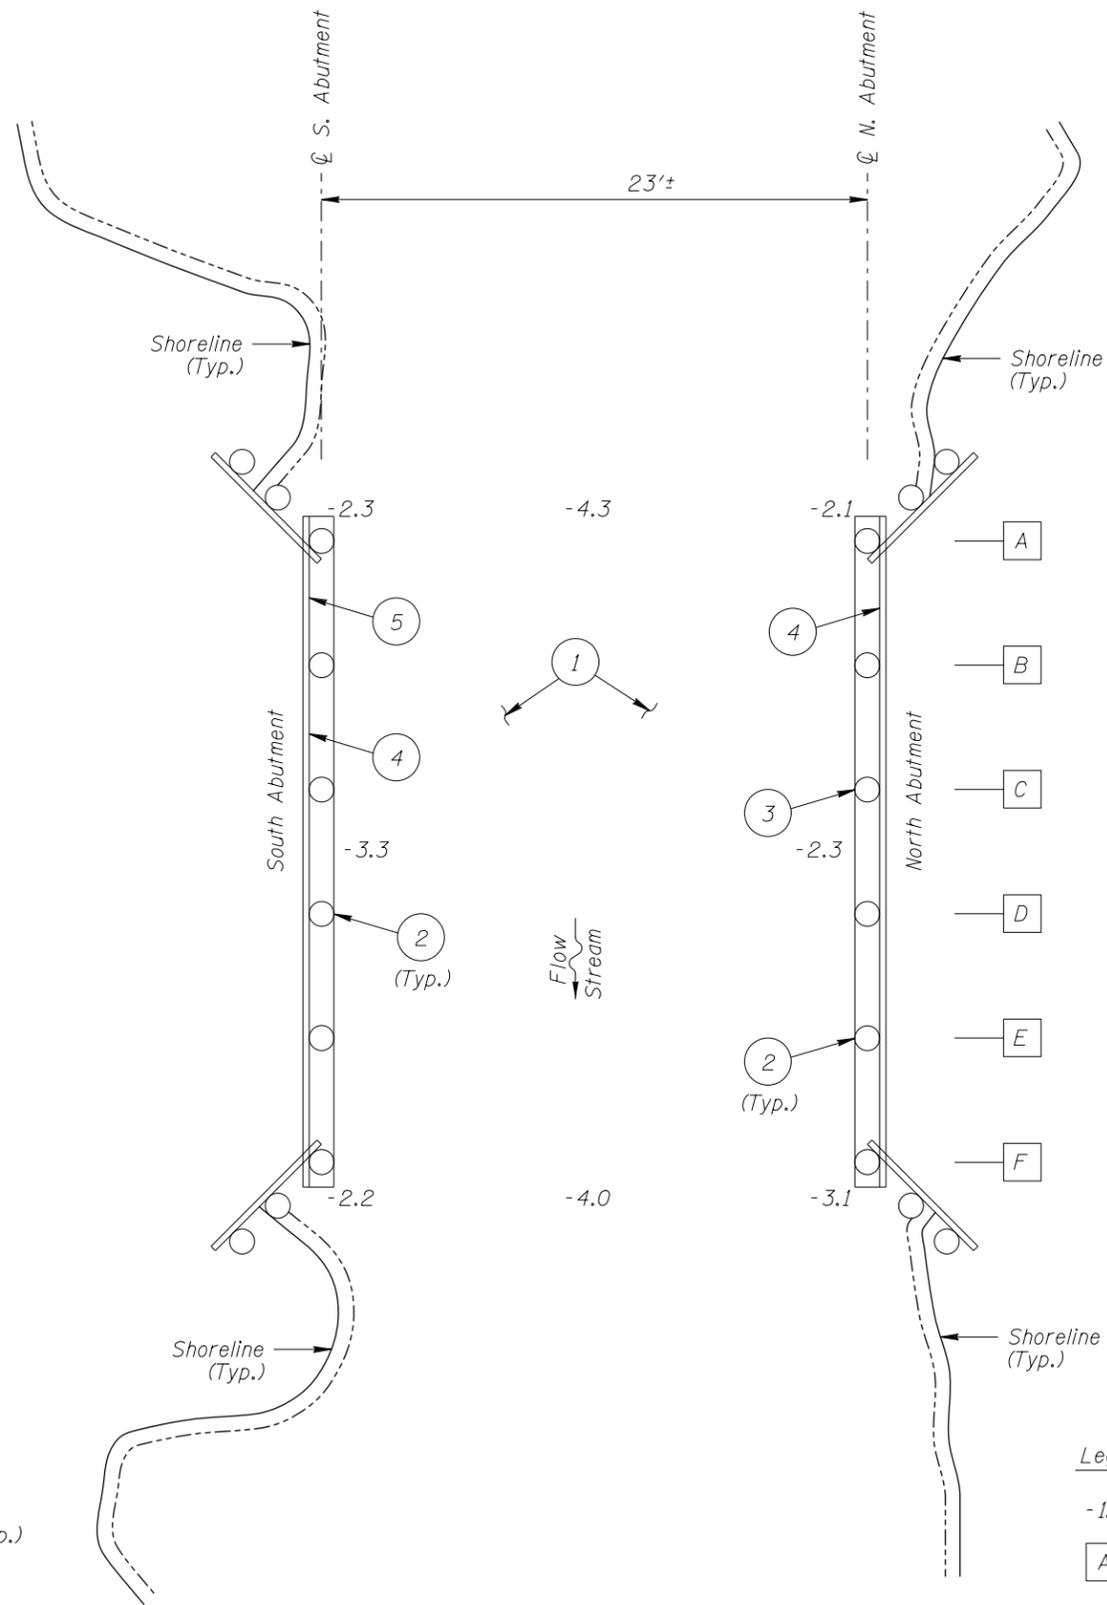
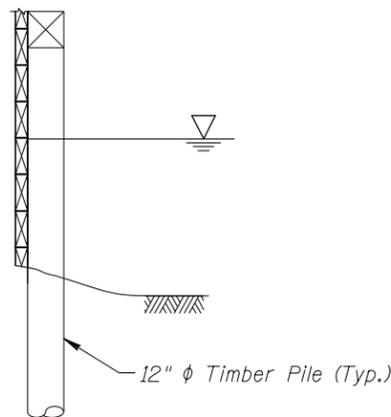
SOUNDING PLAN

- 1 The channel bottom material typically consisted of rocks up to 1 foot in diameter with no appreciable probe rod penetration.
- 2 The timber piles were typically sound with random splitting and checking up to 1/2 inch wide and 1/2 to 1 inch deep.
- 3 Pile C of the North Abutment had no bearing. There was a 1 inch gap between the top of the pile and the bottom of the pile cap. The pile cap above the pile was deflected downward approximately 1 inch.
- 4 The backwall boards were typically sound with random gaps between the boards of up to 1 inch wide. No appreciable loss of backfill was observed.
- 5 The second backwall board up from the waterline at the South Abutment was displaced 2 inches away from the channel.
