UNDERWATER BRIDGE INSPECTION REPORT

STRUCTURE NO. 93278

CSAH 52

PICNIC CREEK

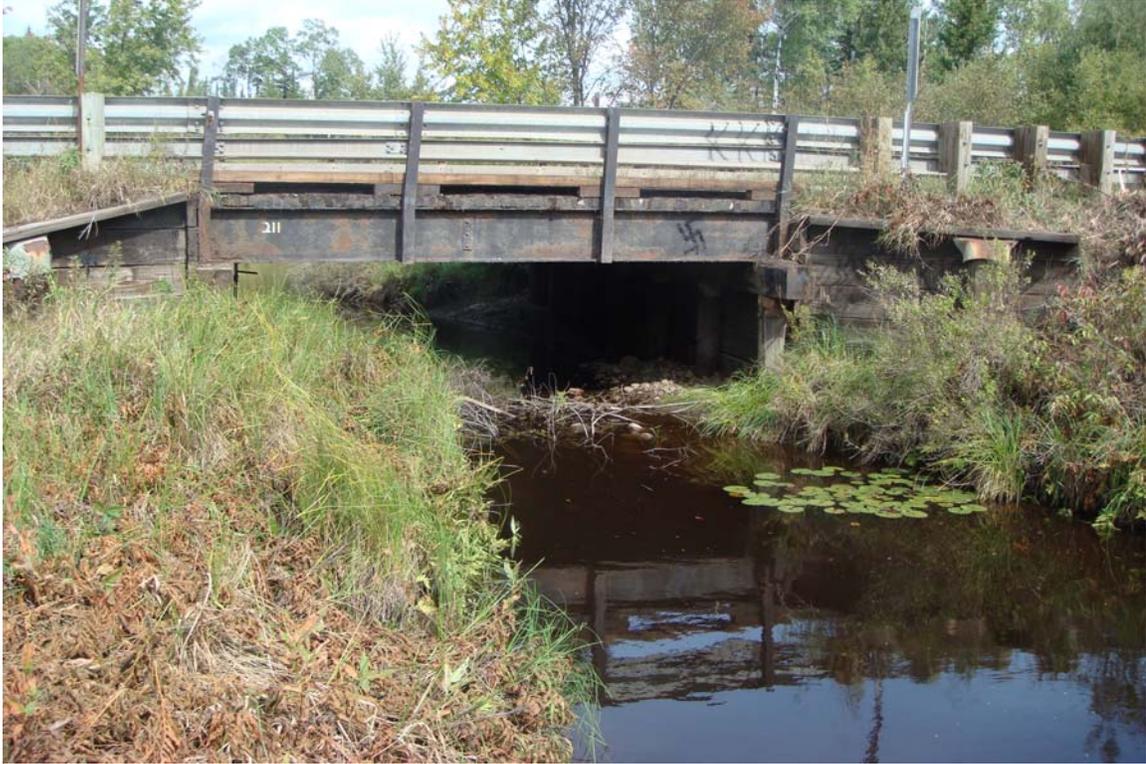
Photograph 1. Overall View of Structure, Looking North.

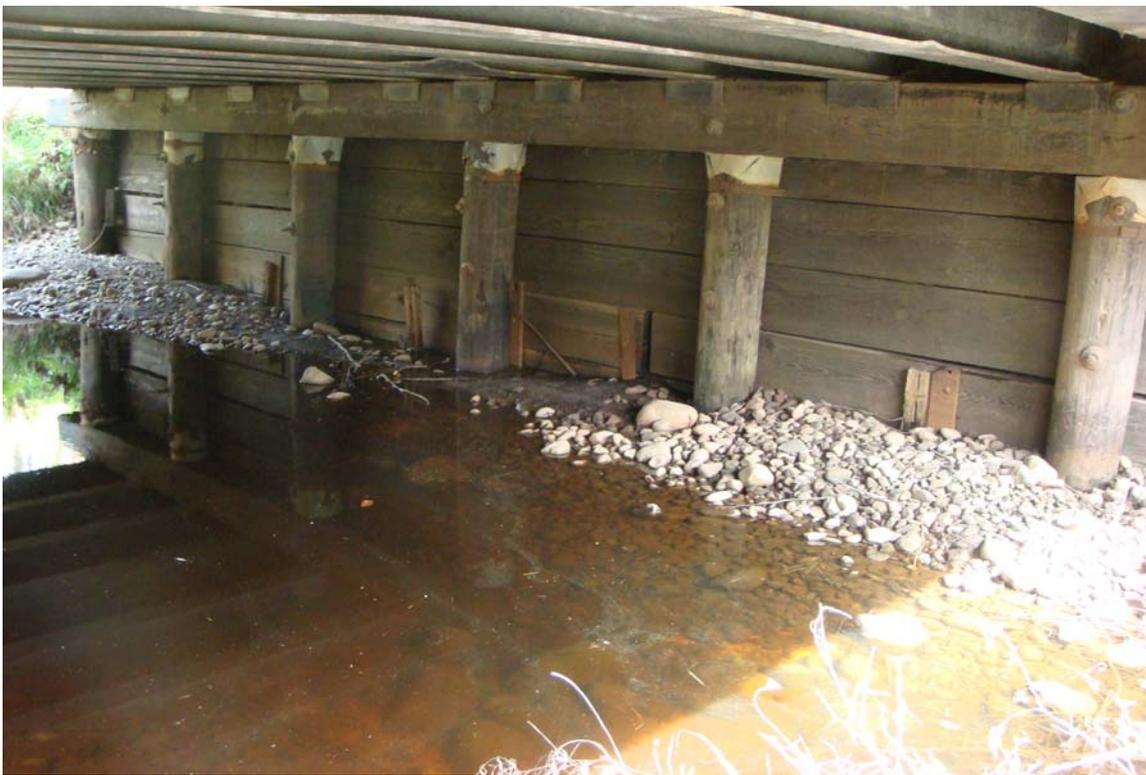
Photograph 2. View of the East Abutment, Looking Northeast.

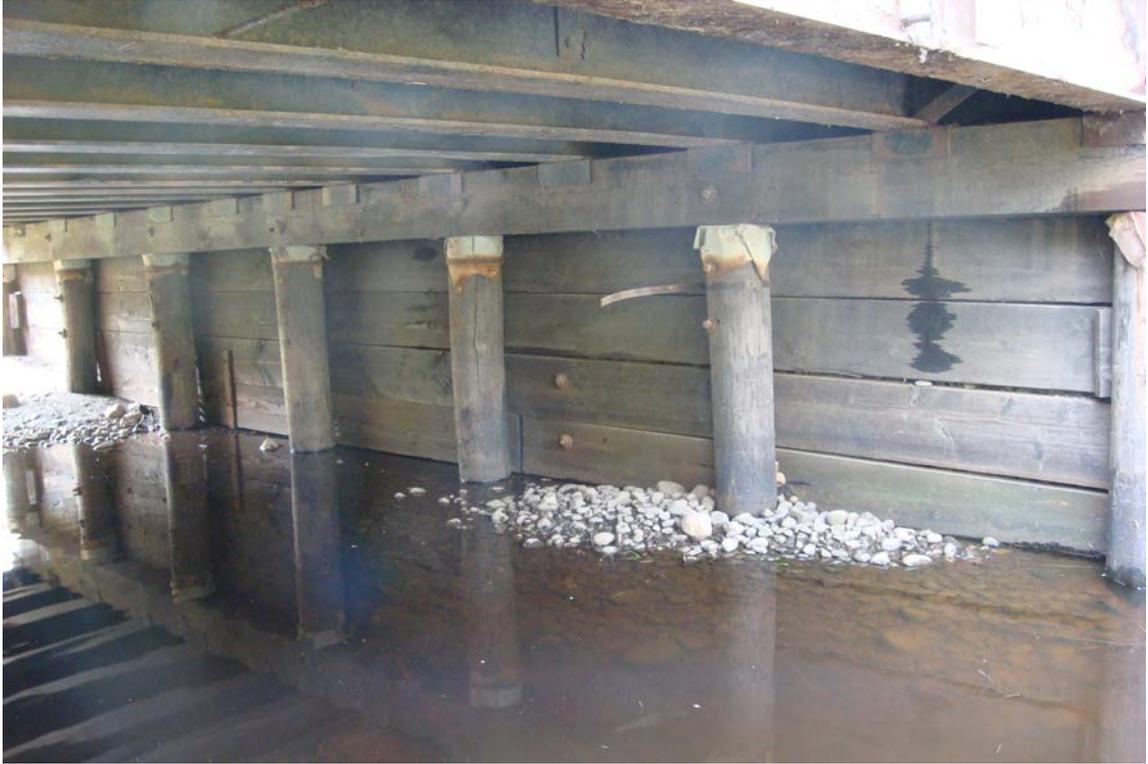
Photograph 3. View of the West Abutment, Looking Southwest.

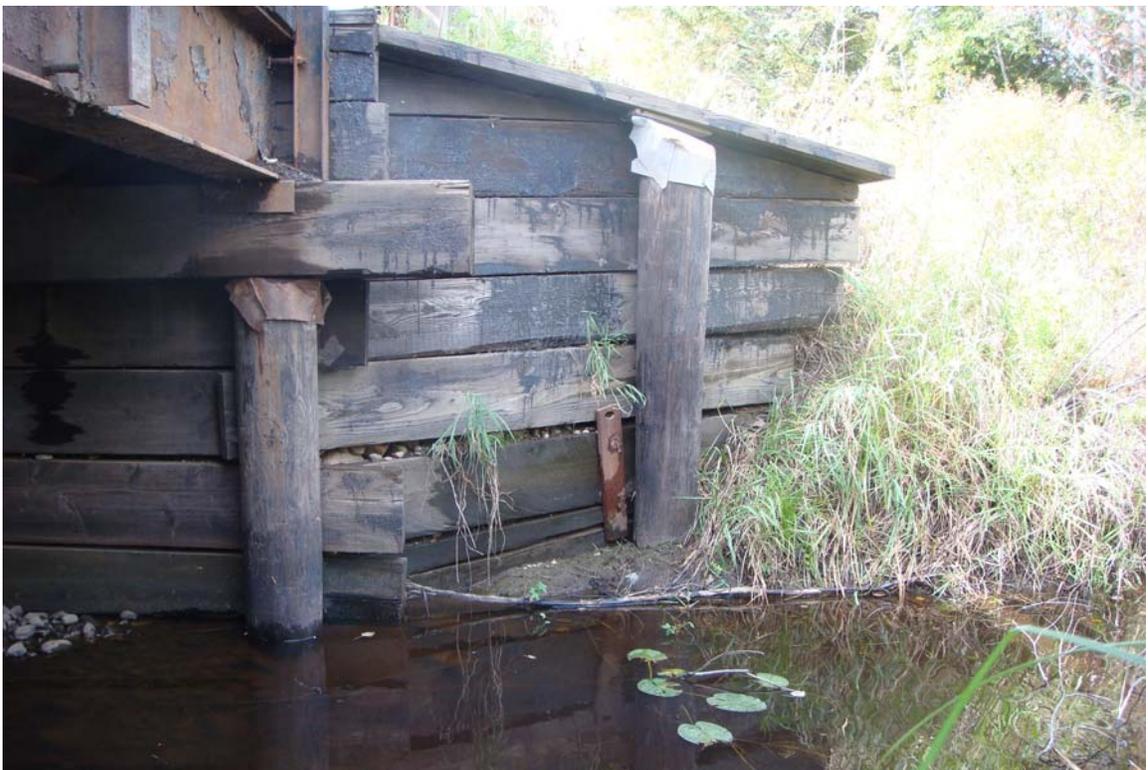
Photograph 4. View of Typical Gaps in the Northwest Wingwall Boards, Looking West.

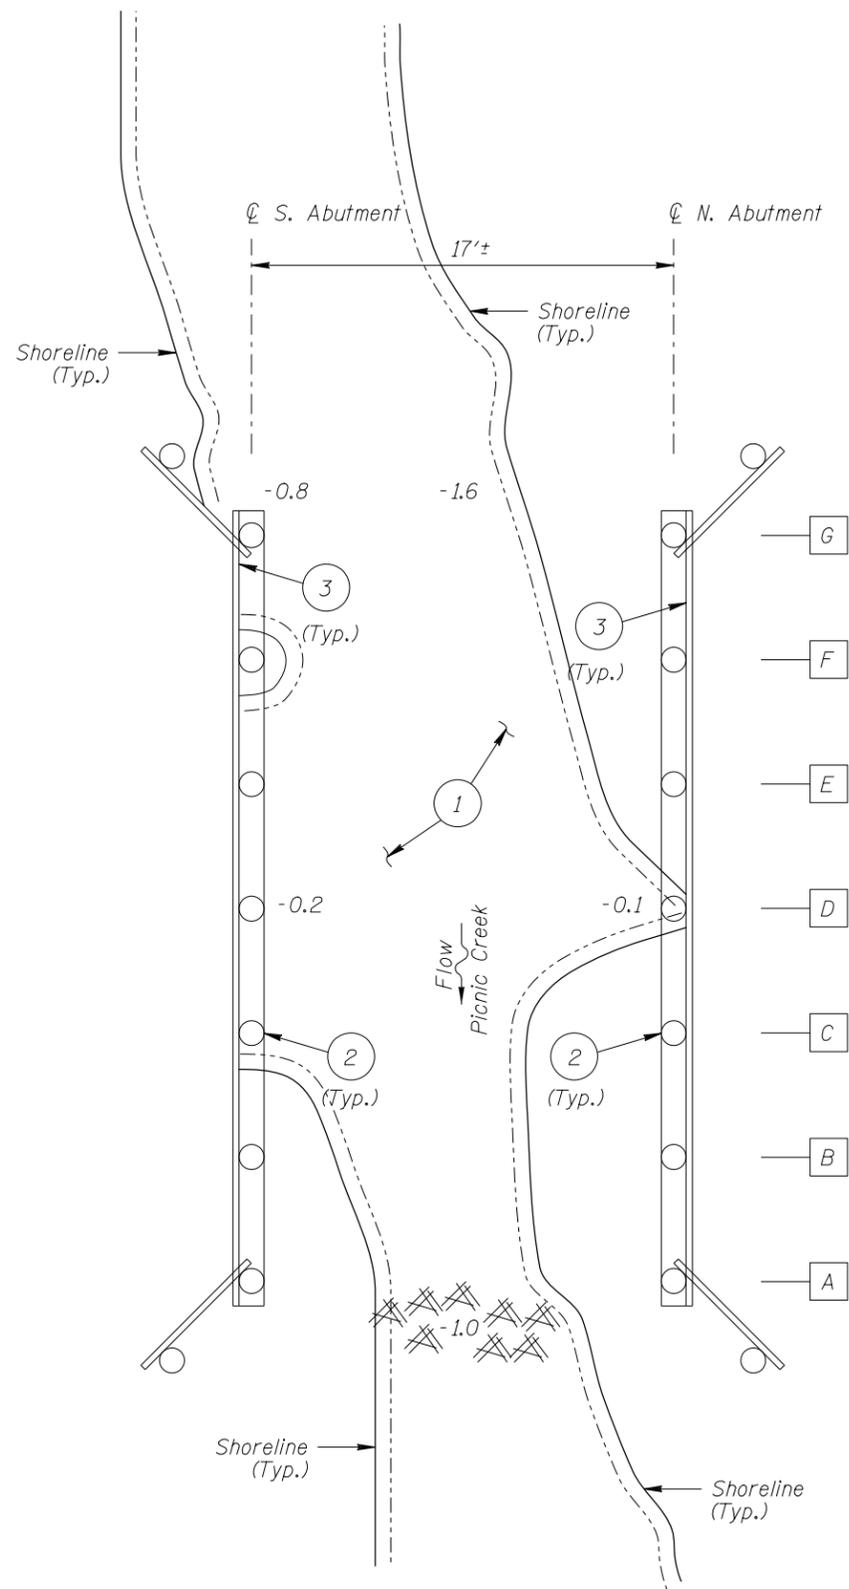
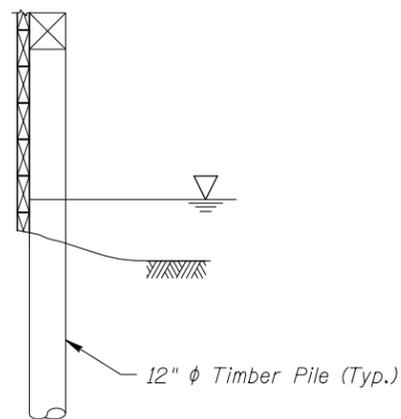
SOUNDING PLAN

- 1 The channel bottom material typically consisted of rocks and stones up to 6 inches in diameter and silt infill with a maximum probe rod penetration of 6 inches.
- 2 The timber piles were typically sound with random splitting or checking up to $\frac{1}{8}$ inch wide and 1 inch deep.
- 3 The backwall boards were typically sound with random gaps between the boards up to 2 inches wide. No appreciable loss of backfill was observed.
- 4 A moderate accumulation of timber debris, consisting of 2 inch diameter and smaller branches, was observed across the downstream fascia and extending from the channel bottom to 1 foot above the waterline.
