UNDERWATER BRIDGE INSPECTION REPORT

STRUCTURE NO. 93280
CR NO. 119
OVER THE
EAST BRANCH OF THE RAT ROOT RIVER
DISTRICT 1 - KOOCHICHING COUNTY

AUGUST 13, 2012
PREPARED FOR THE
MINNESOTA DEPARTMENT OF TRANSPORTATION
BY
COLLINS ENGINEERS, INC.
JOB NO. 7423

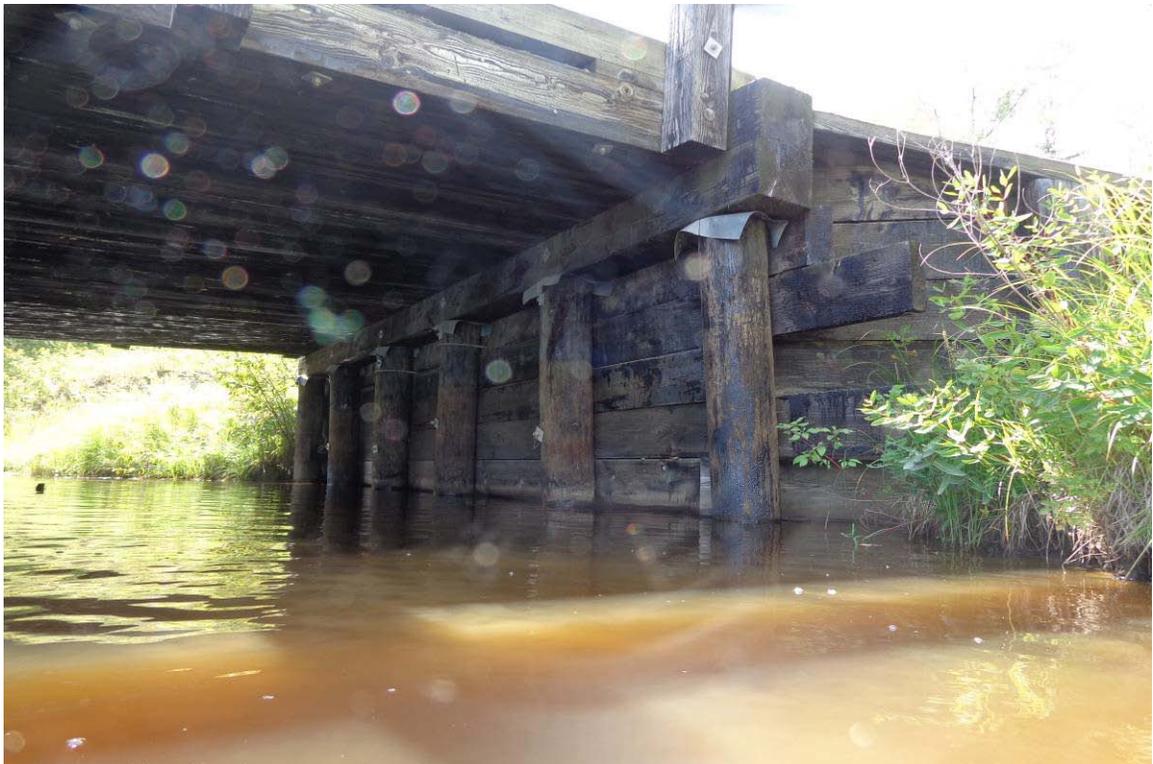
- (E) The east diagonal brace of Pier 2 exhibited a full depth split from Pile 1 to Pile 4, located 2 inches to 6 inches from the top face.
- (F) The pile cap of the West Abutment was slightly rotated back with 75 percent typical bearing on the piles.

Photograph 4. View of West Abutment, Looking Southwest.

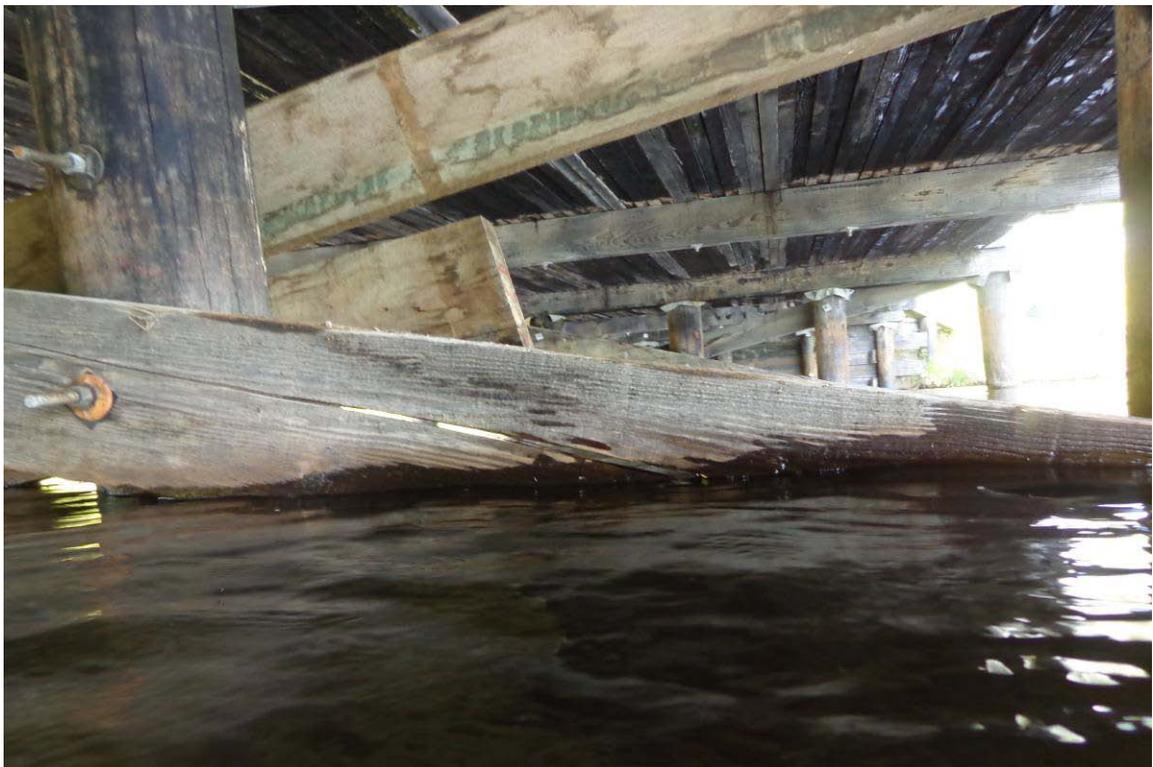
Photograph 6. View of Split in Diagonal Brace at Pier 2, Looking West.

- ⑤ The east diagonal brace of Pier 2 exhibited a full depth split from Pile 1 to Pile 4, located 2 inches to 6 inches from the top face.
- ⑥ The pile cap of the West Abutment was slightly rotated back with 75 percent typical bearing on the piles.

- (A) The diagonal timber cross braces that are split and/or deteriorated through the fasteners at Piers 1 and 2 should be replaced during routine maintenance.

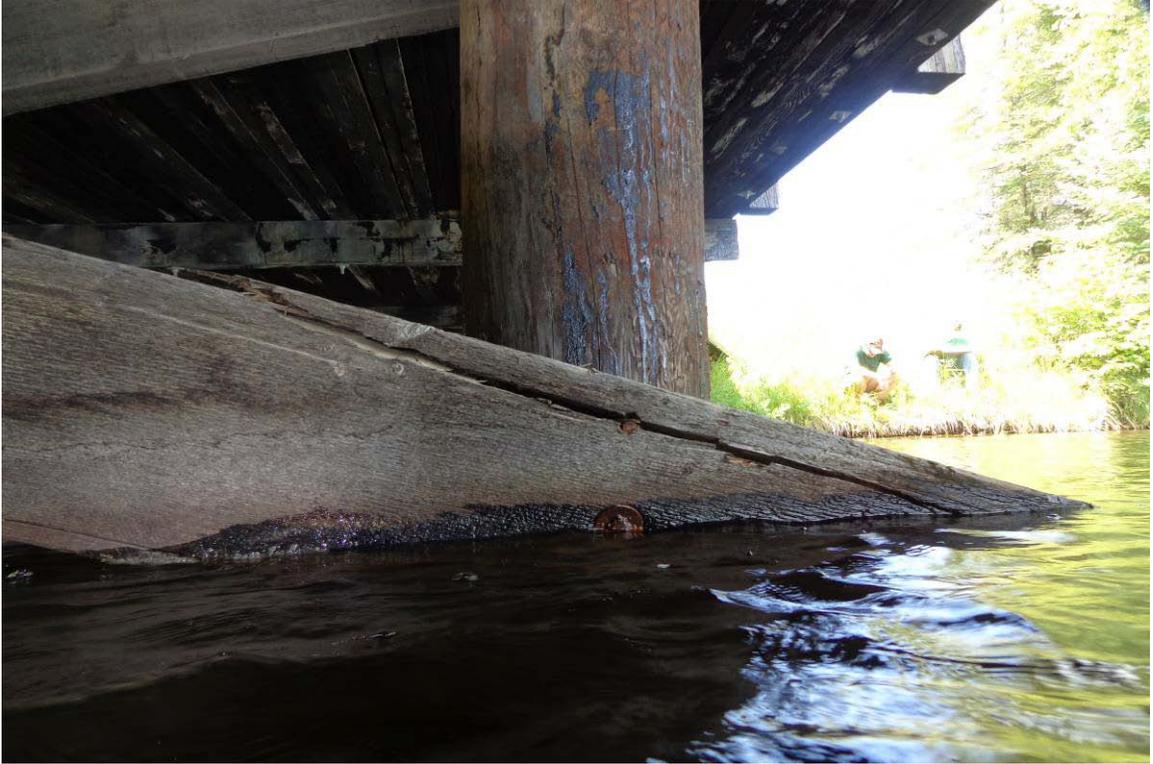
- (C) The east diagonal brace at Pier 1 exhibited a full depth split from Pile 2 extending 3 feet to the north, located 2 inches from the top face.
- (D) Curved steel ice-breaker plates from just below the pile caps down to approximately 1 foot below the waterline were attached to the south face of Pile 6 at Piers 1 and 2.

Photograph 7. View of Split in Diagonal Brace at Pier 1, Looking West.

- ③ The east diagonal brace at Pier 1 exhibited a full depth split from Pile 2 extending 3 feet to the north, located 2 inches from the top face.
- ④ Curved steel ice-breaker plates from just below the pile caps down to approximately 1 foot below the waterline were attached to the south face of Pile 6 at Piers 1 and 2.

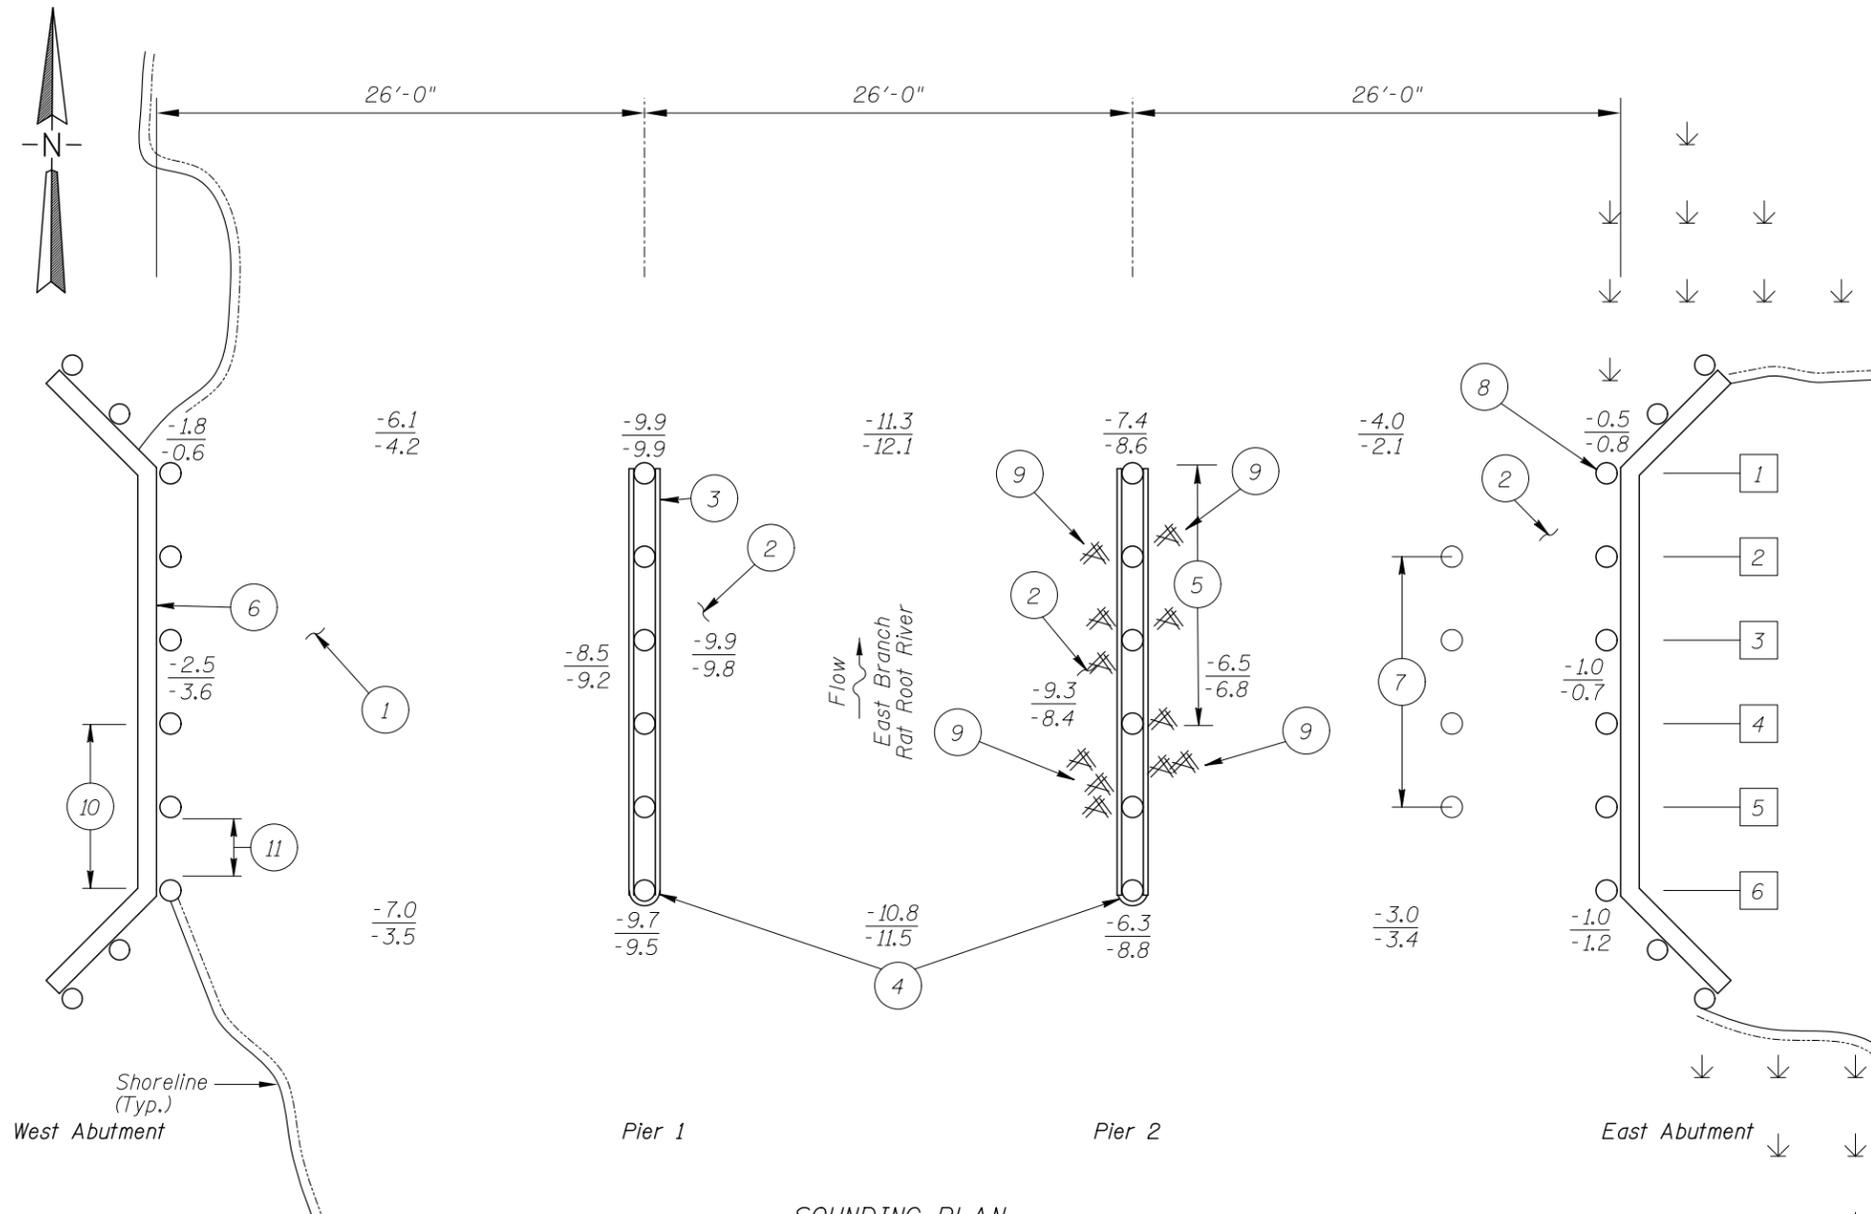
SOUNDING PLAN

- ① The channel bottom material at the West Abutment consisted of soft, silty, sandy clay with 6 inches to 1 foot of probe rod penetration.
- ② The channel bottom material around Piers 1 and 2 and the East Abutment consisted of 6 inch to 12 inch diameter riprap with silty sand infill.

- ⑦ A row of abandoned piles cut off at 2 inches above the channel bottom between Pier 2 and the East Abutment.
- ⑧ A large vertical split approximately 2 feet high by 1/4 inch wide, with 1 inch penetration located at top of Pile 1 of the East Abutment.

- ⑨ Light accumulation of timber debris at Piles 2 through 5 of Pier 2, with up to 6 inch diameter pieces, typically extending from the channel bottom to the waterline.

- ⑩ Escaping fill was observed at 1 inch gap in horizontal planking of the West Abutment, 4 feet above mudline, with 3 inches maximum penetration.
- ⑪ Escaping fill was observed at 1 inch gap in horizontal planking of the West Abutment, 3 feet above mudline, with 3 inches maximum penetration.
