# UNDERWATER BRIDGE INSPECTION REPORT

STRUCTURE NO. 93373

CSAH 52

WHITEFACE RIVER

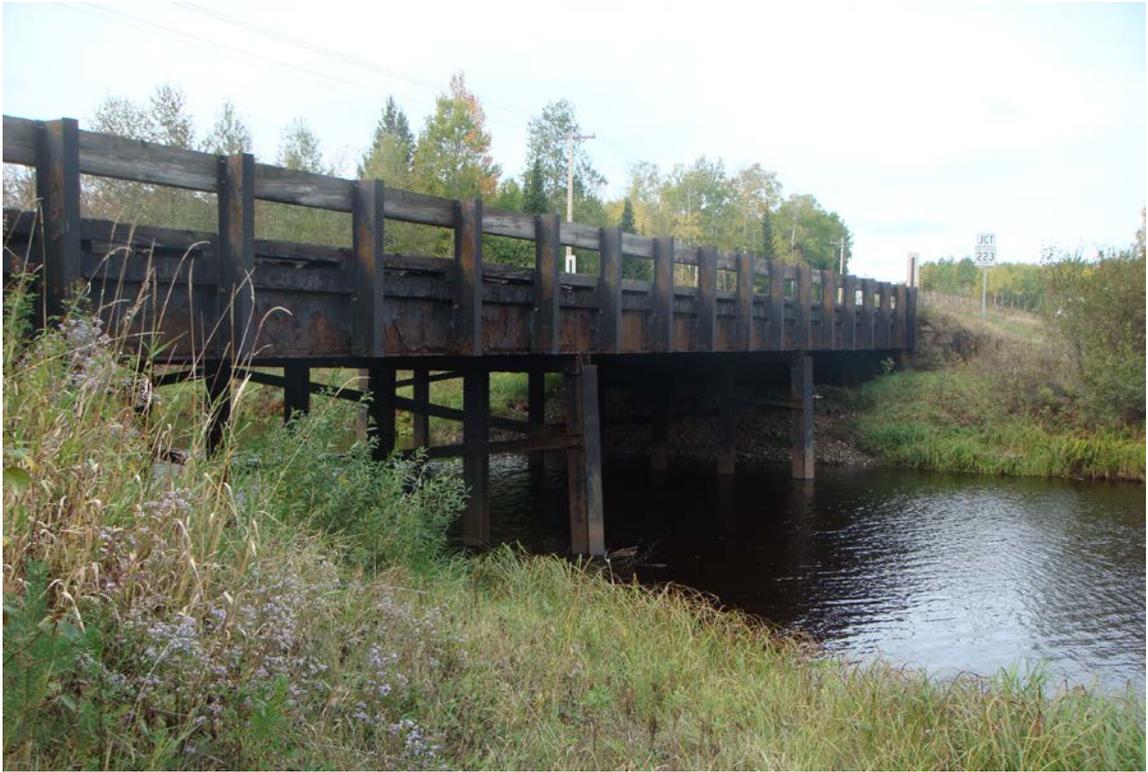
Photograph 1. Overall View, Looking Southwest.

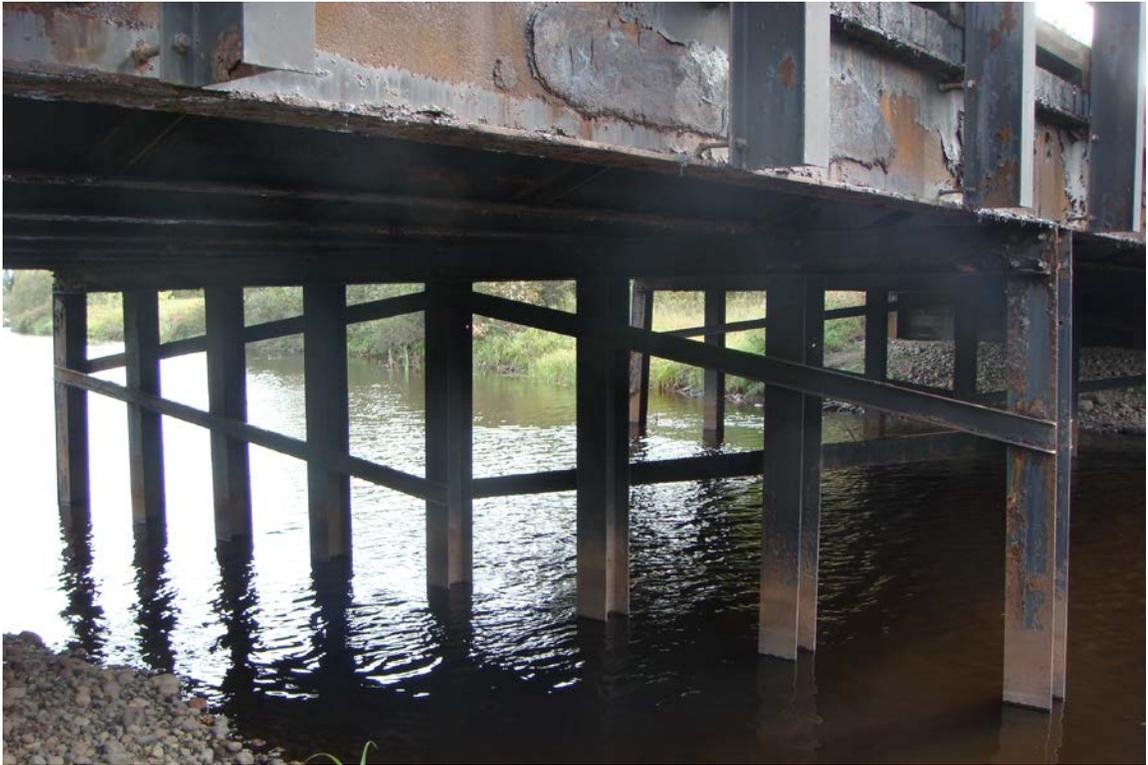
Photograph 2. View Bent 1, Looking Southeast.

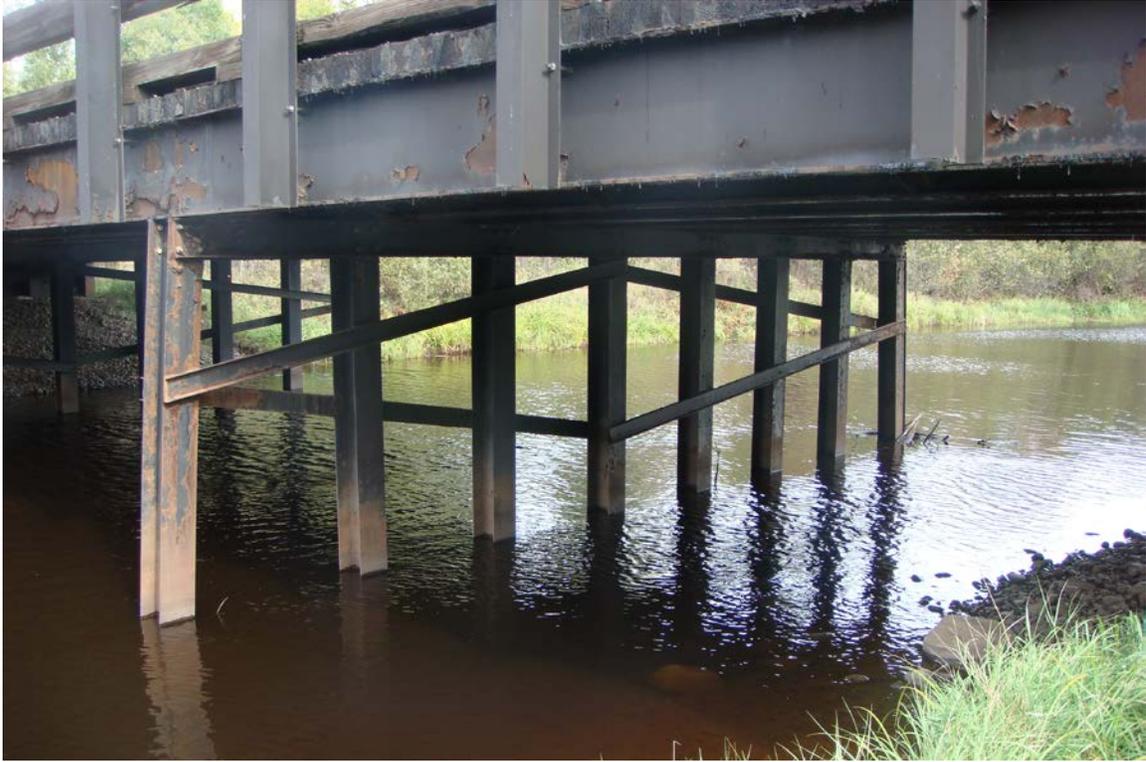
- (C) The steel channel cross-bracing of the bents typically exhibited rust delaminations up to 1/2 inch thick.
- (D) A light accumulation of timber debris, consisting of 6 inch diameter and smaller branches, was observed extending from the channel bottom to the waterline along the entire length of Bent 2 and extended 5 feet upstream and downstream from the bent noses.

Photograph 3. View of Bent 2, Looking East.

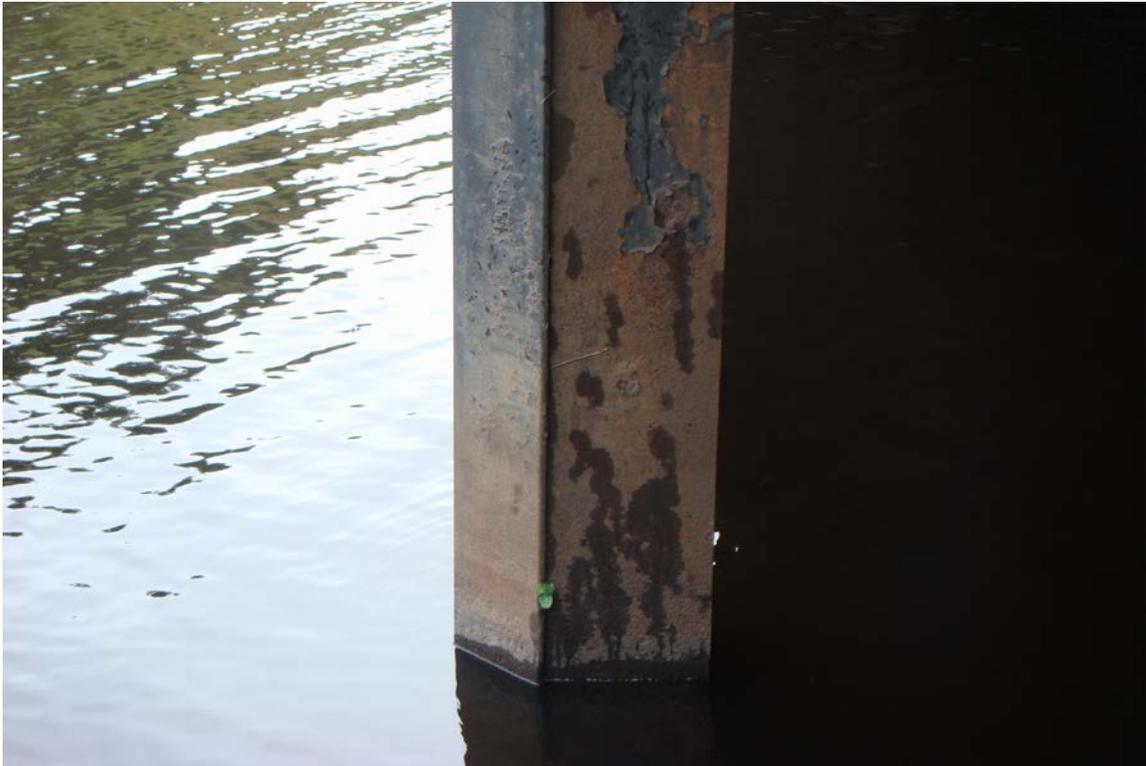
- (B) The steel H-Piles of Bents 1 and 2 typically exhibited 100 percent loss of coating from 1 to 2 feet above the waterline to the channel bottom. The piles exhibited pitting, up to 1/16 inch deep, and random rust nodules, up to 1/2 inch in diameter, from the waterline to the channel bottom. Random rust delaminations, up to 1/8 inch thick, were observed above the waterline.

Photograph 4. View Typical Steel Condition at the Waterline at Bent 1, Looking East.

- (A) Repair the heavily corroded cross-brace at Pile H of Bent 2.
- (B) Monitor steel H-Pile and cross-brace corrosion and if found to be worsening, consideration may need to be given to cleaning and recoating the steel H-Piles, along with the possible need for some localized strengthening repairs.
- (C) Reinspect the submerged substructure units at the normal maximum recommended (NBIS) interval of sixty (60) months.

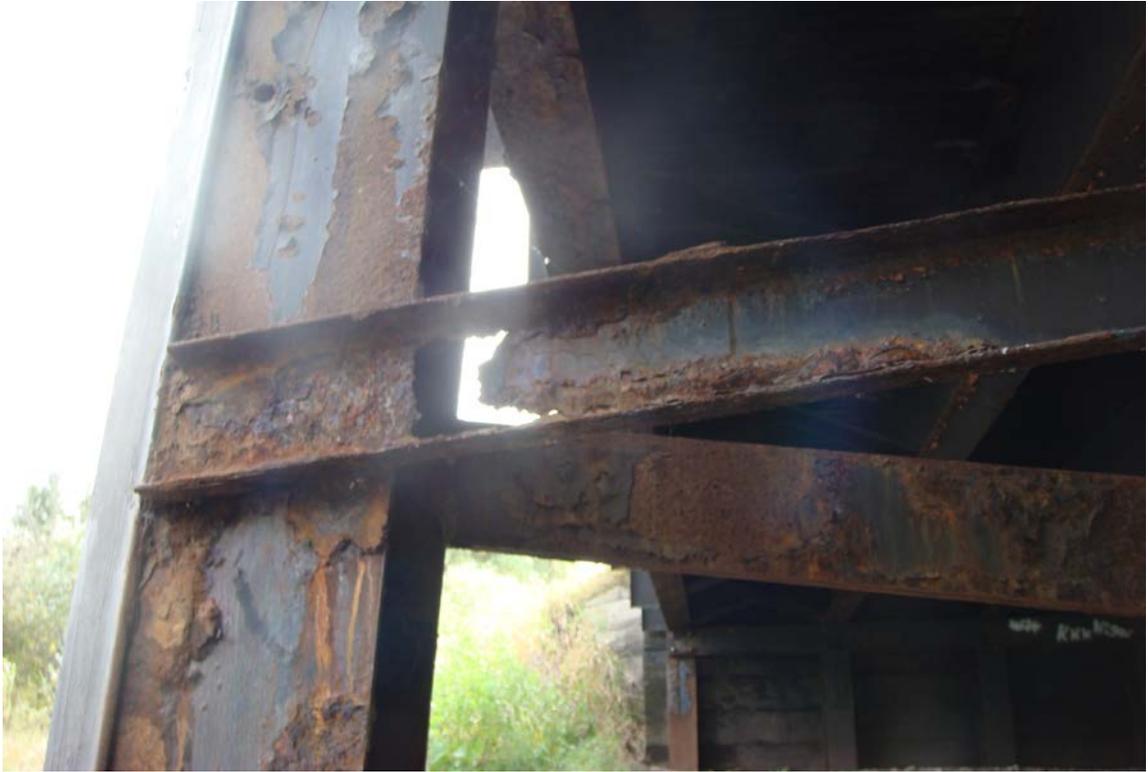
- (E) The west cross-brace at Pile H of Bent 2 exhibited an area of heavier corrosion measuring 3 feet long with up to 100 percent web thickness loss of section.

Photograph 5. View of Heavy Corrosion and 100 Percent Section Loss of the Cross-Brace at Pile H of Bent 2, Looking Northeast.

Repair the heavily corroded cross-brace at Pile H of Bent 2.

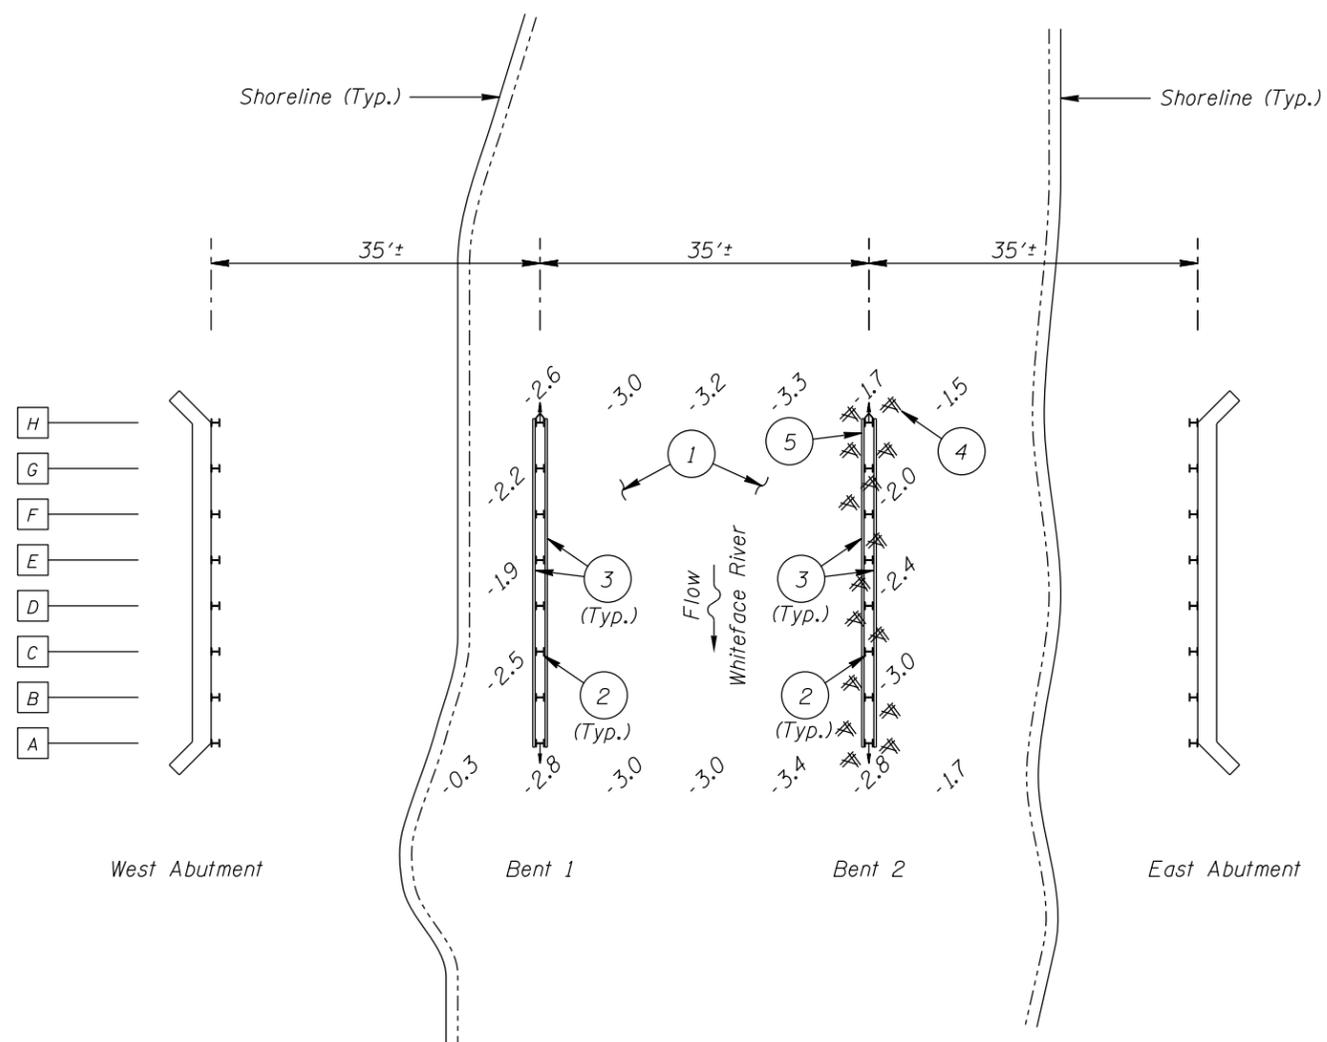
SOUNDING PLAN

- ① The channel bottom material consisted of rocks, up to 6 inches in diameter, and areas of silt infill with a maximum probe rod penetration of 6 inches.

- ② The steel H-Piles of Bents 1 and 2 typically exhibited 100 percent loss of coating from 1 to 2 feet above the waterline to the channel bottom. The piles exhibited pitting, up to 1/16 inch deep, and random rust nodules, up to 1/2 inch in diameter, from the waterline to the channel bottom. Random rust delaminations, up to 1/8 inch thick, were observed above the waterline.

- ③ The steel channel cross-bracing of the bents typically exhibited rust delaminations up to 1/2 inch thick.
- ④ A light accumulation of timber debris, consisting of 6 inch diameter and smaller branches, was observed extending from the channel bottom to the waterline along the entire length of Bent 2 and extended 5 feet upstream and downstream from the bent noses.

- ⑤ The west cross-brace at Pile H of Bent 2 exhibited an area of heavier corrosion measuring 3 feet long with up to 100 percent web thickness loss of section.
