UNDERWATER BRIDGE INSPECTION REPORT

STRUCTURE NO. 93448

CR 453

MINNESOTA DEPARTMENT OF TRANSPORTATION
UNDERWATER BRIDGE INSPECTION

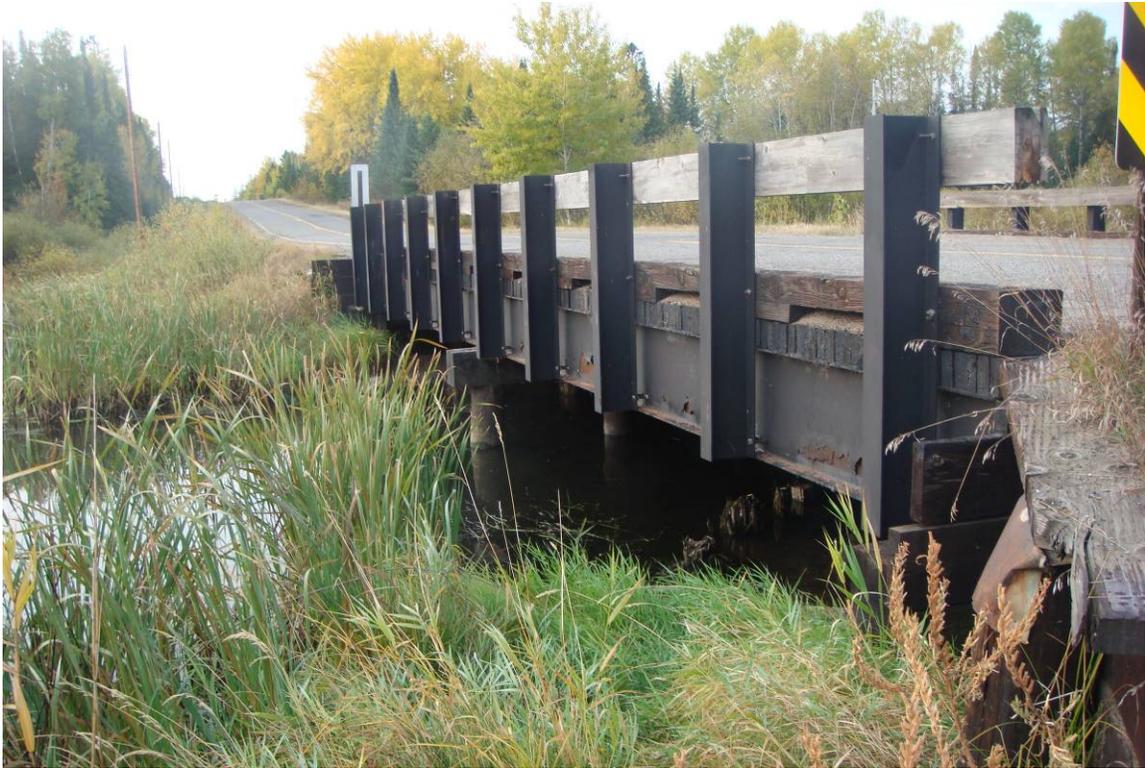
Photograph 1. Overall View of Structure, Looking Southwest

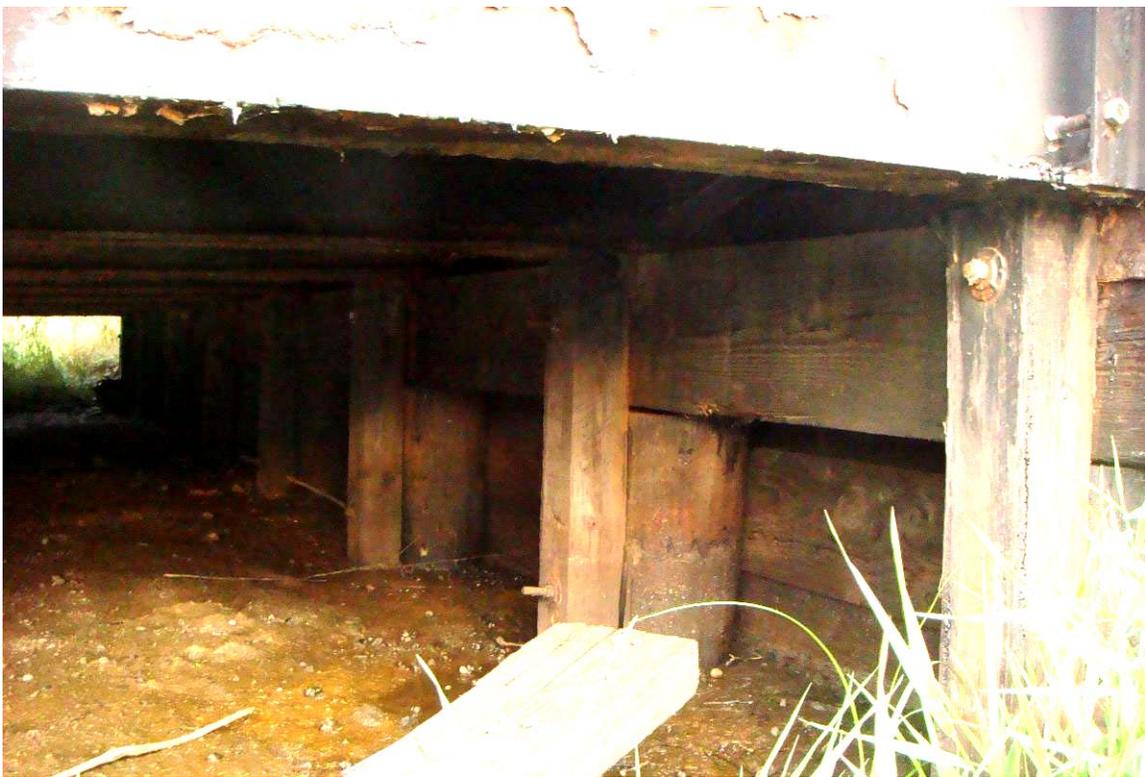
Photograph 2. View of the North Abutment, Looking Northwest

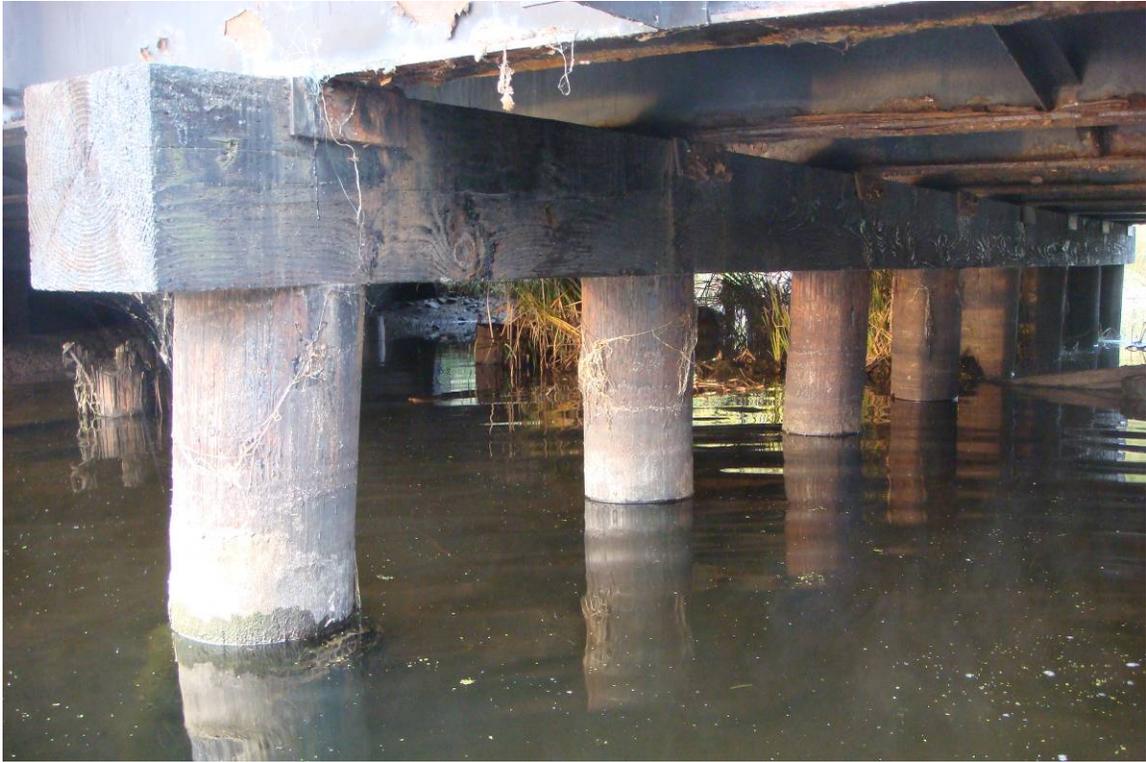
Photograph 3. View of Bent 1, Looking Southwest

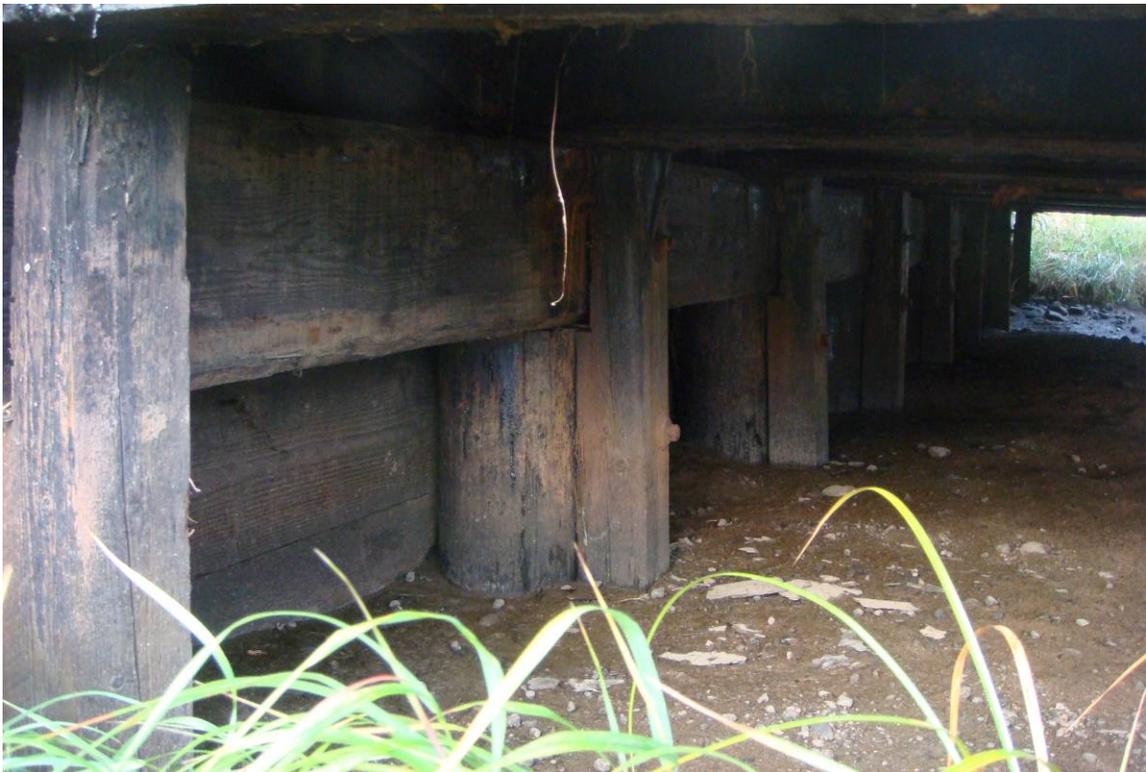
Photograph 4. View of the South Abutment, Looking Southwest

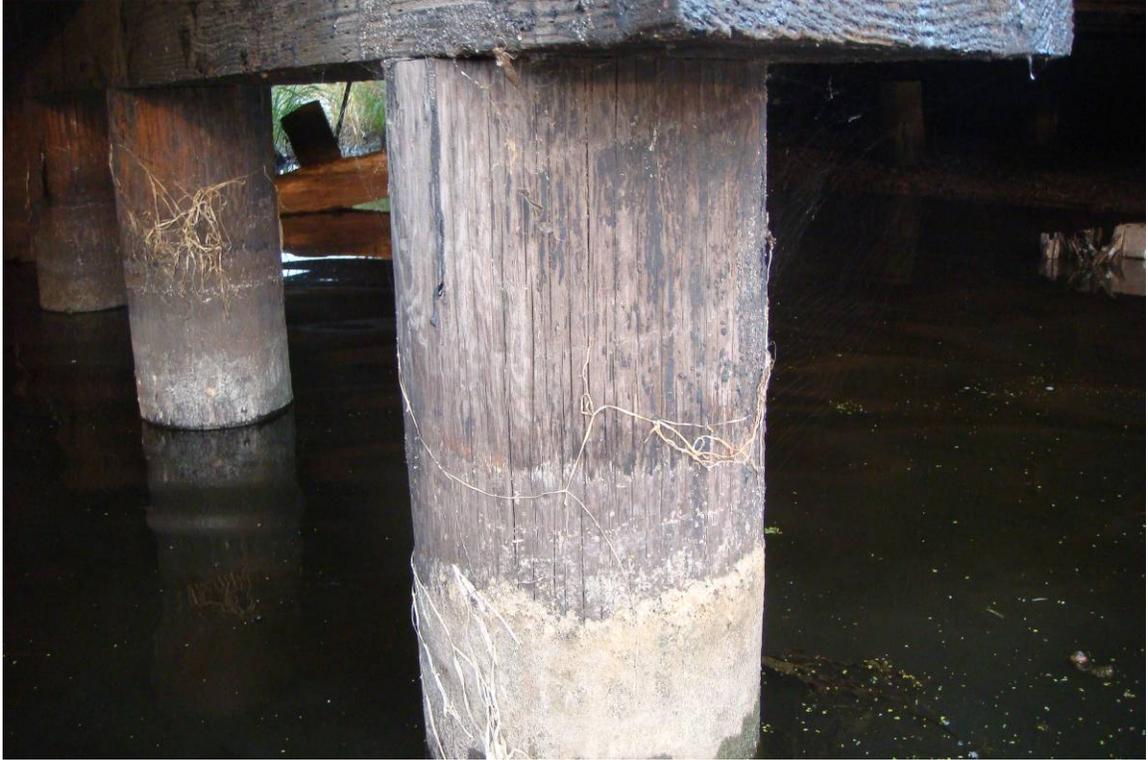
Photograph 5. View of the Typical Timber Pile Condition around the Waterline, Looking Northwest

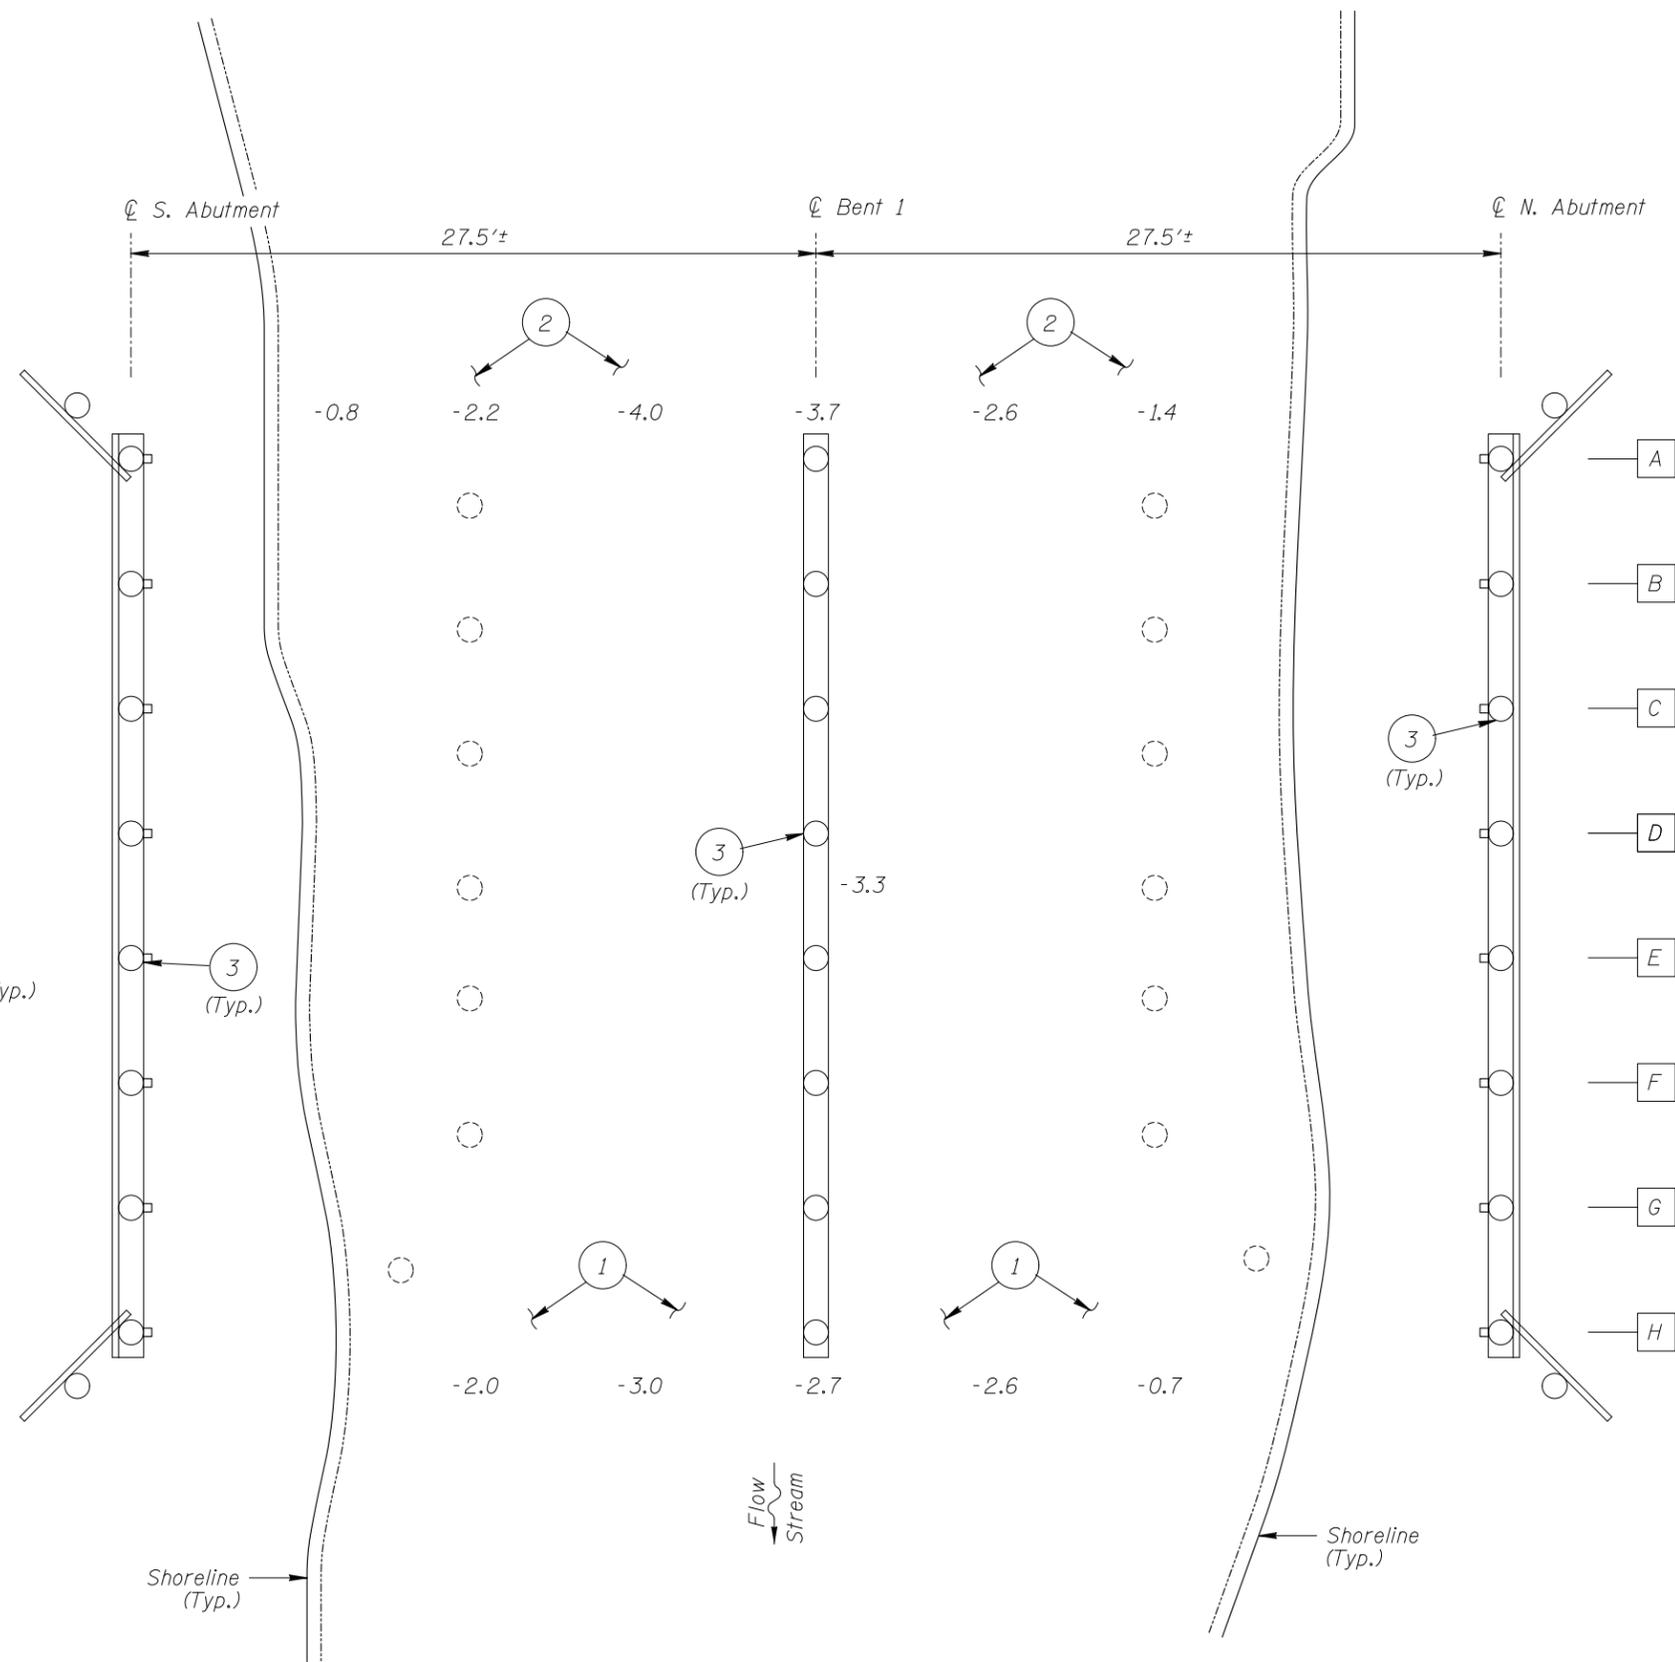
INSPECTION AND SOUNDING PLAN

- 1 The channel bottom material typically consisted of sand allowing up to 2 inches of probe rod penetration.
- 2 The channel bottom material typically consisted of silt allowing up to 2 feet of probe rod penetration.
- 3 The timber of all piles, supplemental piles, backwalls and wingwalls was generally sound allowing a timber awl penetration of up to 1/8 inch and exhibiting random checking or splits up to 1/16 inch wide.
