UNDERWATER BRIDGE INSPECTION REPORT

STRUCTURE NO. 93454
BARRETT ROAD NORTH
OVER THE
PAAVOLA CREEK
ST. LOUIS COUNTY

SEPTEMBER 17, 2012
PREPARED FOR THE
MINNESOTA DEPARTMENT OF TRANSPORTATION
BY
COLLINS ENGINEERS, INC.
JOB NO. 7423

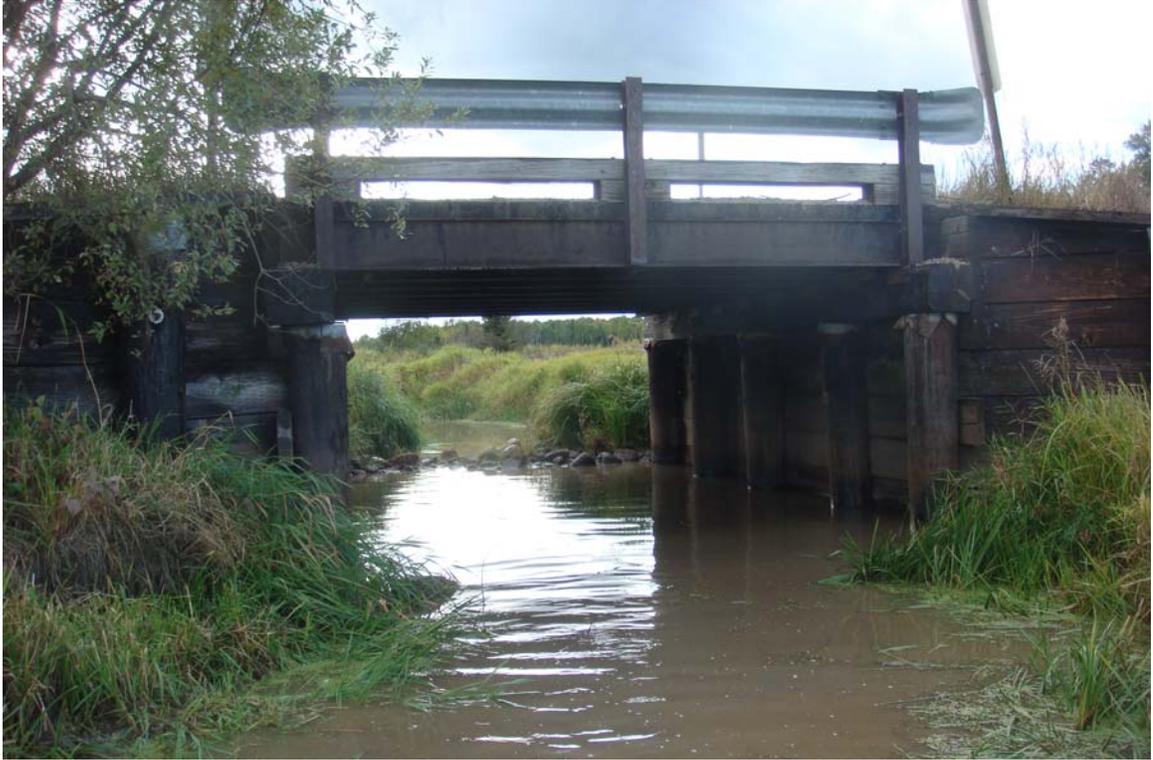
Photograph 1. Overall View of Structure, Looking West

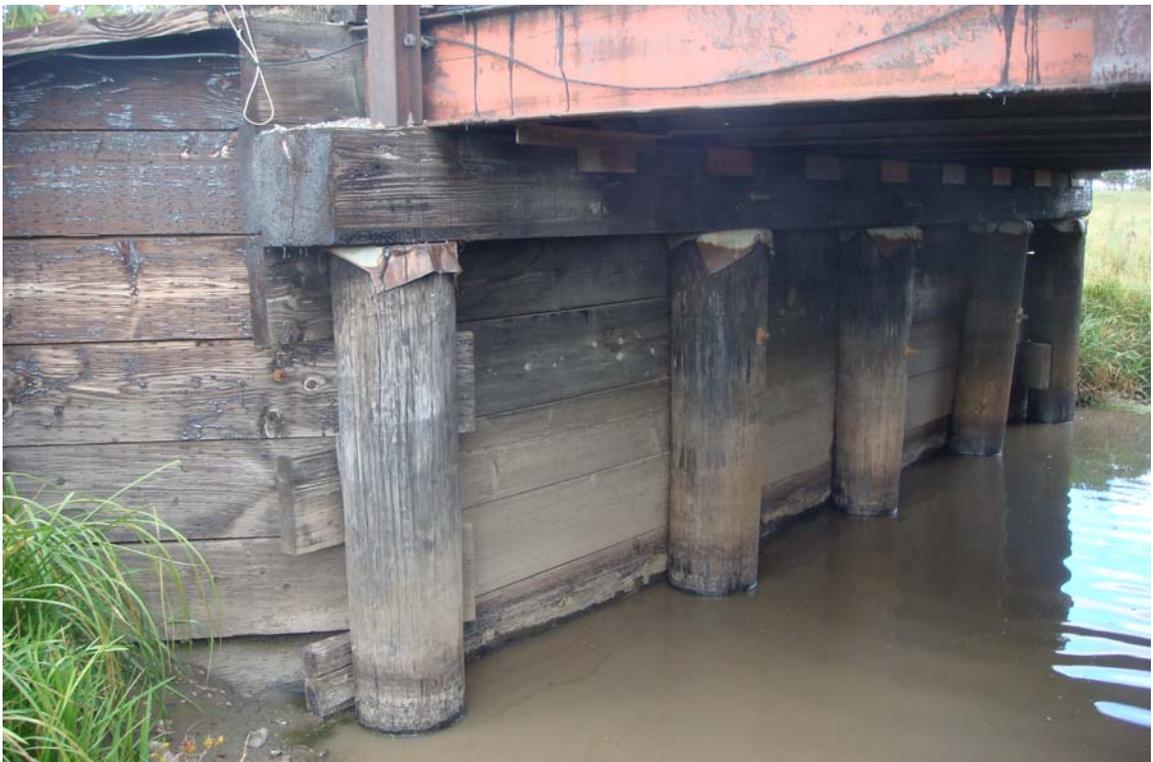
Photograph 2. View of the North Abutment, Looking Northeast.

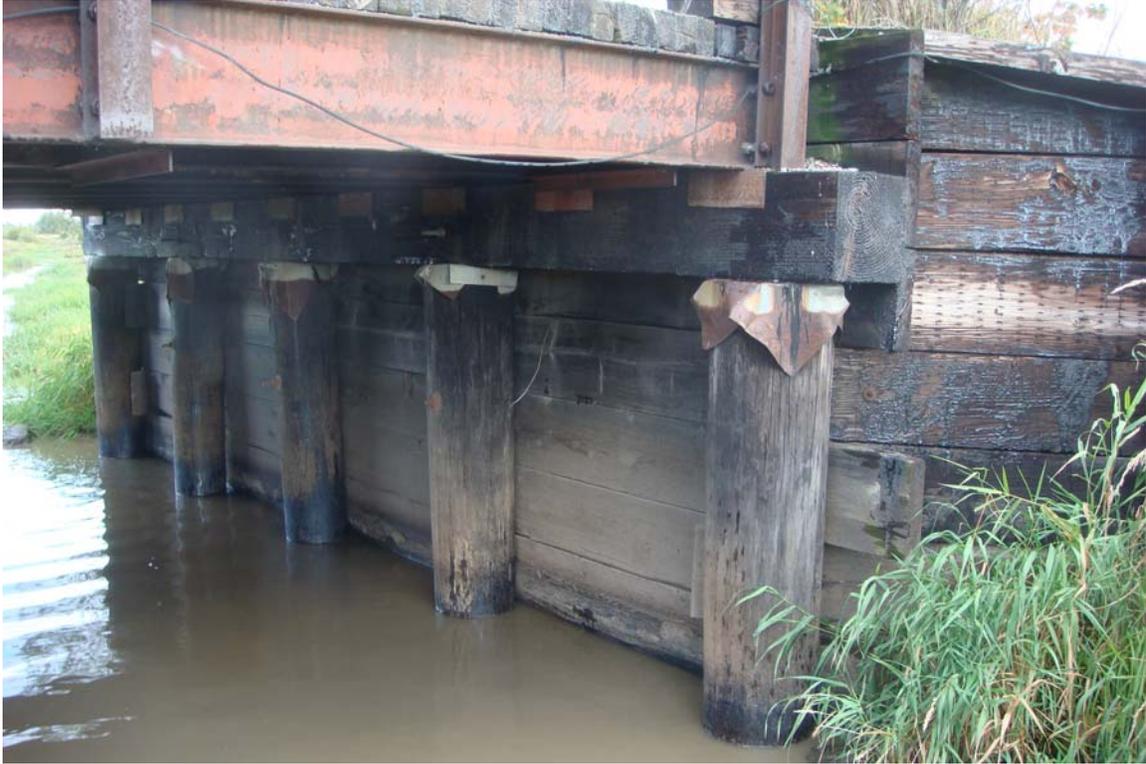
Photograph 3. View of the South Abutment, Looking Southeast.

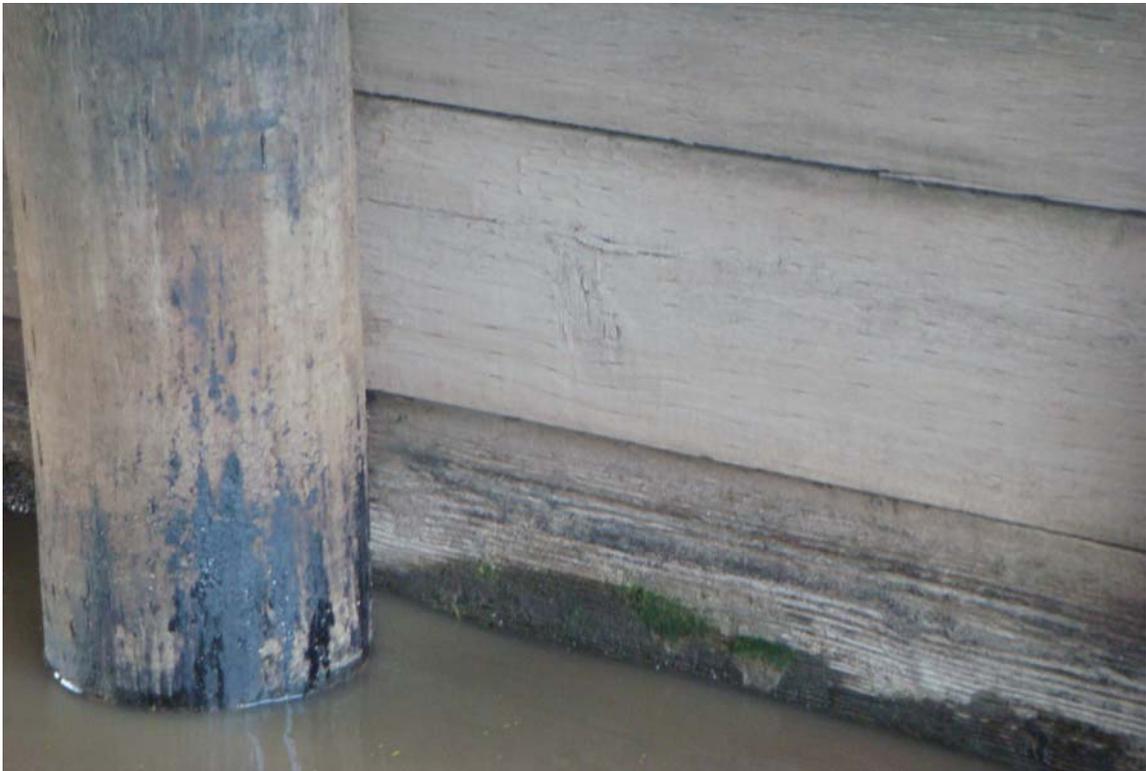
- (A) The channel bottom material typically consisted rocks and gravel with a maximum probe rod penetration of 3 inches.
- (B) The timber piles were typically sound with no hallow sound or major splits. Random splits or checks were typical at all piles. The splitting or checking was up to 1/4 inch wide and 1 inch deep.
- (C) The timber backwall and wingwalls of the both abutments were sound and tight with no noticeable loss of backfill material. Random splits or checks were typical at nearly all wall boards. The splitting or checking was up to 1/4 inch wide and 1 inch deep.

Photograph 4. View of the Typical Timber Conditions around the Waterline, Looking Northwest.

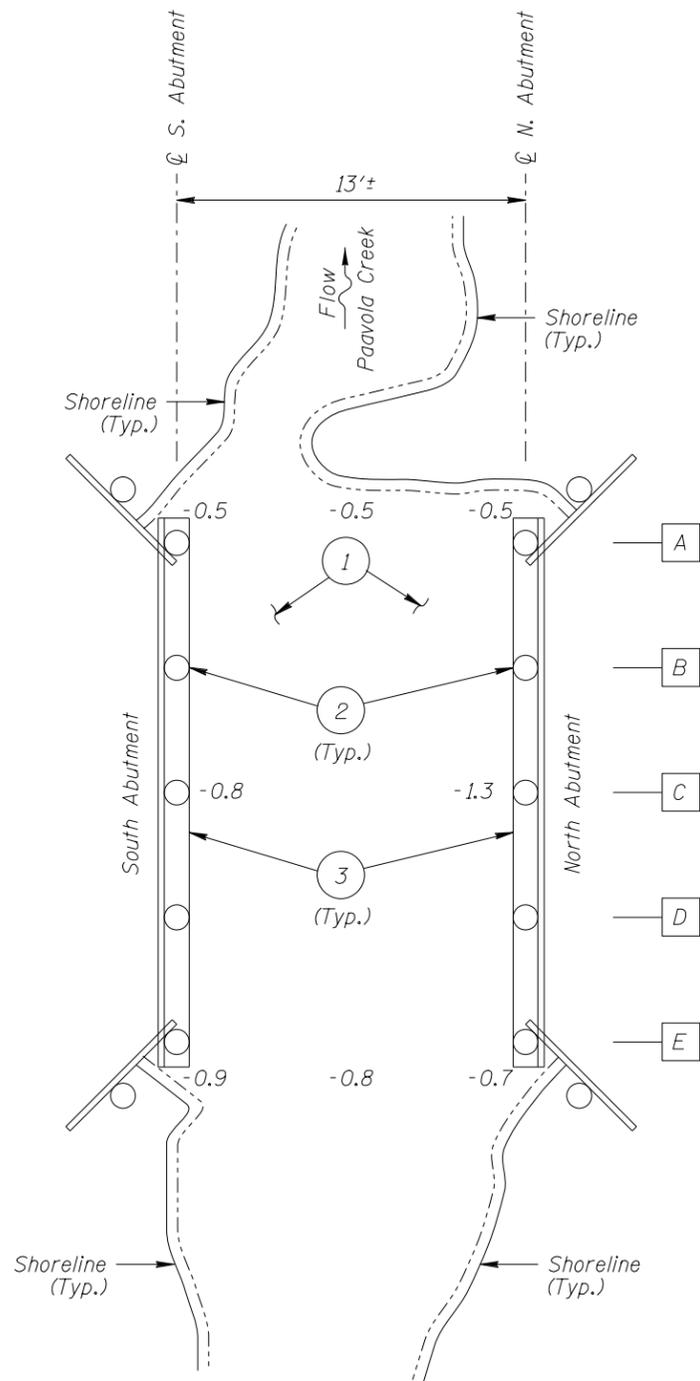
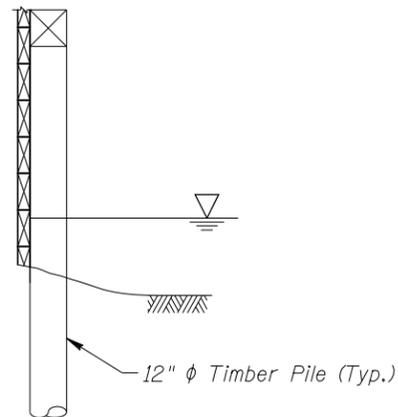
SOUNDING PLAN

- 1 The channel bottom material typically consisted rocks and gravel with up to 3 inches of probe rod penetration.
- 2 The timber piles were typically sound with random splits or checks up to 1/4 inch wide and 1 inch deep.
- 3 The timber backwall and wingwalls were typically sound and tight with no noticeable loss of backfill or defects of structural significance. The backwall and wingwall boards exhibited random splits or checks up to 1/4 inch wide and 1 inch deep.
