UNDERWATER BRIDGE INSPECTION REPORT

STRUCTURE NO. 96026
MSAS 119 (RAILROAD ST.)
OVER
POND OUTLET
CITY OF DULUTH

JULY 26, 2012
PREPARED FOR THE
MINNESOTA DEPARTMENT OF TRANSPORTATION
BY
COLLINS ENGINEERS, INC.
AND
WSB & ASSOCIATES, INC.
JOB NO. 7423

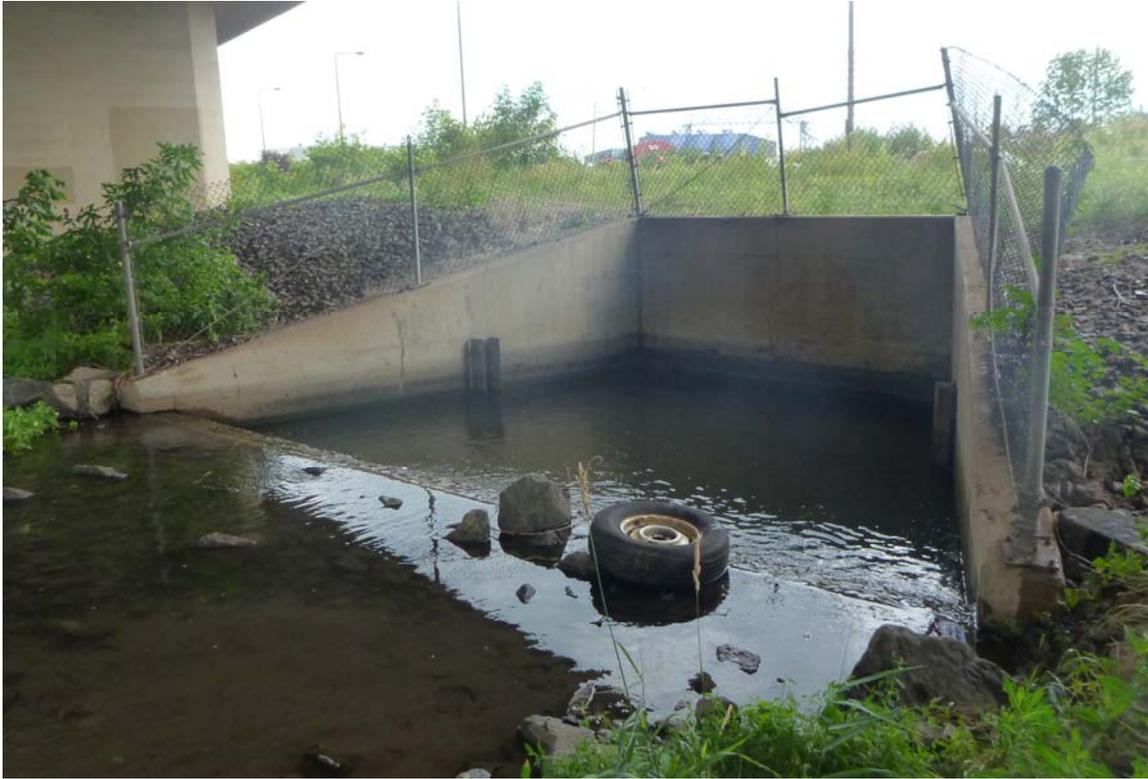
Photograph 1. View of West Opening, Looking Northeast.

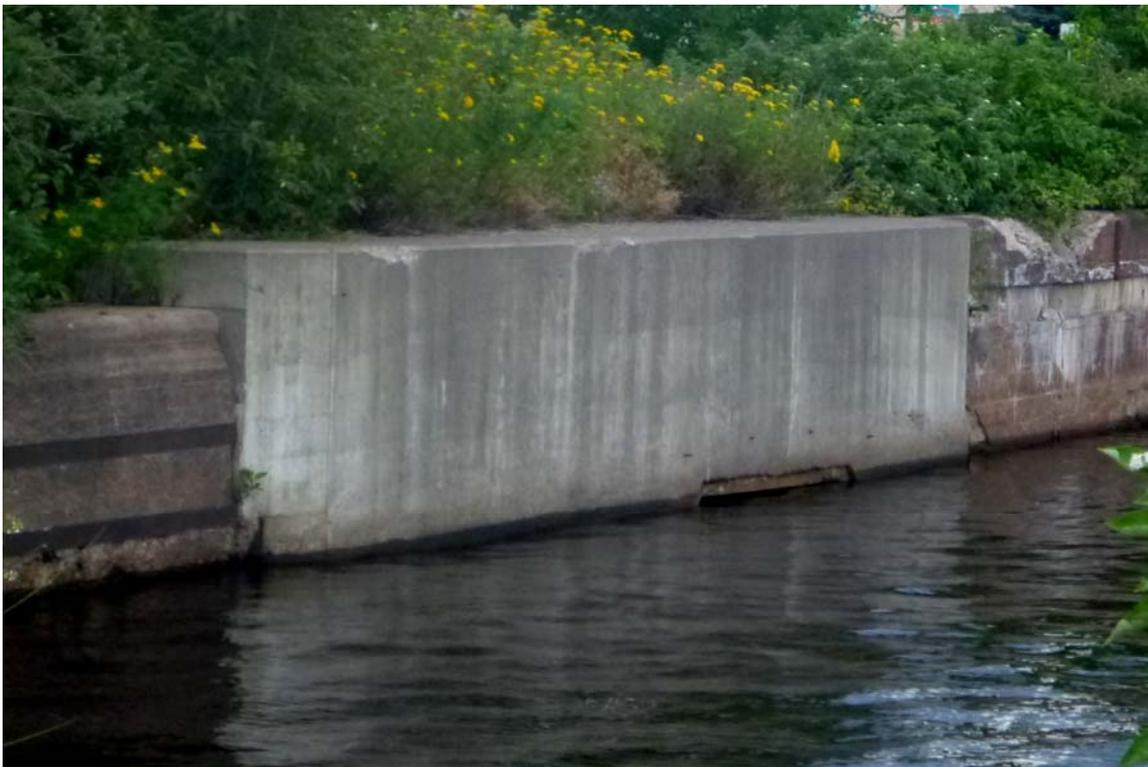
Photograph 2. View of East Opening, Looking Southeast.

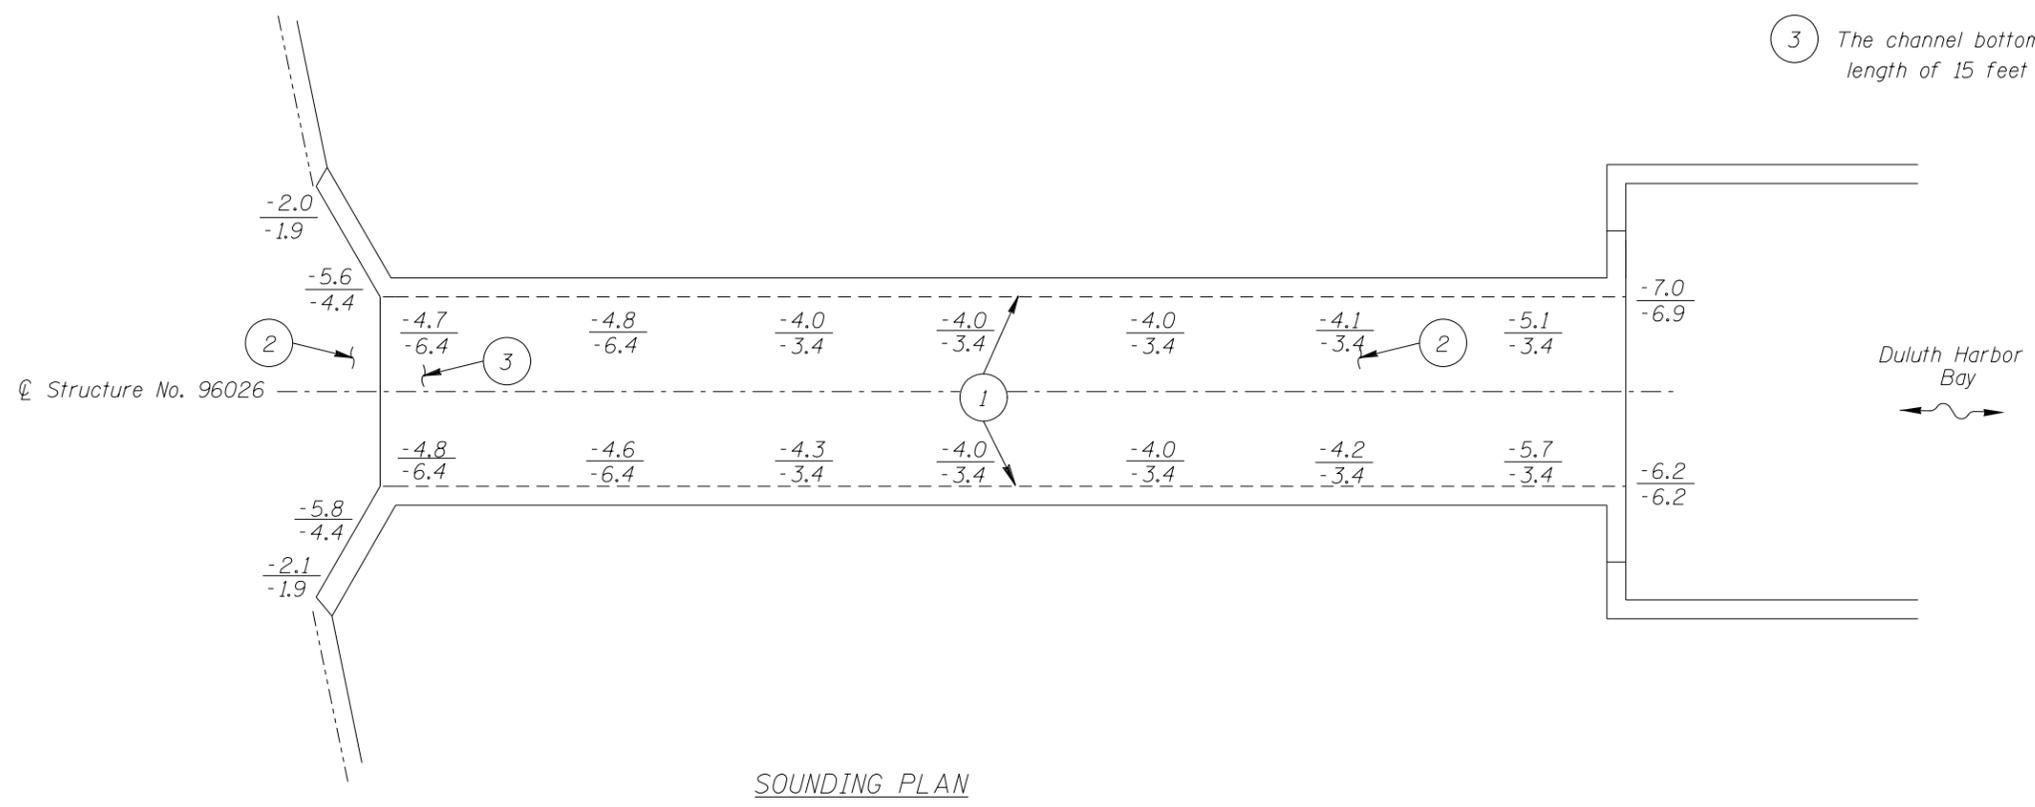
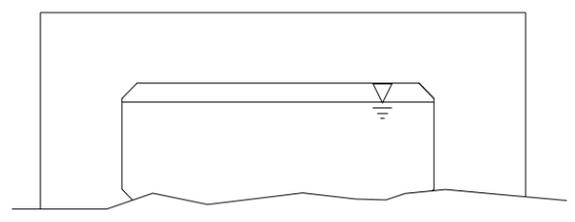
INSPECTION AND SOUNDING PLAN

- 1 The concrete was generally smooth and sound. The joints between culvert segments exhibited 1/4- to 1-inch-wide horizontal gaps (acceptable for tongue and groove joint arrangement) and up to 1/2-inch differentials across adjacent faces at various joints.
- 2 The channel bottom consisted of sand infill (up to 3 feet deep) on culvert floor.
- 3 The channel bottom consisted of riprap with no probe rod penetration for a length of 15 feet along the western end of the box culvert.
