UNDERWATER BRIDGE INSPECTION REPORT

STRUCTURE NO. 97918

CR 725

HELLEWAGS CREEK

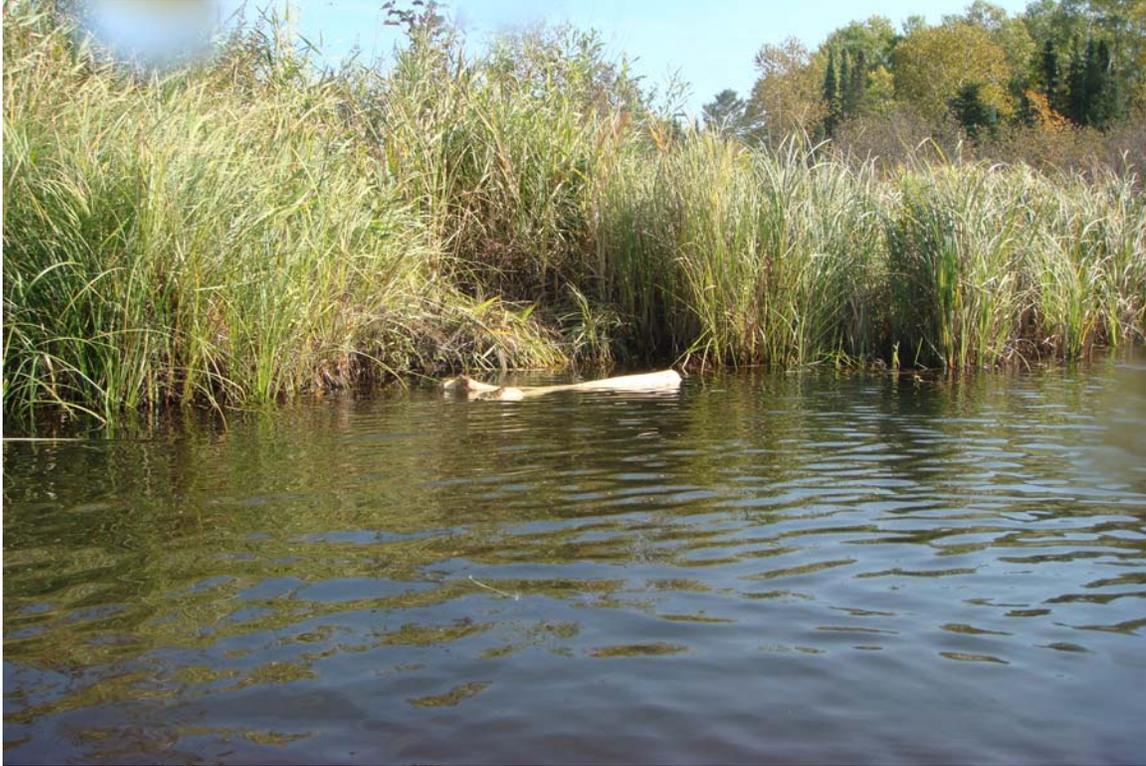
Photograph 1. View of the Downstream Opening of the Structure, Looking Northeast

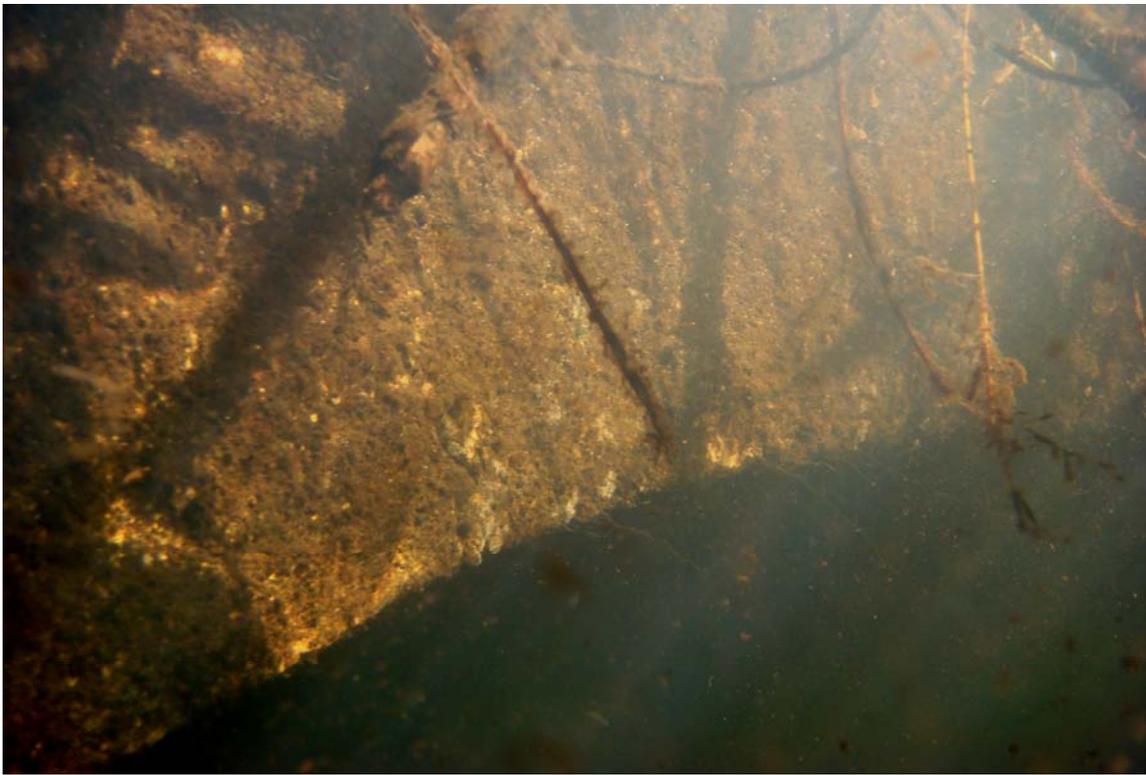
Photograph 2. View of the Typical Concrete Condition Below Water, Looking Northeast.

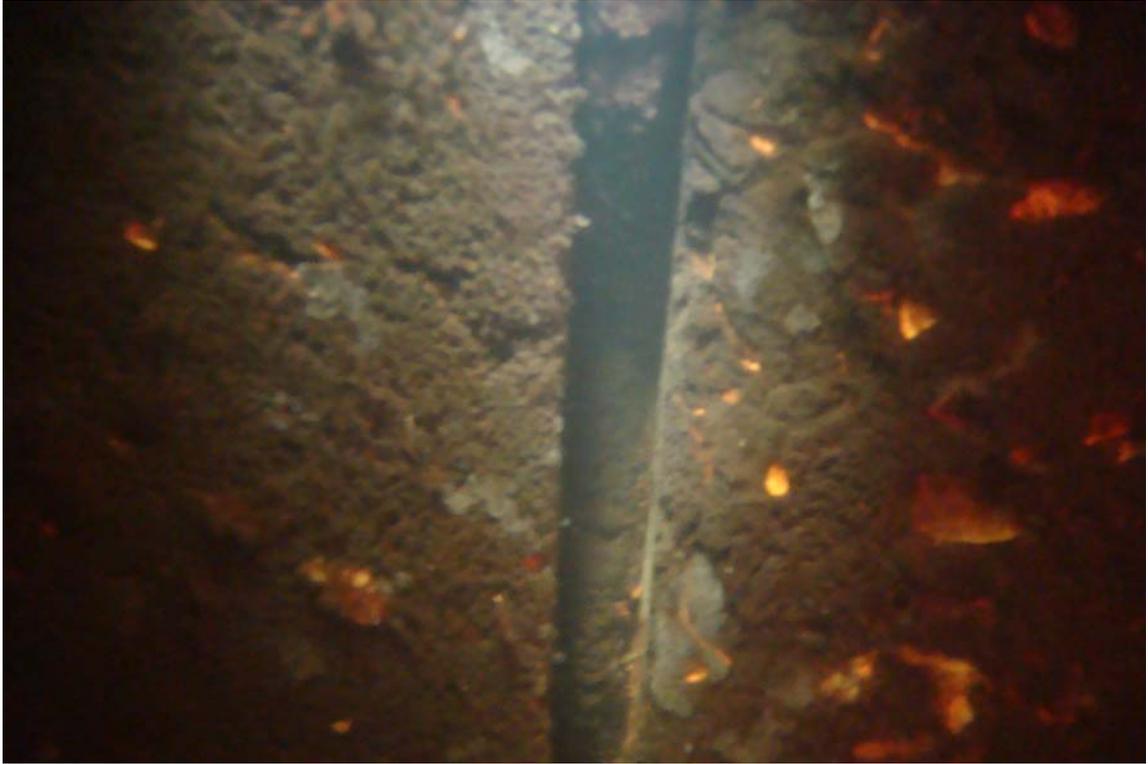
Photograph 3. View of a Typical Concrete Joint, Looking East.

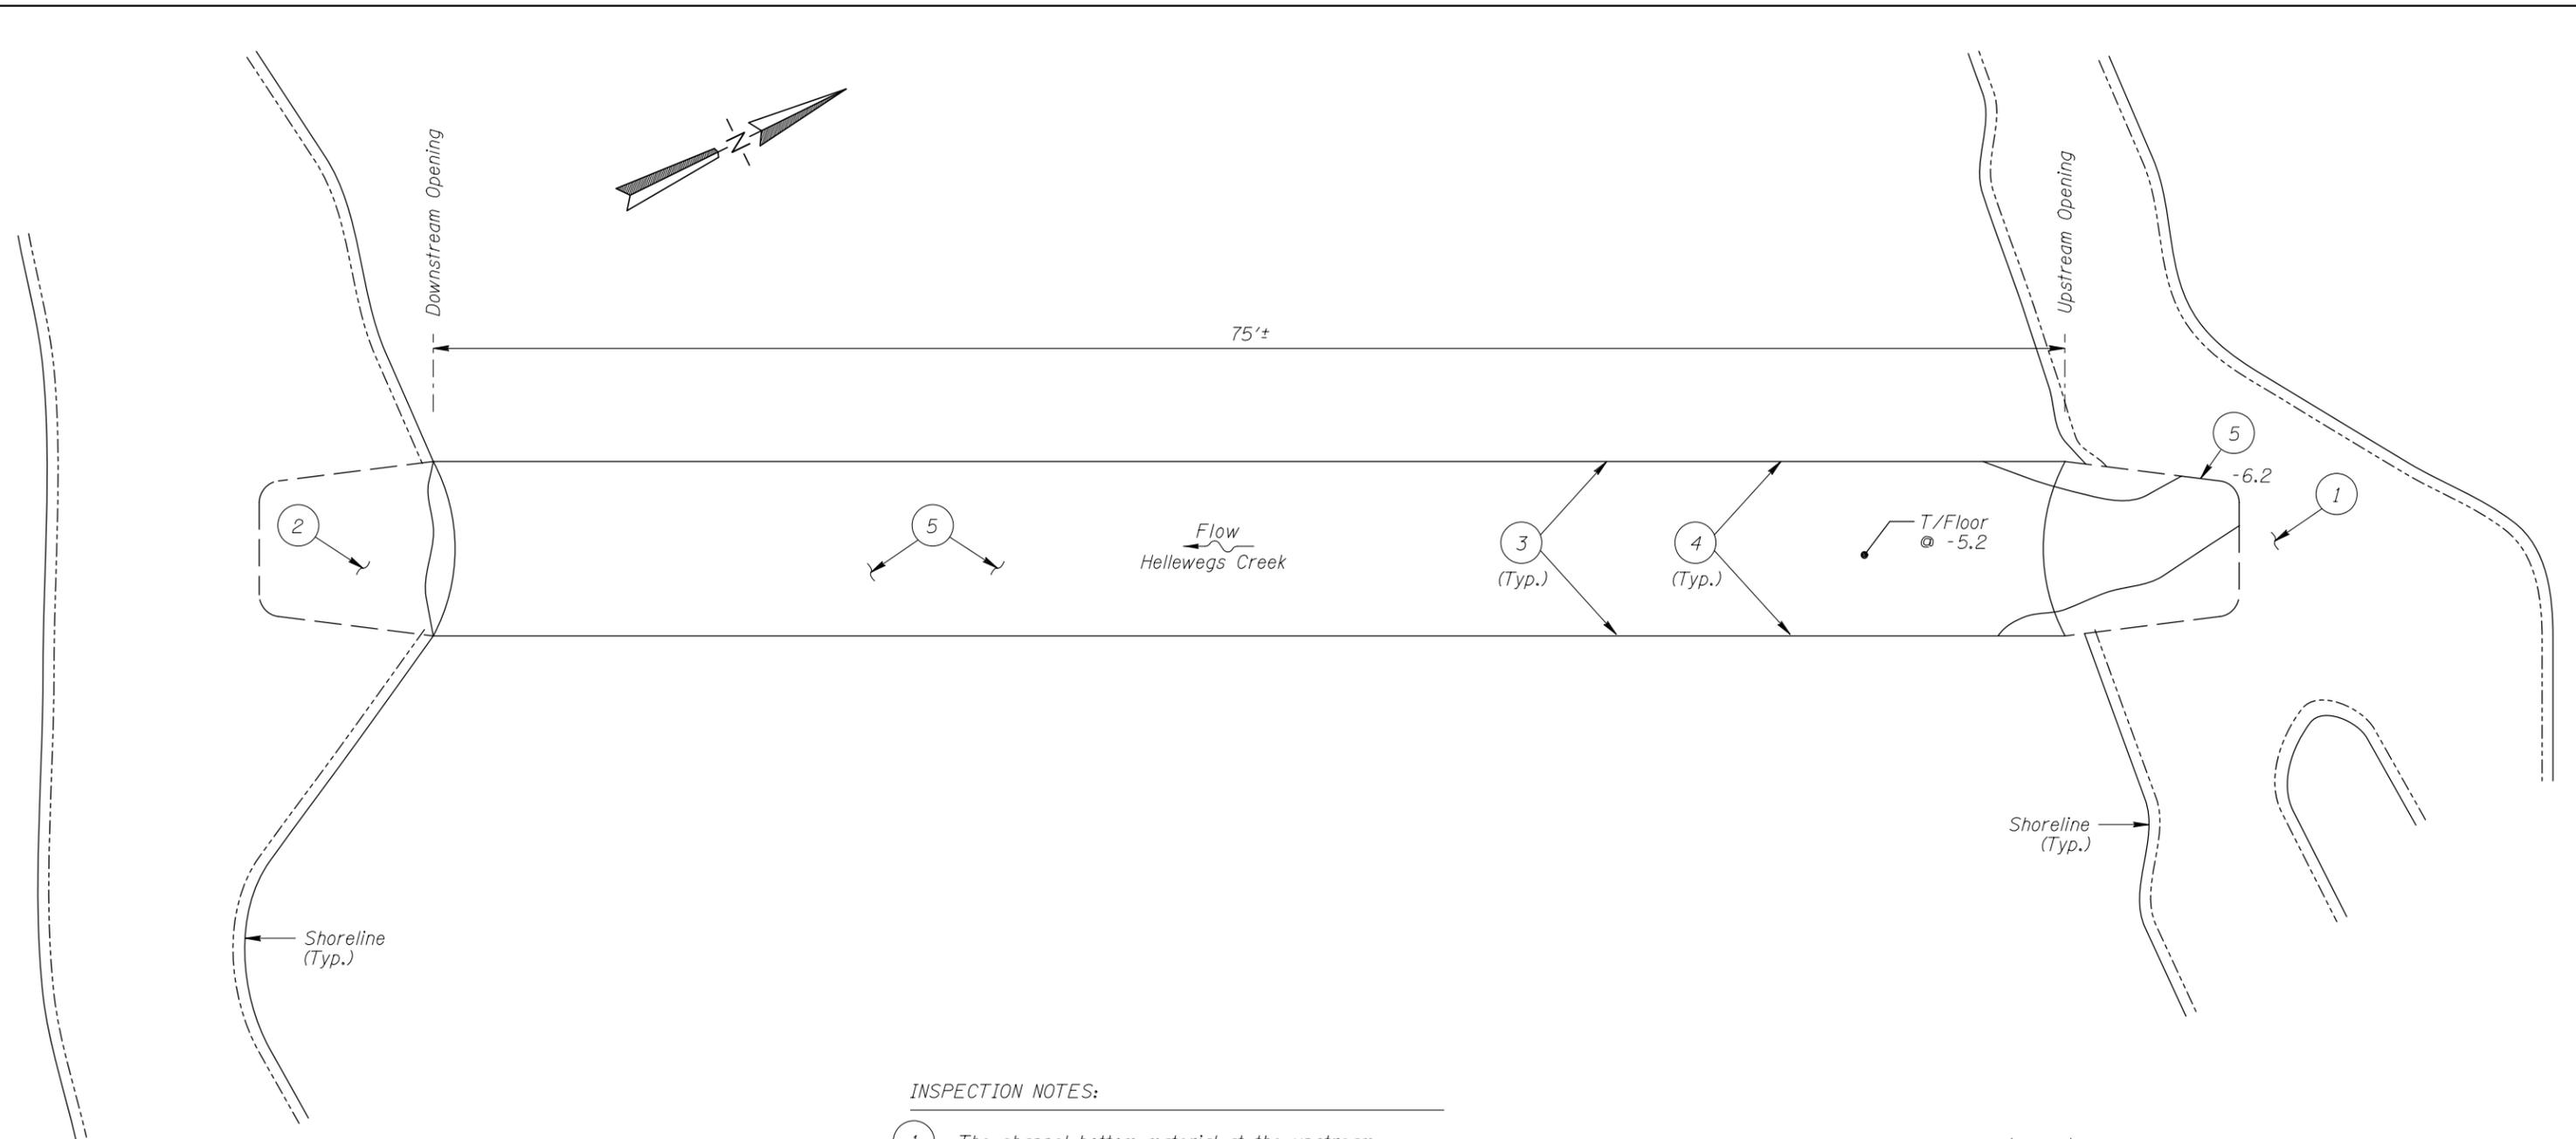
TYPICAL END VIEW OF CULVERT

- 1 The channel bottom material at the upstream opening of the culvert typically consisted of soft silt and small timber debris allowing a maximum probe rod penetration of 1 foot.
- 2 The channel bottom material at the downstream opening of the culvert typically consisted of sandy silt and stones allowing a maximum probe rod penetration of 6 inches.
- 3 All exposed concrete surfaces were smooth and sound.
- 4 All concrete joints were well aligned and with no notable gaps between culvert sections.
- 5 The floor of the culvert was exposed throughout the length of the culvert and at the upstream toe with a maximum vertical toe exposure of 1 foot.
