UNDERWATER BRIDGE INSPECTION REPORT

STRUCTURE NO. L4177

CSAH 116

HUNTING SHACK RIVER

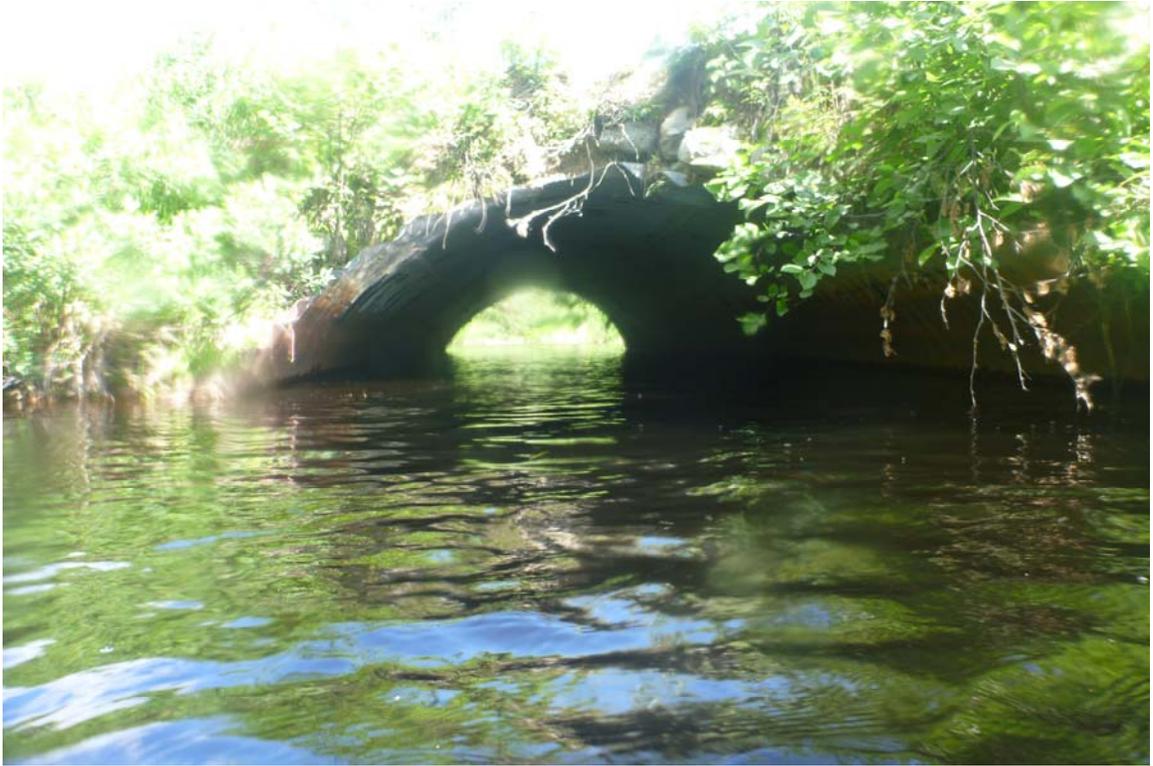
Photograph 1. View of Upstream Opening, Looking North.

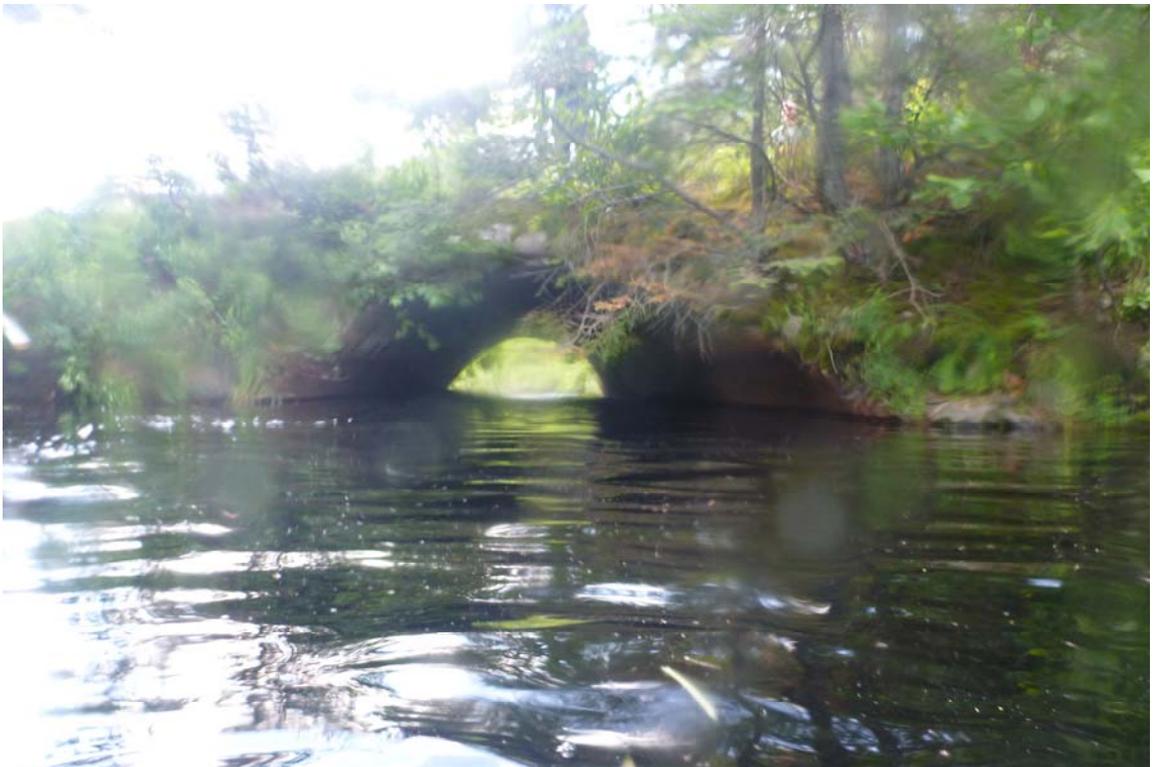
- (A) The corrugated metal pipe exhibited light surface corrosion at the waterline with no significant loss of section.
- (B) The culvert pipe bottom was fairly clean of any infill with only randomly interspersed sandy gravel as well as small rocks.
- (C) The culvert openings were well protected against scour/erosion by up to 1 foot diameter riprap.

Photograph 2. View of Downstream Opening, Looking South.

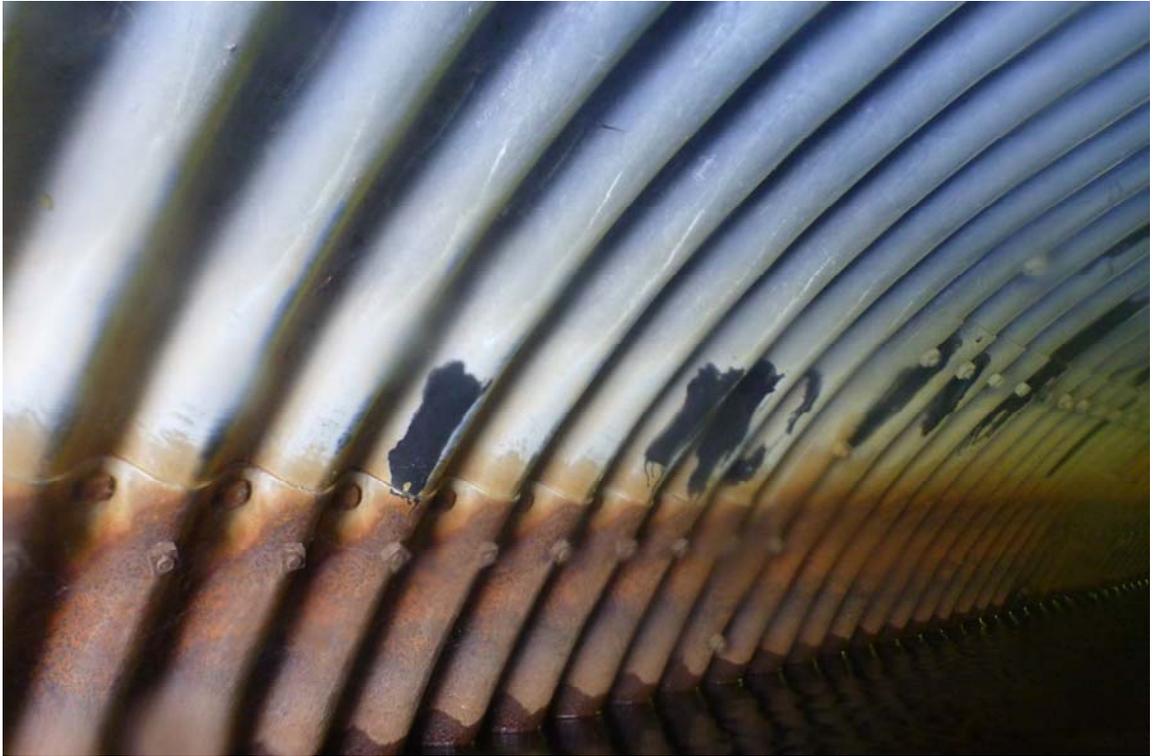
Photograph 3. Typical View of the Steel Condition at the Waterline, Looking Southeast.

- (A) Reinspect the submerged substructure units at the normal maximum recommended (NBIS) interval of sixty (60) months.

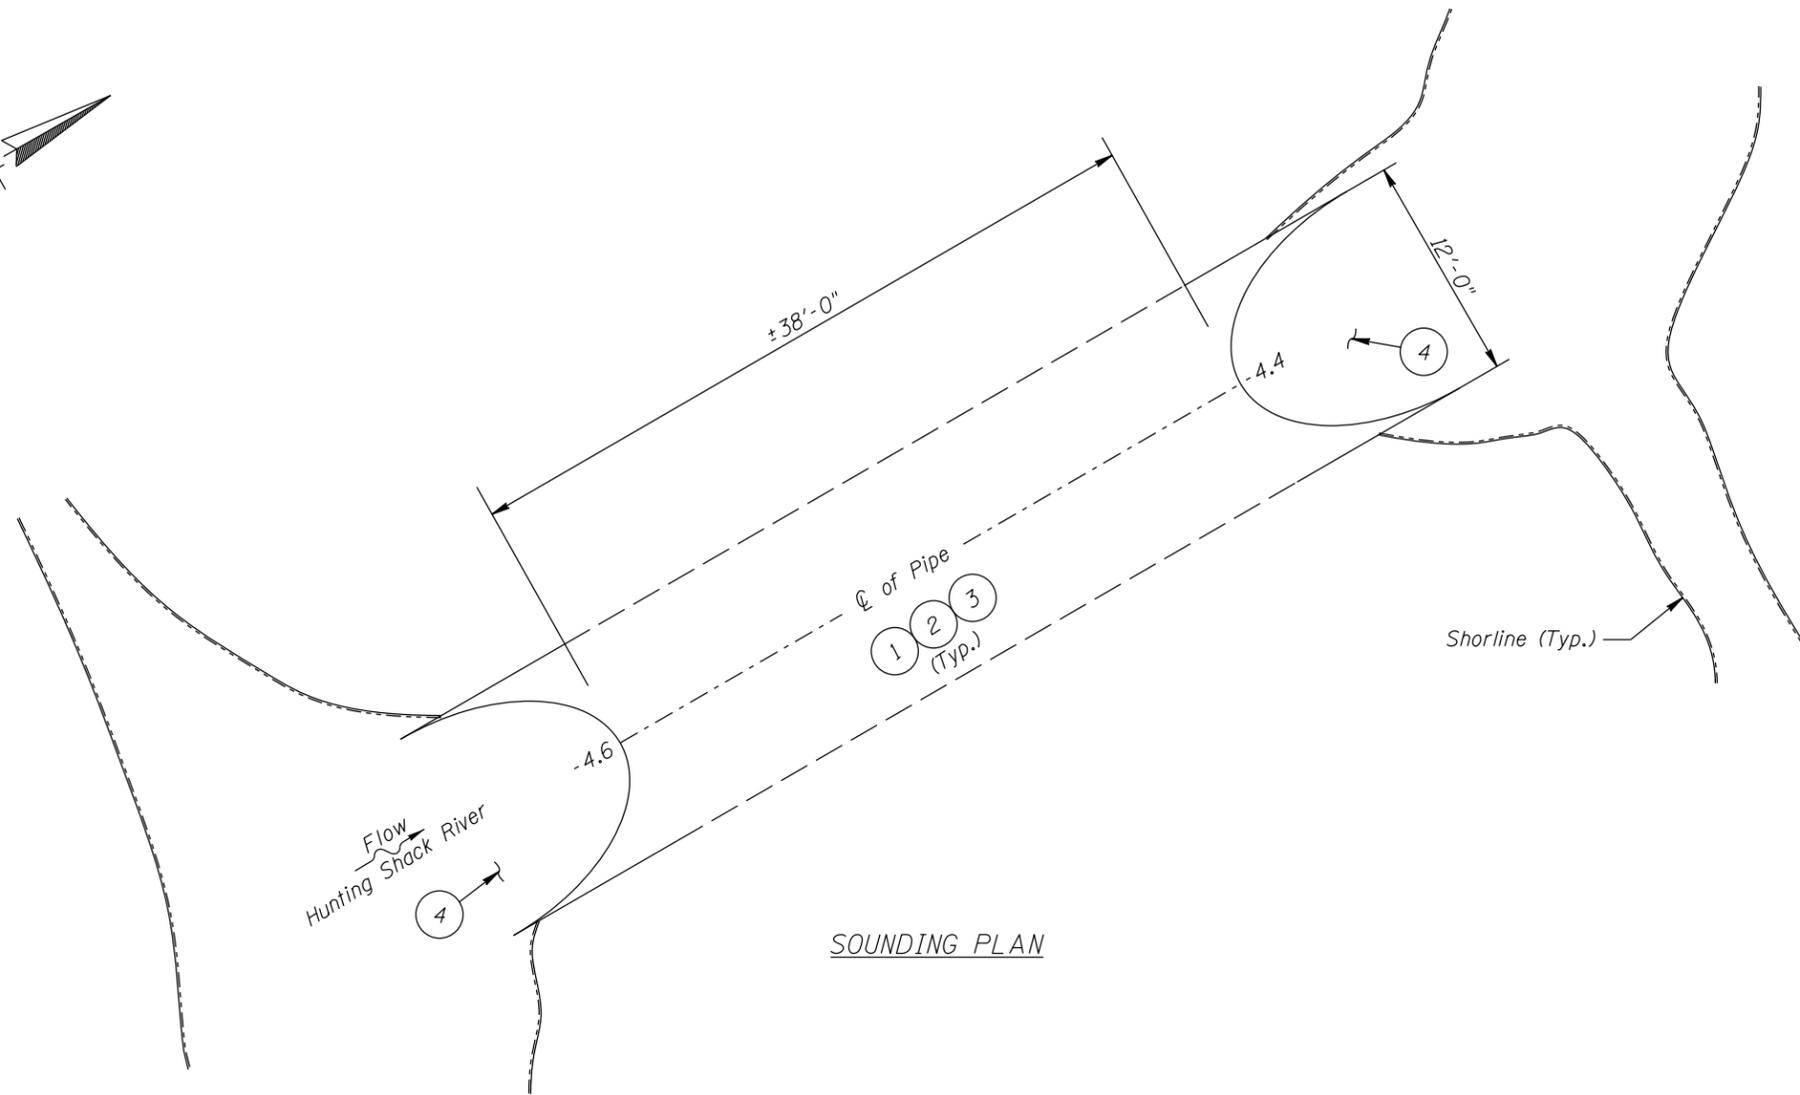
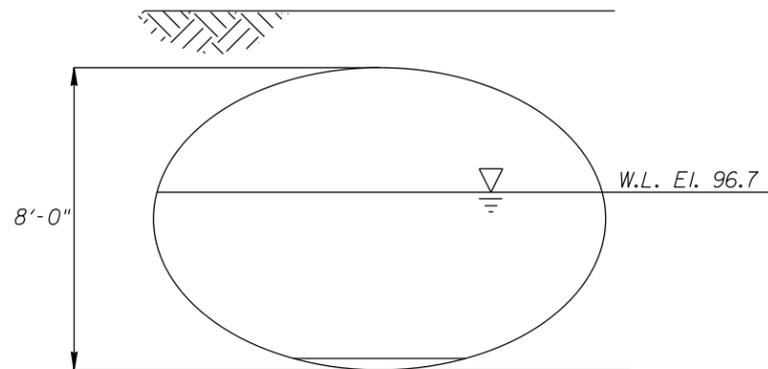
SOUNDING PLAN

- ① The culvert exhibits good galvanizing and only minor surface corrosion with negligible loss of section.
- ② The culvert alignment was in good condition with no deflections or distortions. The joints/fasteners were in place and secure.
- ③ The culvert pipe bottom was fairly clean of any infill with only randomly interspersed sandy gravel as well as small rocks.
- ④ The culvert openings were well protected against scour/erosion by up to 1 foot diameter riprap.
