UNDERWATER BRIDGE INSPECTION REPORT

STRUCTURE NO. L6014

JUNE 18, 2012

MINNESOTA DEPARTMENT OF TRANSPORTATION
UNDERWATER BRIDGE INSPECTION

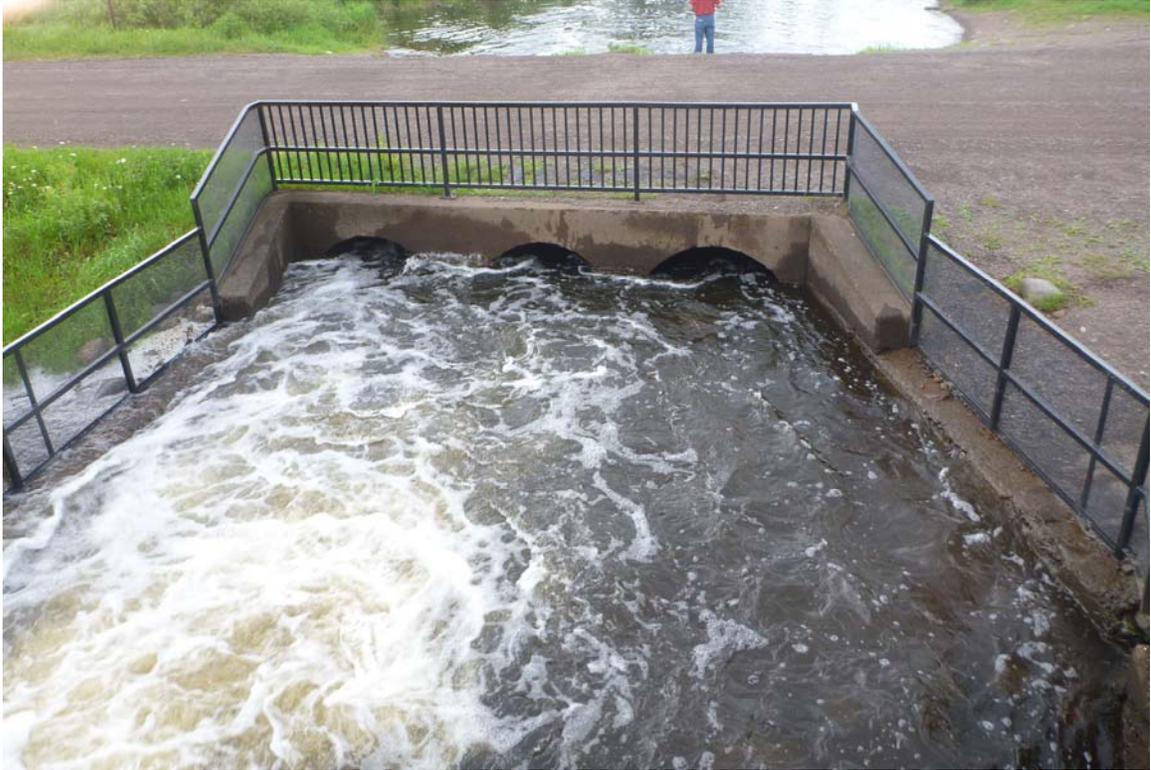
- (C) The concrete of the headwalls and wingwalls was generally sound with only light to moderate scaling with up to 1/2 inch penetration around the waterline. The concrete extended into the channel bottom.

Photograph 1. View of Upstream Openings and Headwall, Looking North.

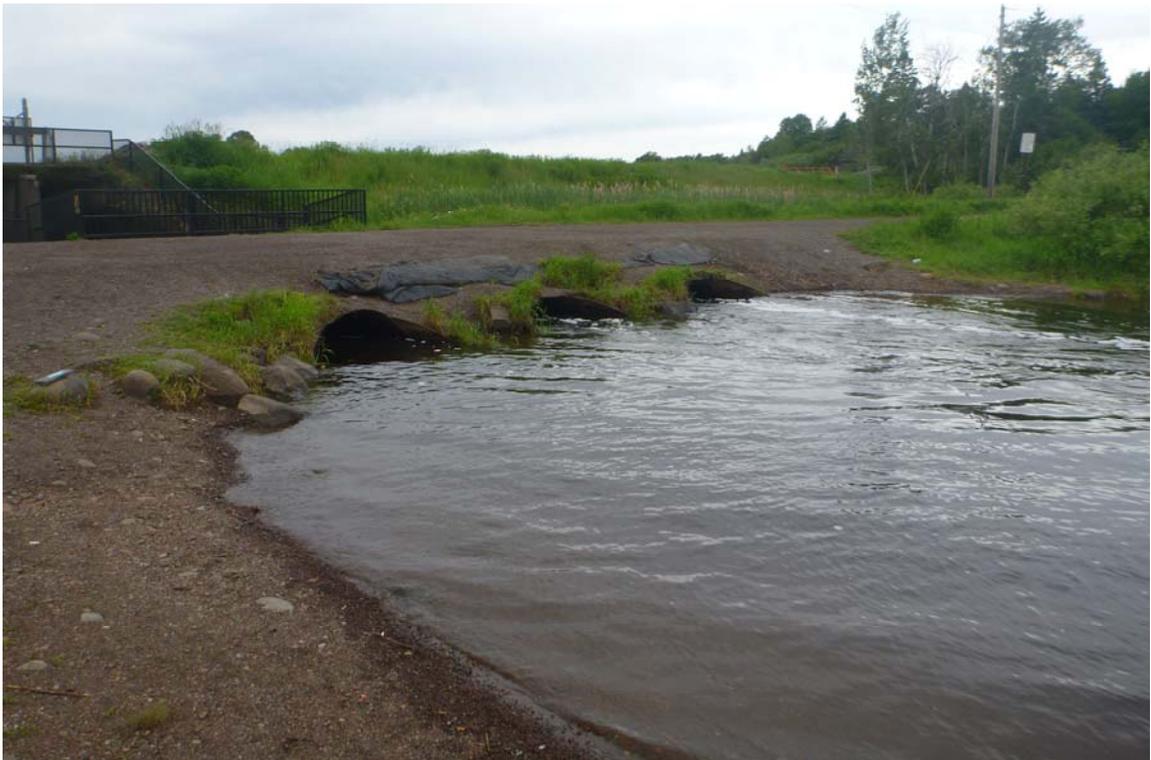
Photograph 2. View of Downstream Openings, Looking West.

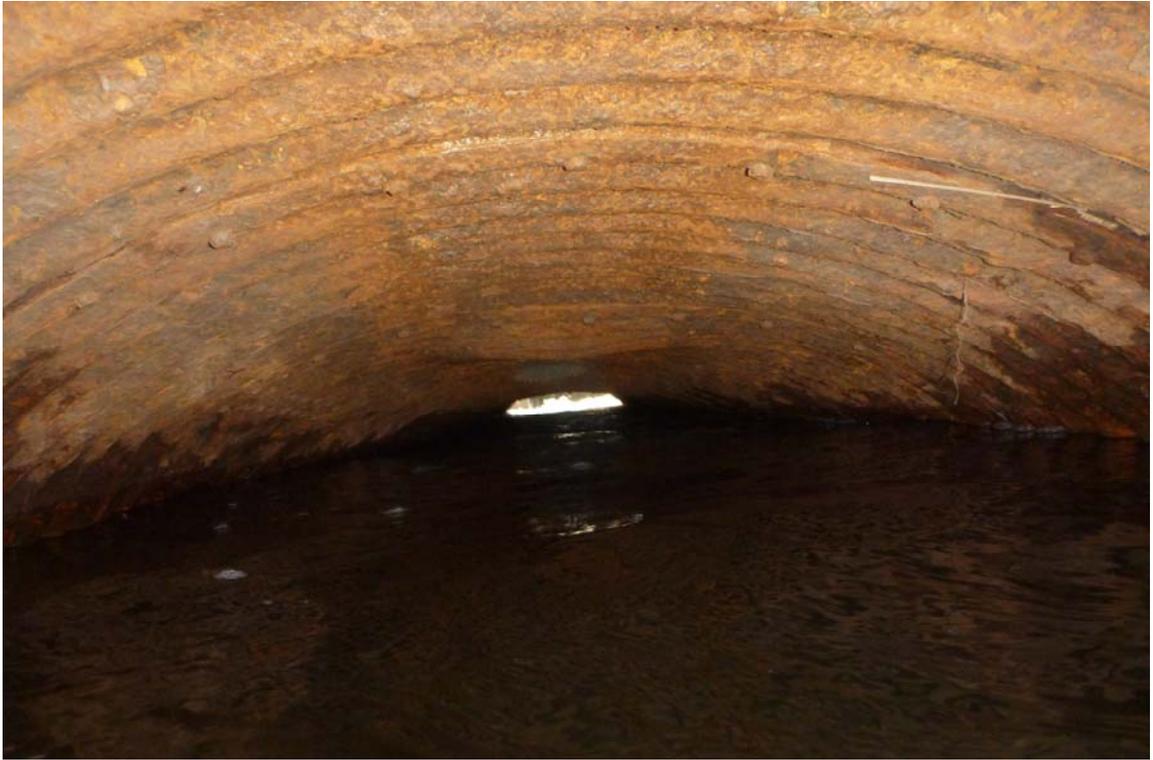
- (D) The top of the pipe has deflected/deformed downward 4 to 6 inches at approximately 5 feet to 10 feet from the downstream end of Pipes 1 and 2.
- (E) The top of Pipe 3 has deflected/deformed downward 2 inches at approximately 15 feet from the downstream end of the culvert.

Photograph 3. View along the Length of CMP #1, Looking Southwest.

- (A) Monitor the roadway for any signs of settlement or depressions that may suggest CMP culvert deflection or distortion, which may warrant further action and a more frequent inspection.

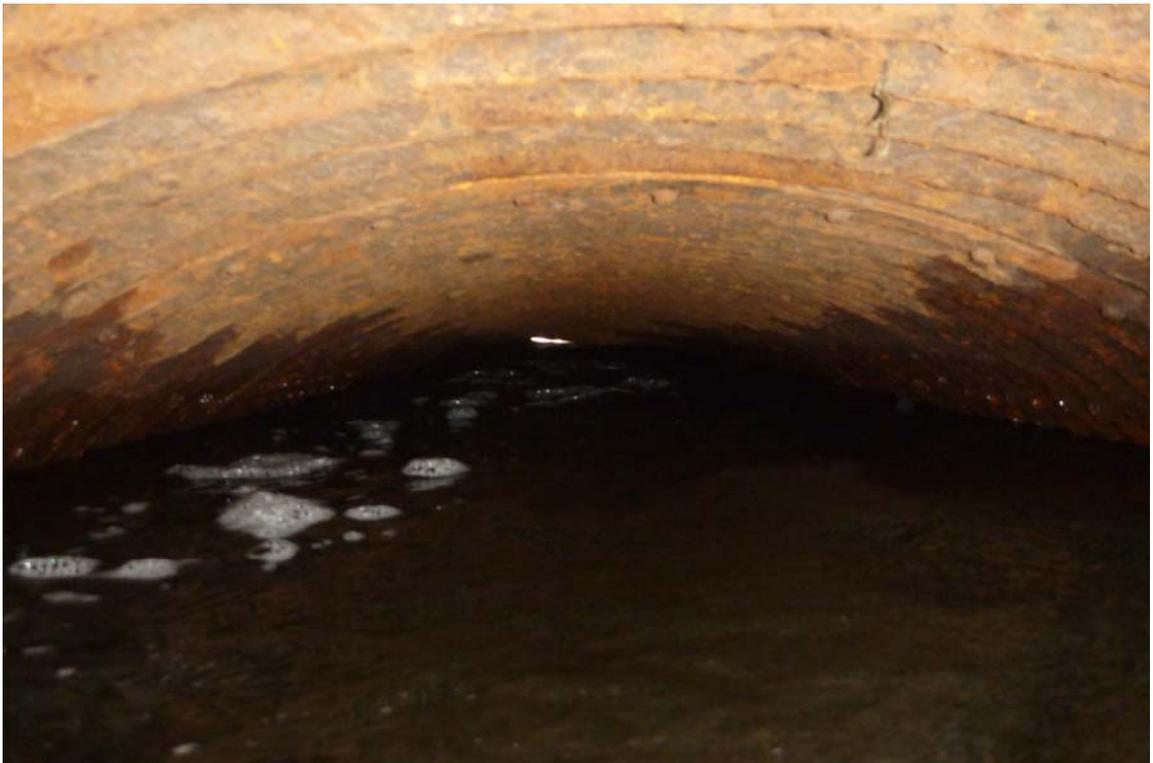
Photograph 4. View along the Length of CMP #2, Looking Southwest.

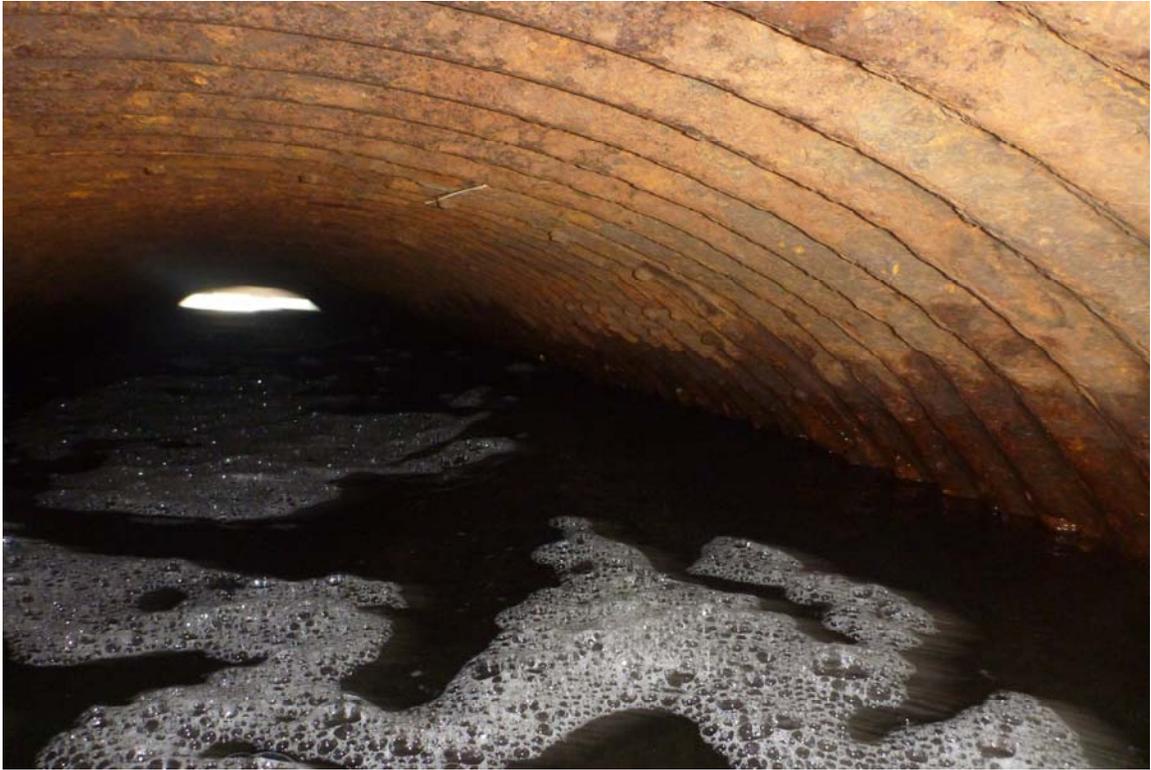
Photograph 5. View along the Length of CMP #3, Looking Southwest.

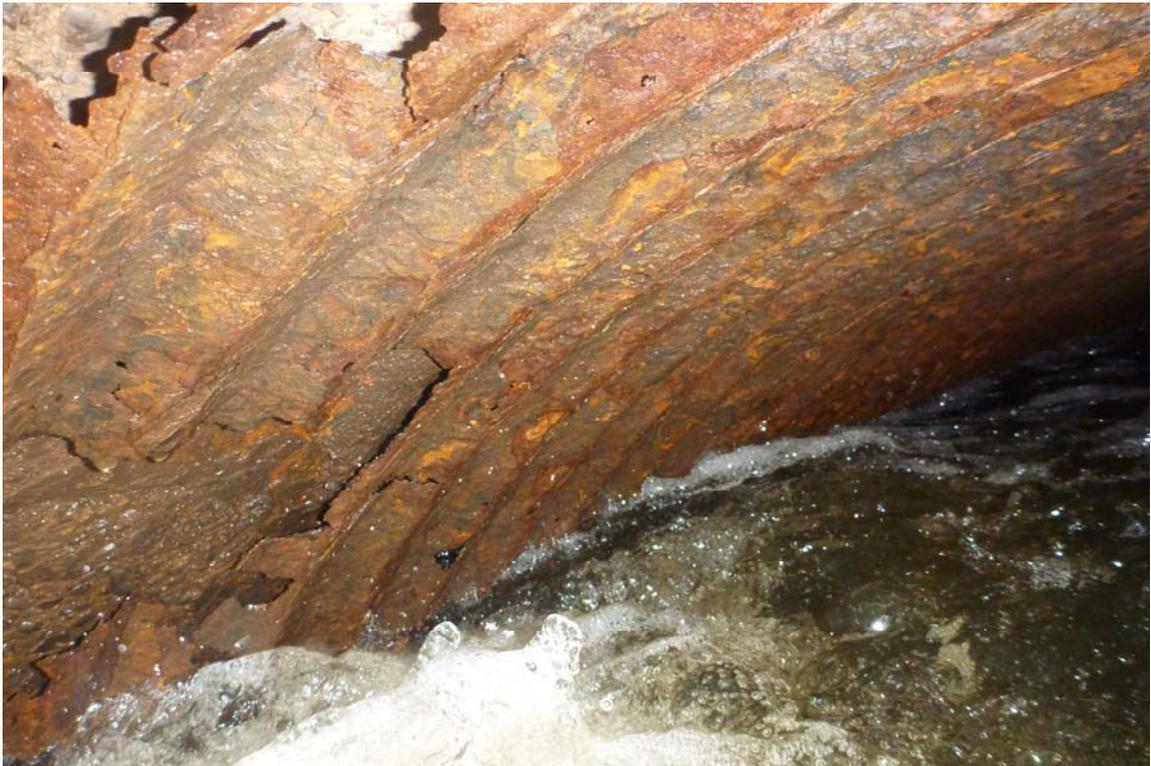
- (B) A 6 inch band of heavy corrosion was noted along the waterline with delaminations, typically 1/8 inch thick, and widespread areas of 100 percent section loss measuring 1 inch to 2 inches wide on the ribs of the corrugations. Within the affected area, the section loss typically ranged between 50 and 80 percent. The corrosion was heavier on the upstream and downstream quarters of the culverts. Moderate, less severe corrosion was observed above and below the noted 6 inch band with no associated complete loss of section.

Photograph 6. View of the Typical Steel Condition at and above the Waterline Showing Heavy Corrosion and 100 percent Section Loss, Looking North.

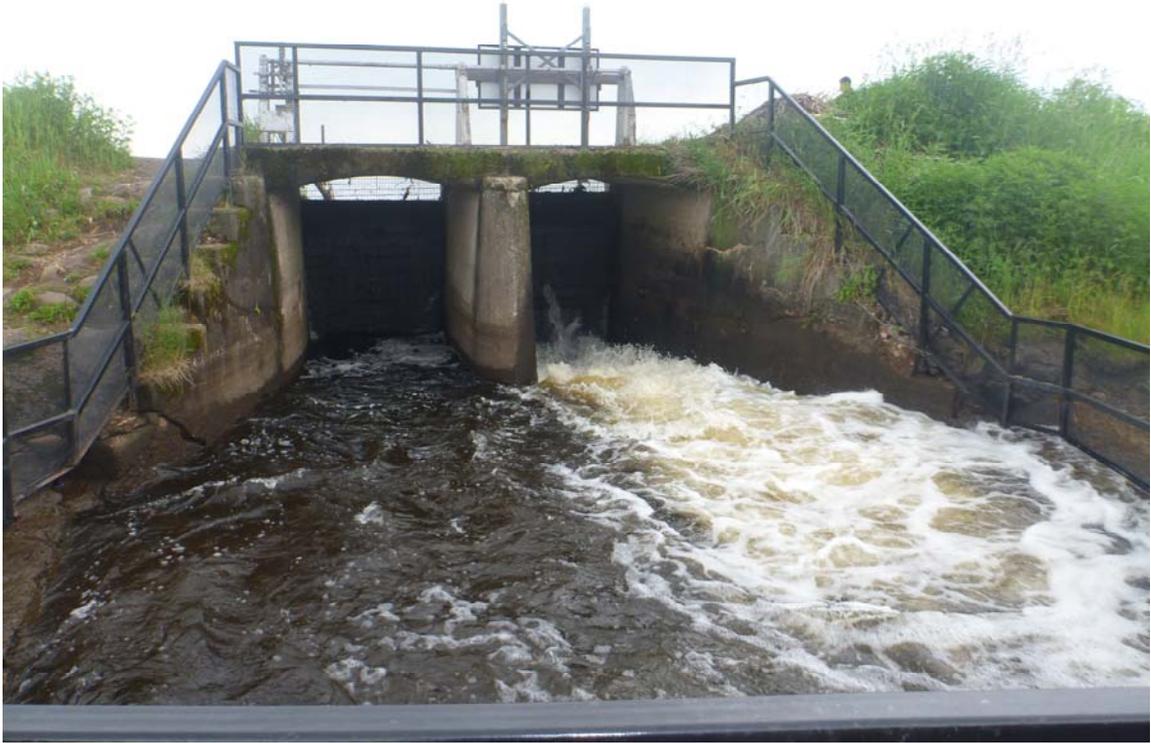
Photograph 7. View of the Upstream Channel and Dam Gates to the Lake, Looking Southwest.

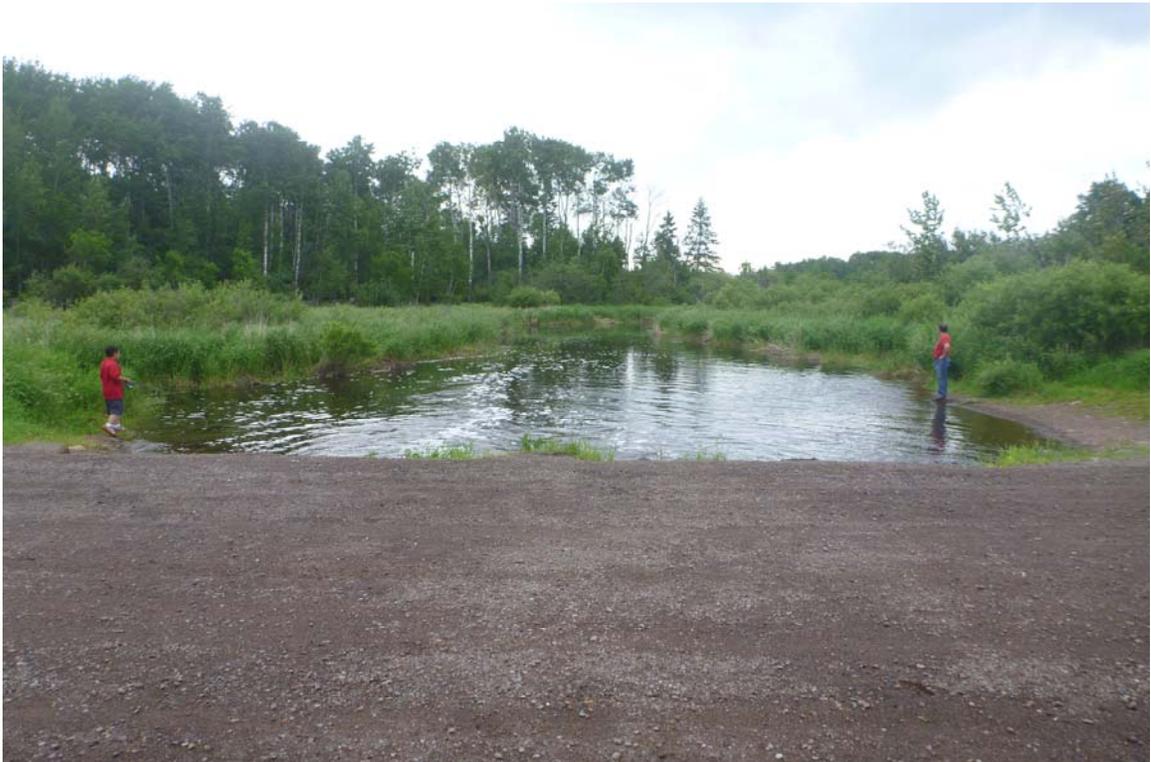
- (A) The channel bottom material in the culverts and upstream and downstream of the culvert openings consisted of 1 foot diameter and smaller stone and gravel with some sand infill allowing no probe rod penetration.

Photograph 8. View of the Downstream Channel, Looking Northeast.

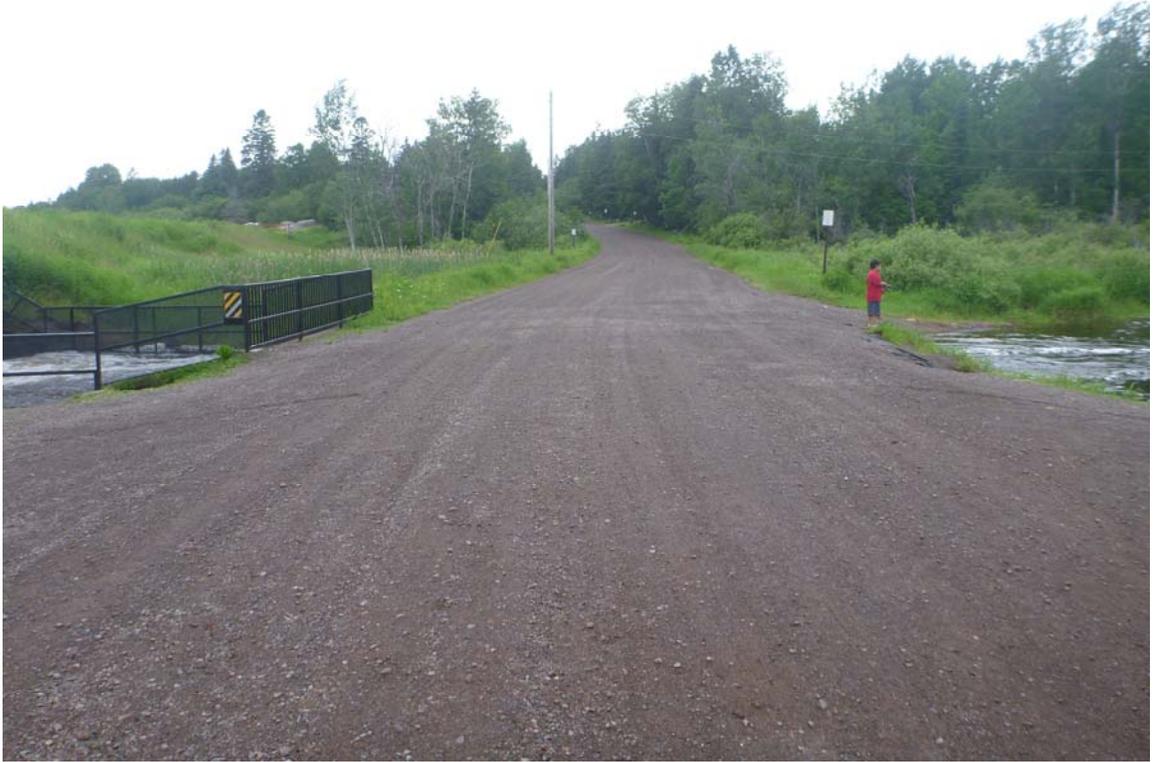
Photograph 9. View of TWP 198 Roadway over the Three CMP Culverts, Looking Northwest.

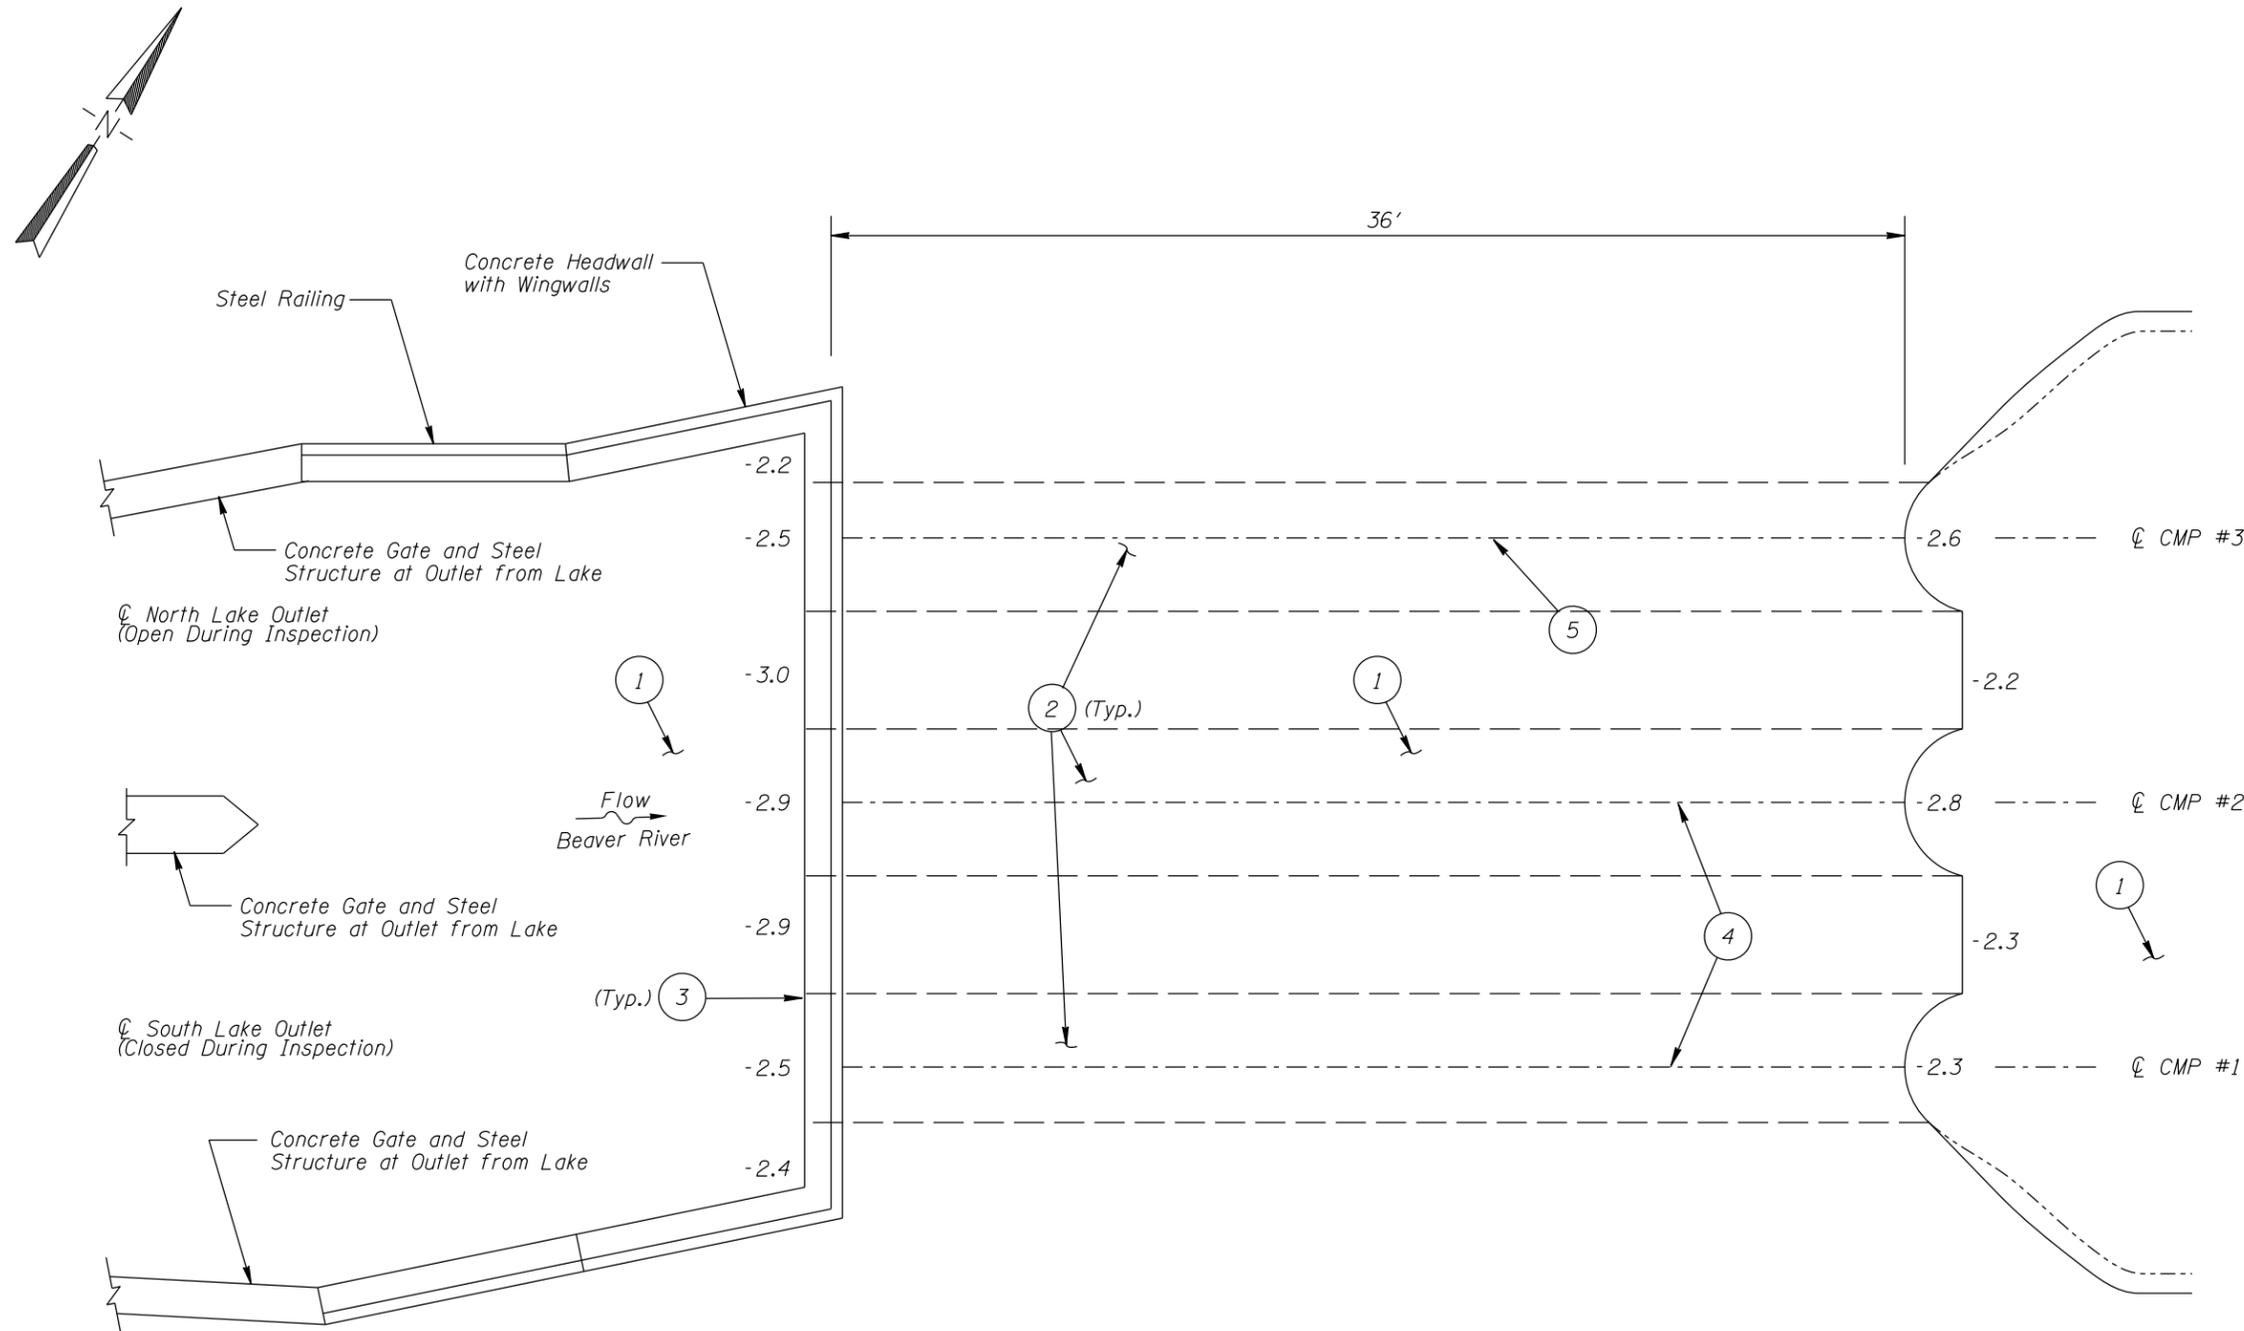
- INSPECTION NOTES:**
- 1 The channel bottom material in the culverts and upstream and downstream of the culvert openings consisted of 1 foot diameter and smaller stone and gravel with some sand infill allowing no probe rod penetration.

- 2 A 6 inch band of heavy corrosion was noted along the waterline with delaminations, typically 1/8 inch thick, and widespread areas of 100 percent section loss measuring 1 inch to 2 inches wide on the ribs of the corrugations. Within the affected area the section loss typically ranged between 50 and 80 percent. The corrosion was heavier on the upstream and downstream quarters of the culverts. Moderate corrosion was observed above and below the deteriorated 6 inch band with no associated complete section loss.

- 3 The concrete of the headwalls and wingwalls was generally sound with light to moderate scaling with up to 1/2 inch penetration around the waterline. The concrete extended completely into the channel bottom.

- 4 The top of the pipe has deflected/deformed downward 4 to 6 inches at approximately 5 feet to 10 feet from the downstream end of CMP #1 and #2.
 - 5 The top of Pipe 3 has deflected/deformed downward ±2 inches at approximately 15 feet from the downstream end of the culvert.
