UNDERWATER BRIDGE INSPECTION REPORT

STRUCTURE NO. L6106

CR 180

BOG CREEK

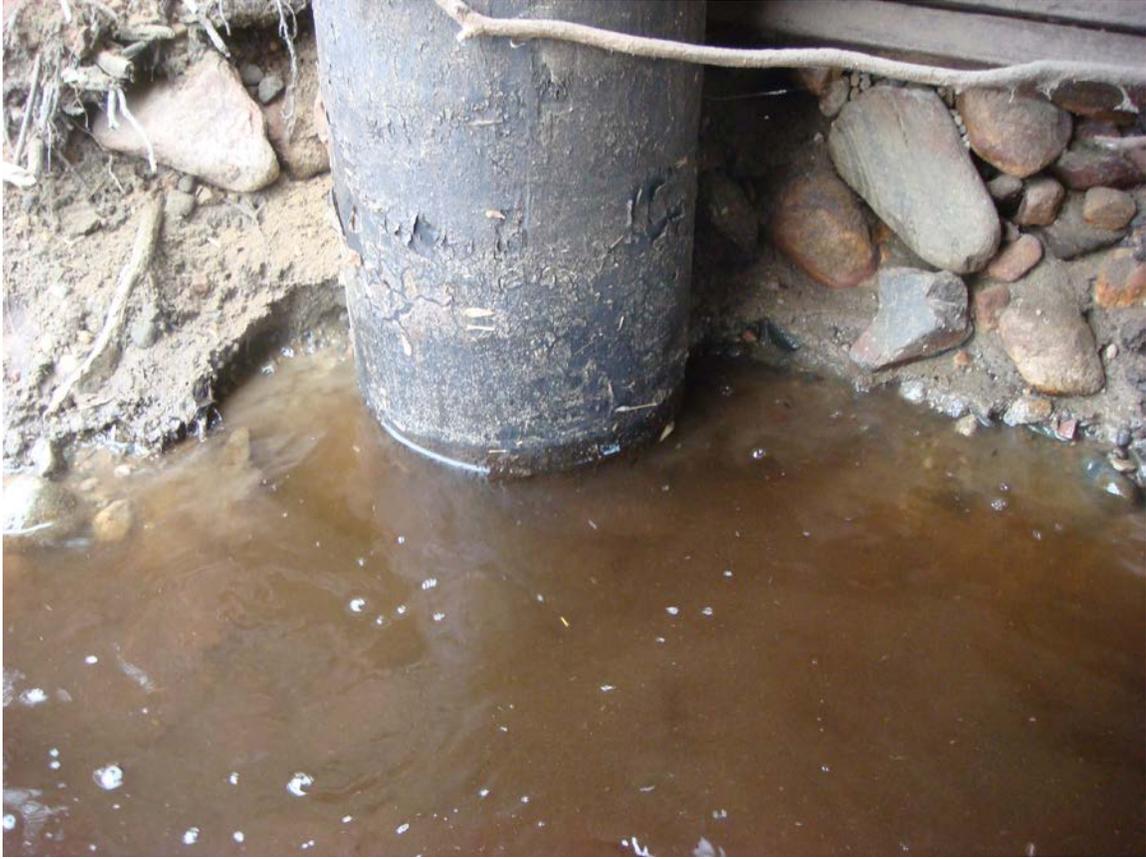
- (C) The timber of Piles B, C, D, E, and F of the East and West Abutments and Bent 1 were typically in fair condition allowing an awl penetration of 1/2 inch. Random splits or checks were observed with a maximum width of 1/2 inch and up to 3 inches deep.

Photograph 5. View of the Typical Timber Pile Condition at the Waterline, Looking East.

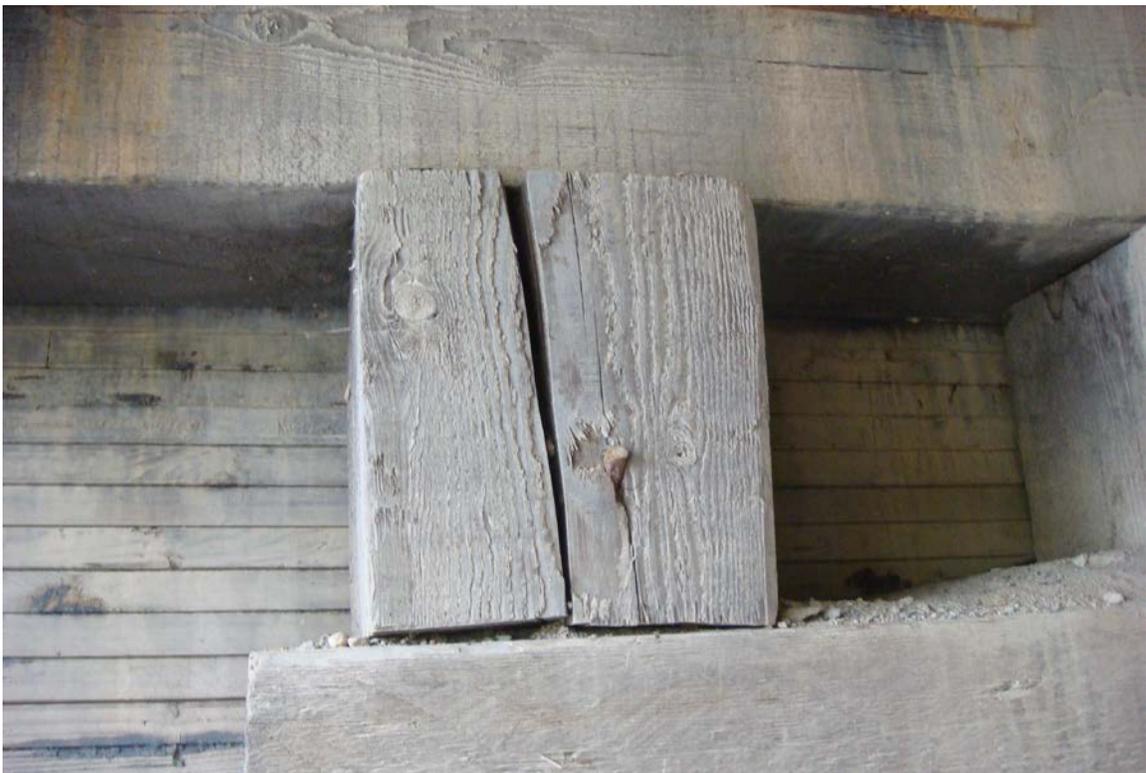
- (I) The pile extension at Piles B, C, D, E, and F of the East Abutment exhibited splitting typically 1.5 inches deep.
- (J) The sill at the West Abutment was displacing out towards the channel and has rotated towards the west. As a result, the piles were only bearing on approximately 10 percent of the top surface area. A 1/2 inch to 3/4 inch gap was observed between the top of the pile and the bottom of the sill on the east face. The backwall consists of rough cut 2" x 4" boards stacked flatwise. The wall is rotating similarly to the cap, sill and pile extensions.

Photograph 6. View of Typical Splitting in Pile Extension, Looking East.

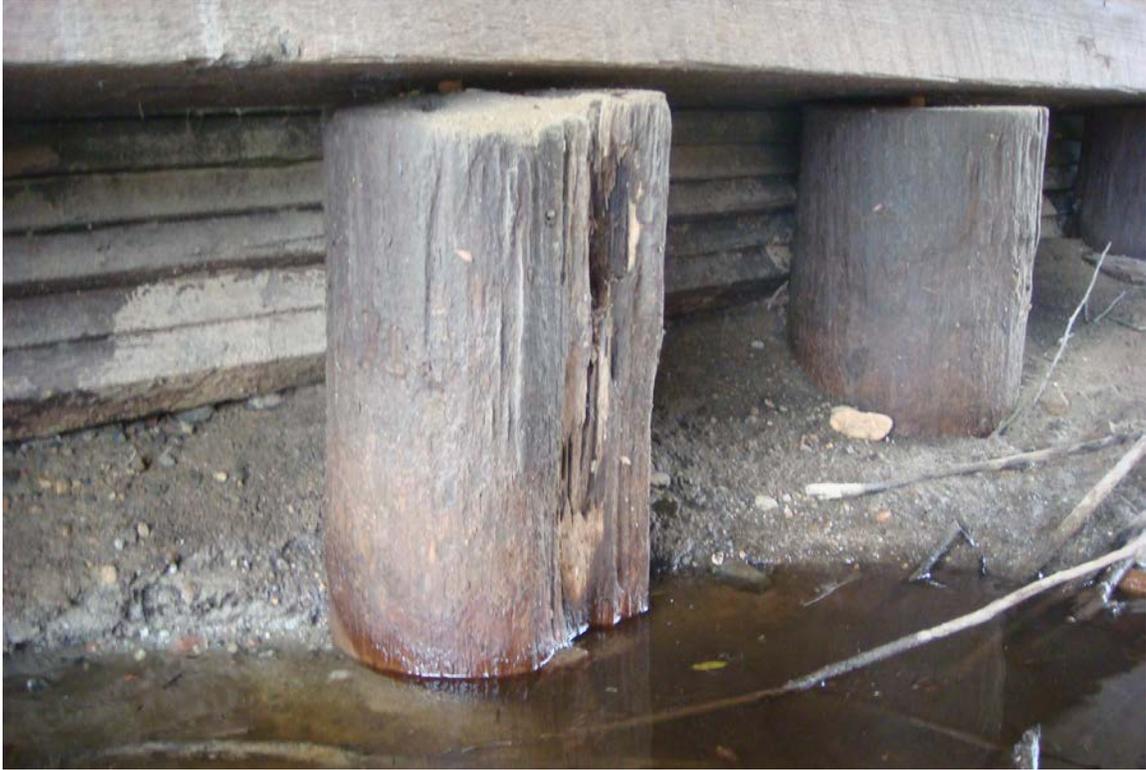
- (D) The west face of Pile E of the East Abutment exhibited approximately 25 percent loss of section.
- (E) Pile E of the West Abutment exhibited approximately 25 percent loss of section.

Photograph 7. View of Pile E of the East Abutment with Timber Section Loss, Looking Southeast.

- (A) Repairs, such as pile replacement or structural jacketing, should be considered for Piles D and E of the West Abutment and Pile E of the East Abutment to restore full load carrying capacity of the piles. Monitor the splitting and timber decay (exterior softness) on all other piles and consider repairs if conditions worsen.

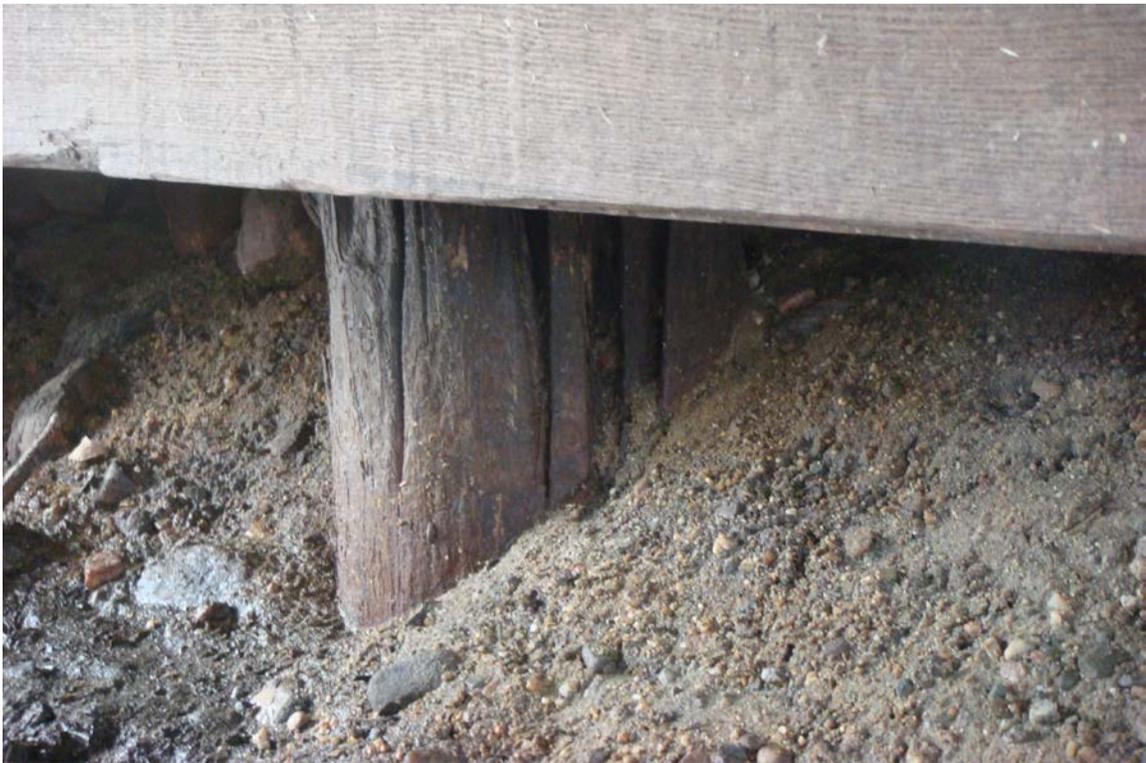
- (F) Pile D of the West Abutment exhibited approximately 33 percent loss of section.
- (G) Pile G of the East Abutment had a 1 inch gap on the west side of the pile between the top of the pile and the bottom of the pile cap.

Photograph 8. View of Pile D of the West Abutment with Timber Section Loss, Looking Southwest.

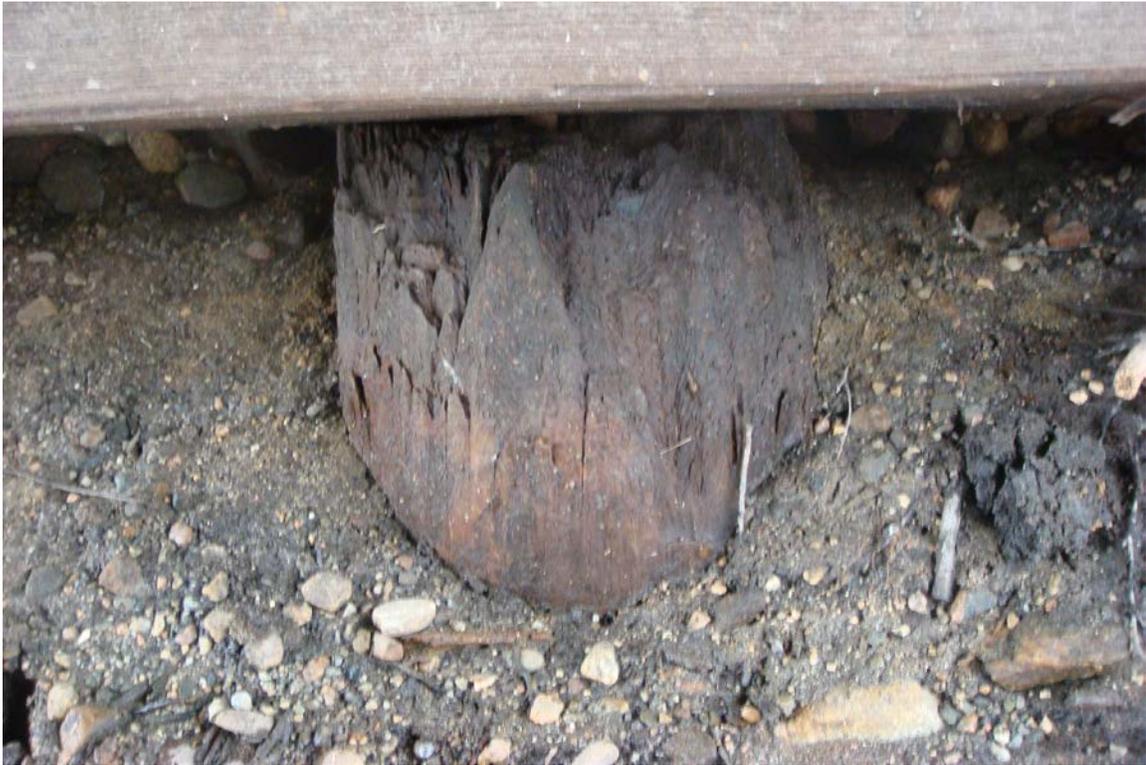
Photograph 9. View of Pile E of the West Abutment with Timber Section Loss, Looking West.

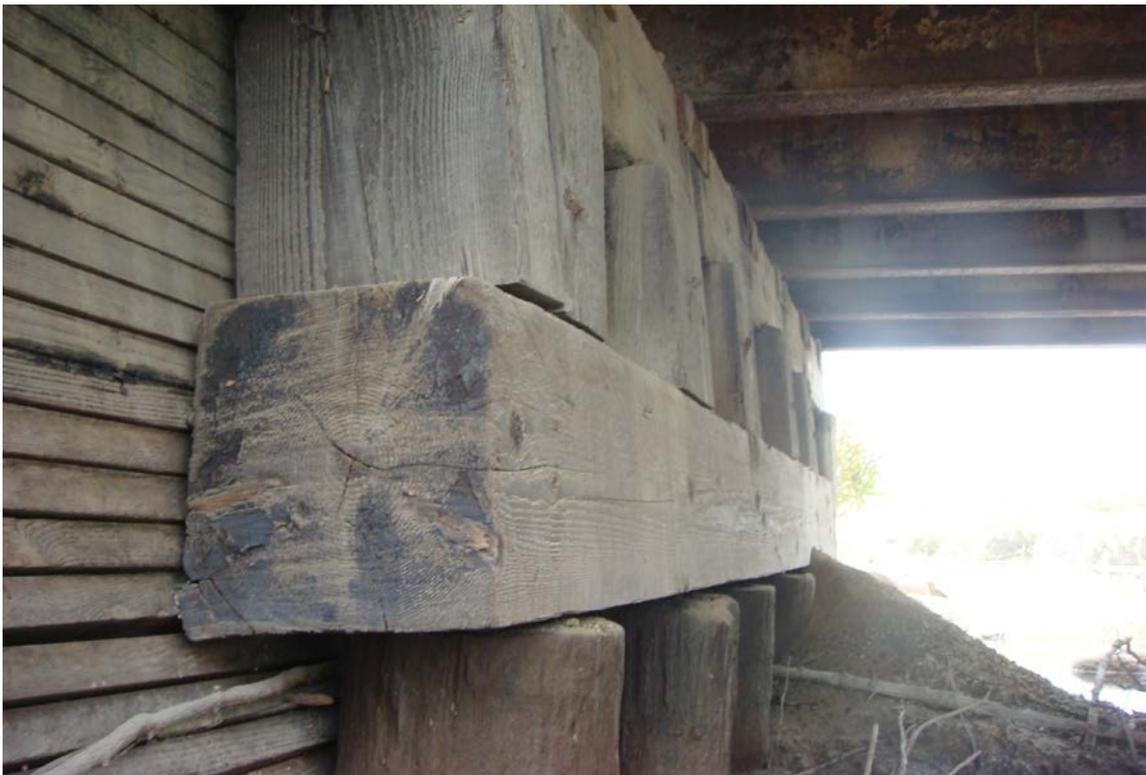
- (K) The East Abutment was displacing out towards the channel and has rotated towards the east. As a result, only 1 inch on the east sides of the piles was bearing. A 1/2 inch to 1.5 inch wide gap was observed between the top of the piles and the bottom of the sill on the west face. The pile cap has shifted 1 inch to the east and appears to be a result of the loss of backfill behind the abutment. Backfill was observed mounded up to 2 feet high to the west of the abutment. The backwall consists of rough cut 2" x 4" boards stacked flatwise. The wall is rotating similarly to the cap, sill and pile extensions.

Photograph 10. View of the Timber Sill Rotation and Backwall Heaving/Displacement at the East Abutment, Looking South.

- (B) Shim all piles on the East and West Abutments as soon as possible to restore full bearing. Closely monitor the rotation/displacement of the backwall, sill, and piles until an above water inspection and/or further analysis can determine the necessary repairs and/or posting of the bridge for a maximum load limit.

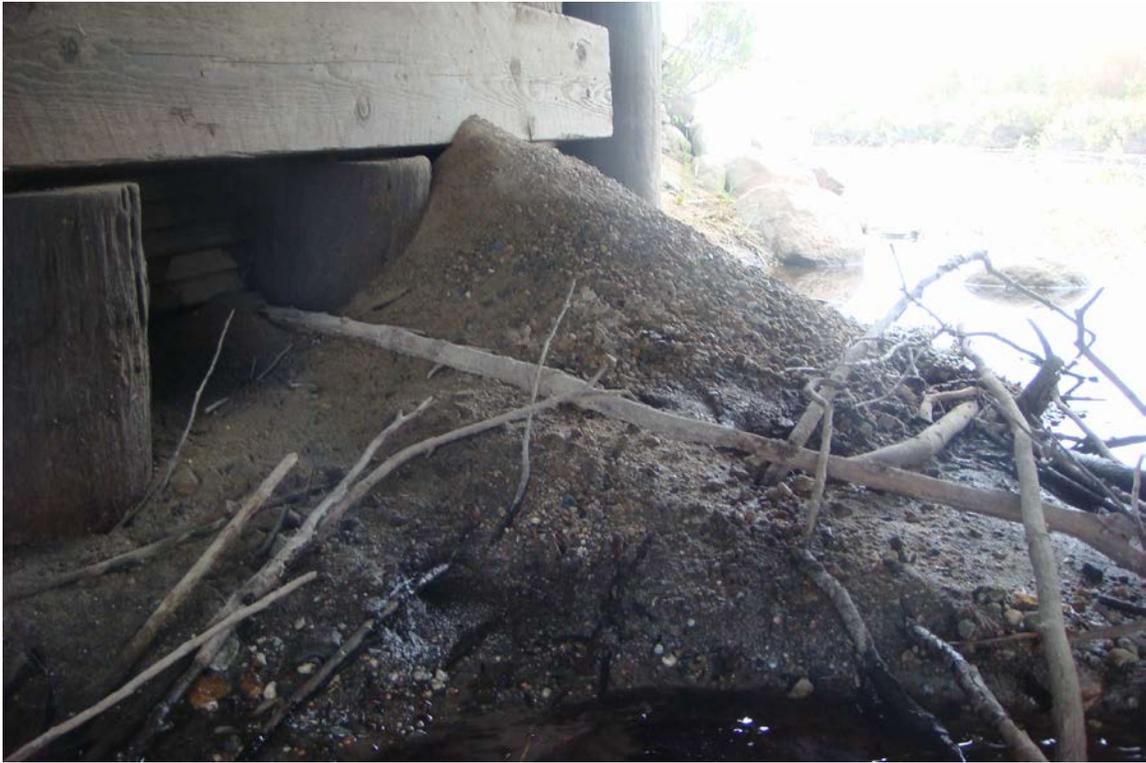
Photograph 11. View of Mounded Up Sediment and Backfill Material at the East Abutment, Looking South.

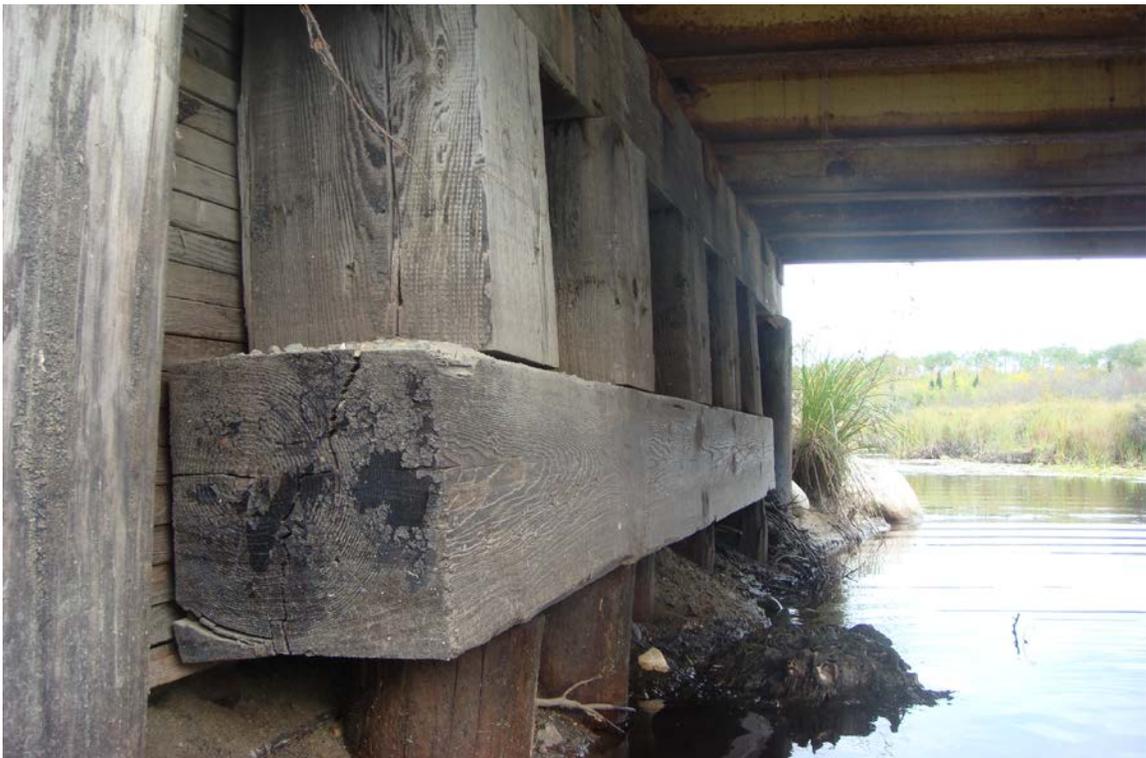
Photograph 12. View of the Timber Sill Rotation and Backwall Heaving at the East Abutment, Looking South.

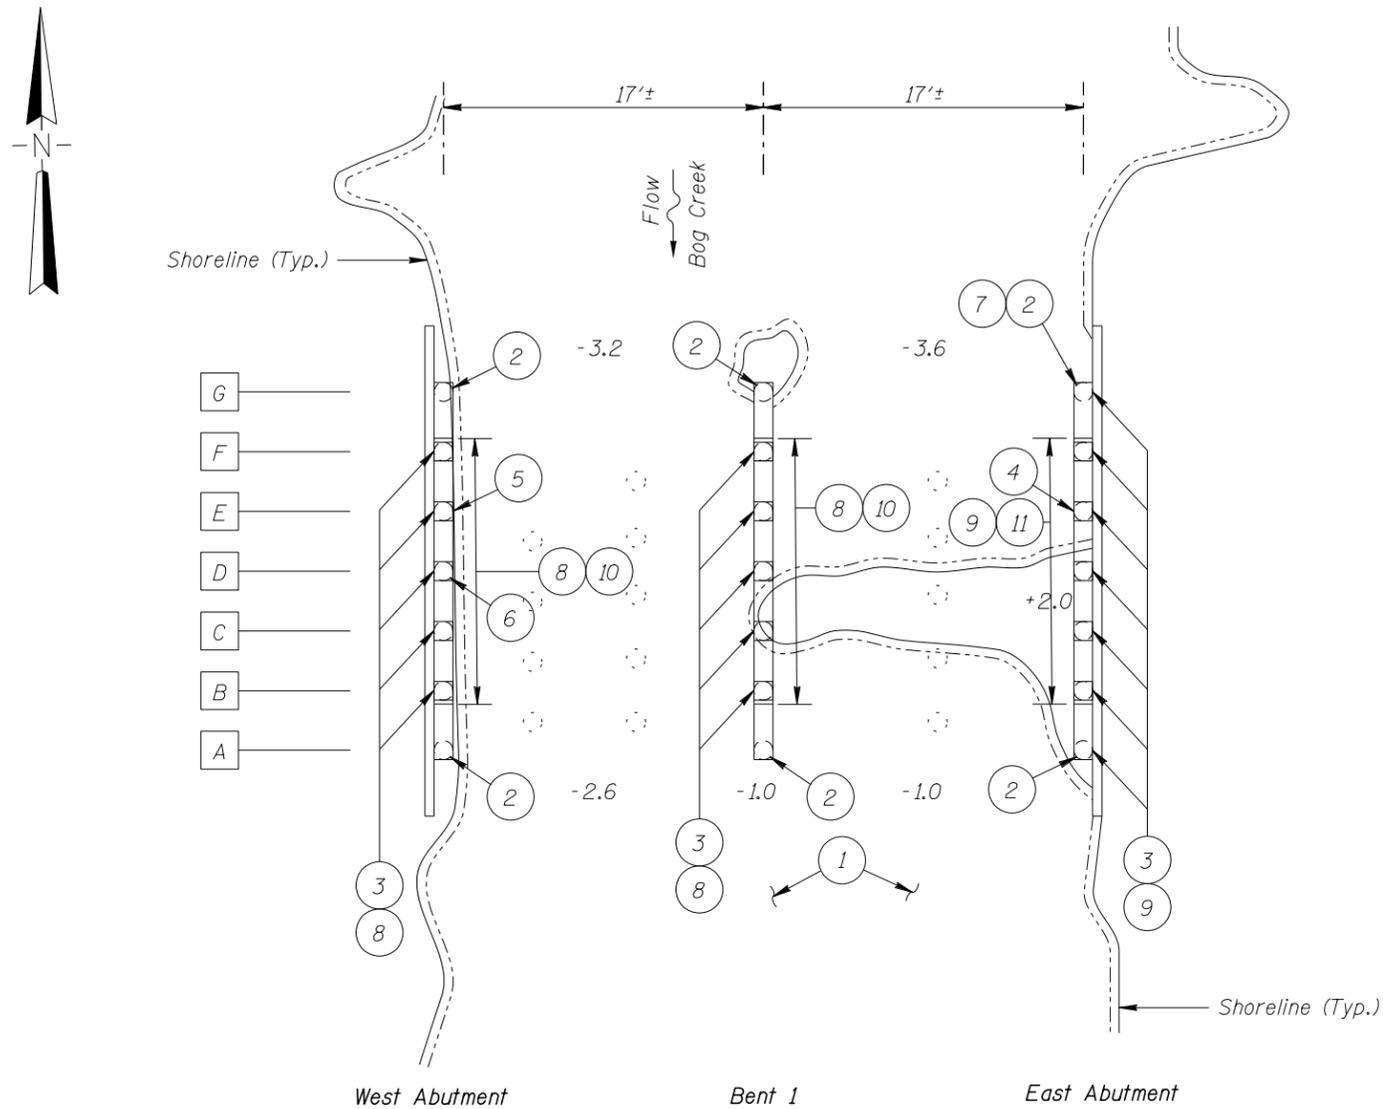
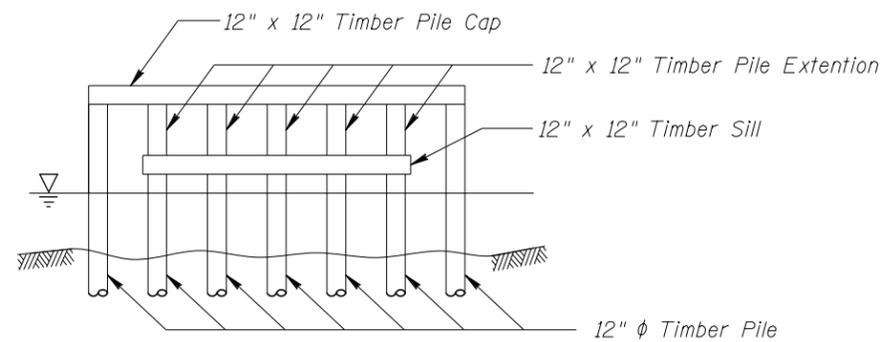
- 1 The channel bottom material consisted of cobbles, gravel, and sand with a maximum probe rod penetration of 18 inches
- 2 The timber of Piles A and G of the East and West Abutments and Bent 1 and the pile caps were typically sound with random splits or checks. The splits were a maximum of 1/2 inch wide and 3 inches deep.

- 3 The timber of Piles B, C, D, E, and F of the East and West Abutments and Bent 1 were typically in fair condition allowing an awl penetration of 1/2 inch. Random splits or checks were observed with a maximum width of 1/2 inch and up to 3 inches deep.

- 4 The west face of Pile E of the East Abutment exhibited approximately 25 percent loss of section.
- 5 Pile E of the West Abutment exhibited approximately 25 percent loss of section.

- 6 Pile D of the West Abutment exhibited approximately 33 percent loss of section.
- 7 Pile G of the East Abutment had a 1 inch gap on the west side of the pile between the top of the pile and the bottom of the pile cap.

- 8 The timber of the sill and the pile extensions at the West Abutment and Bent 1 were in fair condition with random splits or checks up to 3/4 inch wide.

- 9 The pile extension at Piles B, C, D, E, and F of the East Abutment exhibited splitting typically 1.5 inches deep.
- 10 The sill at the West Abutment was displacing out towards the channel and has rotated towards the west. As a result, the piles were only bearing on approximately 10 percent of the top surface area. A 1/2 inch to 3/4 inch gap was observed between the top of the pile and the bottom of the sill on the east face. The backwall consists of rough cut 2" x 4" boards stacked flatwise. The wall is rotating similarly to the cap, sill and pile extensions.

- 11 The East Abutment was displacing out towards the channel and has rotated towards the east. As a result, only 1 inch on the east sides of the piles was bearing. A 1/2 inch to 1.5 inch wide gap was observed between the top of the piles and the bottom of the sill on the west face. The pile cap has shifted 1 inch to the east and appears to be a result of the loss of backfill behind the abutment. Backfill was observed mounded up to 2 feet high to the west of the abutment. The backwall consists of rough cut 2" x 4" boards stacked flatwise. The wall is rotating similarly to the cap, sill and pile extensions.

- 12 Although outside the scope of the underwater inspection it was observed that the steel girders exhibited heavy corrosion with appreciable loss of section.
