UNDERWATER BRIDGE INSPECTION REPORT

STRUCTURE NO. L6116

MSAS 140 (LAKE AVE.)

SEPTEMBER 26, 2012

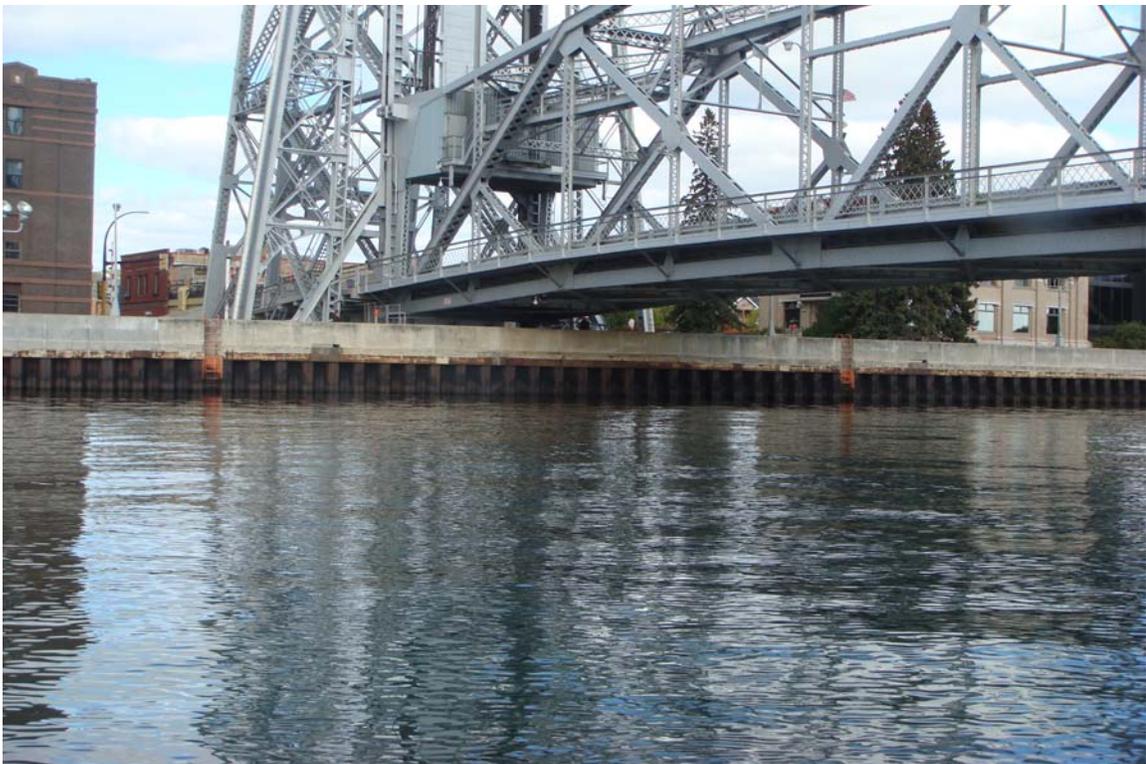
Photograph 2. View of the North Sea Wall, Looking Northeast.

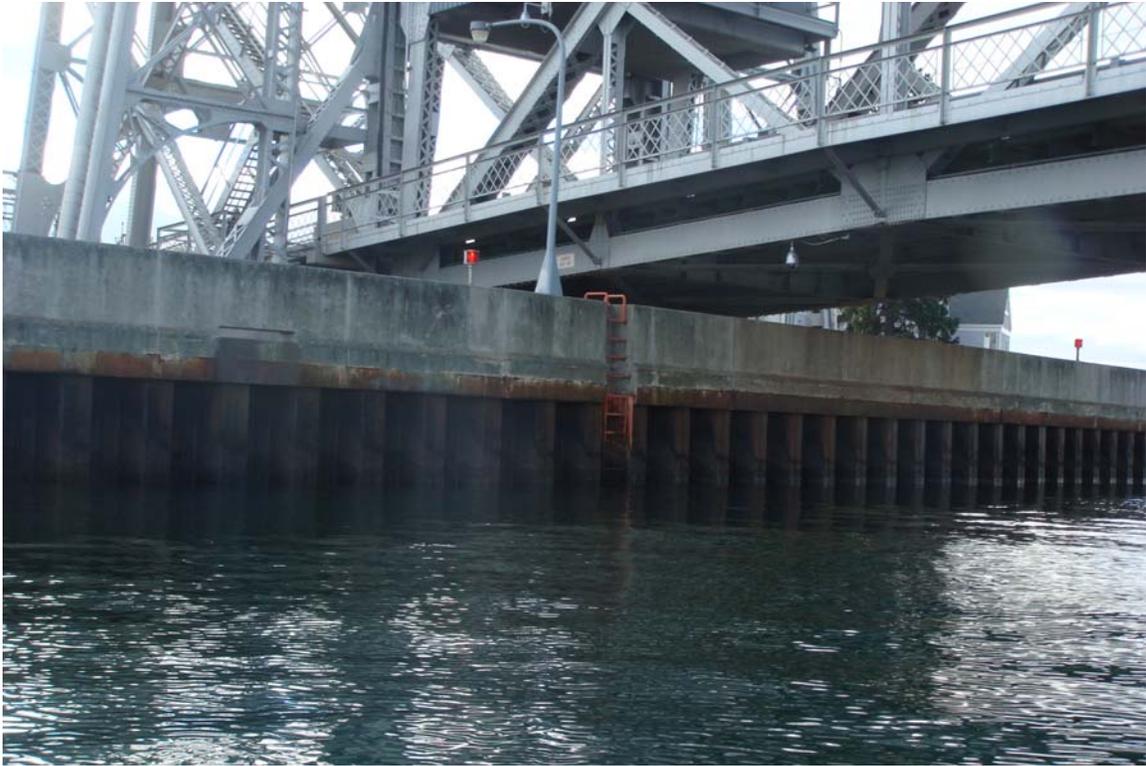
Photograph 3. View of the South Sea Wall, Looking Southwest.

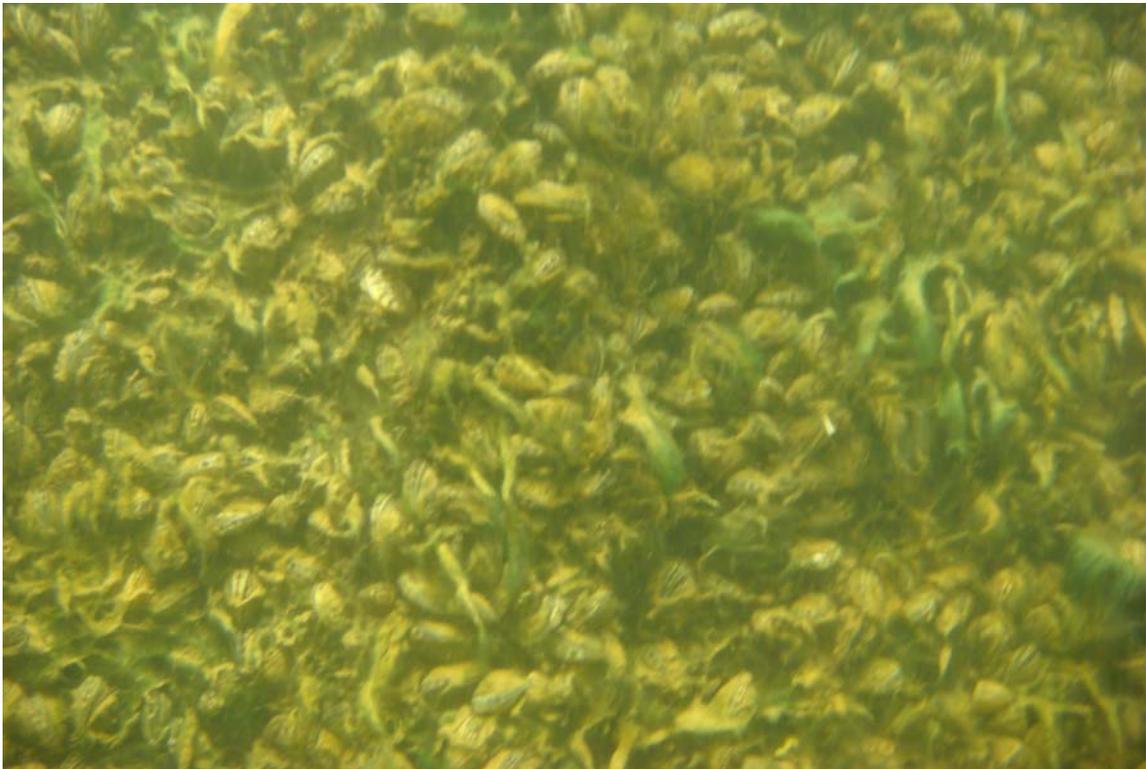
- (A) The channel bottom material typically consisted of concrete rubble and stones.
- (B) The steel sheet piling exhibited rust nodules typically 1/2 inch in diameter on approximately 50 percent the surface area with associated pitting up to 1/32 inch deep from 2 feet below the waterline to the channel bottom. A 1/2 inch thick layer of zebra mussels was also observed covering the surface in this area.
- (C) All sheet pile interlock seams appeared tight with no noticeable gaps or separation.

Photograph 4. View of the Typical Steel Sheet Pile Condition Covered in Zebra Mussels, Looking North.

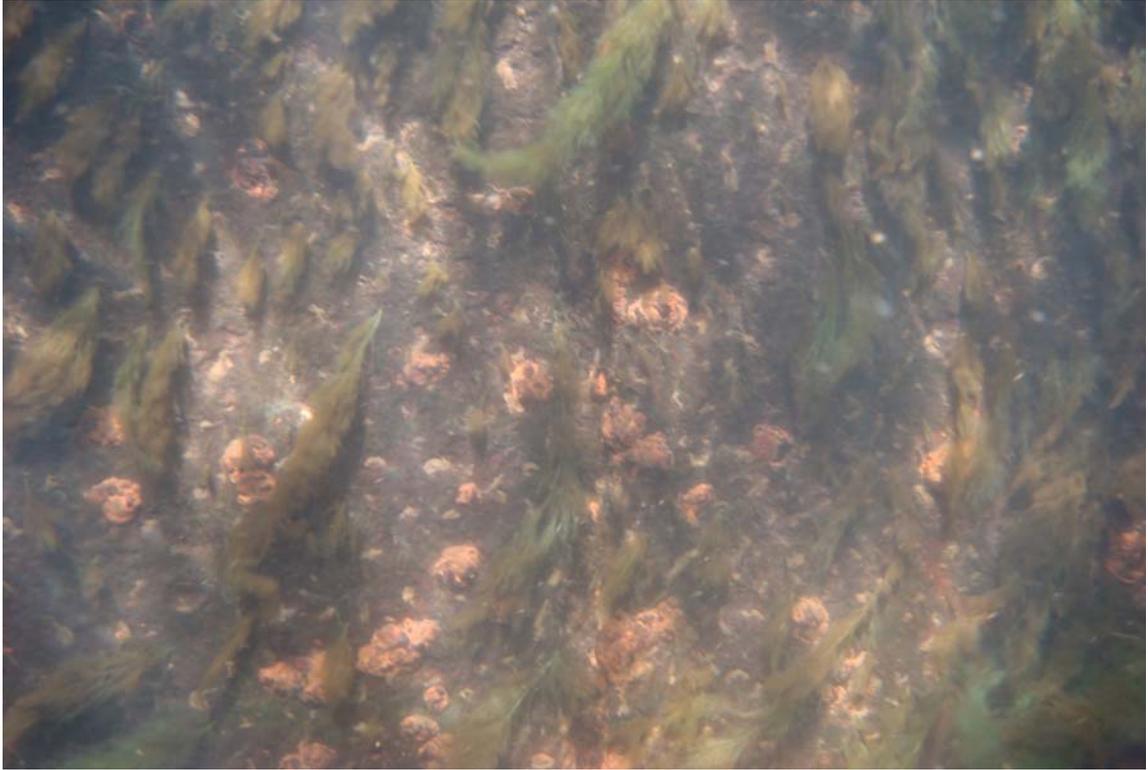
Photograph 5. View of the Typical Steel Sheet Pile Condition without Zebra Mussels, Looking North.

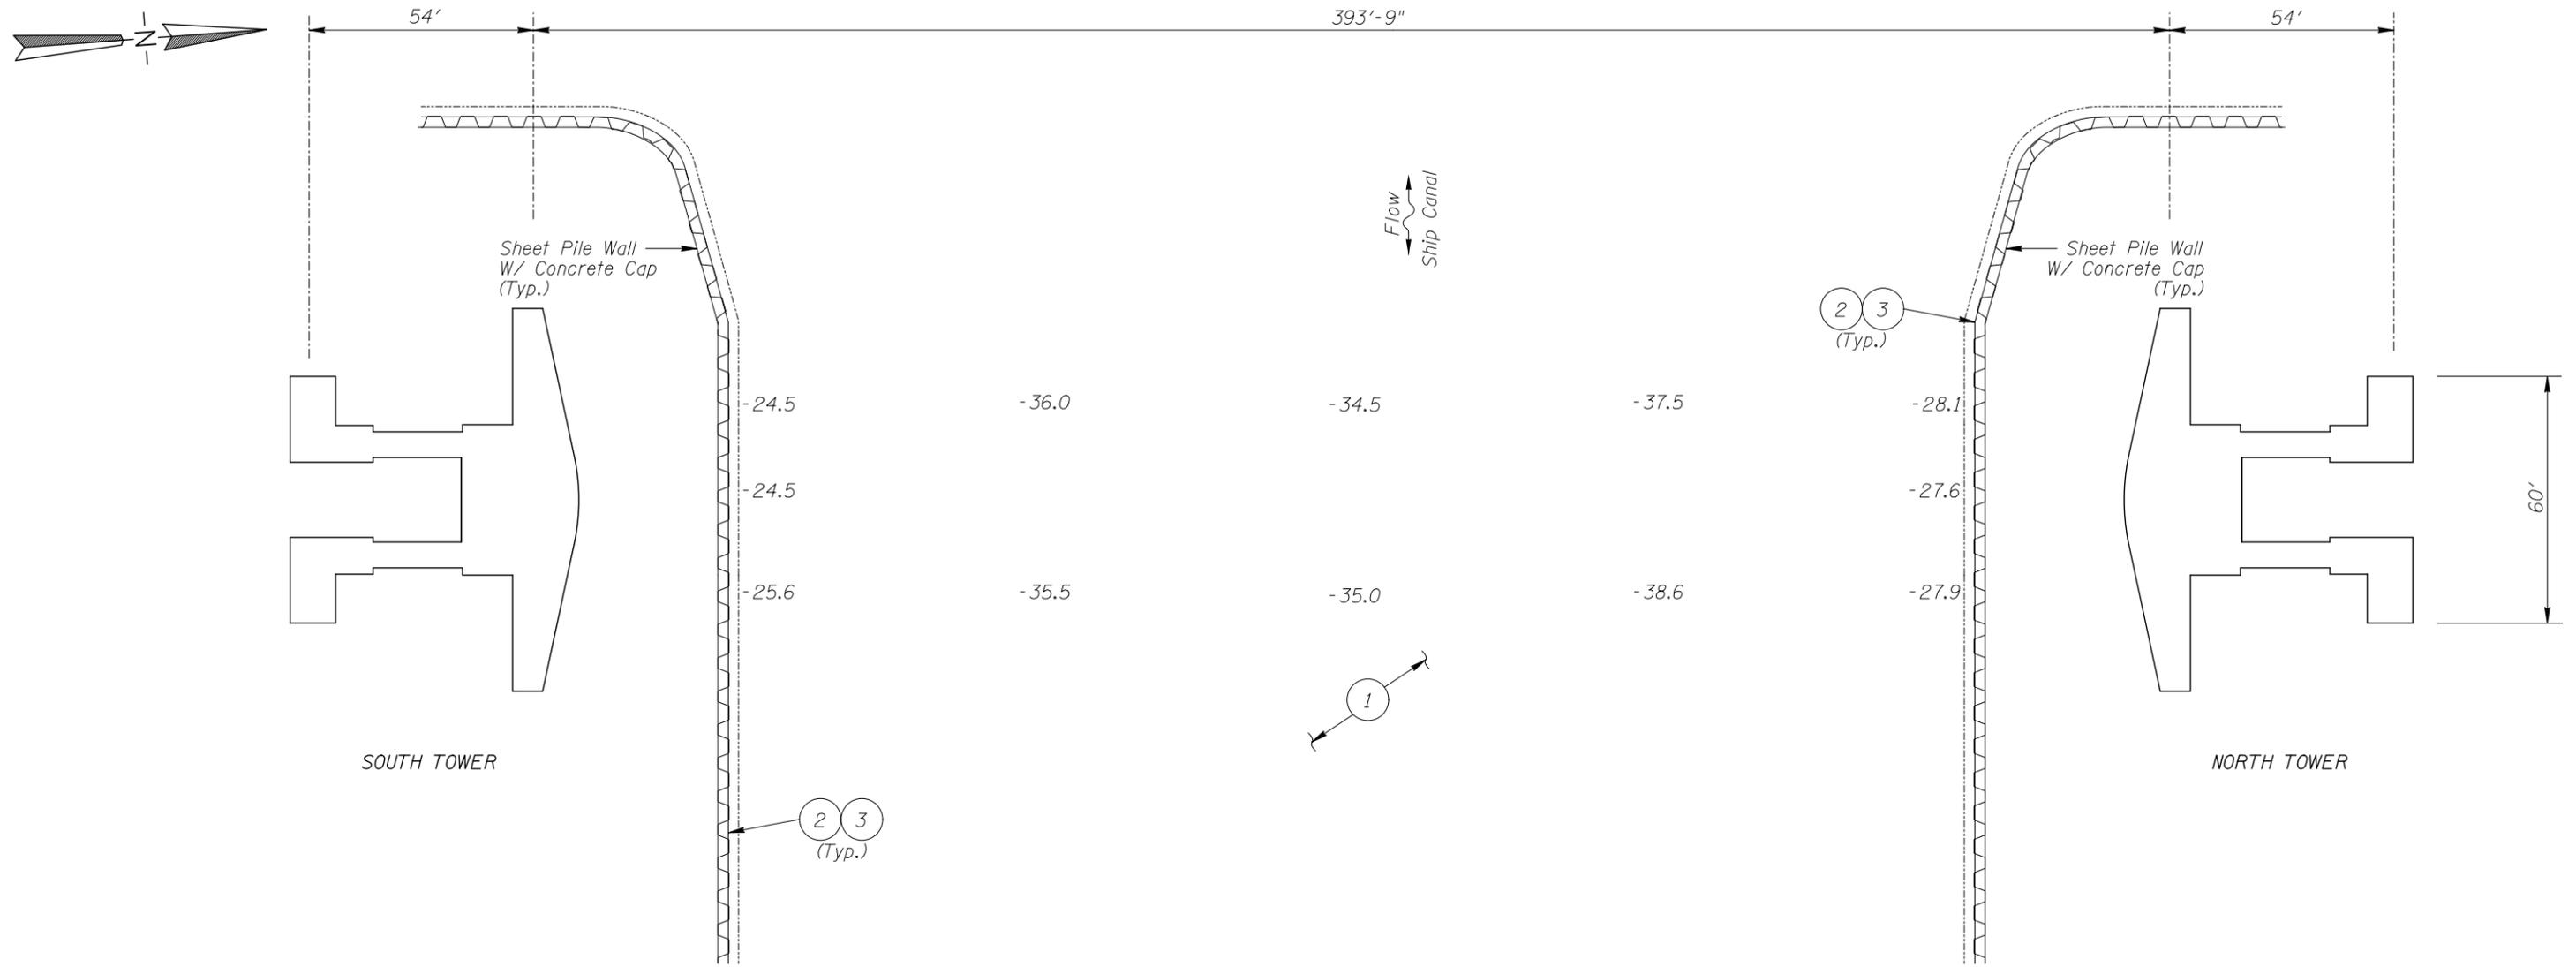
- 1 The channel bottom material typically consisted of concrete rubble and stones.
- 2 The sheet piling exhibited rust nodules typically 1/2 inch in diameter on approximately 50 percent of the surface area with associated pitting up to 1/32 inch deep from 2 feet below the waterline to the channel bottom. A 1/2 inch thick layer of zebra mussels was also observed covering the surface in this area.
- 3 All sheet pile wall interlock seams appeared tight with no noticeable gaps or separation.
