UNDERWATER BRIDGE INSPECTION REPORT

STRUCTURE NO. L8500  
WEST GATE BLVD (MUN 191)  
OVER  
KEENE CREEK  
CITY OF DULUTH

DECEMBER 3, 2012

MINNESOTA DEPARTMENT OF TRANSPORTATION  
UNDERWATER BRIDGE INSPECTION

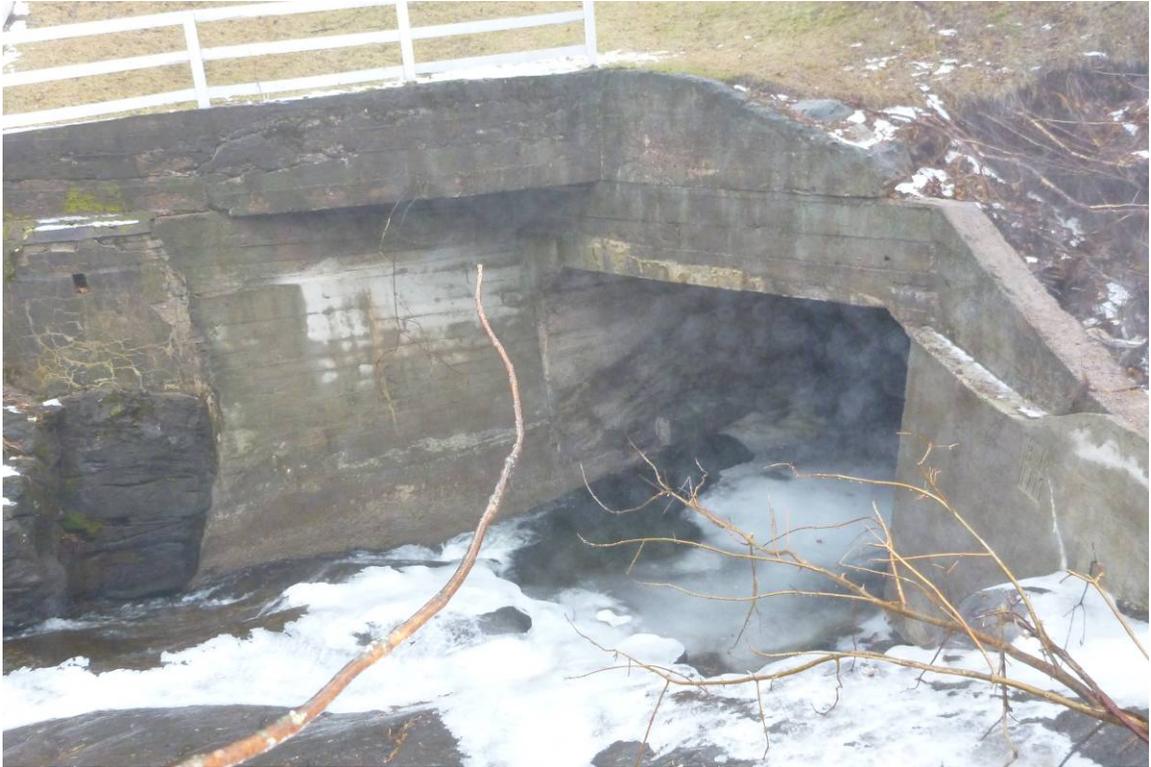
Photograph 1. Overall View of the Upstream Opening, Looking Southeast.

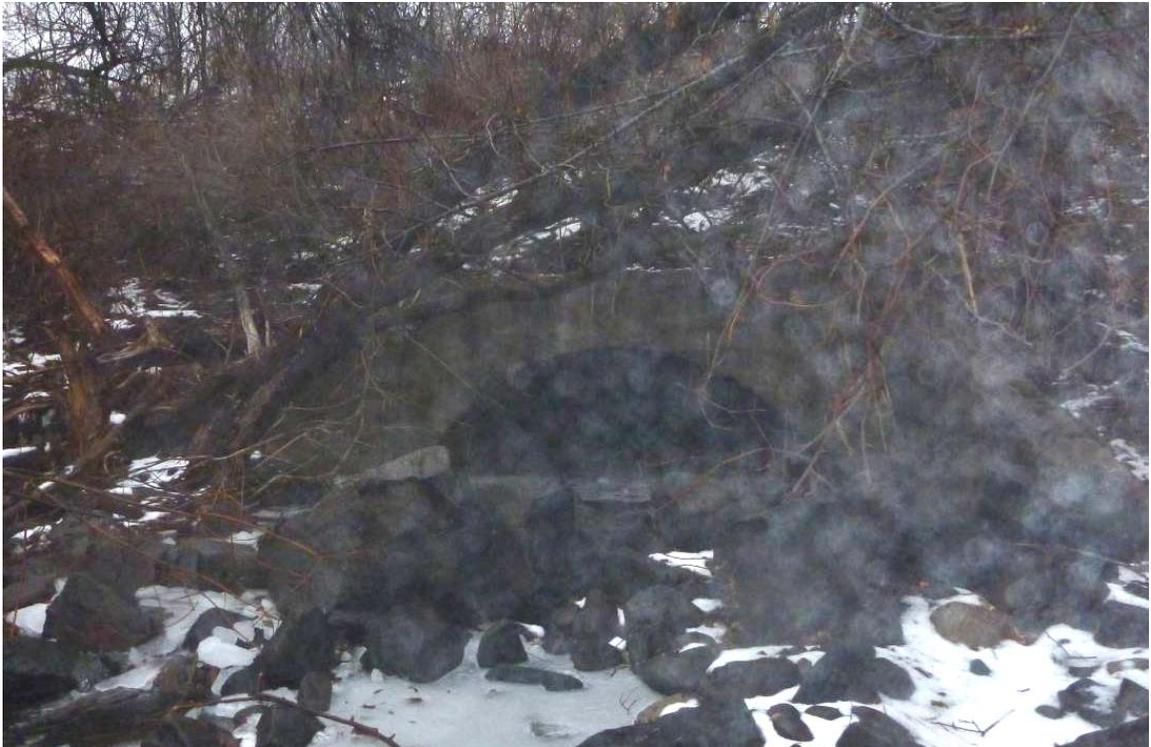
Photograph 2. Overall View of the Downstream Opening, Looking North.

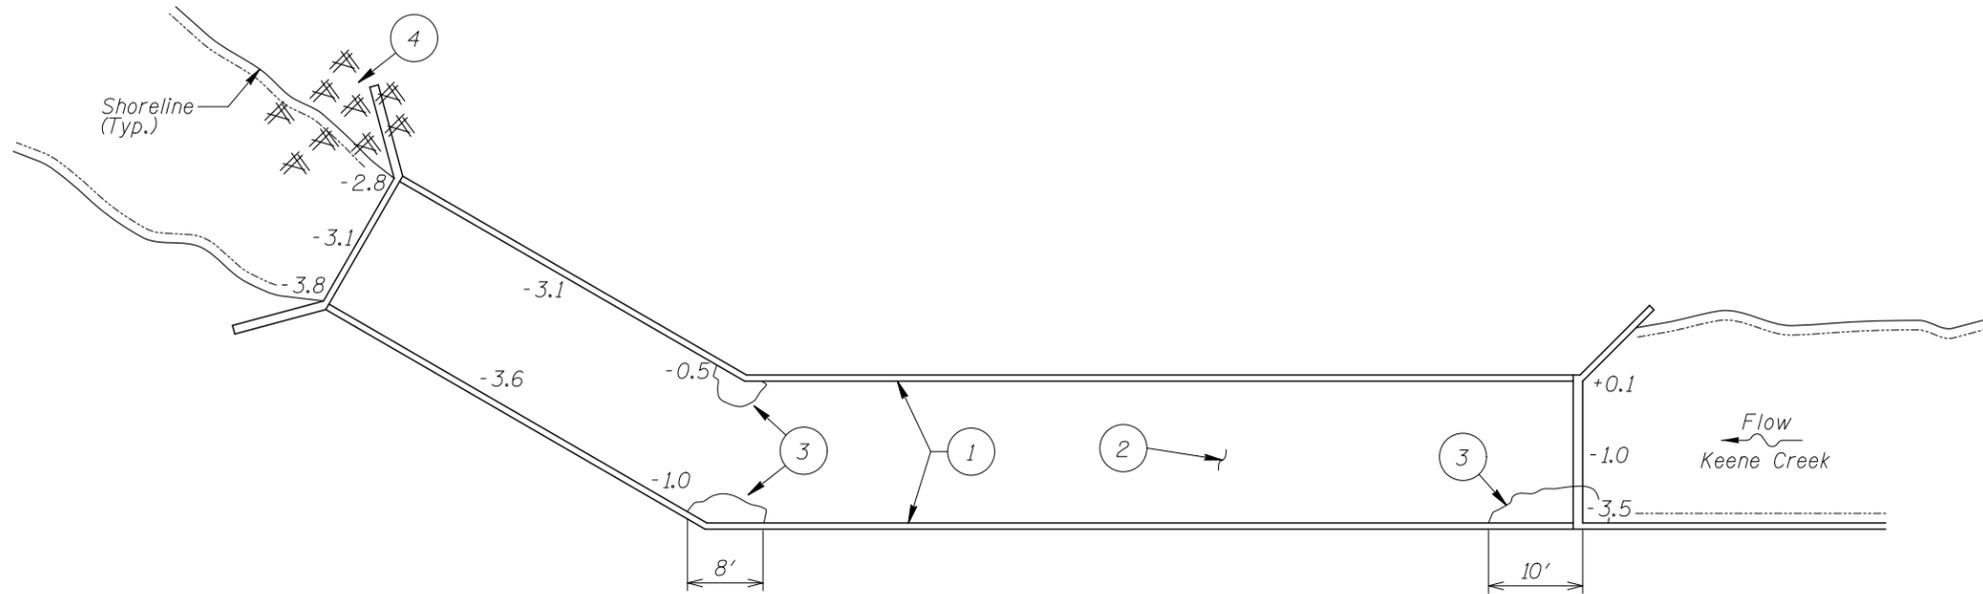
SOUNDING PLAN

- ① The concrete exhibited cracking up to 1/8 inch wide with efflorescence along culvert walls and ceiling. Several small spalls with exposed reinforcing steel were observed throughout the barrel.
- ② Culvert floor consisted of bedrock and small boulders.
- ③ Undermining was observed along the bottom of the culvert wall measuring up to 1 foot vertically and 1.5 foot of horizontal penetration.
- ④ A light to moderate accumulation of timber debris was observed at the downstream opening.

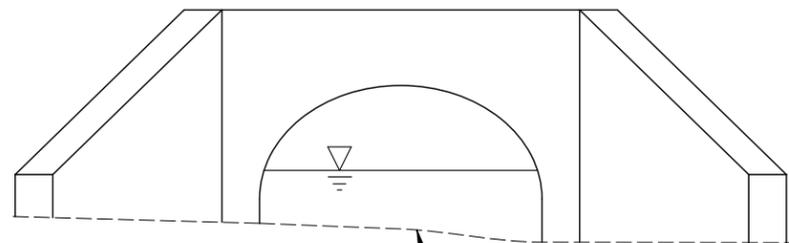
DOWNSTREAM OPENING PROFILE  
(Looking Upstream)

Channel Bottom  
on 12/3/12  
(BEDROCK)

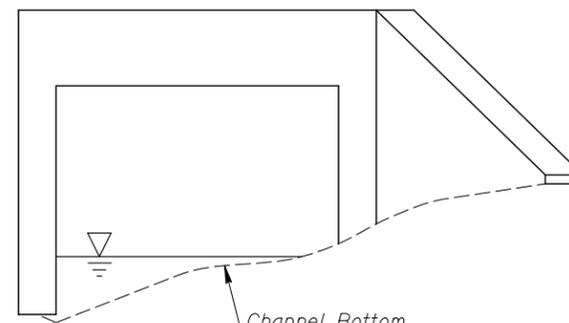
UPSTREAM OPENING PROFILE  
(Looking Downstream)

Channel Bottom  
on 12/3/12  
(BEDROCK)
