UNDERWATER BRIDGE INSPECTION REPORT

STRUCTURE NO. L9222

TWP 6205

BREDA CREEK

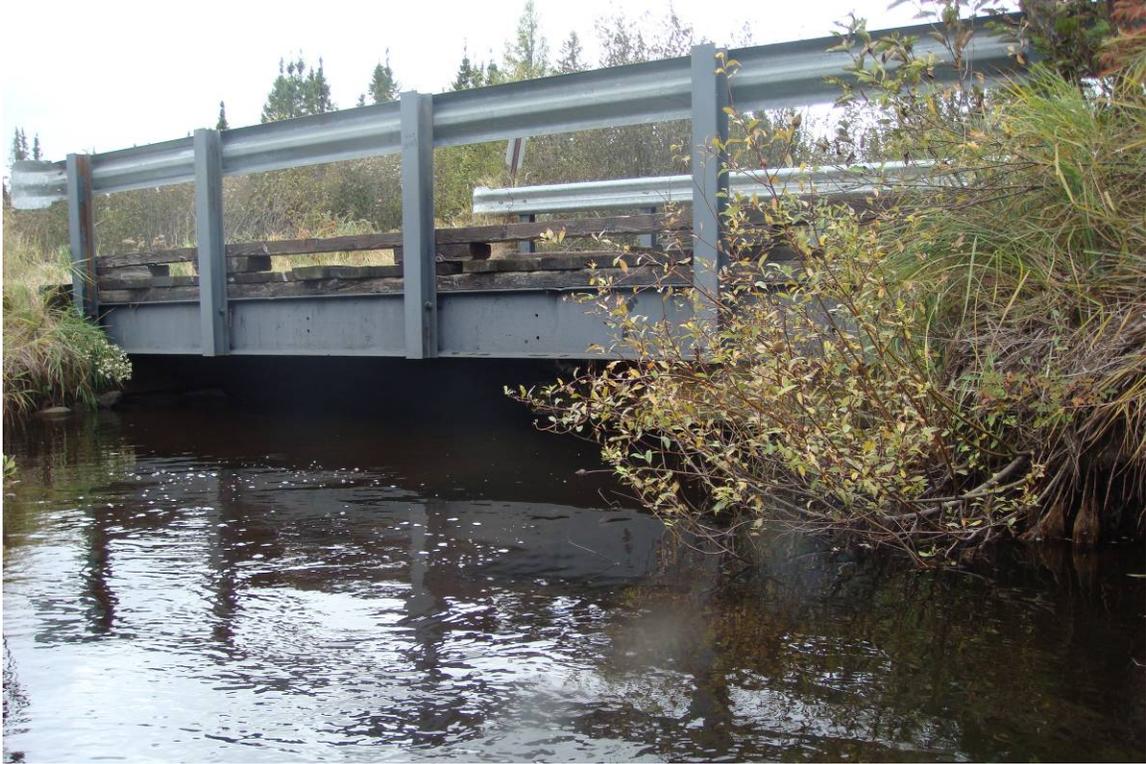
Photograph 1. Overall View of the Structure, Looking Southwest.

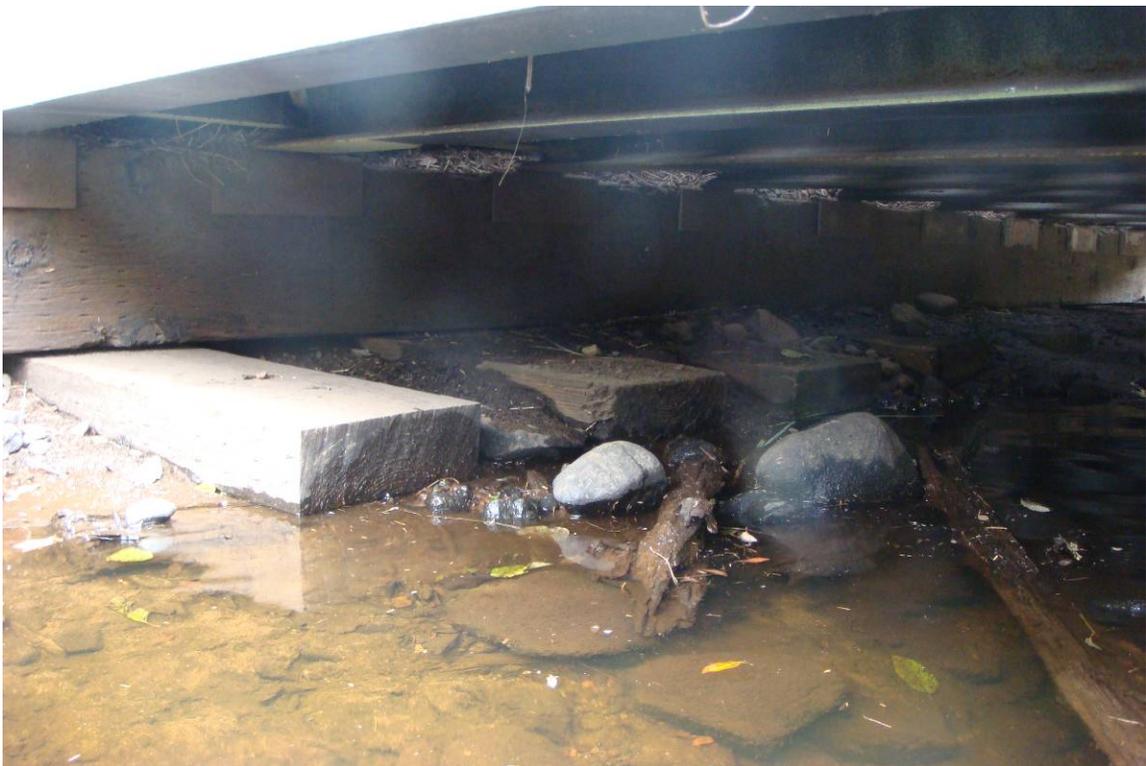
Photograph 2. View of the North Abutment, Looking Northeast.

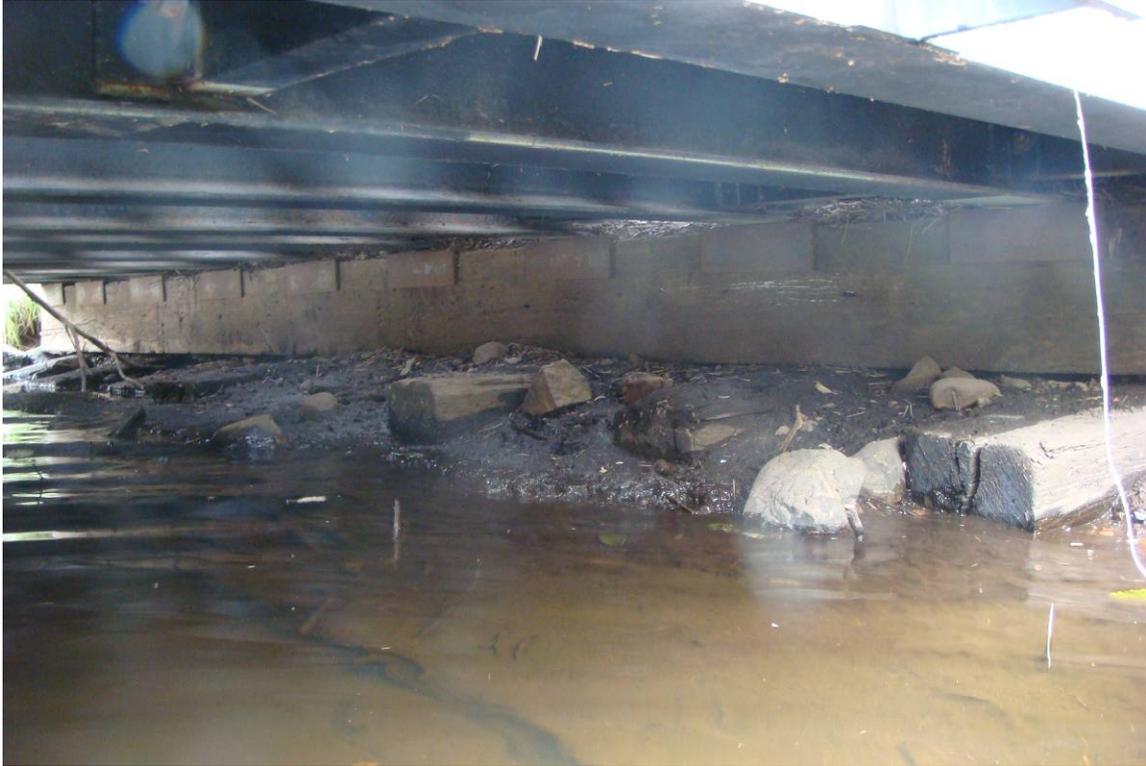
The substructure units inspected below water at Structure No. L9222, the North and South Abutments, were found to be in satisfactory to fair condition with some defects of structural significance. The timber of the block footings and grade beam was sound and had no signs of decay. The grade beam was not bearing fully on the three easterly block footings of the South Abutment.

Photograph 3. View of the South Abutment, Looking Southeast.

- (A) The three easterly block footings should be shimmed to restore full bearing to the grade beam at the South Abutment.
- (B) Reinspect the submerged substructure units at the normal maximum recommended (NBIS) interval of sixty (60) months.

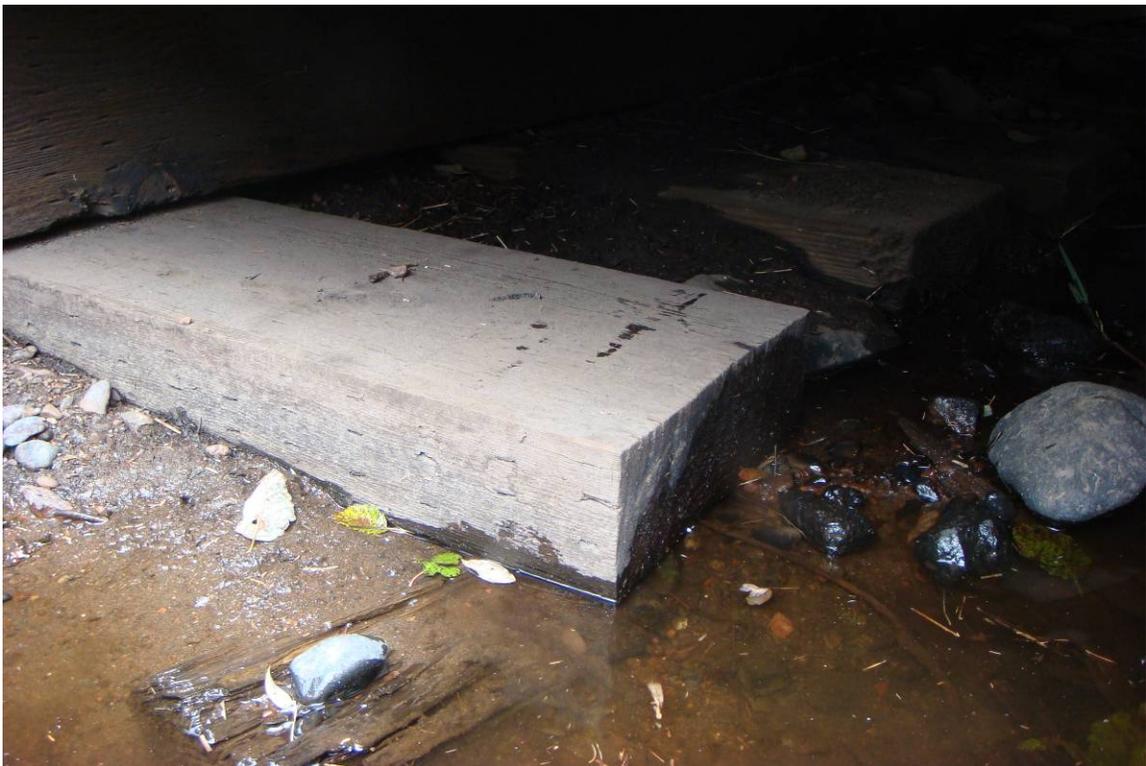
Photograph 4. View of the Typical Timber Condition at the Waterline of the Timber Block Footing Boards, Looking East.

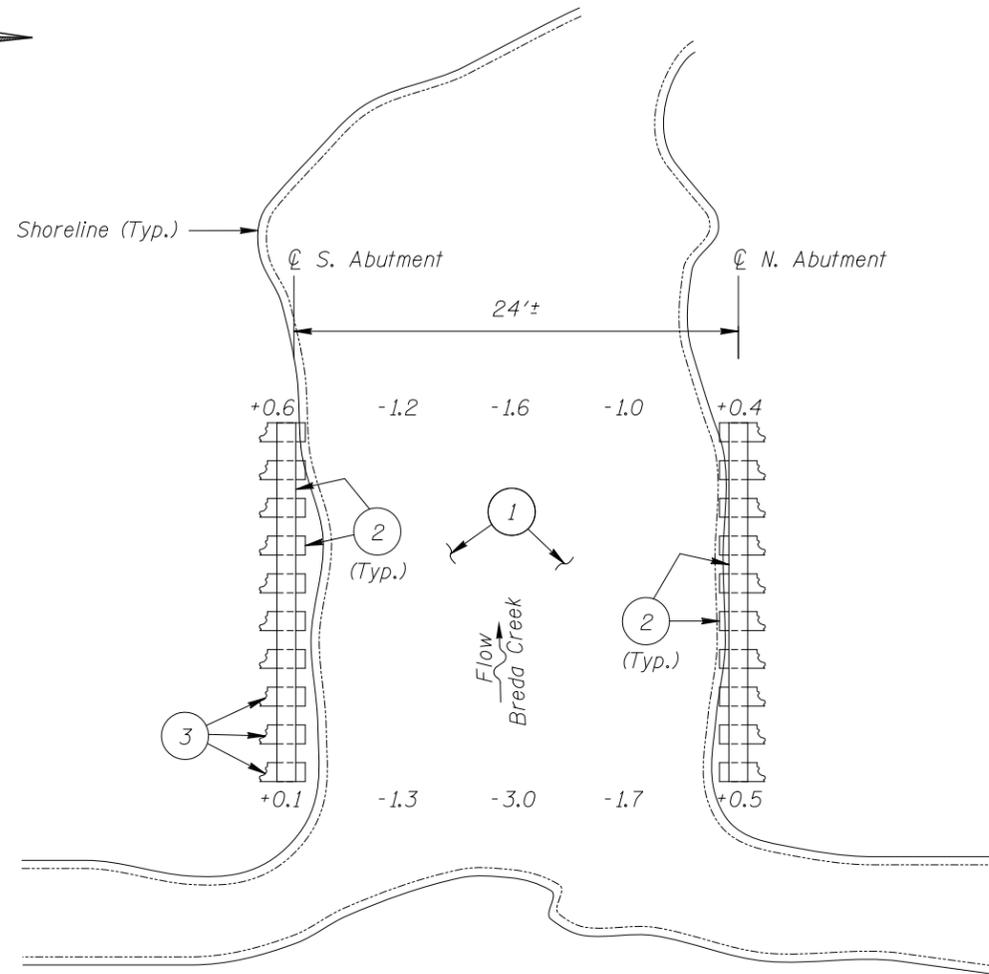
SOUNDING PLAN

- ① The channel bottom material consisted of sand, gravel, and scattered rocks allowing a maximum probe rod penetration of 4 inches.
- ② The timber of the grade beam and block footings was typically sound.
- ③ The grade beam at the South Abutment was not bearing fully on the east three block footings. A 1 inch gap was observed between the top of the block footings and the bottom of the north face of the grade beam.
