UNDERWATER BRIDGE INSPECTION REPORT

STRUCTURE NO. R0278

DISTRICT 1 - KOOCHICHING COUNTY

MINNESOTA DEPARTMENT OF TRANSPORTATION  
UNDERWATER BRIDGE INSPECTION

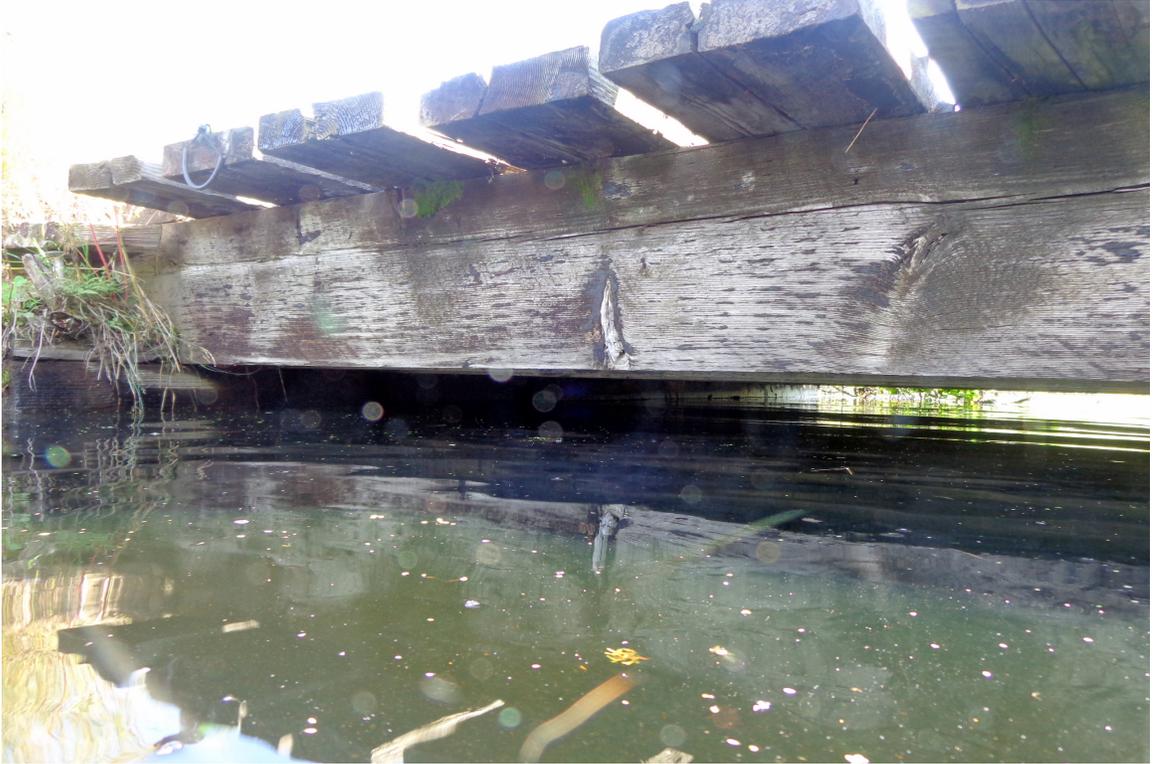
- (E) There was a 6 inch wide by 3 feet long by 6 inches deep gap along the backwall by the second pile from the downstream end of the north abutment.
- (F) There was a 3 inch wide by 3 feet long by 6 inches deep gap along the backwall by the fourth pile from the downstream end of the North Abutment.

- (H) The second and third piles from the downstream end of the North Abutment

exhibited surface cracking and delaminating on portions of the perimeter with 0.5 to 1 inch of maximum penetration in outer shell from the top of pile to 2 feet below the waterline.

Photograph 1. View of North Abutment, Looking Northeast.

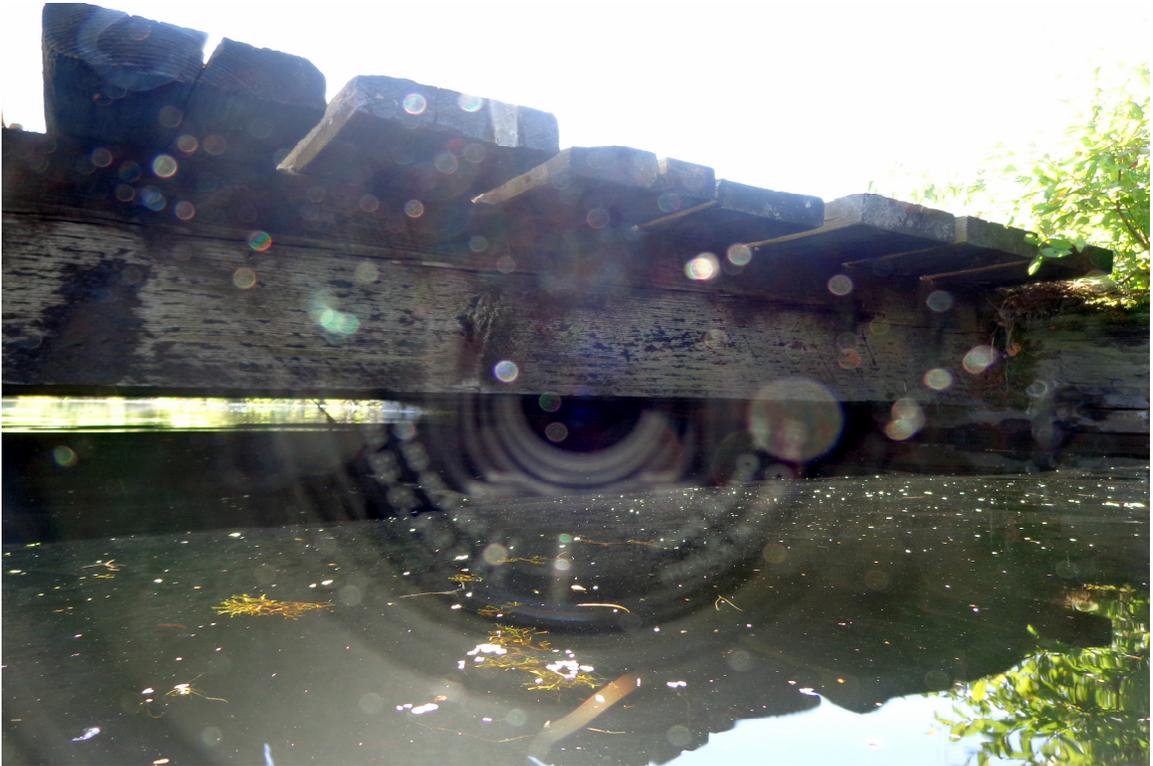
- (I) The first pile on the downstream end of the South Abutment was split and delaminated with a 2 inch penetration. This condition extends from the top of pile to 1 foot below the waterline.

- (J) There was a 3 inch wide by 6 inch penetration gap (reduced bearing area) between the pile caps and all piles on South Abutment.
- (K) The channel bottom consisted of silty sand with a maximum probe rod penetration of 3 inches.

- (L) The backwall between the first and second pile from downstream end of South Abutment exhibited a gap 5 feet long by 6 inches wide by 6 inches deep between pile cap and backwall.

Photograph 2. View of South Abutment, Looking Southeast.

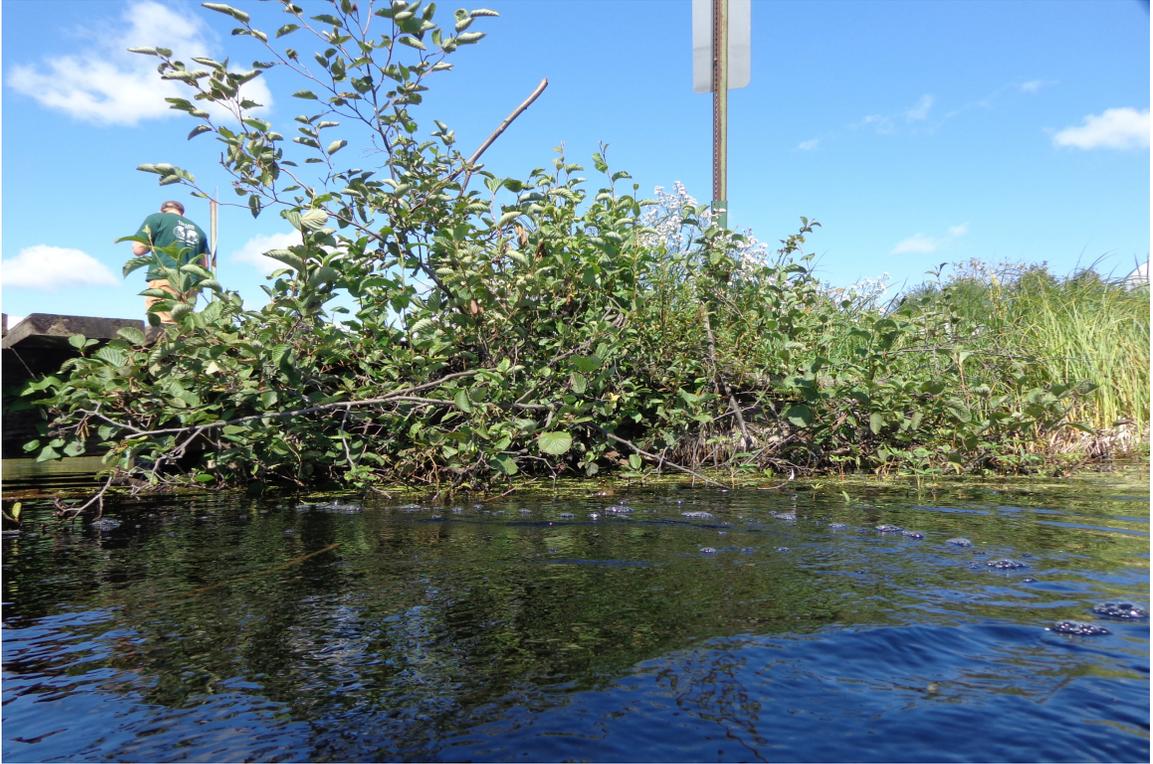
- (A) All wingwalls and planking were displaced with evidence of fill material spilling out.
- (B) The plank on the west wingwall of the North Abutment as well as both wingwalls on the south abutment (first two from the top) have failed at the joint backwall area, exposing some backfill.

Photograph 3. View of Northeast Wingwall, Looking Northwest.

- (A) Remove vegetation from the beam cap to prevent accelerated deterioration.
- (B) Monitor gaps and loss of backfill at all wingwalls, and if found to be affecting the roadway embankment, repair may be necessary.
- (C) Reinspect the submerged substructure units at the normal maximum recommended (NBIS) interval of sixty (60) months.

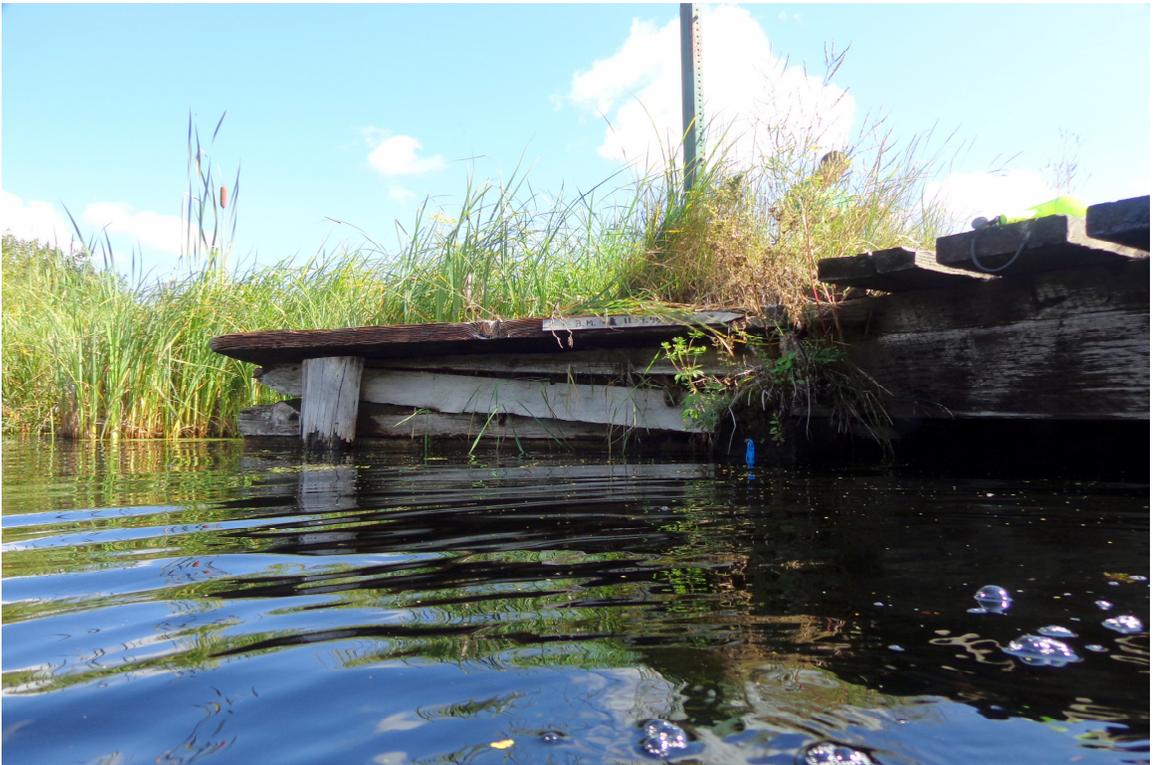
Photograph 4. View of Northwest Wingwall, Looking Northeast.

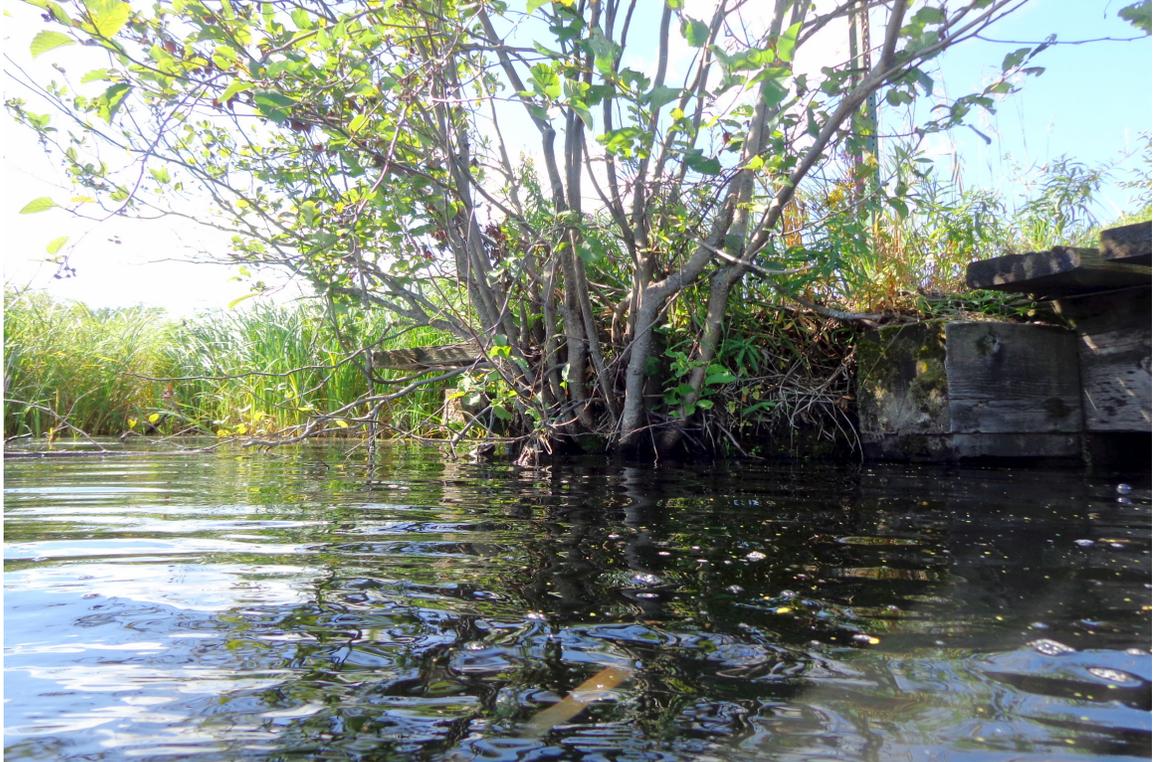
Photograph 5. View of Southeast Wingwall, Looking Southwest.

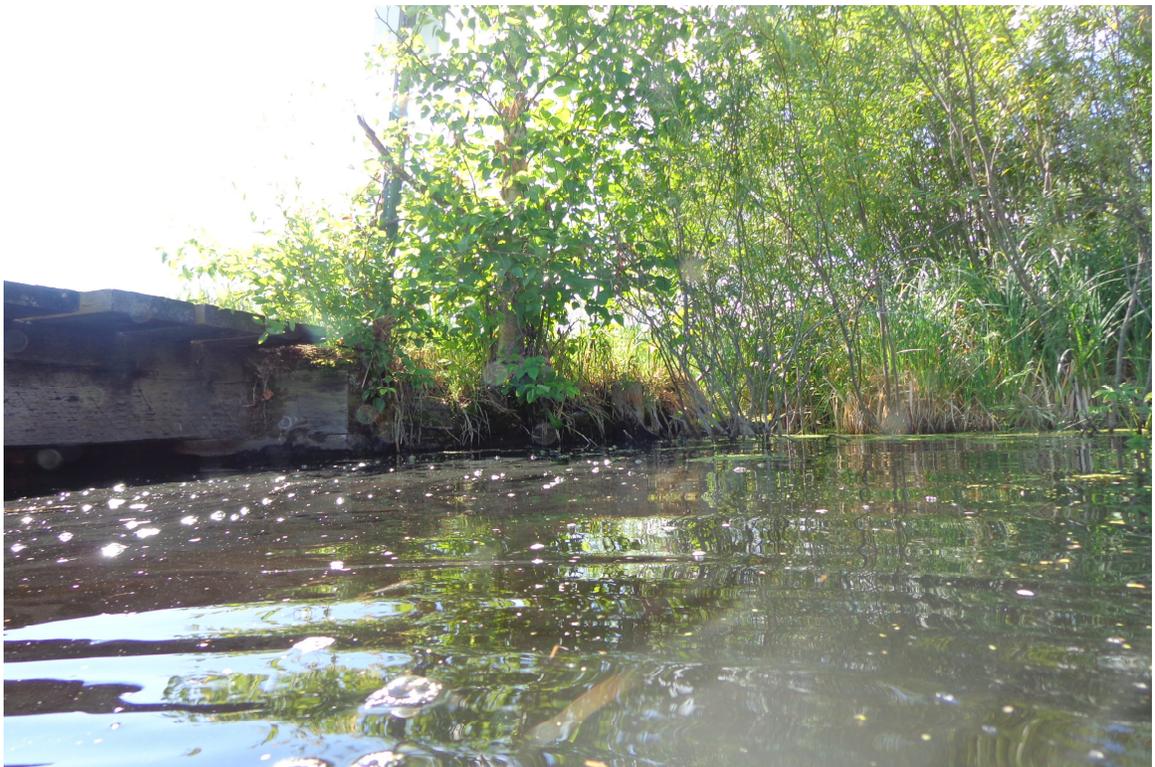
Photograph 6. View of Southwest Wingwall, Looking Southeast.
