UNDERWATER BRIDGE INSPECTION REPORT

STRUCTURE NO. 57503
CSAH NO. 7
OVER THE
RED LAKE RIVER
DISTRICT 2 - PENNINGTON COUNTY

PREPARED FOR THE
MINNESOTA DEPARTMENT OF TRANSPORTATION
BY
COLLINS ENGINEERS, INC.
JOB NO. 3512 (CEI 164)

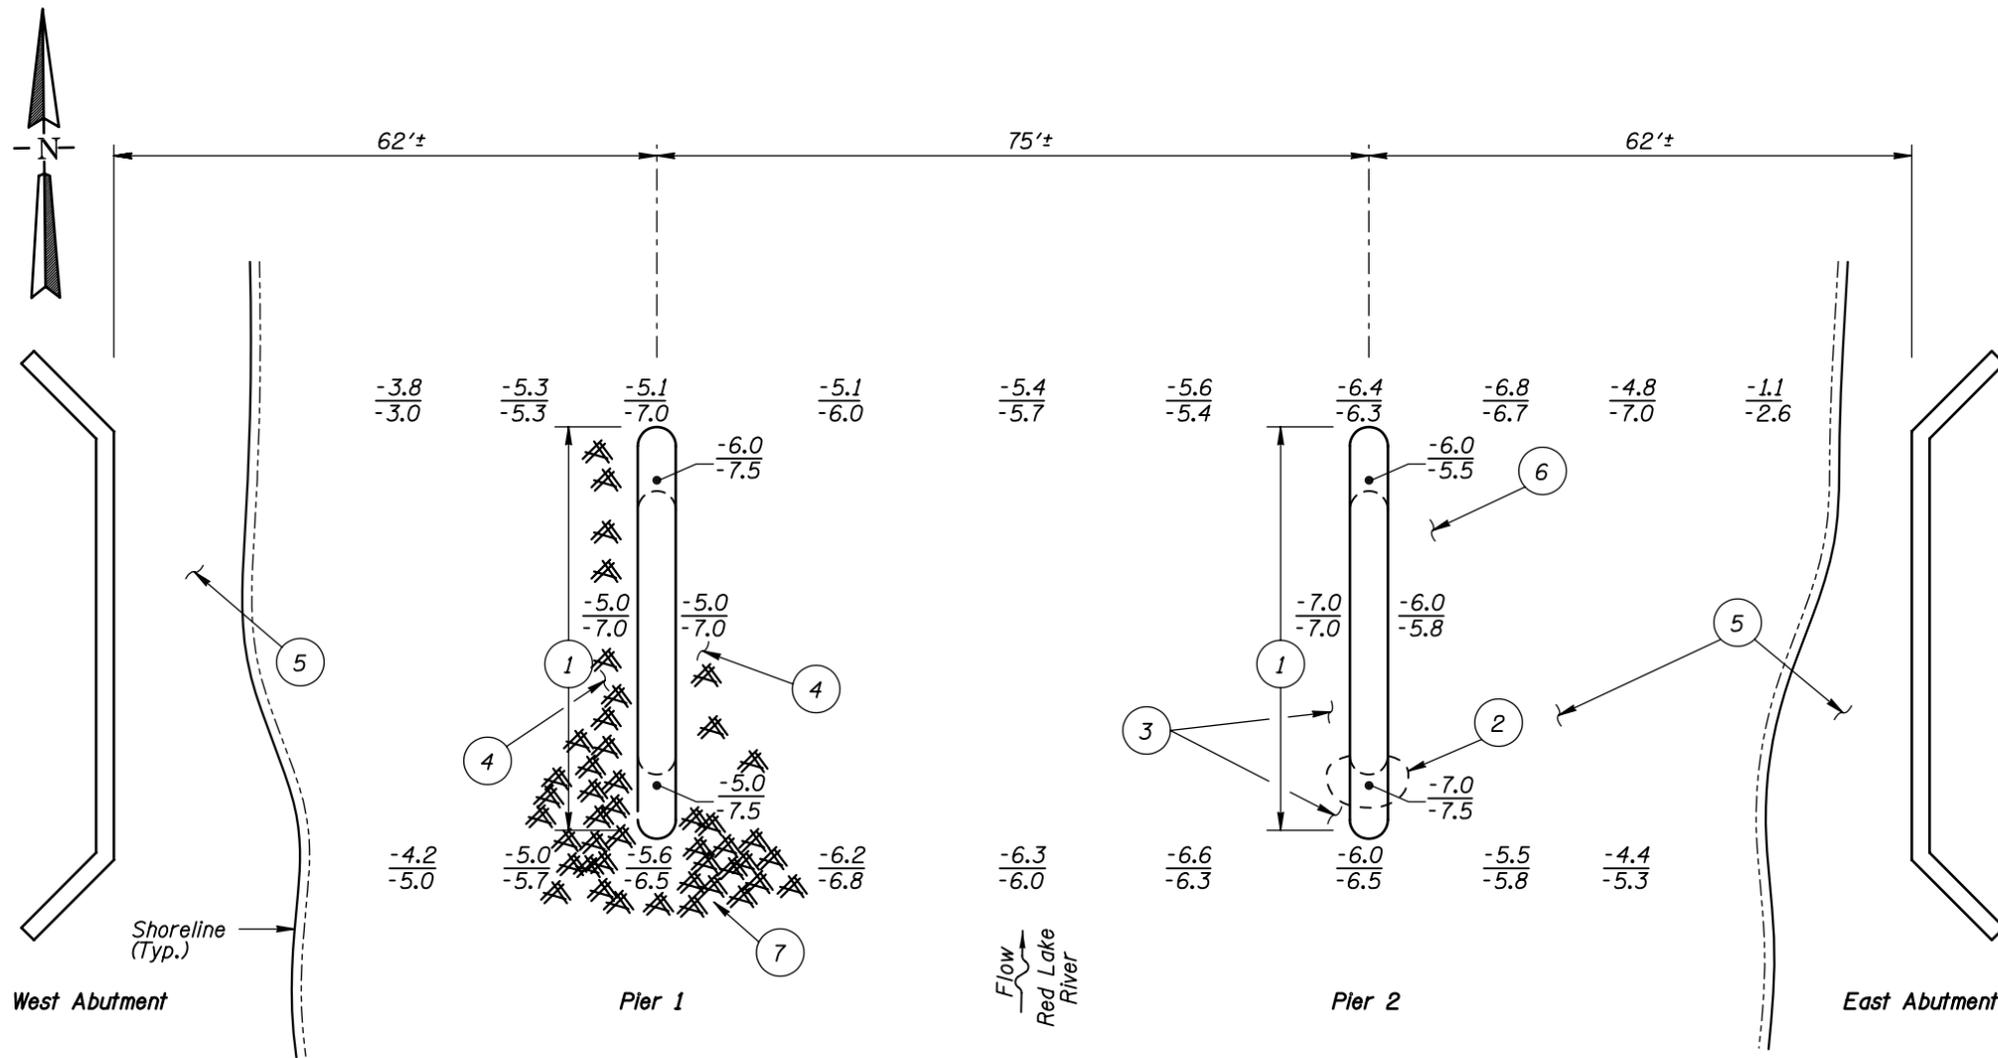
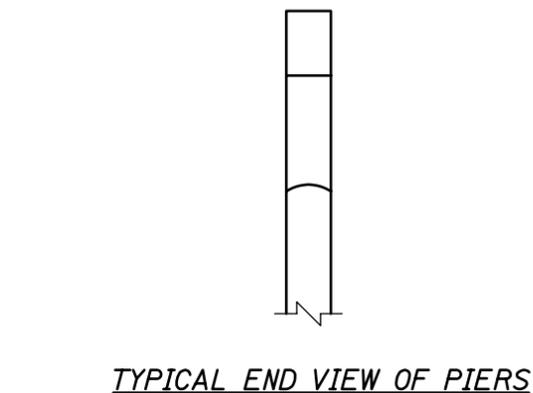
| INSPECTION AND SOUNDING PLAN | | |

- ① Overall, the concrete piers were in good condition, except for an 8-inch length of exposed reinforcing steel located 1-1/2 foot below the waterline at the upstream end of Pier 1, which was noted in the previous inspection on 9/07/97 but was obscured by timber debris during this inspection.

- ② A minor scour depression, 1 foot deep with a radius of 2 to 3 feet, was observed at the upstream end of Pier 2.
- ③ The channel bottom consisted of sand with scattered heavy riprap and no penetration at the upstream end and west side of Pier 2.

- ④ The channel bottom consisted of soft, sandy infill with up to 2 feet of probe rod penetrations along both sides of Pier 1.
- ⑤ The channel bottom on the upstream east side of Pier 2 and the slopes at the abutments consisted of gravel with random accumulations of heavy riprap.

- ⑥ The channel bottom on the downstream east side of Pier 2 consisted of sandy infill with probe rod penetrations of 6 inches.
- ⑦ A heavy accumulation of timber debris, which included timbers up to 1 foot in diameter, was observed around the upstream nose extending from the channel bottom to the waterline. The debris extended 10 feet upstream, 20 feet into the adjoining spans, along the east upstream half and along the entire west side of Pier 1.

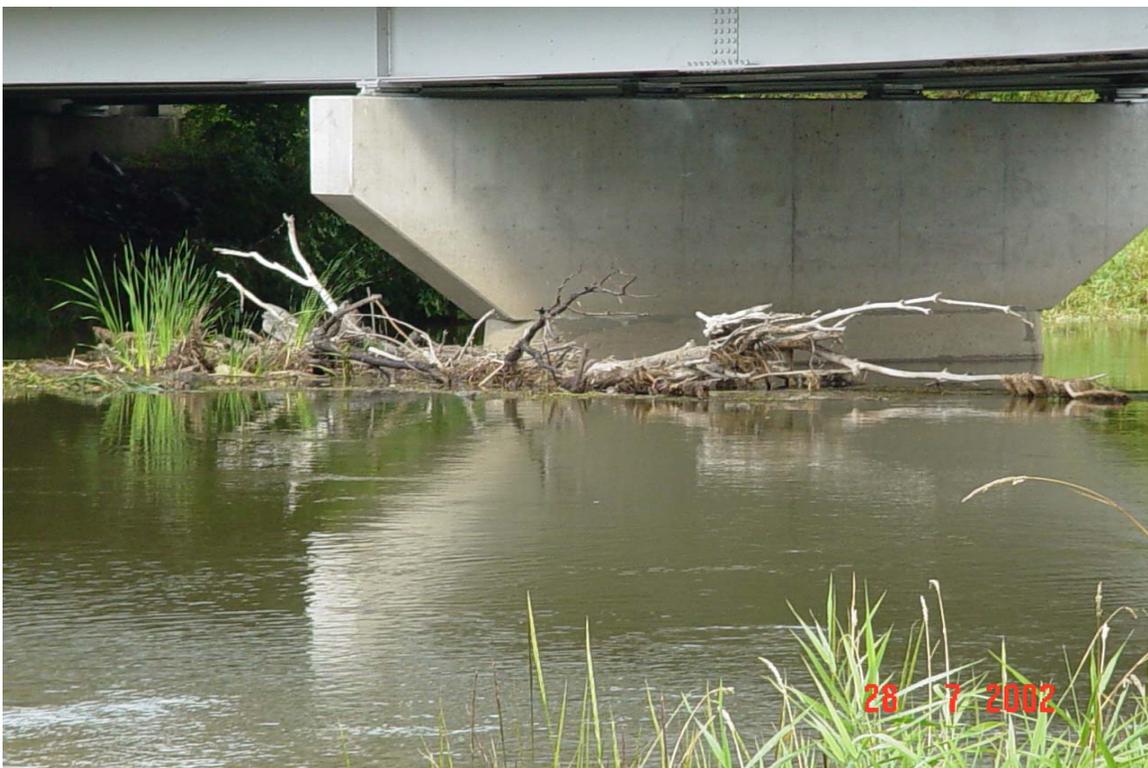
Photograph 2. View of Pier 1, Looking Northwest.

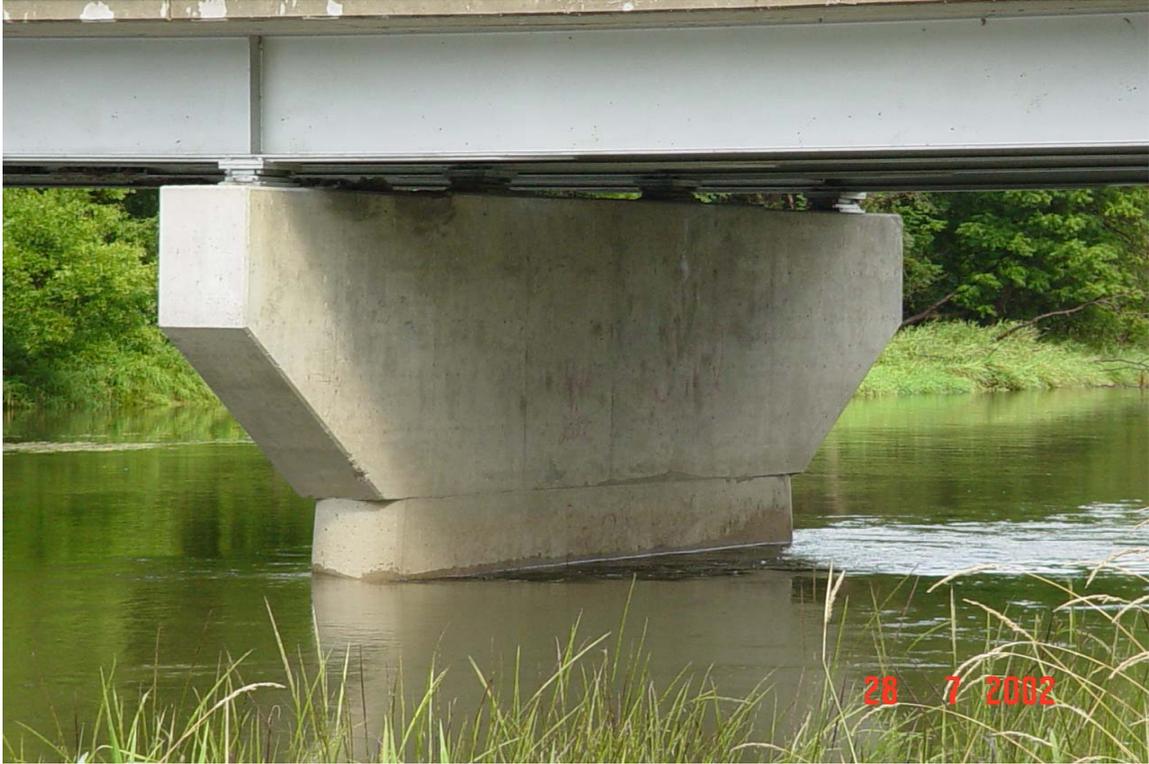
Photograph 3. View of Pier 2, Looking Northwest.

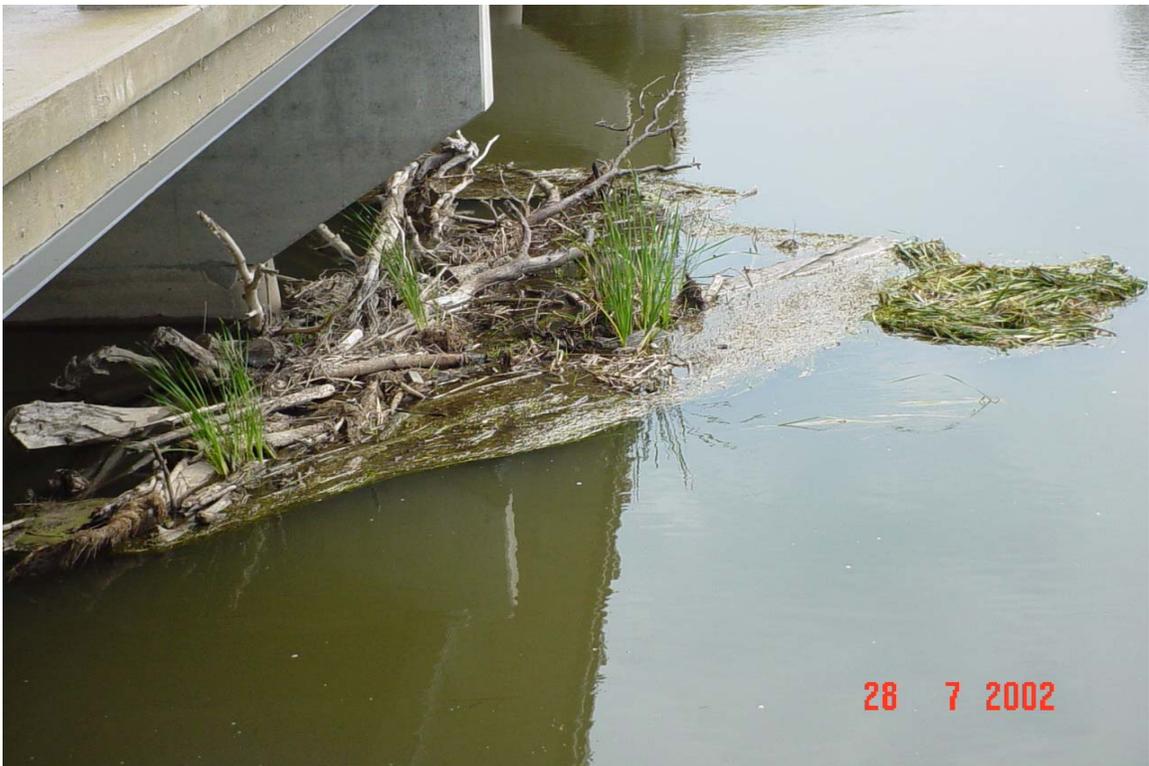
Photograph 4. View of Timber Debris at Pier 1, Looking East.

- (A) Remove the timber debris from around Pier 1 to alleviate further accumulations, scour influence, and excessive lateral loads on the pier.

Remove the timber debris from around Pier 1 to alleviate further accumulations, scour influence, and excessive lateral loading on the pier.
