UNDERWATER BRIDGE INSPECTION REPORT

STRUCTURE NO. 57504

THIEF RIVER

MINNESOTA DEPARTMENT OF TRANSPORTATION  
UNDERWATER BRIDGE INSPECTION

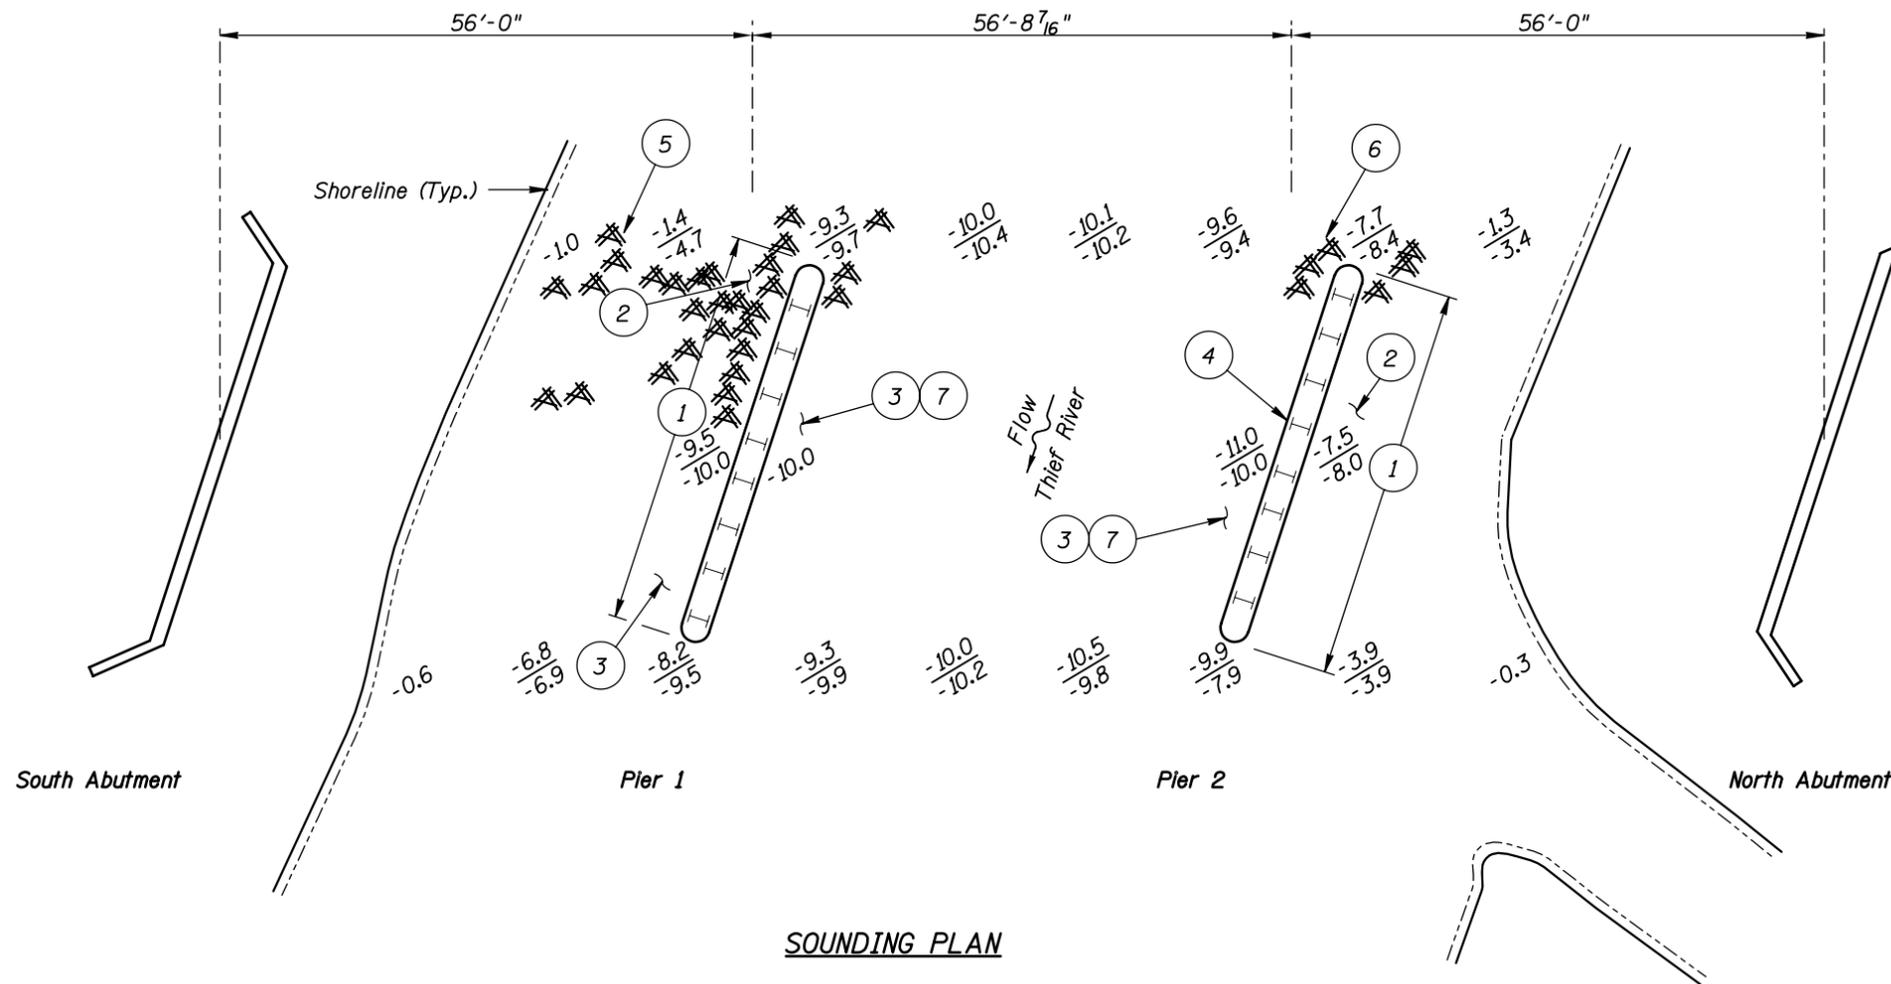
**INSPECTION AND SOUNDING PLAN**

- 1 Overall, the concrete piers were in good condition with no scaling or defects of structural significance observed.
- 2 The channel bottom consisted of soft silty sand infilling with up to 1.5 foot of probe rod penetrations.

- 3 The channel bottom consisted of 1 to 6 inches of soft silt over firm gravel, cobbles and scattered riprap.
- 4 Vertical timber planking was observed along the middle portion of the south side of Pier 2 extending 6 inches above the channel bottom.

- 5 A heavy accumulation of timber debris, which included timbers up to 1 foot in diameter, was observed at the upstream end of Pier 1, extending to the midpoint of the south side of Pier 1, to the south shoreline, and from the channel bottom to 5 feet above the waterline.

- 6 A light to moderate accumulation of timber debris, which included timbers up to 1 foot in diameter, was observed at the upstream end of Pier 2 extending from the channel bottom to 4.5 feet below the waterline.

- 7 Scattered timber debris, which included timbers up to 6 inches in diameter, was observed along the channel sides of the piers.

- (A) Remove accumulations of timber debris at both piers and from within the channel to alleviate further accumulation, scour influence, and any excessive lateral force on the piers.

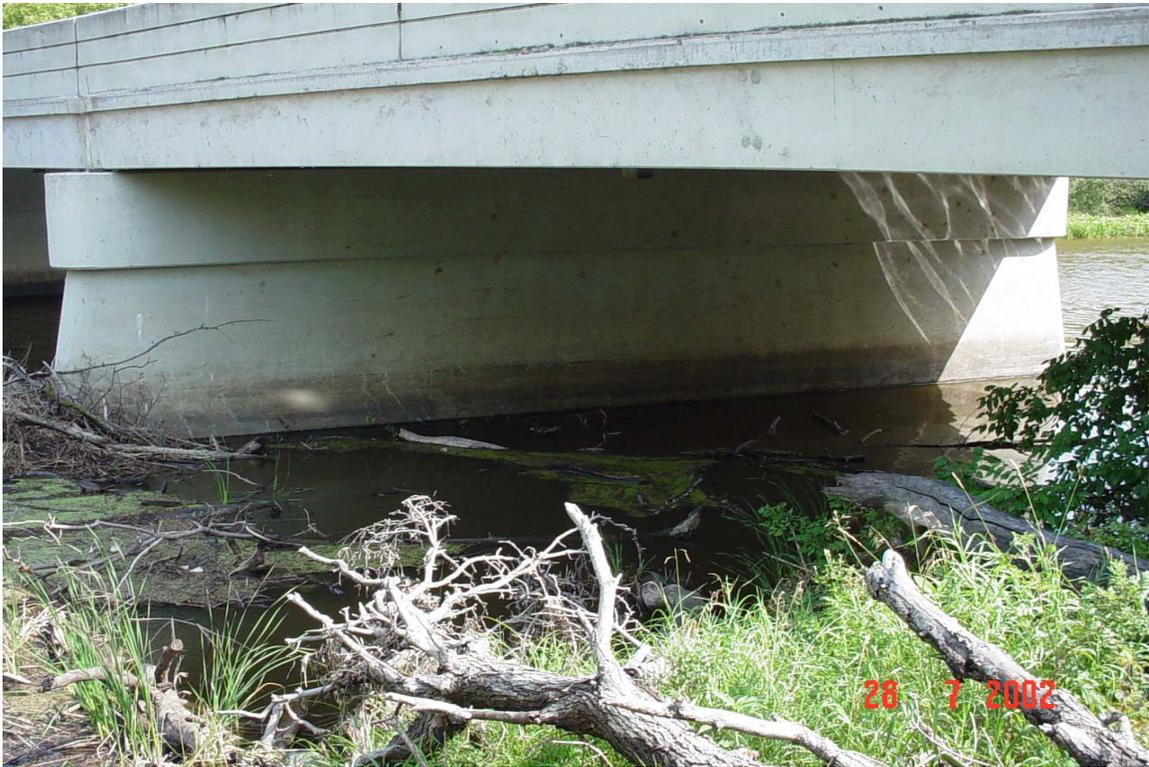
- (A) A heavy accumulation of timber debris was observed at the upstream end of Pier 1 extending to the midpoint of the south side of Pier 1. The timber debris also extended to the south shoreline, and overall, extended from the channel bottom to 5 feet above the waterline. A light to moderate accumulation of timber debris was observed at the upstream end of Pier 2 extending from the channel bottom to 4.5 feet below the waterline. Scattered timber debris was also observed along the channel sides of both piers.
- (B) Overall, the concrete piers were in good condition with no significant defects observed.

Photograph 2. View of Pier 1, Looking Northeast.

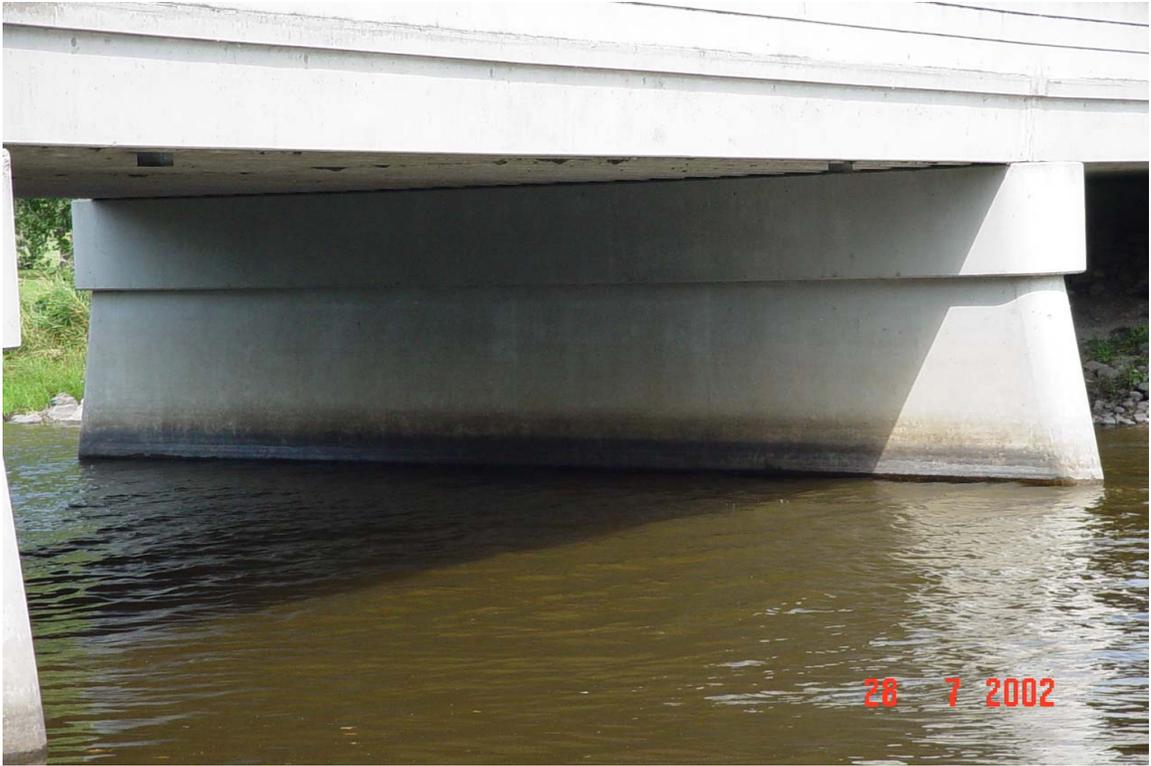
Photograph 3. View of Pier 2, Looking Northwest.

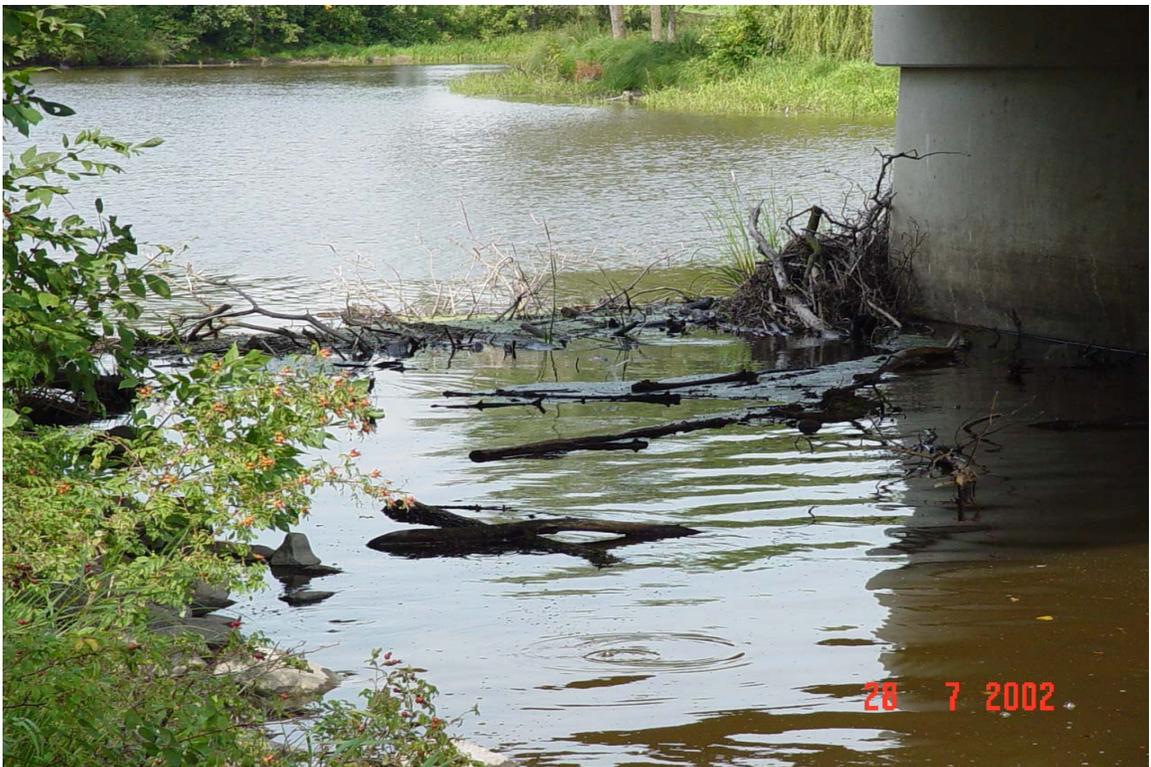
Photograph 4. View Timber Debris at Pier 1, Looking West.
