UNDERWATER BRIDGE INSPECTION REPORT

STRUCTURE NO. 57518
CSAH NO. 3
OVER THE
RED LAKE RIVER
DISTRICT 2 - PENNINGTON COUNTY

PREPARED FOR THE
MINNESOTA DEPARTMENT OF TRANSPORTATION
BY
COLLINS ENGINEERS, INC.
JOB NO. 3512 (CEI 9A)

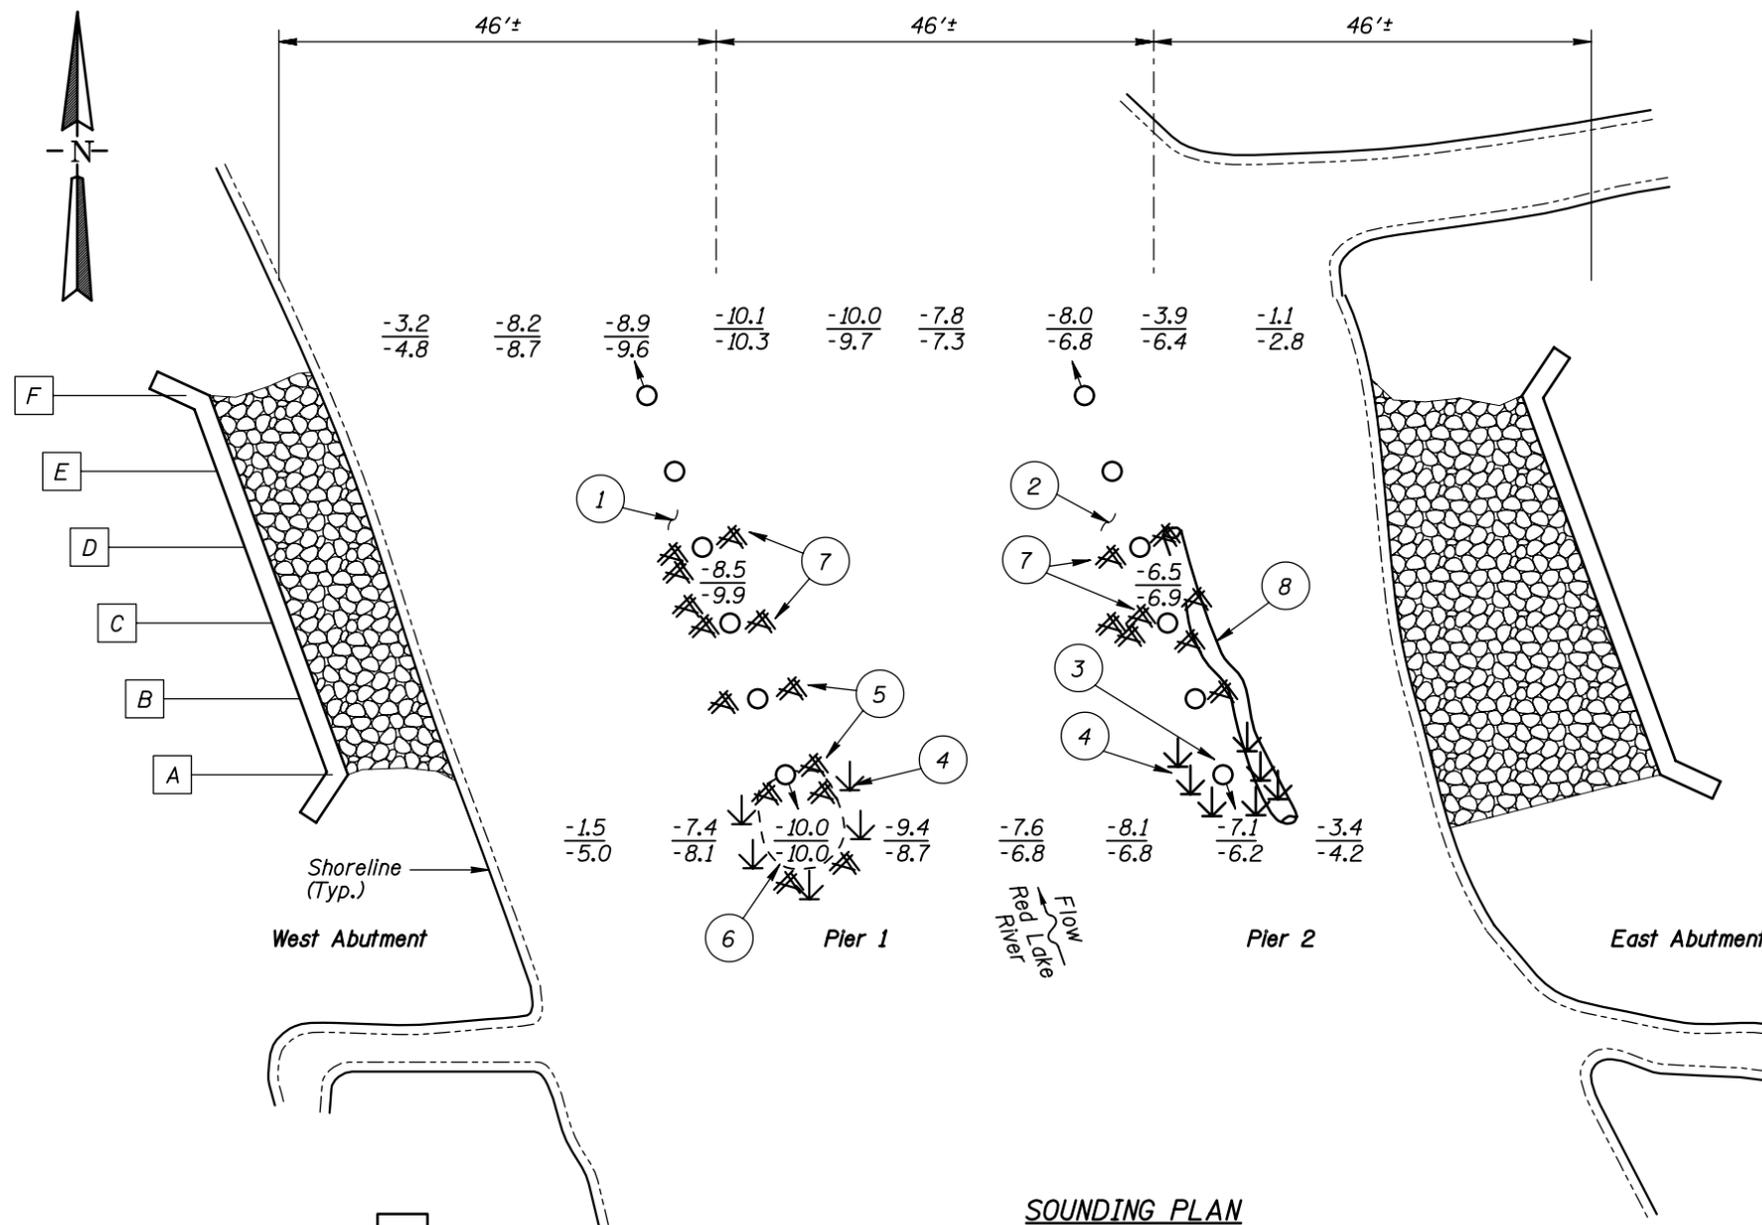
- 1 The channel bottom material around Pier 1 consisted of sandy gravel with 3 inches of probe rod penetration.
- 2 The channel bottom material around Pier 2 consisted of sand with 12 inches of probe rod penetration.

- 3 Area of soft, sandy infilling with 1 to 1.5 feet probe rod penetration was located at the downstream side of Pile A at Pier 2.
- 4 A moderate (Pier 1) to heavy (Pier 2) accumulation of grassy vegetation was observed at the upstream nose of both piers, 5 feet wide by 4 feet long, extending from the waterline to channel bottom.

- 5 Up to 3 inch diameter timber debris and organic material was observed around the two upstream piles of Pier 1 and extended from the waterline to the mudline and 4 feet out from the piles.

- 6 A 6 foot diameter by 1-1/2 foot deep scour depression was observed around the upstream pile of Pier 1.
- 7 Up to 3 inch diameter timber drift and organic material was observed around Piles C and D of Pier 1 and around Piles B, C, and D of Pier 2. The drift and organic material extended from the waterline to the mudline and 2 feet out from the piles.

- 8 A 1 foot diameter log on the east side of Pier 2 extended from the the downstream fascia of Pier 2 to Pile D of Pier 2.

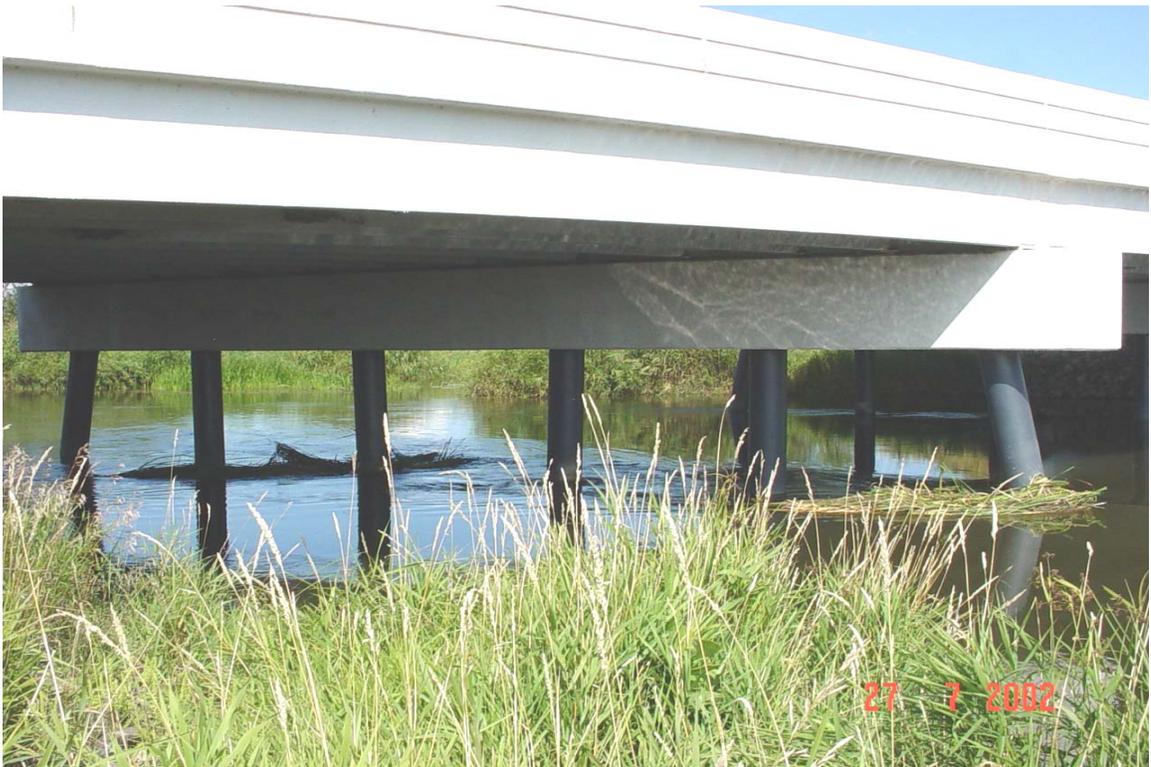
Photograph 2. View of Pier 1, Looking Northeast.

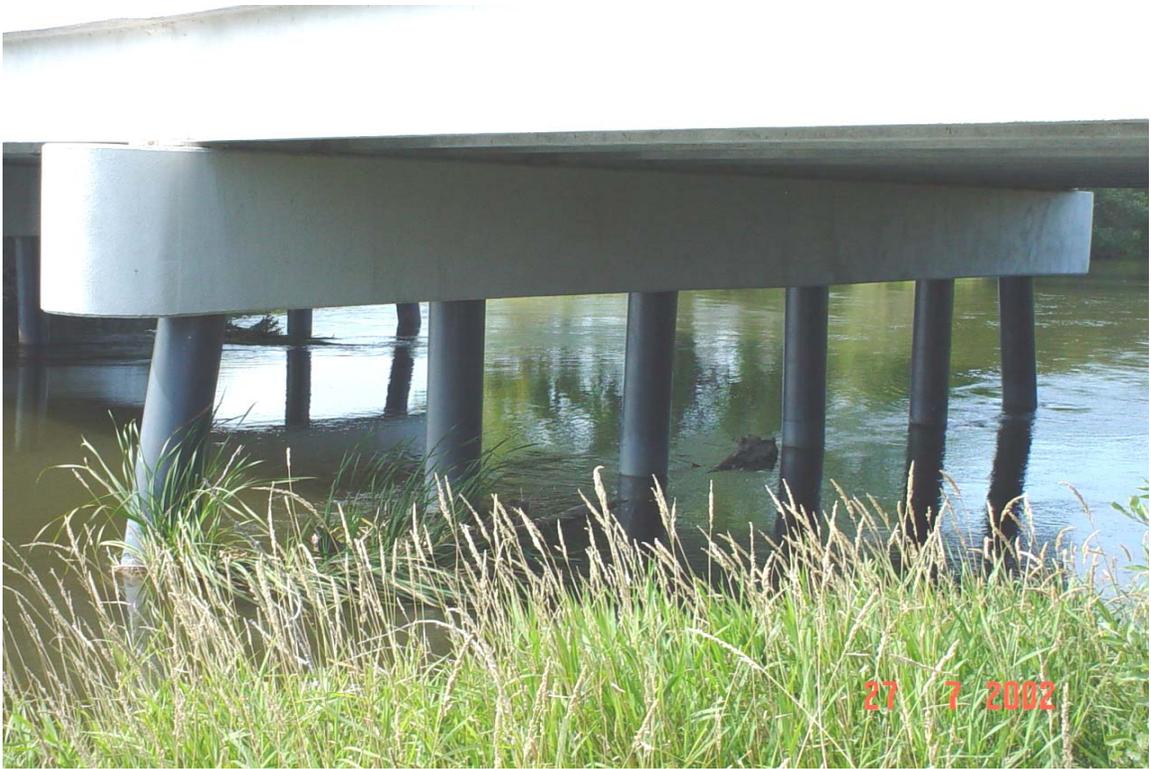
Photograph 3. View of Pier 2, Looking Northwest.

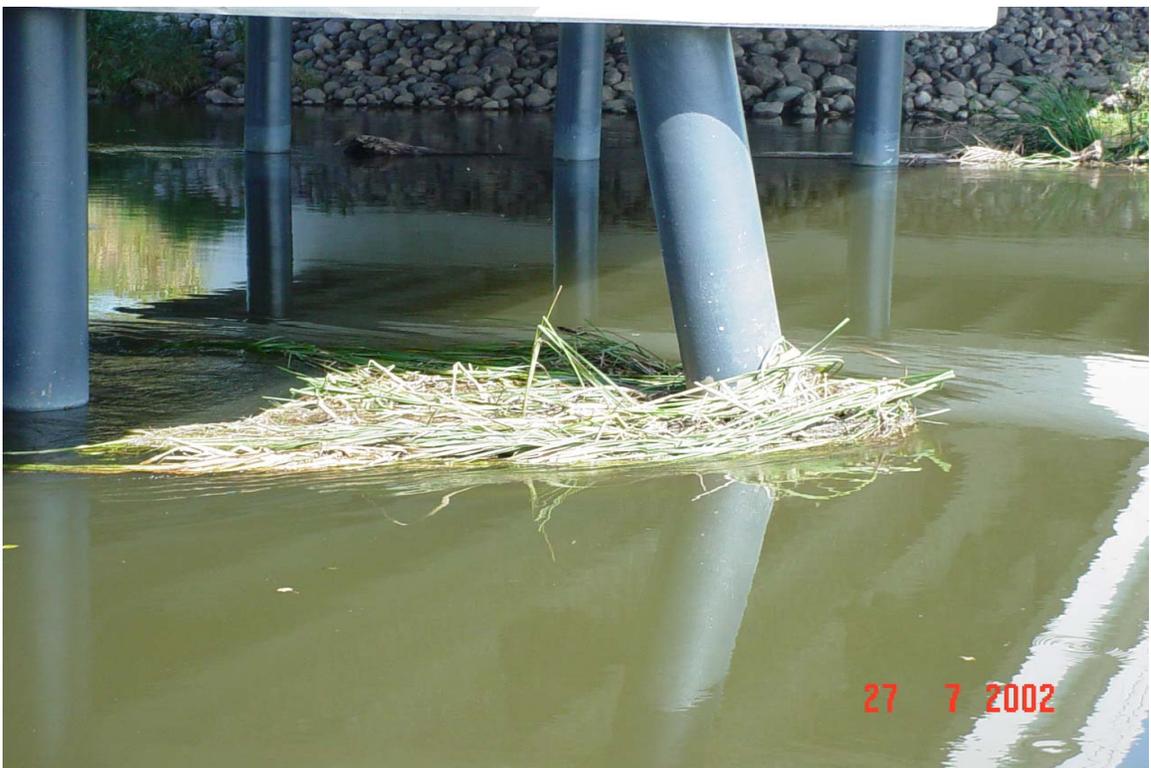
Photograph 4. View of Debris at the Upstream Pile of Pier 1, Looking East.

Ideally, remove timber debris and organic material during regular maintenance of bridge.

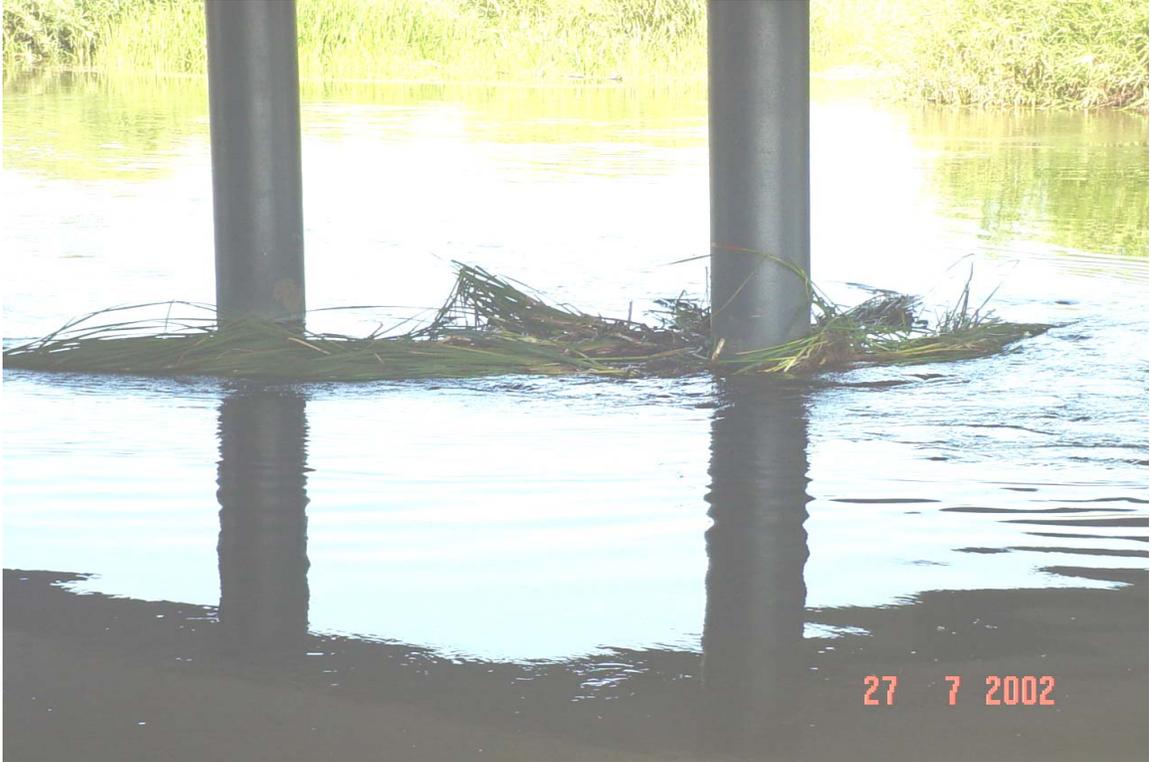
Photograph 5. View of Debris at Piles C and D of Pier 1, Looking Northeast.

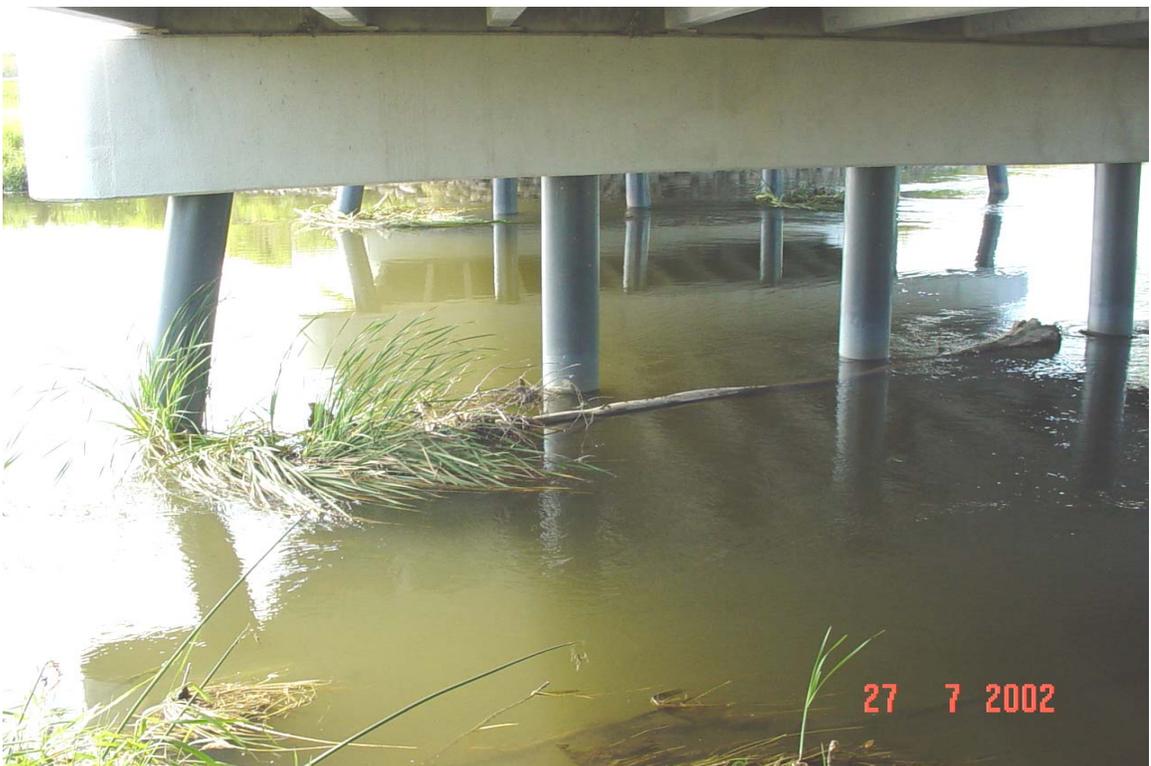
Photograph 6. View of Debris Along Pier 2, Looking West.
