UNDERWATER BRIDGE INSPECTION REPORT

STRUCTURE NO. 5824  
CSAH NO. 1  
OVER THE  
CLEARWATER RIVER  
DISTRICT 2 - RED LAKE COUNTY

PREPARED FOR THE  
MINNESOTA DEPARTMENT OF TRANSPORTATION  
BY  
COLLINS ENGINEERS, INC.  
JOB NO. 3512 (CEI 173)

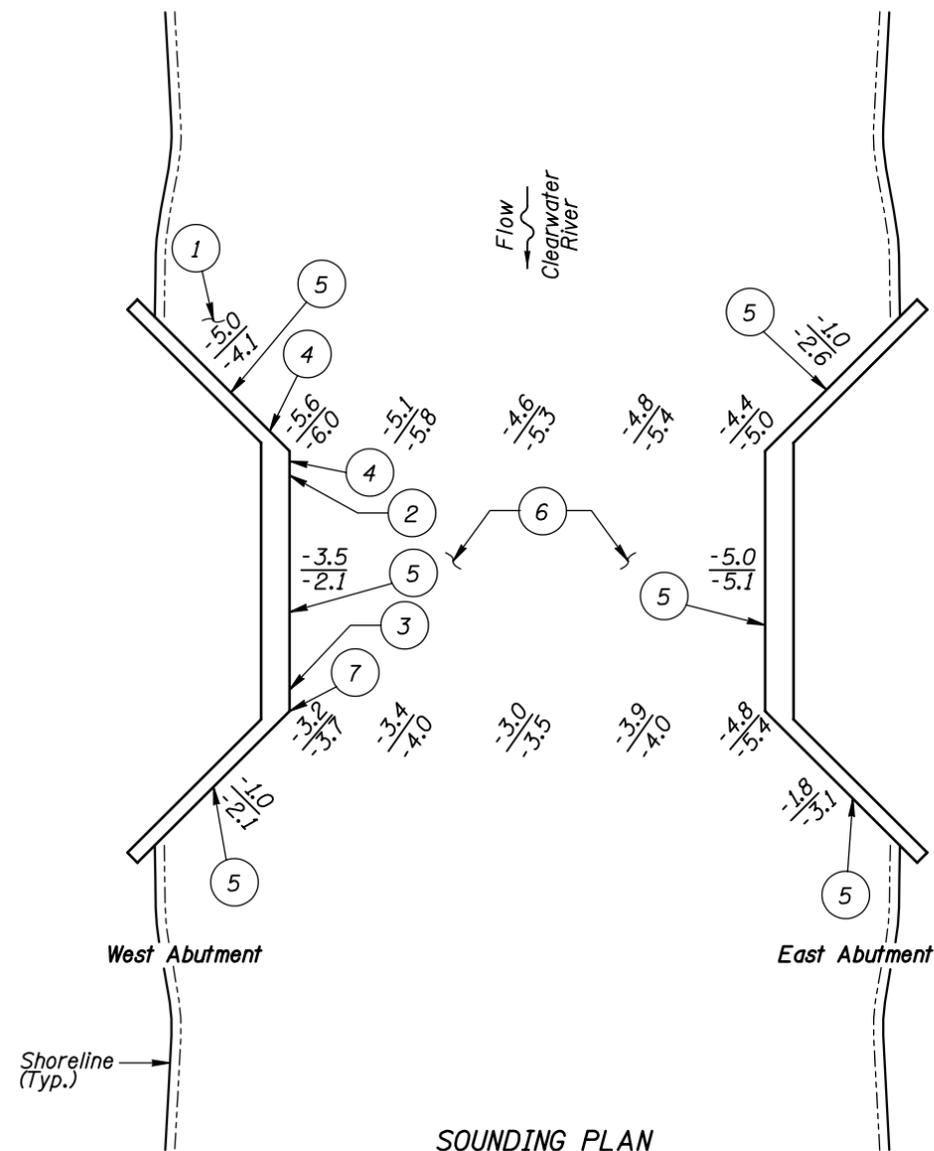
- 1 The channel bottom material consisted of silty sand with up to 1 foot of probe rod penetration.
- 2 1.5-foot-diameter void located at the waterline with 4 inches of penetration and no exposed reinforcing steel.

- 3 1-foot-diameter void located 1 foot below the waterline with 2 inches of maximum penetration.
- 4 3 feet along the wingwall and 4 feet along the breastwall, spalling and poor consolidation was observed from 0.5 feet above the waterline to 3 feet below the waterline with 6 inches of maximum penetration and lightly corroded exposed steel reinforcing at the corner of abutment and wingwall.

- 5 Random hairline map cracking was observed on the breastwalls and wingwalls from the waterline to 3 feet above the waterline.
- 6 The channel bottom material consisted of up to 1-foot-diameter riprap.

- 7 4-inch-diameter void and area of poor consolidation located at the waterline with 2 inches of penetration.

- (A) Although the channel bottom appears to have remained stable since the last inspection, according to Item 113, the bridge is rated as scour critical, and therefore, it is recommended that the channel bottom be closely monitored after major flood events and during biennial and future underwater inspections.

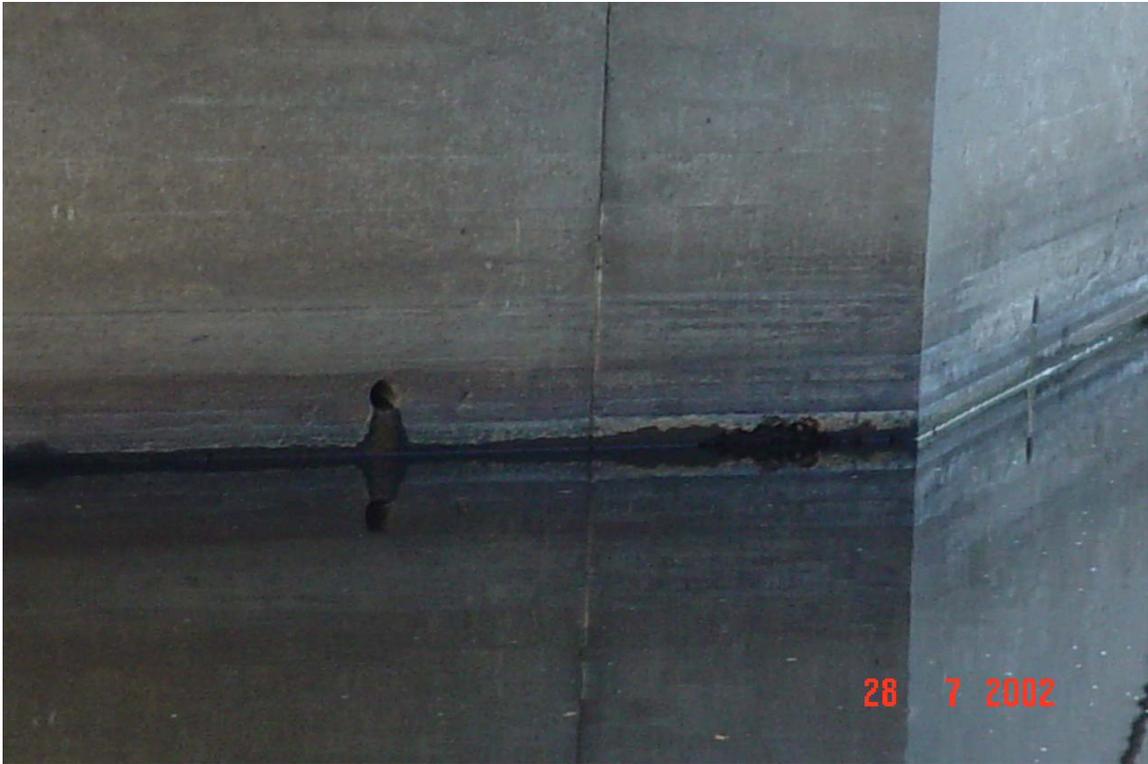
- (A) A void was observed 4 feet from the north end of the West Abutment at the waterline measuring 1.5 feet in diameter with 4 inches of penetration. Spalling and poor consolidation with up to 6 inches of maximum penetration was observed extending north of the previously mentioned void along the breastwall and for 3 feet along the wingwall exposing lightly corroded steel reinforcing at the corner.
- (B) A 1-foot-diameter void was observed 3 feet from the south end of the West Abutment at 1 foot below the waterline with 2 inches of maximum penetration.
- (C) Random hairline map cracking was observed on the breastwalls and wingwalls from the waterline to 3 feet above the waterline.

Photograph 3. View of the Upstream End of the West Abutment.  
Note Spalling and Section Loss at Waterline.
