UNDERWATER BRIDGE INSPECTION REPORT

STRUCTURE NO. 60506

RED RIVER OF THE NORTH

MINNESOTA DEPARTMENT OF TRANSPORTATION
UNDERWATER BRIDGE INSPECTION

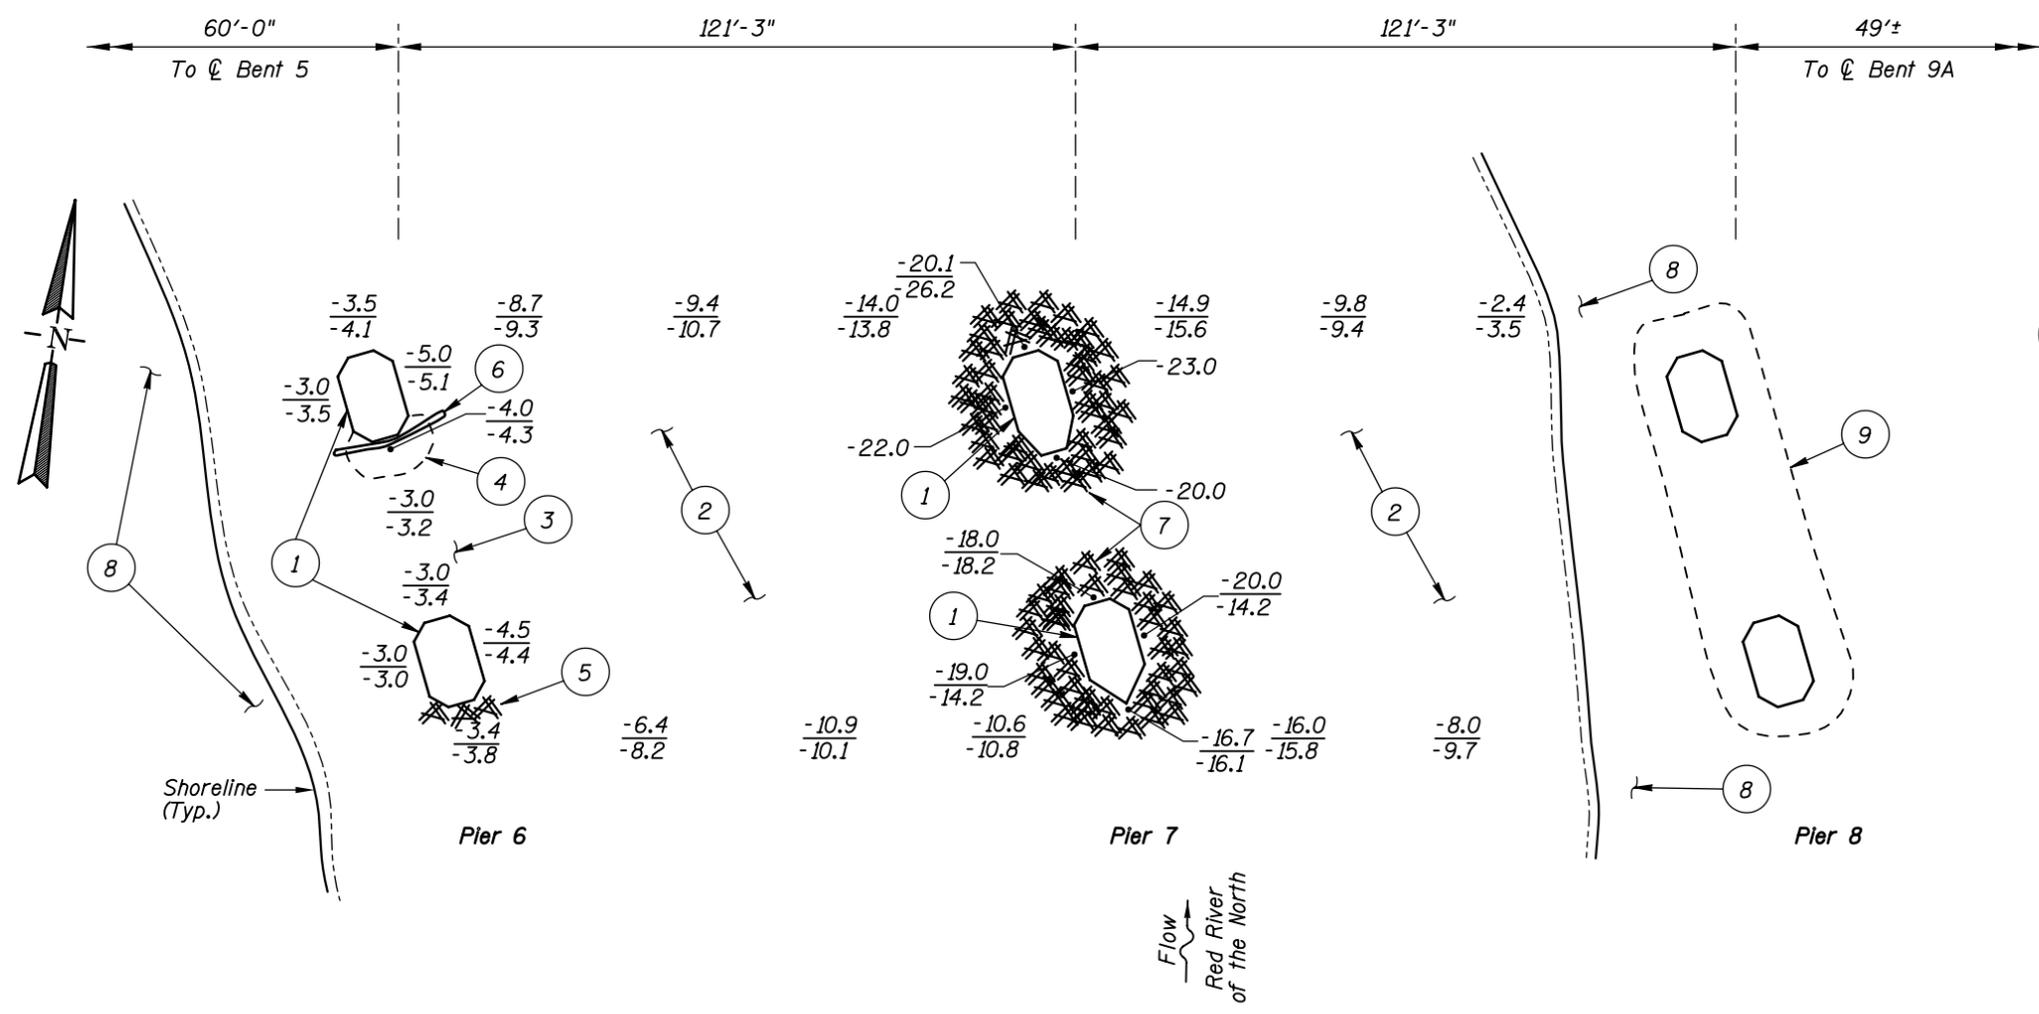
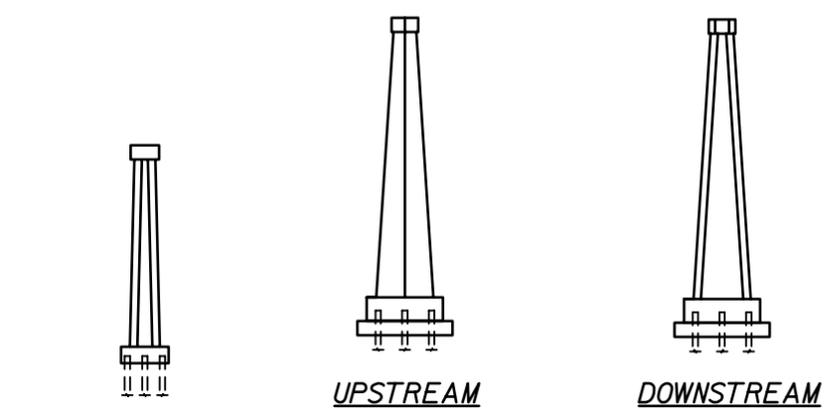
SOUNDING PLAN

- ① Overall, the reinforced concrete piers were in good condition with no deterioration of structural significance.
- ② The channel bottom consisted of firm clay overlaid by 2 inches of silt and scattered random riprap with a probe rod penetration of 3 inches.

- ③ The channel bottom consisted of sandy silt with up to 1 foot of probe rod penetration.
- ④ A scour depression was observed around the upstream side of the downstream column of Pier 6 and measured approximately 1 foot deep with a 3 foot radius.

- ⑤ A light accumulation of timber debris, consisting of 6 inch diameter branches, was observed at the upstream end of Pier 6 and extended from the channel bottom to the waterline.

- ⑥ A 6 inch diameter log was observed at the upstream end of the downstream column of Pier 6.
- ⑦ A heavy accumulation of timber debris, consisting of 1 to 2 foot diameter logs, was observed around the entire perimeter of both columns of Pier 7 and extended approximately 8 feet out away from the pier columns and up to 6 feet above the channel bottom.

- ⑧ Both riverbanks of the channel exhibited moderate erosion.
- ⑨ Dry scour depression was observed around Pier 8 and measured approximately 3 feet in radius and 1 to 2 feet deep.

- (A) Remove the heavy accumulations of timber debris from around Pier 7 during routine maintenance.

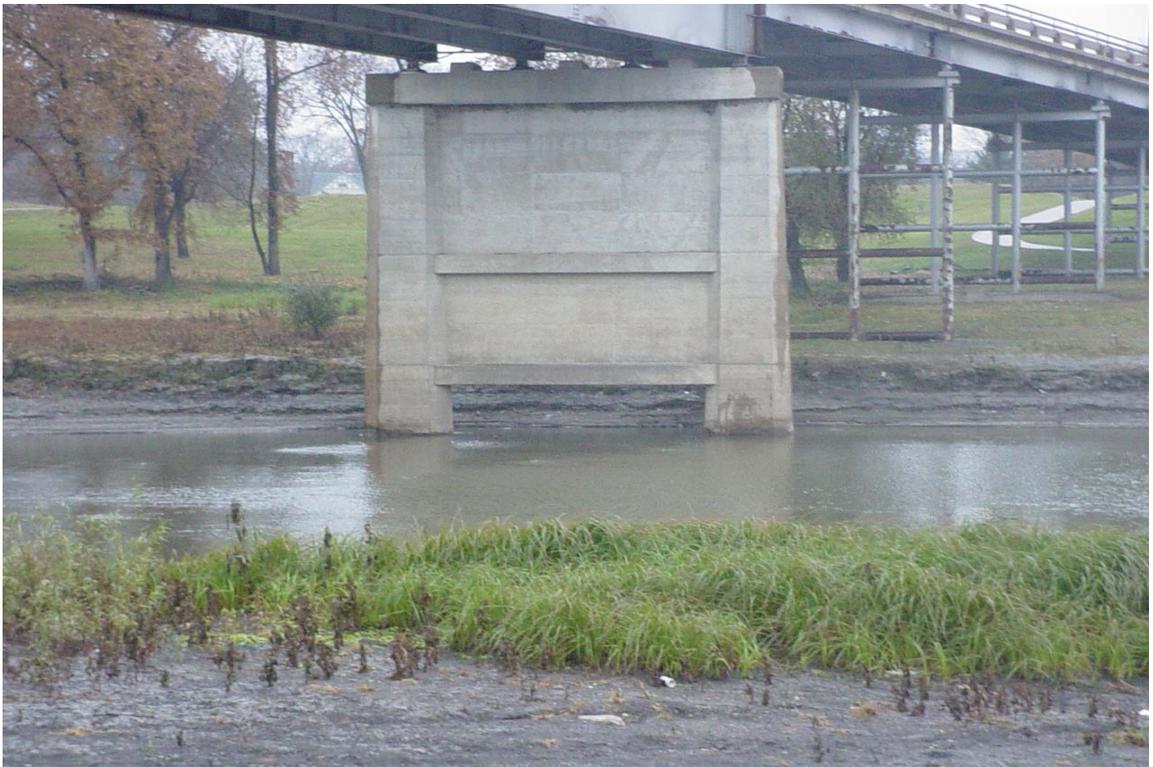
- (A) A scour pocket was observed around the upstream side of the downstream column of Pier 6 and measured approximately 1 foot deep with a 3 feet radius.
- (B) A heavy accumulation of timber debris, consisting of 1 to 2 foot diameter logs, was observed around the entire perimeter of both columns of Pier 7 and extended approximately 8 feet out away from the pier and up to 6 feet above the channel bottom.
- (C) A light accumulation of timber debris, consisting of 6 inch diameter branches, was observed at the upstream end of Pier 6 and extended from the channel bottom to the waterline.

Photograph 2. View of Pier 6, Looking Southwest.

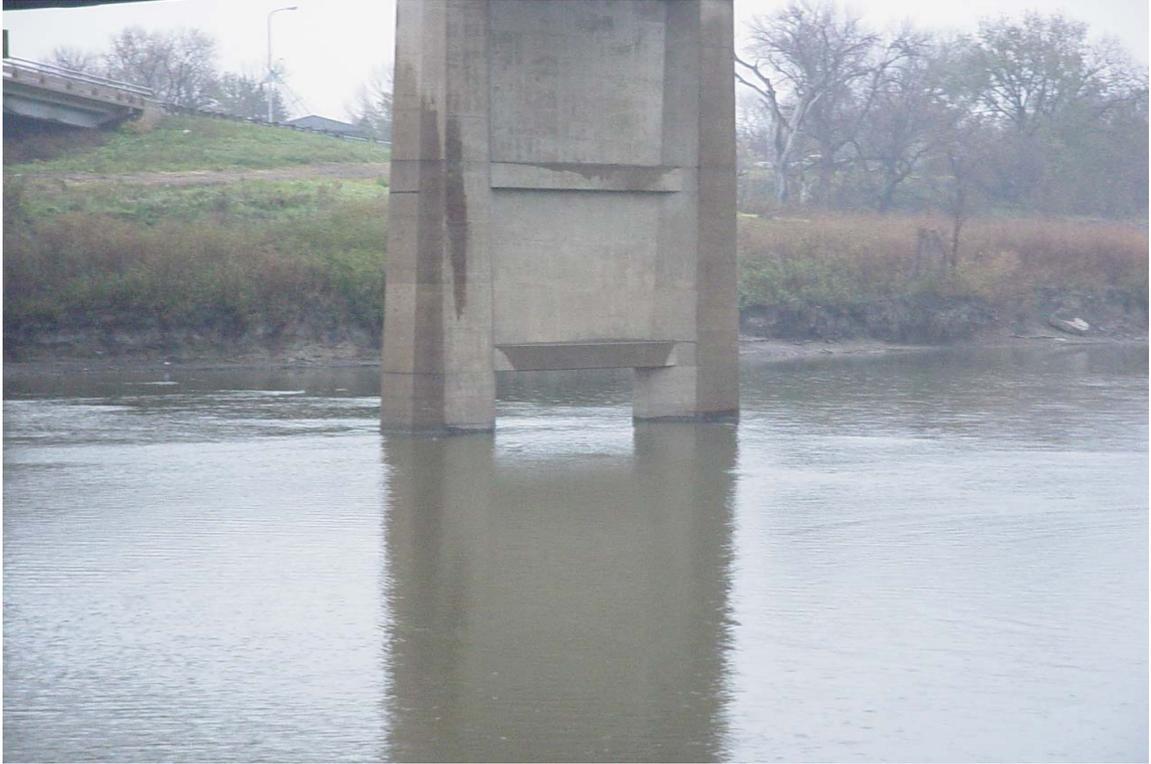
Photograph 3. View of Pier 7, Looking Southeast.

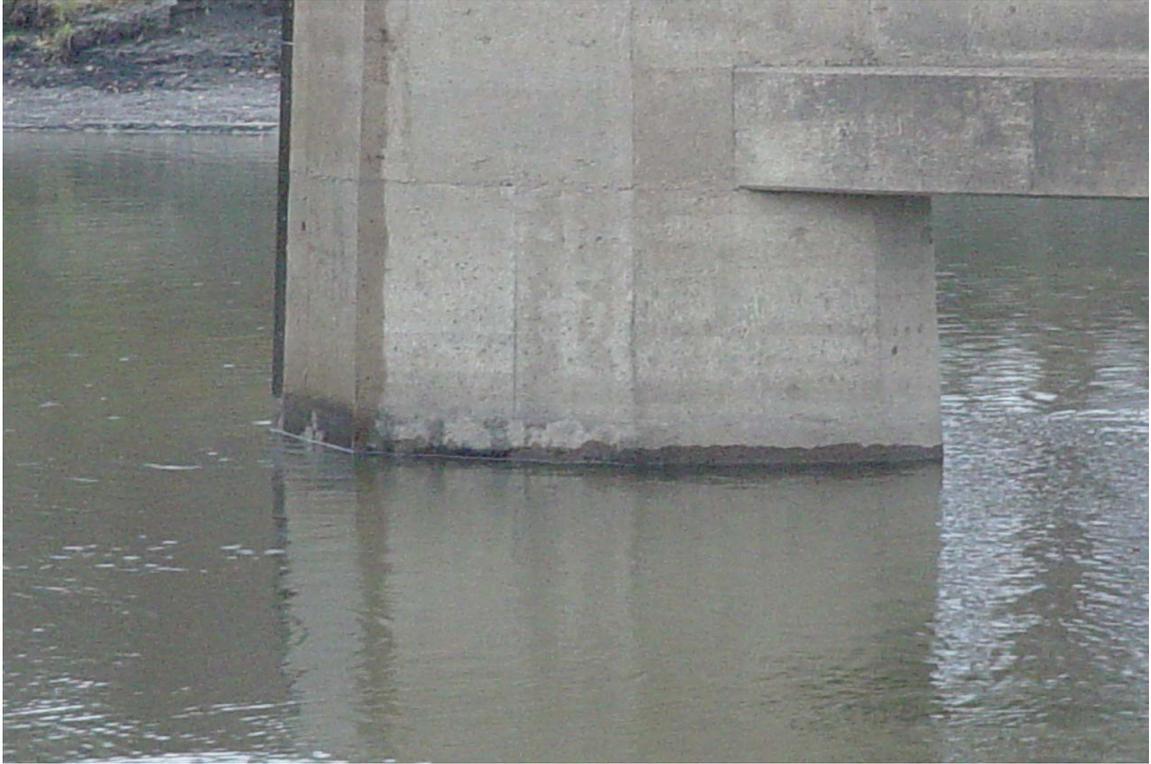
Photograph 5. View of the Upstream Column of Pier 7, Looking Southwest.

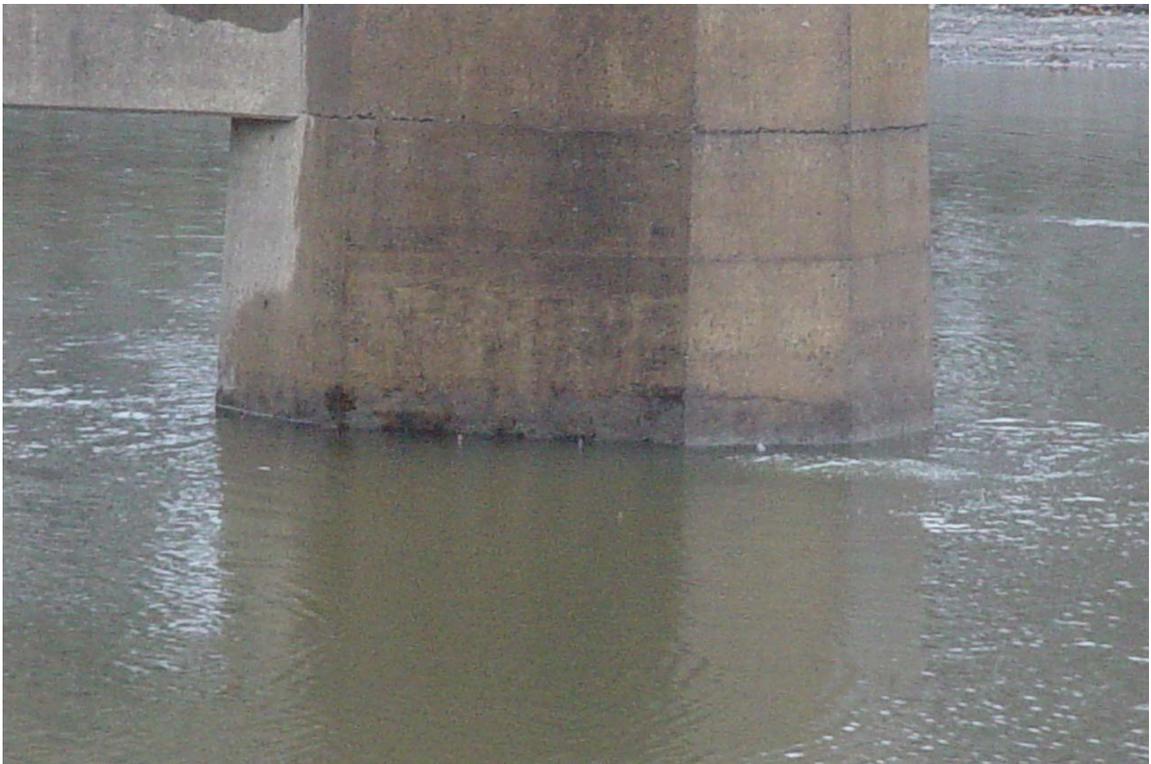
Photograph 6. View of the Downstream Column of Pier 7, Looking Southwest.
