UNDERWATER BRIDGE INSPECTION REPORT

STRUCTURE NO. 63516
CSAH NO. 13
OVER THE
RED LAKE RIVER
DISTRICT 2 - RED LAKE COUNTY

PREPARED FOR THE
MINNESOTA DEPARTMENT OF TRANSPORTATION
BY
COLLINS ENGINEERS, INC.
JOB NO. 3512 (CEI 172)

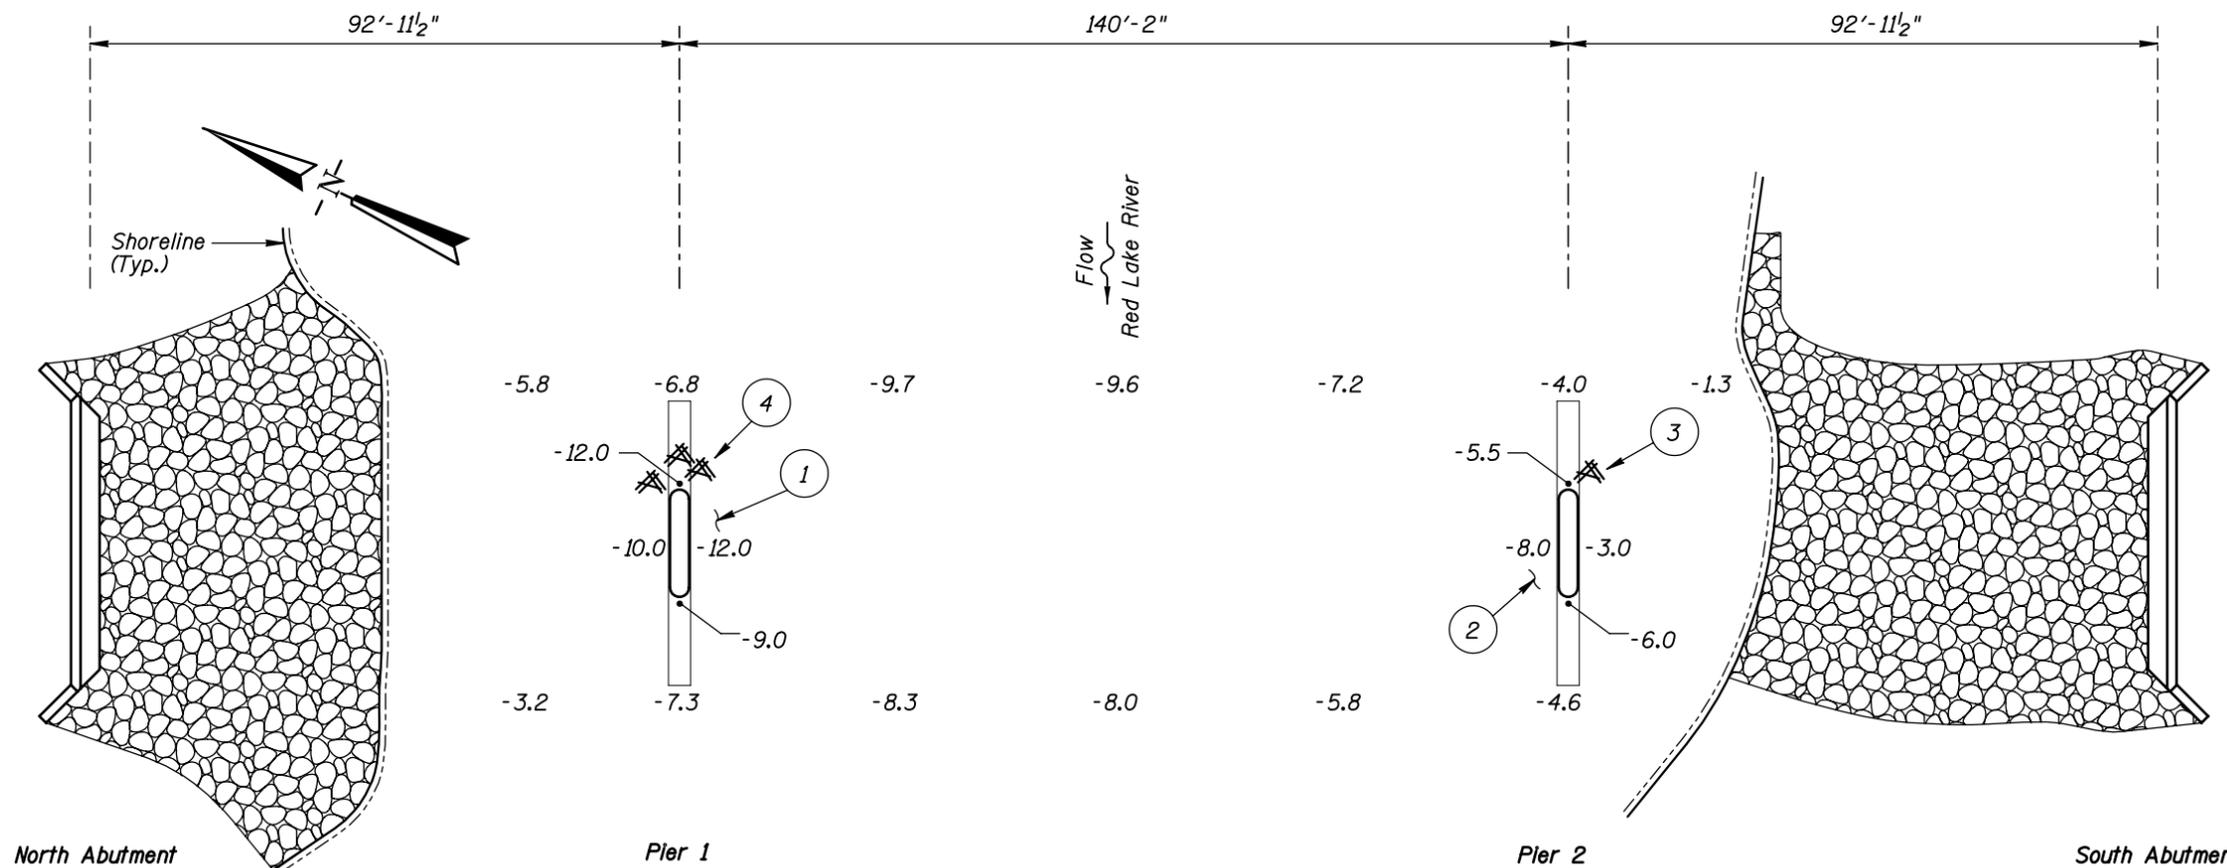
SOUNDING PLAN

- INSPECTION NOTES:**
- 1 The channel bottom consisted of riprap and interspersed sandy gravel with no probe rod penetration.
 - 2 The channel bottom consisted of soft silt and scattered riprap with 1 foot of probe rod penetration.
 - 3 A 4-inch-diameter piece of timber was embedded in the channel bottom at the upstream nose of Pier 2.
 - 4 A light accumulation of 6-inch-diameter and smaller timber debris was observed at the upstream nose of Pier 1 extending from the channel bottom to 3 feet above the channel bottom.

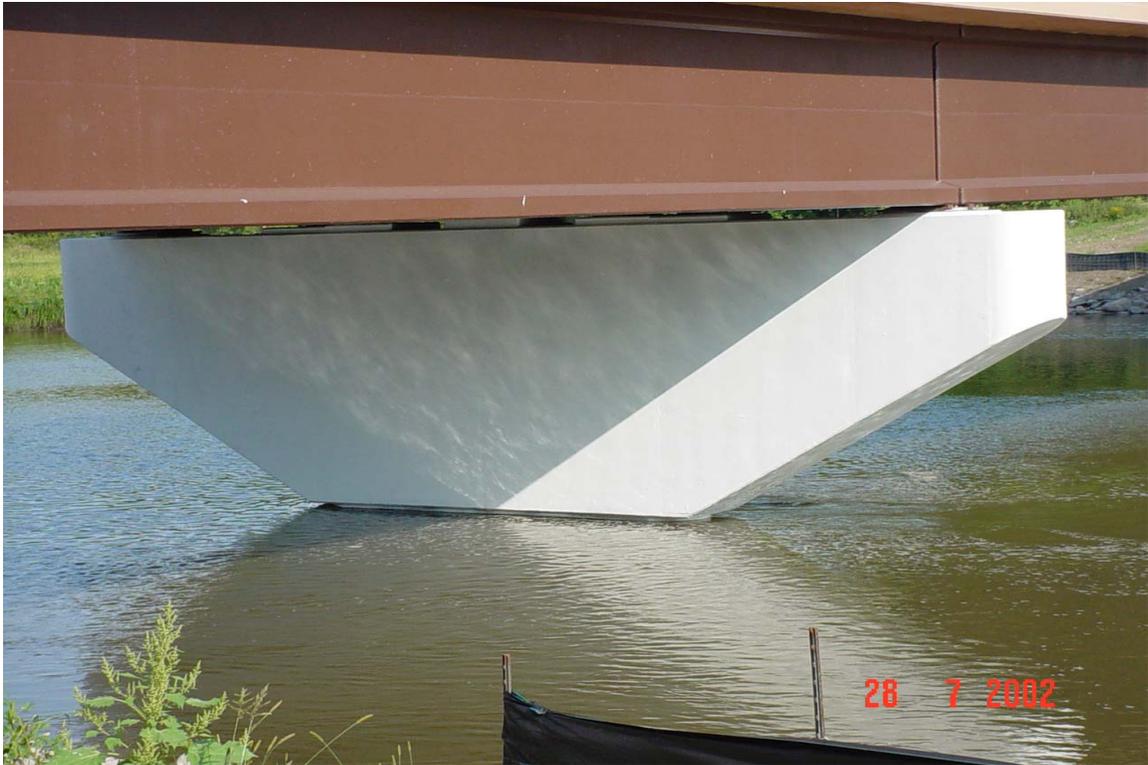
- (A) A light accumulation of 6-inch-diameter and smaller timber debris was observed at the upstream end of Pier 1 extending from the channel bottom to 3 feet above the channel bottom.

Photograph 2. View of Pier 1, Looking Northeast.

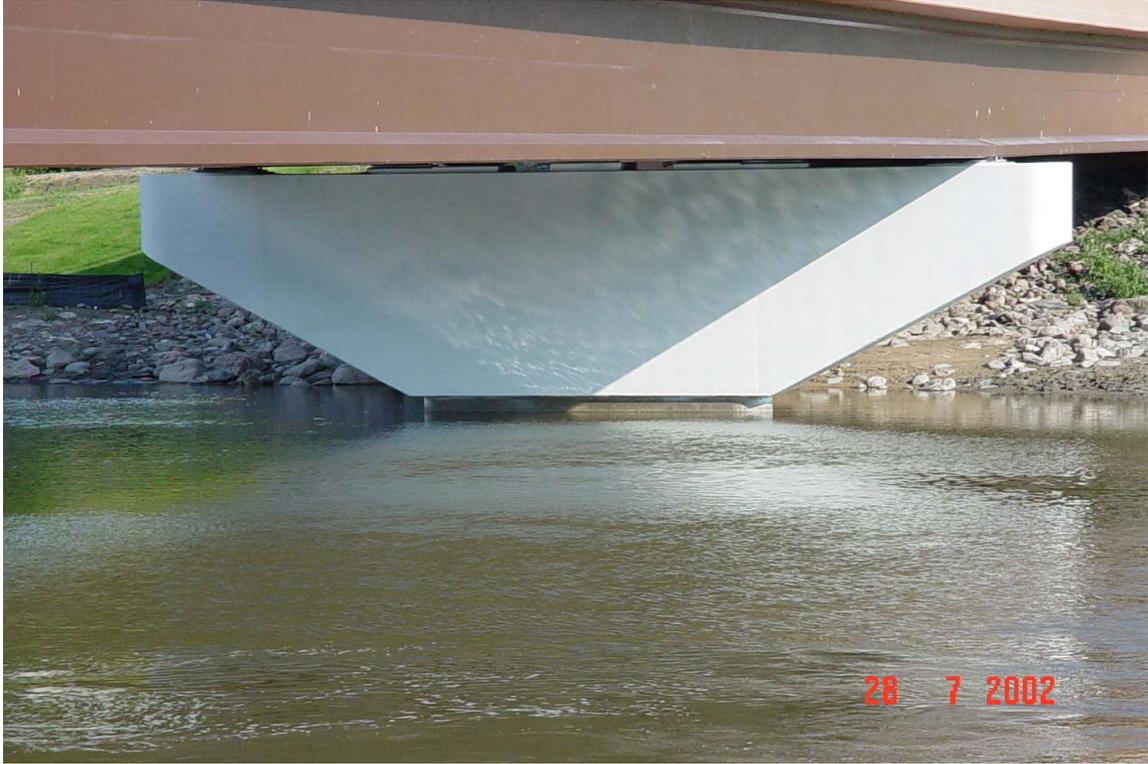
Photograph 3. View of Pier 2, Looking Northeast.
