UNDERWATER BRIDGE INSPECTION REPORT

STRUCTURE NO. 6613

RED LAKE RIVER

MINNESOTA DEPARTMENT OF TRANSPORTATION
UNDERWATER BRIDGE INSPECTION

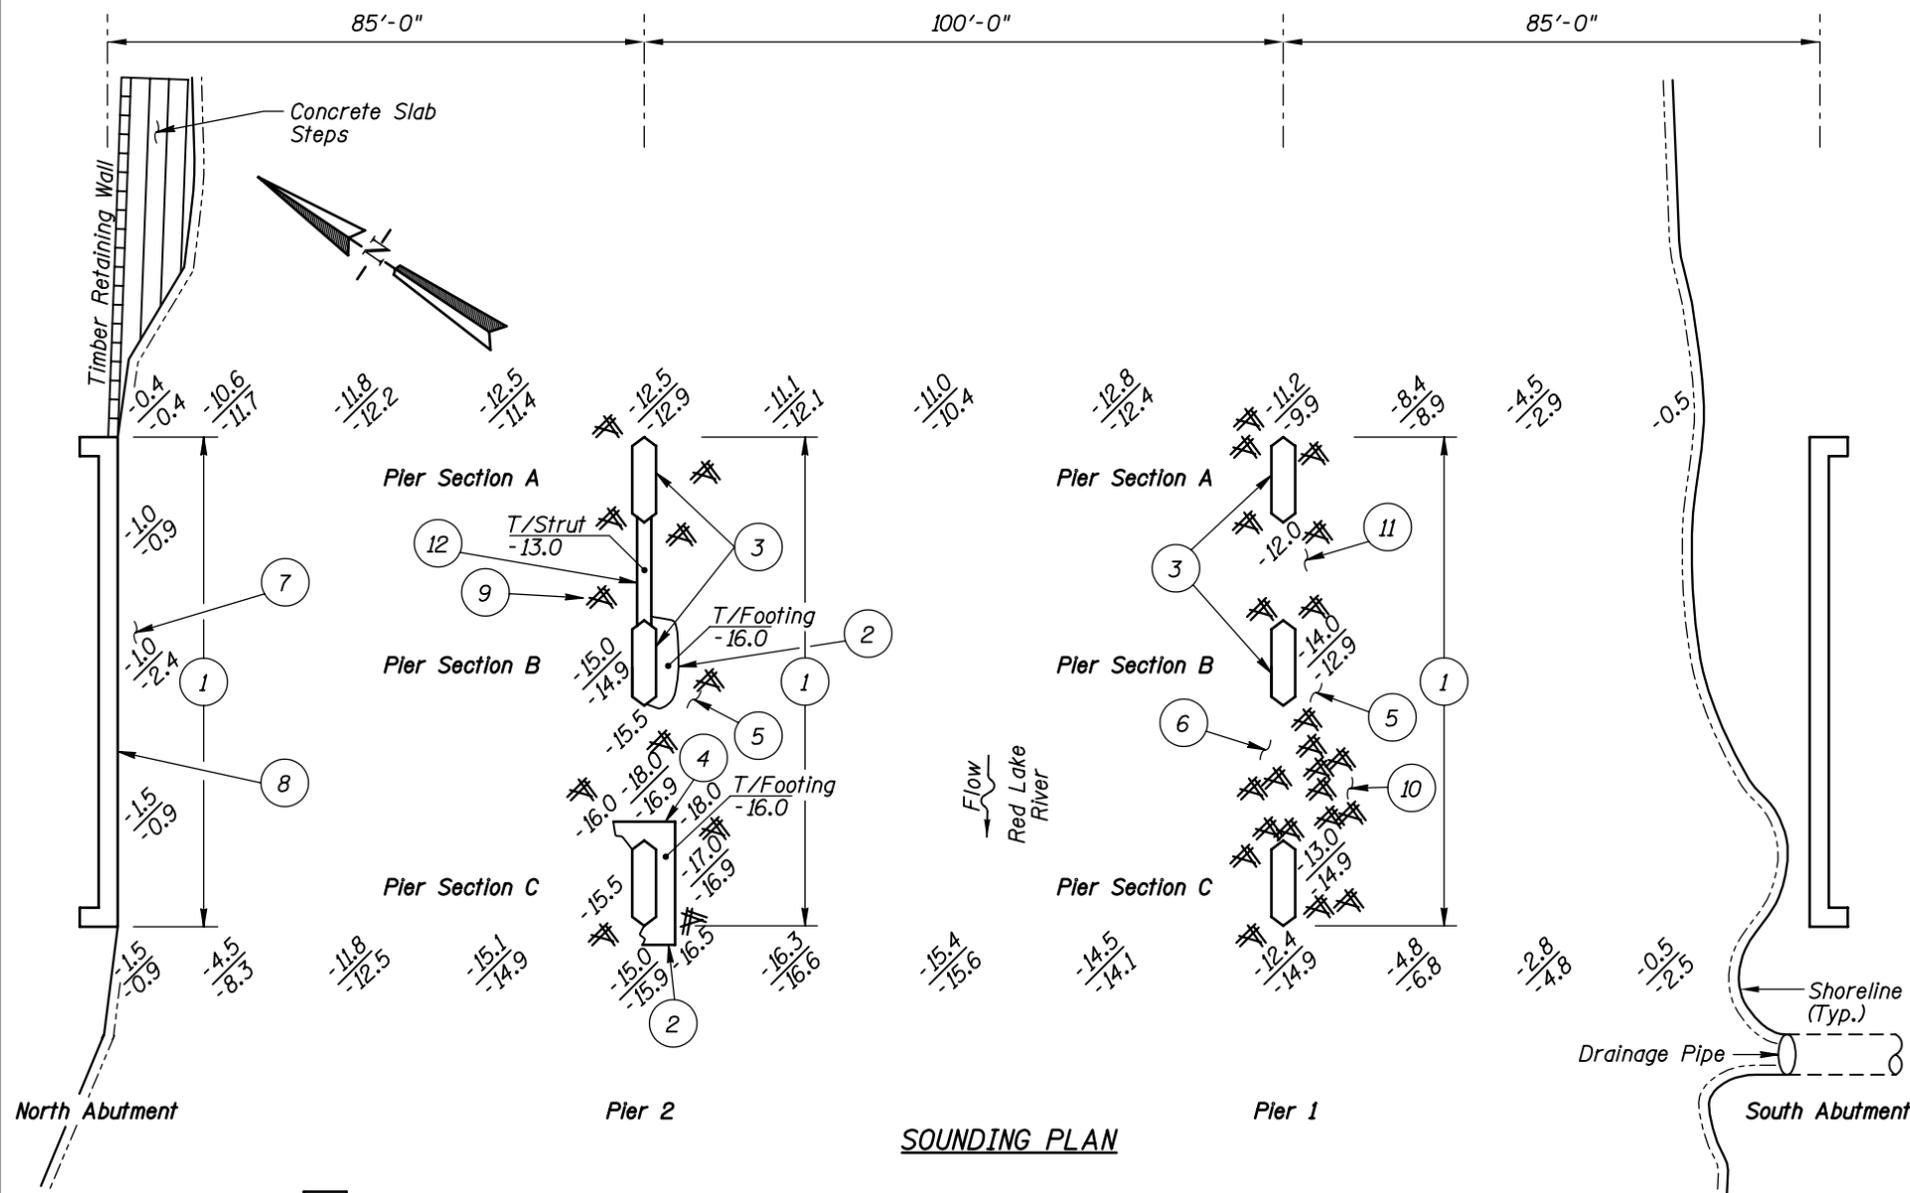
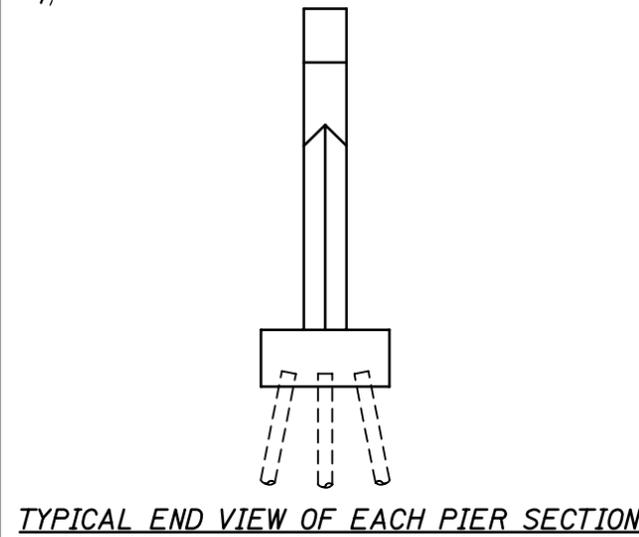
- 1 Overall, the concrete piers and abutments were in good condition with no defects of structural significance.
- 2 Section C of Pier 2 exhibited partial footing exposure with a maximum vertical exposure of 2 feet along the upstream end. The top of the footing only was exposed at Section B of Pier 2.

- 3 Light scaling was observed on the shafts of Sections A and B from the waterline to 1 foot below the waterline with a maximum penetration of 1/4 inch.

- 4 Timber formwork was observed around the footing at Section C of Pier 2.
- 5 The channel bottom consisted of sand, gravel and cobbles with probe rod penetrations from 6 inches to 1 foot.

- 6 The channel bottom consisted of soft sandy infilling along the downstream channel side and between Sections B and C of Pier 1.
- 7 The channel bottom consisted of silt and cobbles at the North Abutment with probe rod penetrations of 6 inches to 1 foot.

- 8 A vertical crack was observed in the construction joint at the North Abutment, typically 1/16 inch wide and up to 1/8 inch wide at the bottom.
- 9 A light accumulation of 6-inch-diameter and smaller timber debris was observed along Pier 2 from the channel bottom to 2 feet above the channel bottom.

- 10 A heavy accumulation of 1-foot-timber debris was observed from the channel bottom to the waterline.
- 11 A moderate accumulation of 1-foot-diameter and smaller timber debris was observed on the channel bottom to 5 feet above the channel bottom along Section A of Pier 1.

- 12 The concrete strut connecting Sections A and B of Pier 2 exhibited 3 feet of vertical exposure.

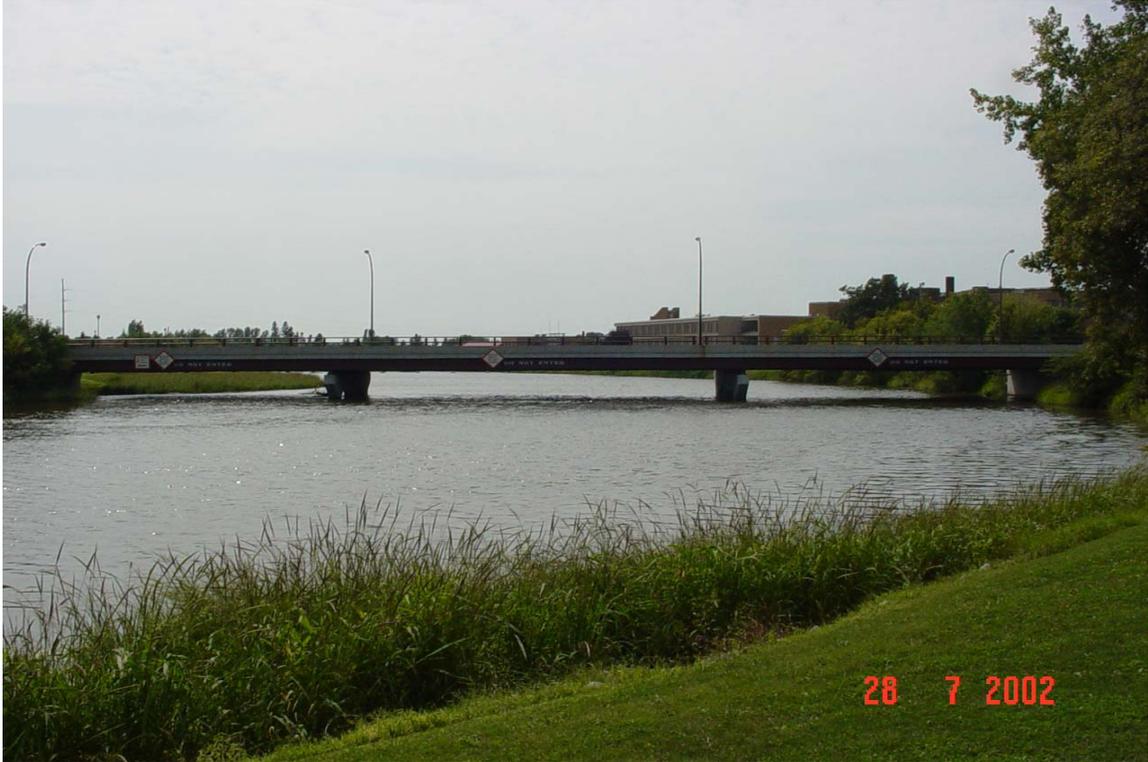
Photograph 1. Overall View of the Structure, Looking Southwest.

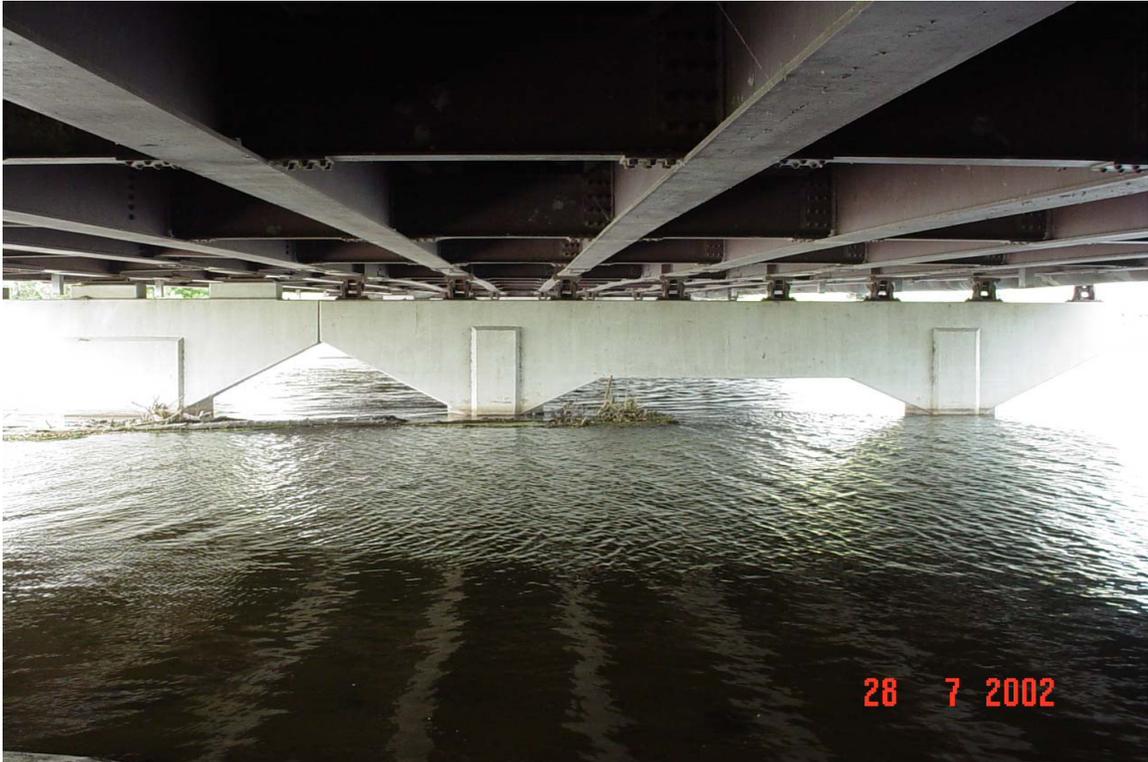
Photograph 2. View of Pier 1, Looking Northwest.

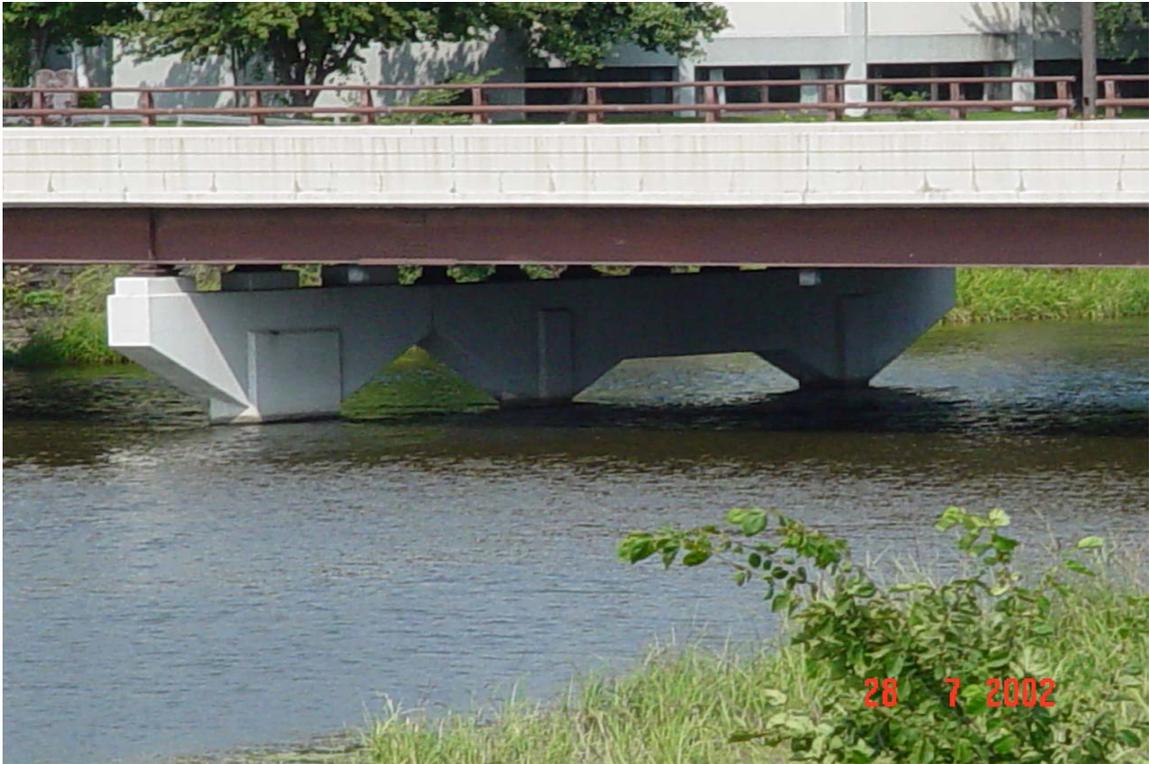
- (A) The footing at Section C of Pier 2 was exposed around most of the pier section with a maximum vertical face exposure of 2 feet at the upstream end, and the concrete strut connecting Sections A and B of Pier 2 exhibited 3 feet of vertical exposure. The top of the footing at Section B of Pier 2 was also exposed on the southerly side.

Photograph 3. View of Pier 2, Looking Northeast.

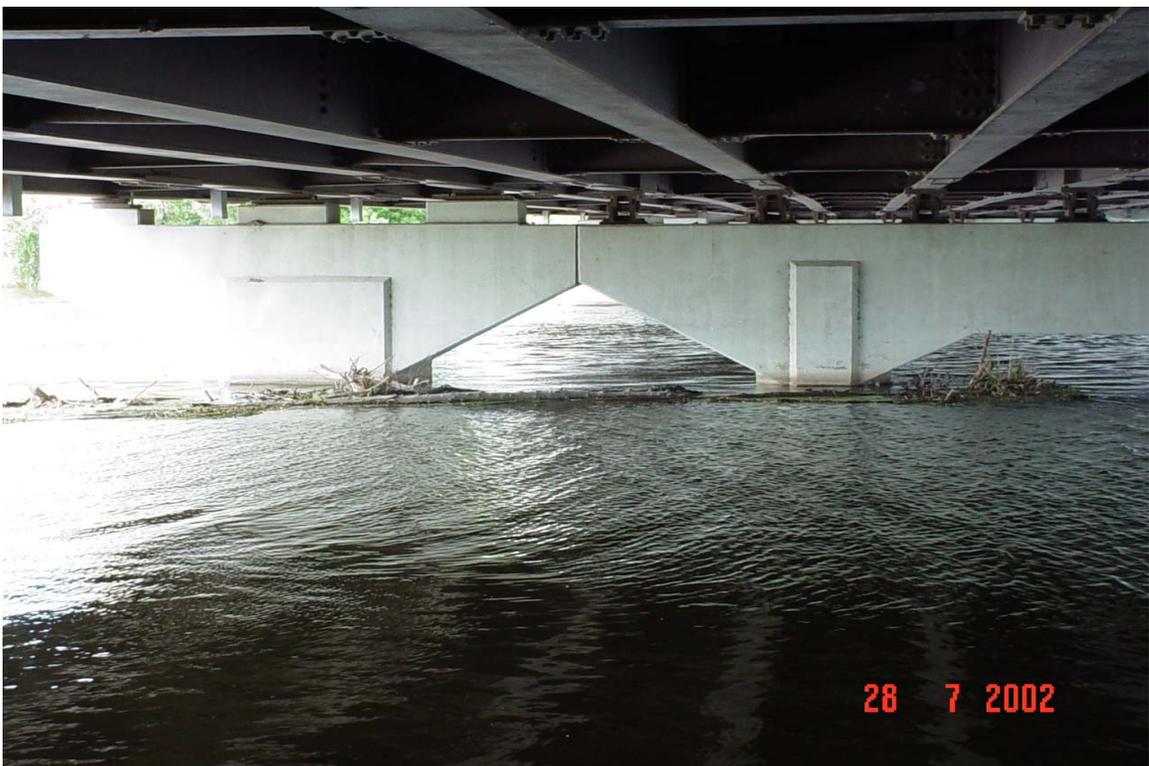
- (B) There was a light accumulation of 6-inch-diameter and smaller timber debris along Pier 2 on the channel bottom. A moderate accumulation of 1-foot-diameter timber debris was observed on the channel bottom to 5 feet above the channel bottom along Section A of Pier 1. The debris continued along the shore side of the pier and developed in to a heavy accumulation that extended from the channel bottom to the waterline.

Photograph 4. View of Timber Debris at Pier 1, Looking Northwest.

- (A) Remove accumulated timber debris from around both piers during routine maintenance of the bridge.
