UNDERWATER BRIDGE INSPECTION REPORT

STRUCTURE NO. 6632
CSAH NO. 39
OVER THE
RED RIVER OF THE NORTH
DISTRICT 2 - NORMAN COUNTY

PREPARED FOR THE
MINNESOTA DEPARTMENT OF TRANSPORTATION
BY
COLLINS ENGINEERS, INC.
JOB NO. 3512 (CEI 43)

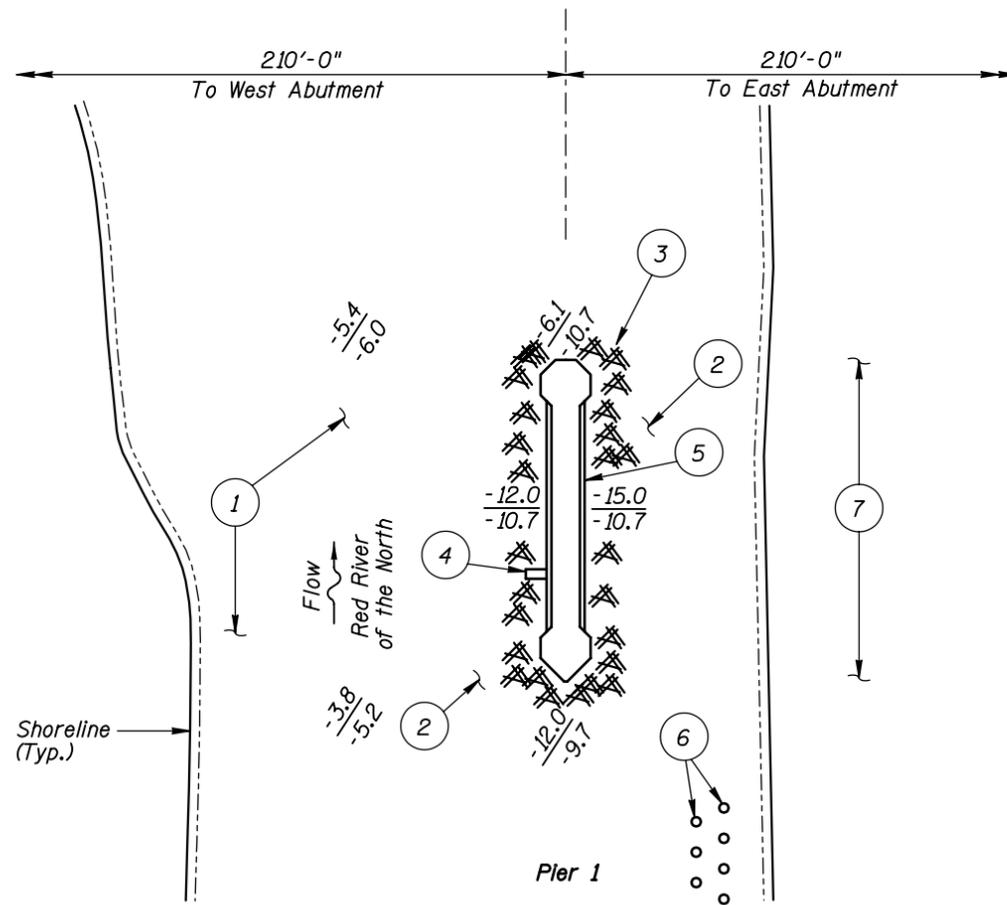
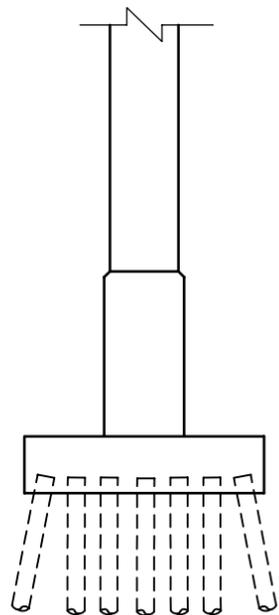
- 1 The channel bottom material consisted of silty clay with up to 1 foot of probe rod penetration.
- 2 The channel bottom material around the pier consisted of 2 inch diameter cobbles, gravel, and silty clay with up to 2 feet of probe rod penetration.

- 3 Moderate timber debris was observed around the entire perimeter of Pier 1, with a heavy accumulation at the upstream nose which extended from the channel bottom up to the waterline with pieces having a maximum diameter of 2 feet.

- 4 An I-beam was observed protruding through the pier face at the upstream 1/4 point on the west side, 2 feet above the channel bottom.
- 5 The concrete of the pier was typically in good condition with random areas of minor popouts and exposed aggregate on both faces.

- 6 Abandoned timber piles cut off 1 to 2 feet below the waterline were observed along the upstream east bank of the channel.
- 7 The east bank of the channel exhibited heavy erosion and resulted in an approximately 10 feet high vertical bank under the bridge.

- (A) Remove the accumulation of timber debris from around the perimeter of Pier 1 during routine maintenance, to inhibit further accumulation and restrict scour influence.

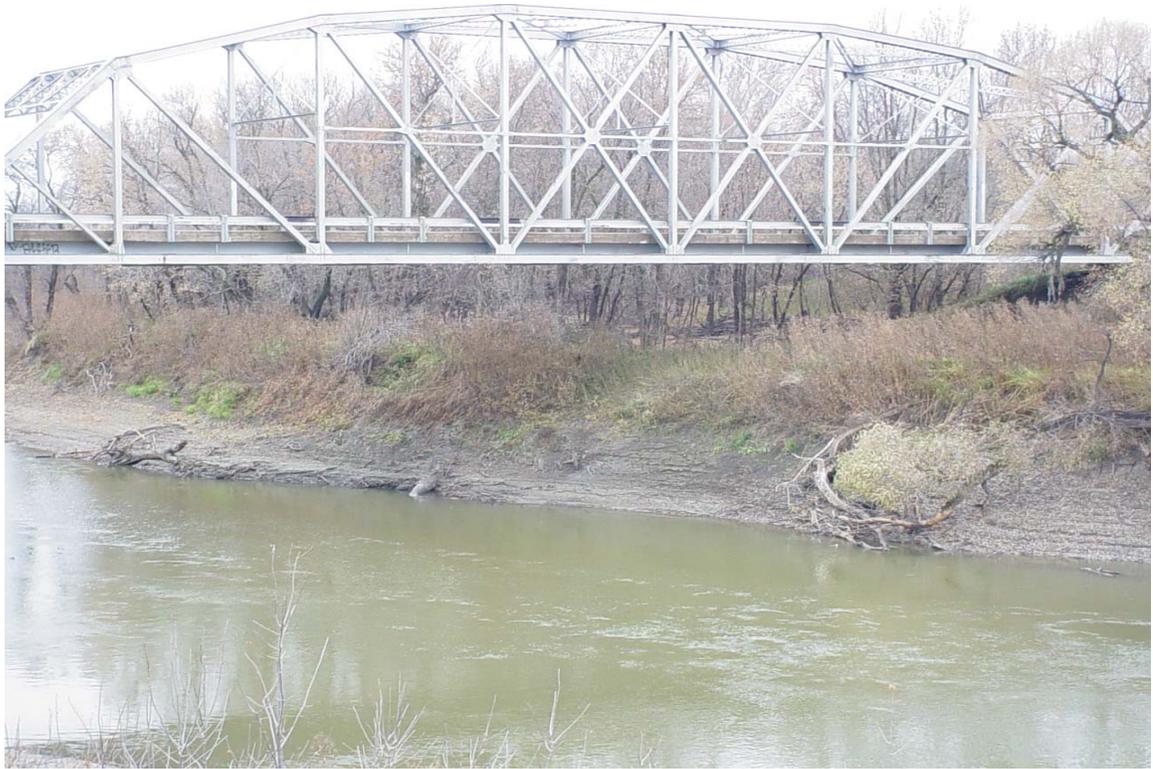
Photograph 1. Overall View of the West Bank, Looking Southwest.

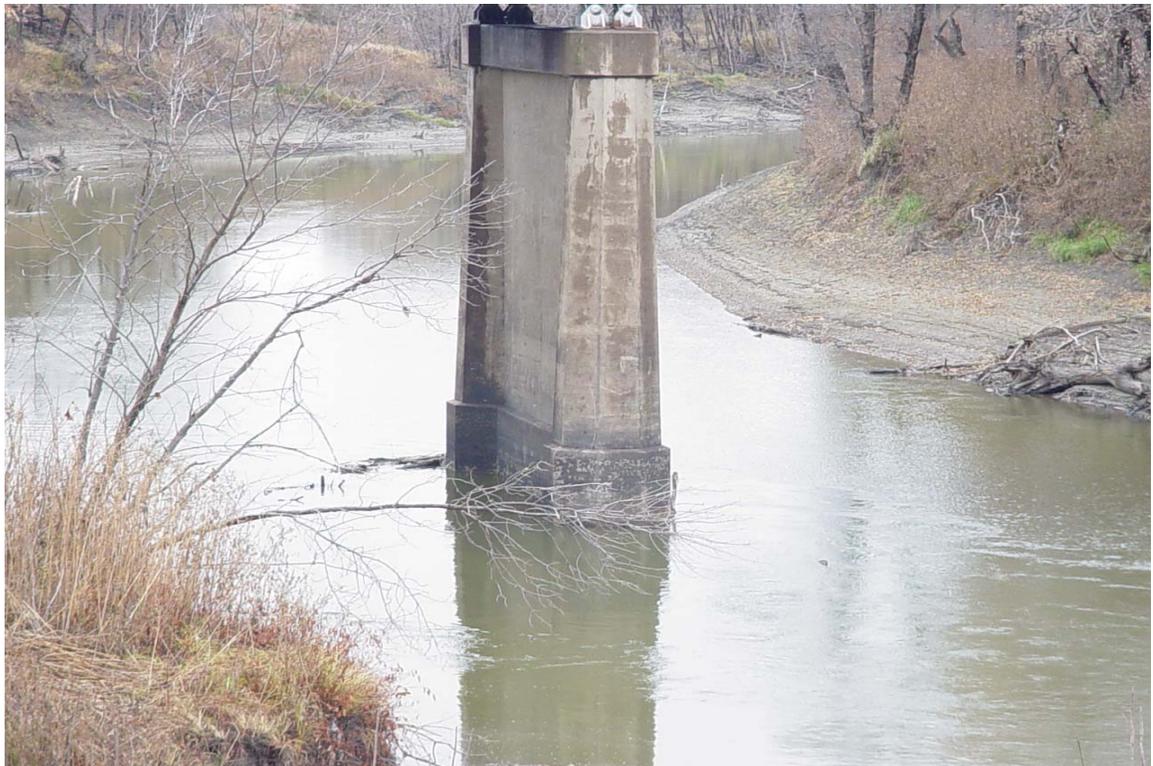
Photograph 2. View of Pier 1, Looking South.

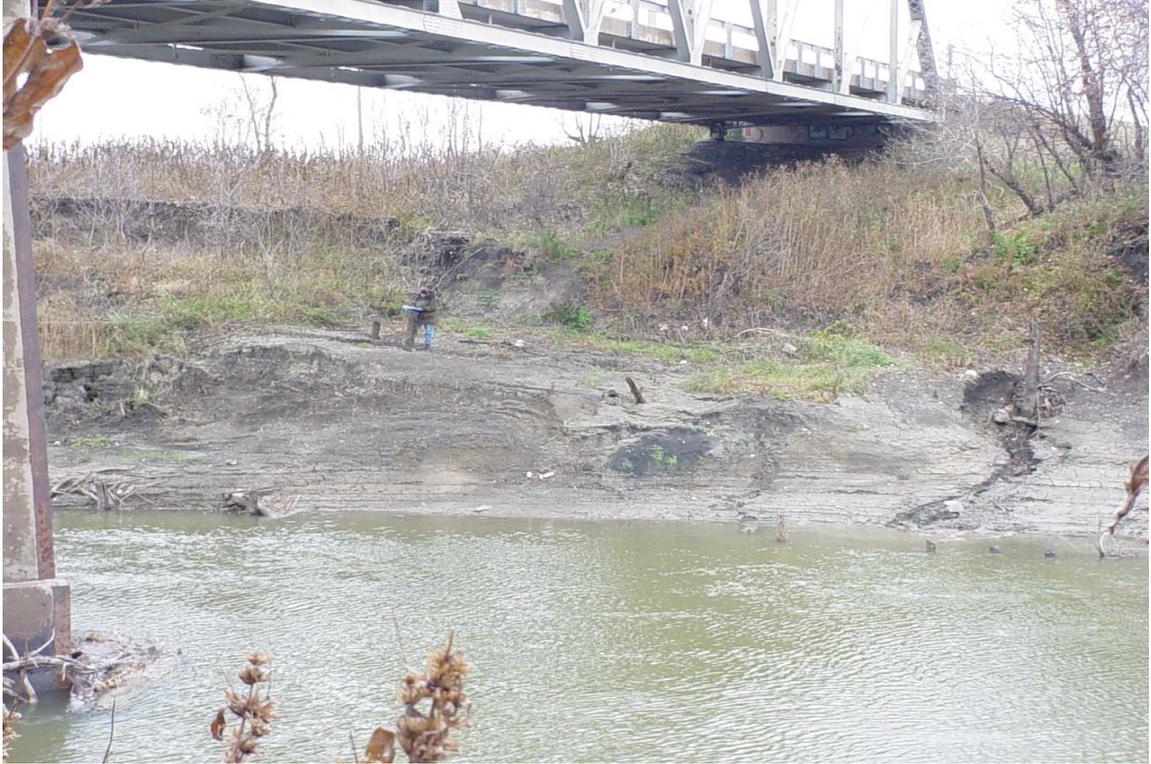
- (A) A heavy accumulation of timber debris, consisting of logs and branches up to 2 feet in diameter, was observed at the upstream end of Pier 1 and extended from the channel bottom up to the waterline. In addition, a moderate accumulation of timber debris was observed around the entire perimeter of the pier.
- (B) The concrete of Pier 1 was typically in good condition with random areas of minor popouts and exposed aggregate on both faces.
- (C) The east bank of the channel exhibited heavy erosion that has resulted in an approximately 10 feet high vertical bank under the bridge.

Photograph 3. Overall View of the East Bank, Looking East.

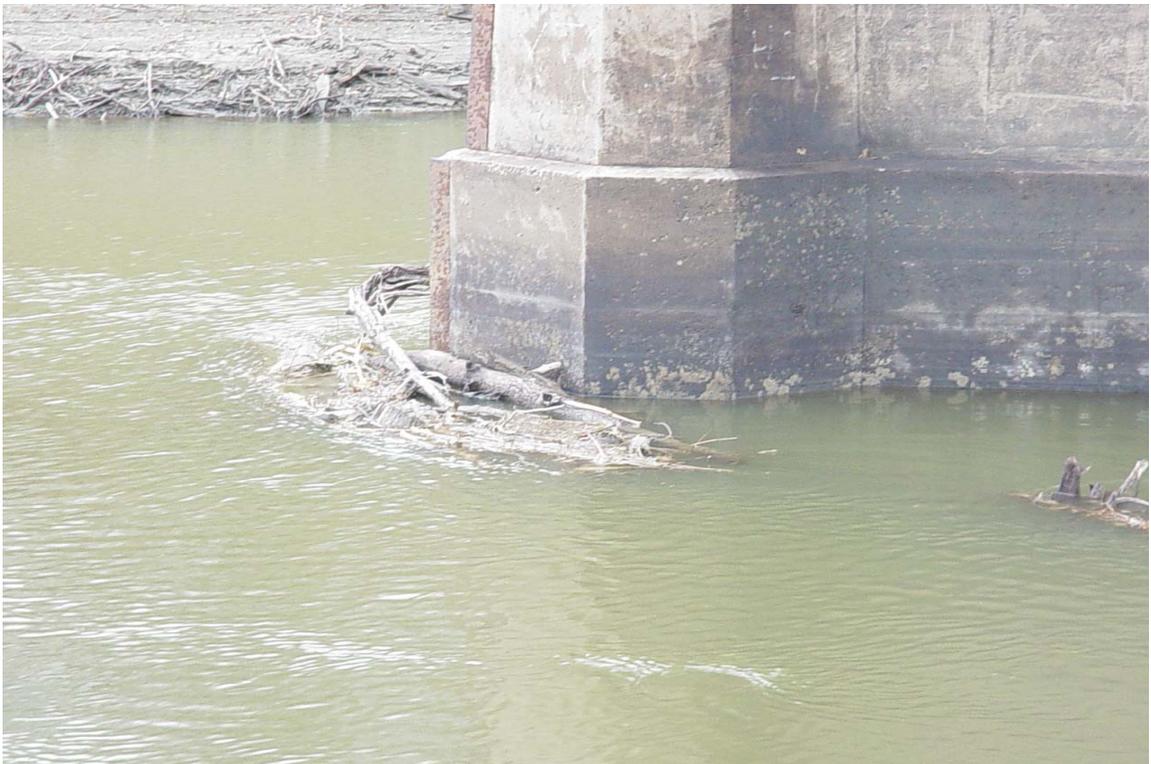
Photograph 4. View of the Timber Debris at the Upstream Nose of Pier 1, Looking West.

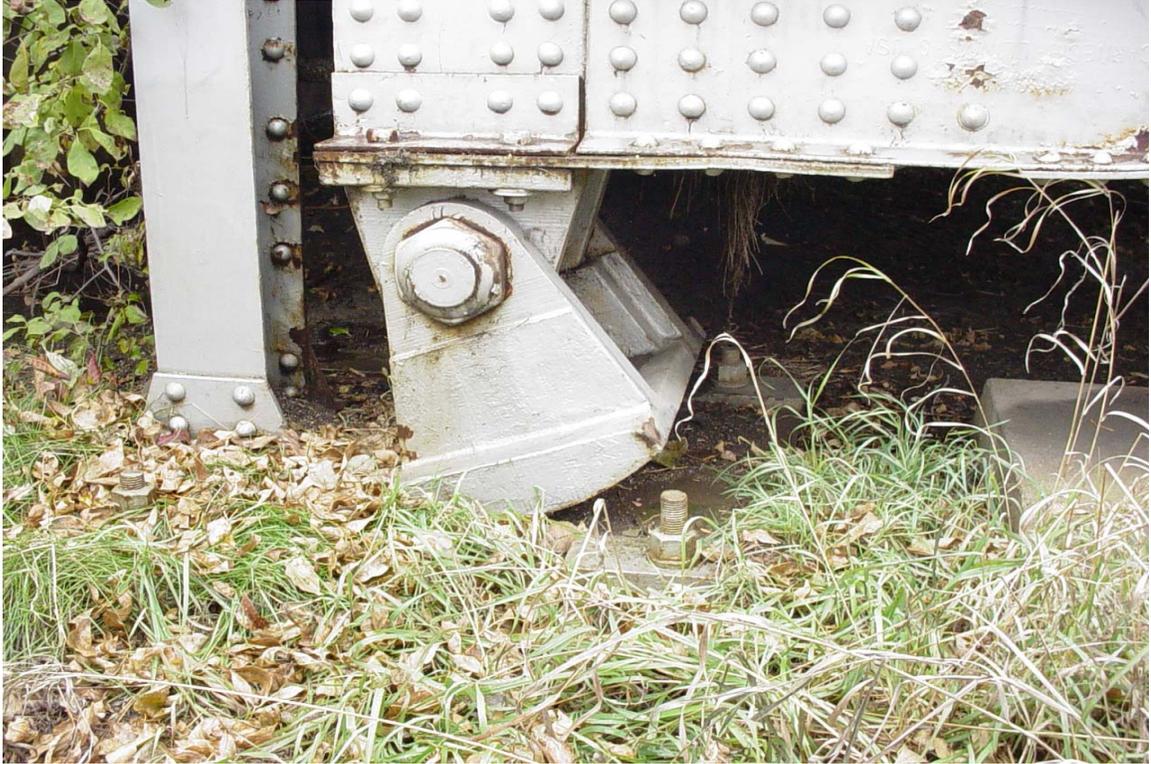
The substructure unit inspected at Bridge No. 6632, Pier 1, was found to be in good condition below water with no defects of structural significance observed. A heavy accumulation of timber debris, however, was observed at the upstream nose of the pier. A notable amount of aggradation of channel bottom material was observed at the downstream nose of the pier since the last inspection. Although well beyond the scope of an underwater inspection, it should also be noted that the rocker bearings at the West Abutment were considerably rolled back towards the abutment wall at the time of the inspection.

Photograph 5. View of the Rocker Bearing at the West Abutment, Looking North.

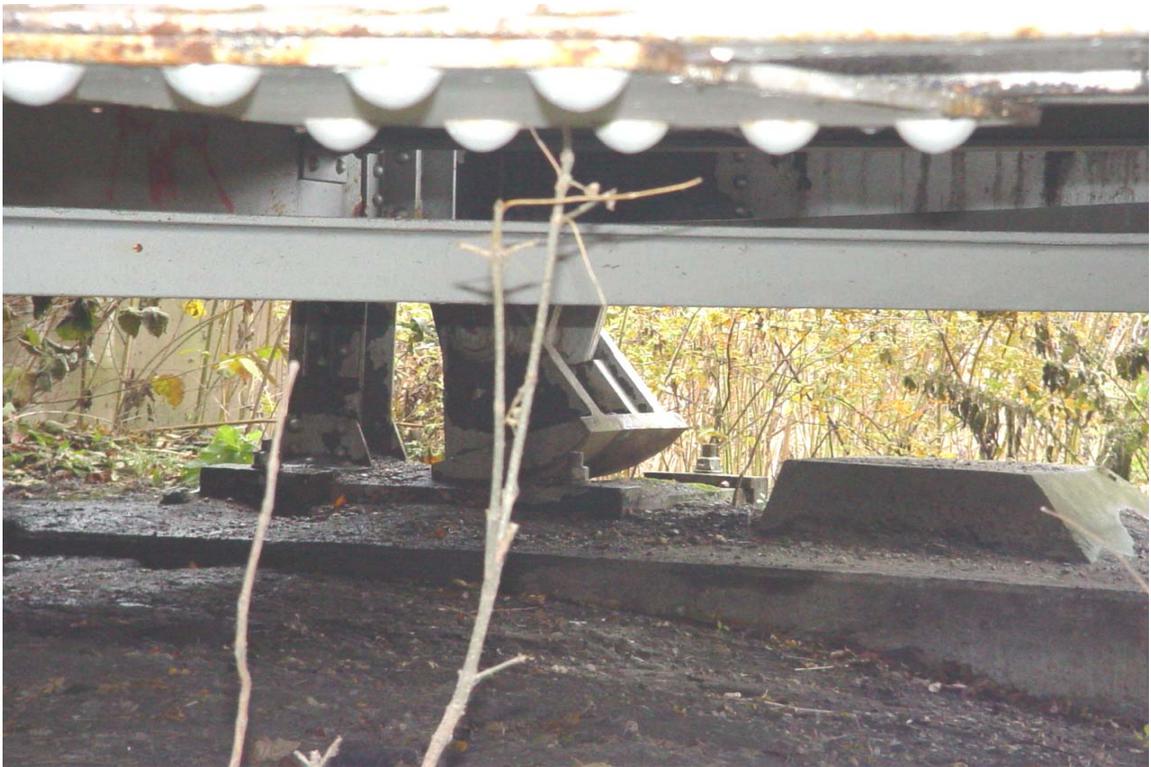
Photograph 6. View of the Rocker Bearing at the West Abutment, Looking North.
