UNDERWATER BRIDGE INSPECTION REPORT

STRUCTURE NO. 97373
CSAH 37
OVER
HEIR CREEK
DISTRICT 2 - CLEARWATER COUNTY

PREPARED FOR THE
MINNESOTA DEPARTMENT OF TRANSPORTATION
BY
COLLINS ENGINEERS, INC.
JOB NO. 3512 (CEI 35)

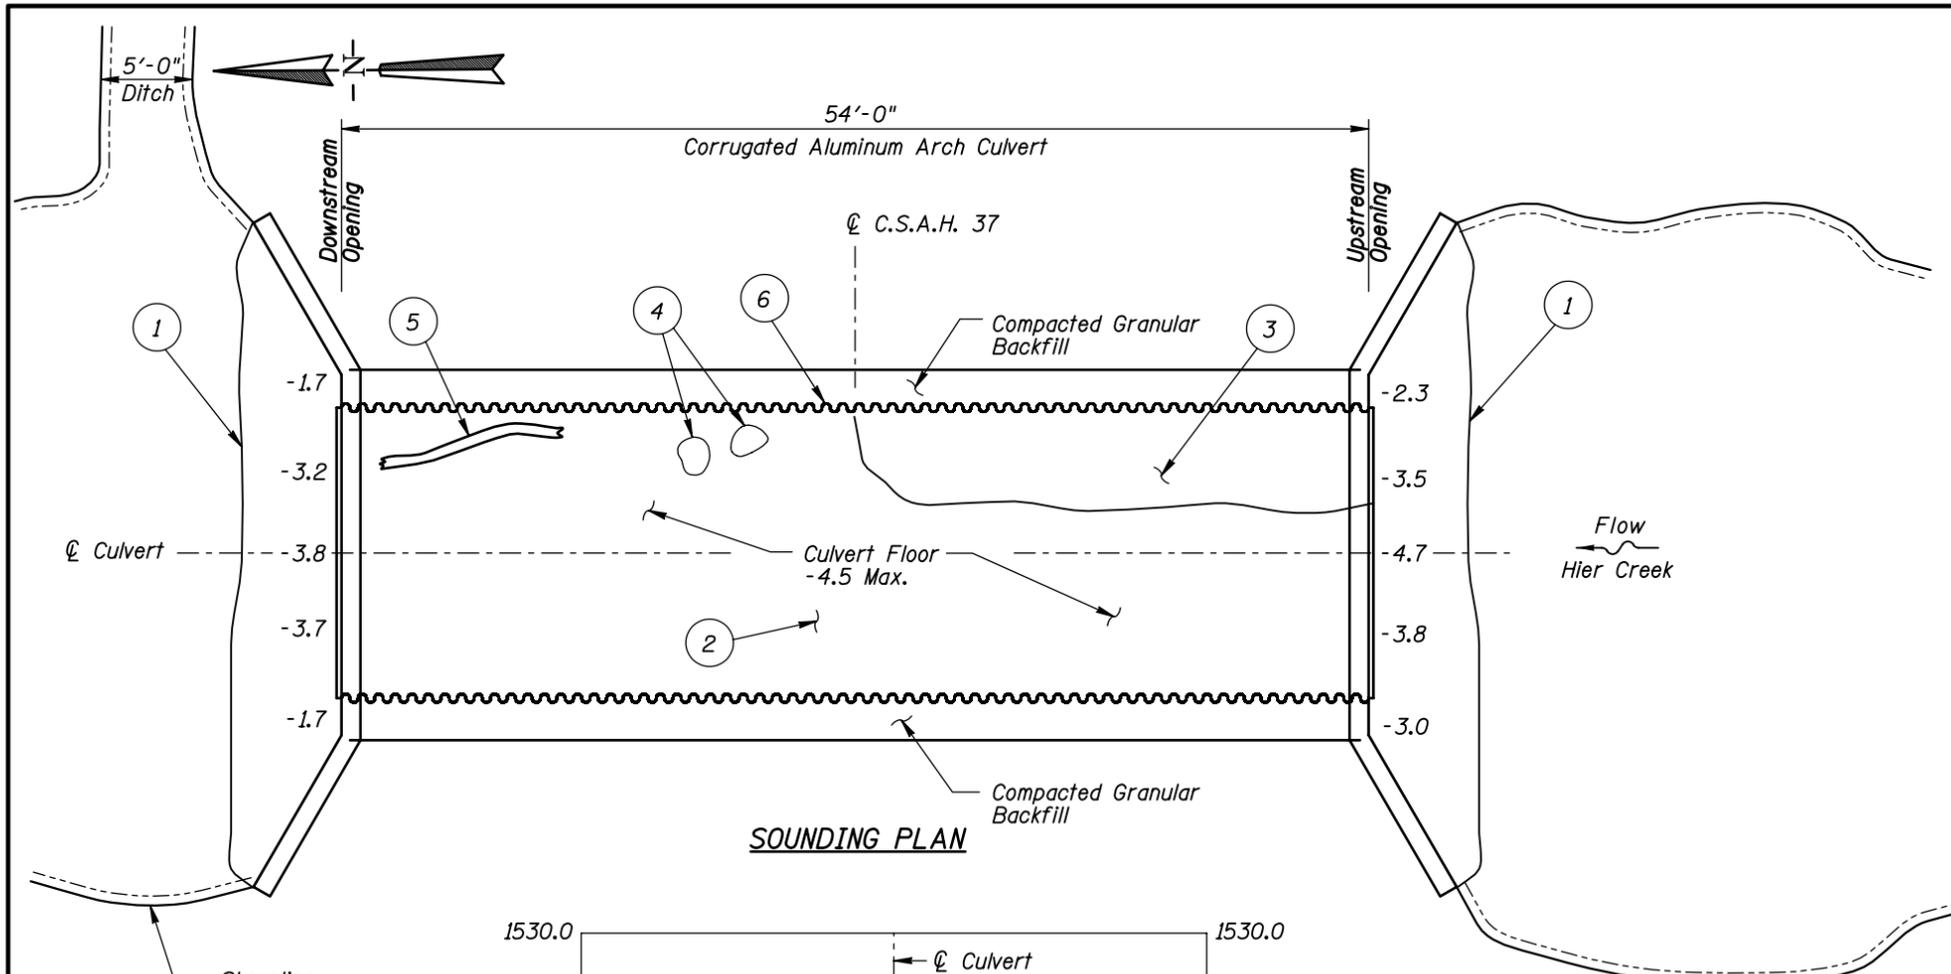
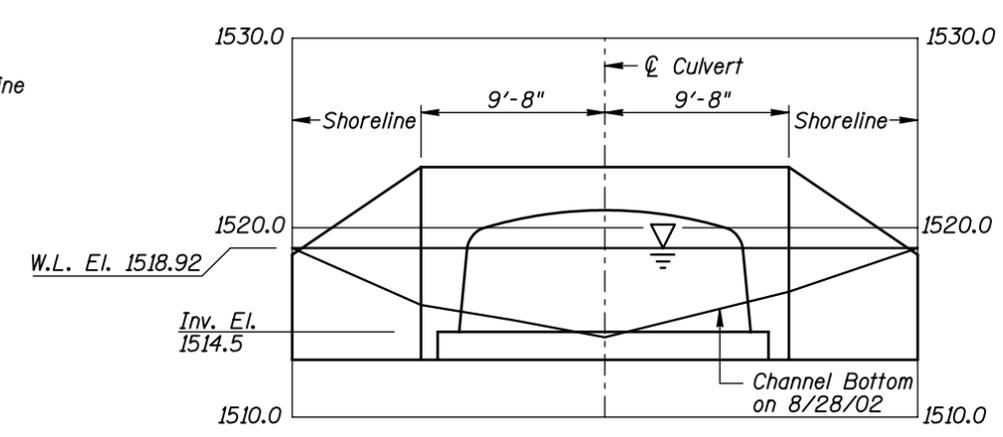
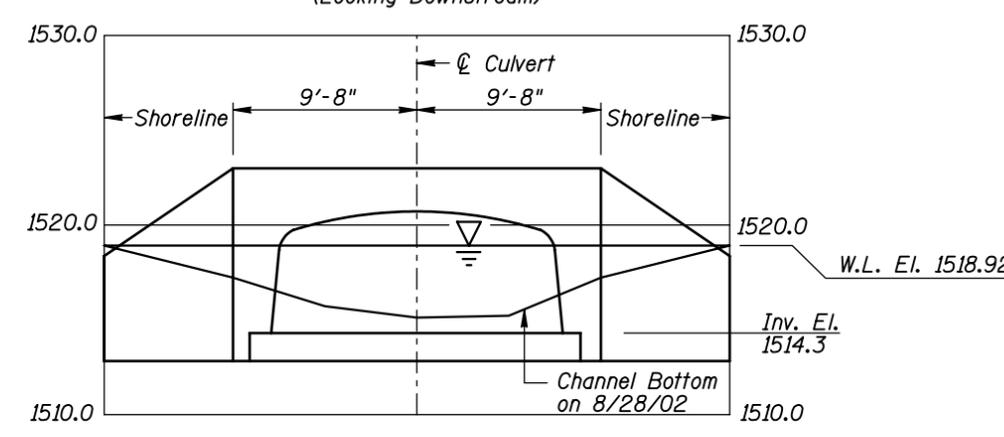
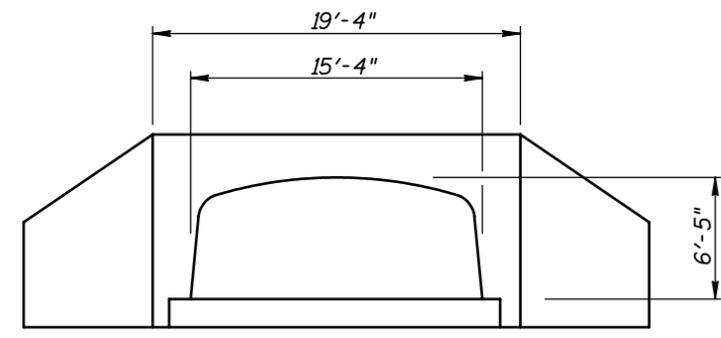
1. The channel bottom consisted of riprap covered with silty sand with 6 inches of probe rod penetration.
2. Culvert floor was typically covered with a 2 inch layer of silty, sandy gravel.
3. Area of culvert floor covered with a 6-inch layer of silty, sandy gravel located on the east side of the culvert floor from the upstream opening to the mid point of the culvert.
4. Two pieces of riprap, 1 to 2 foot in diameter, located on the east side of the culvert floor between the mid point of the culvert and downstream 1/4 point.
5. A 6 inch diameter, 15 foot long log on the culvert floor at the downstream end.
6. The corrugated aluminum arch culvert was in good, sound condition with all joints secure and properly fitted with no gaps and no surface corrosion observed.

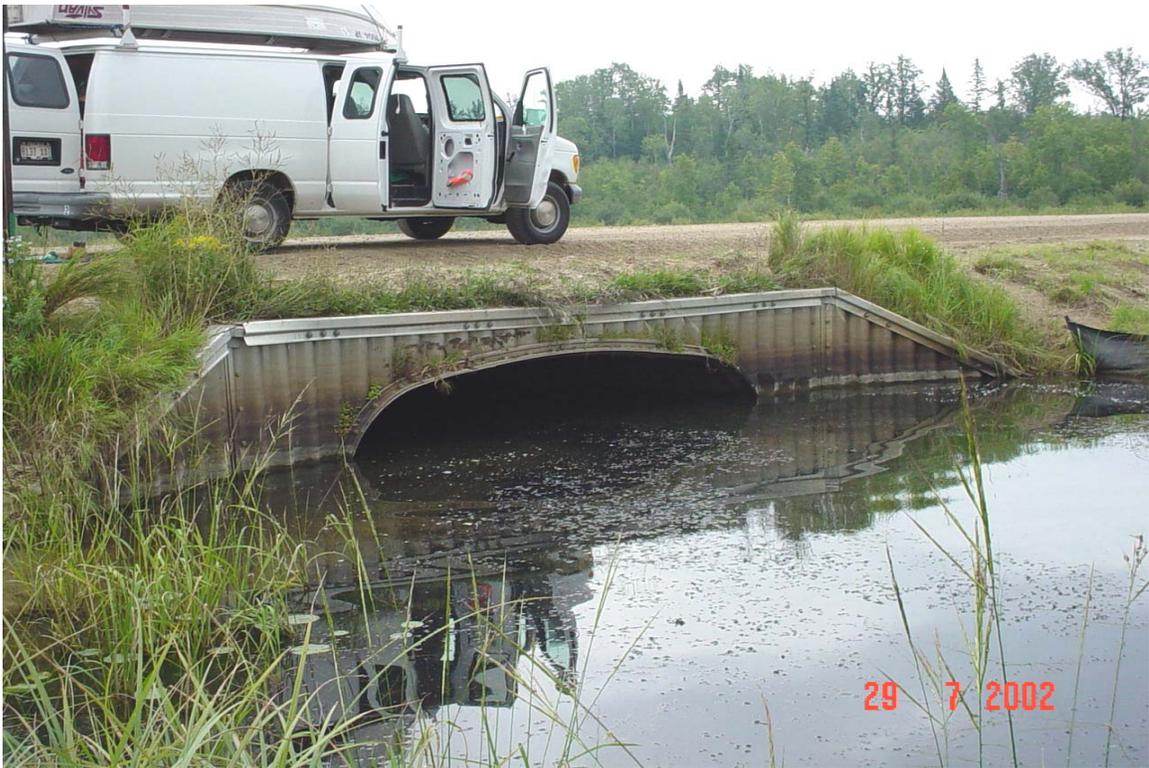
Photograph 1. Overall View of Structure, Looking Northeast.

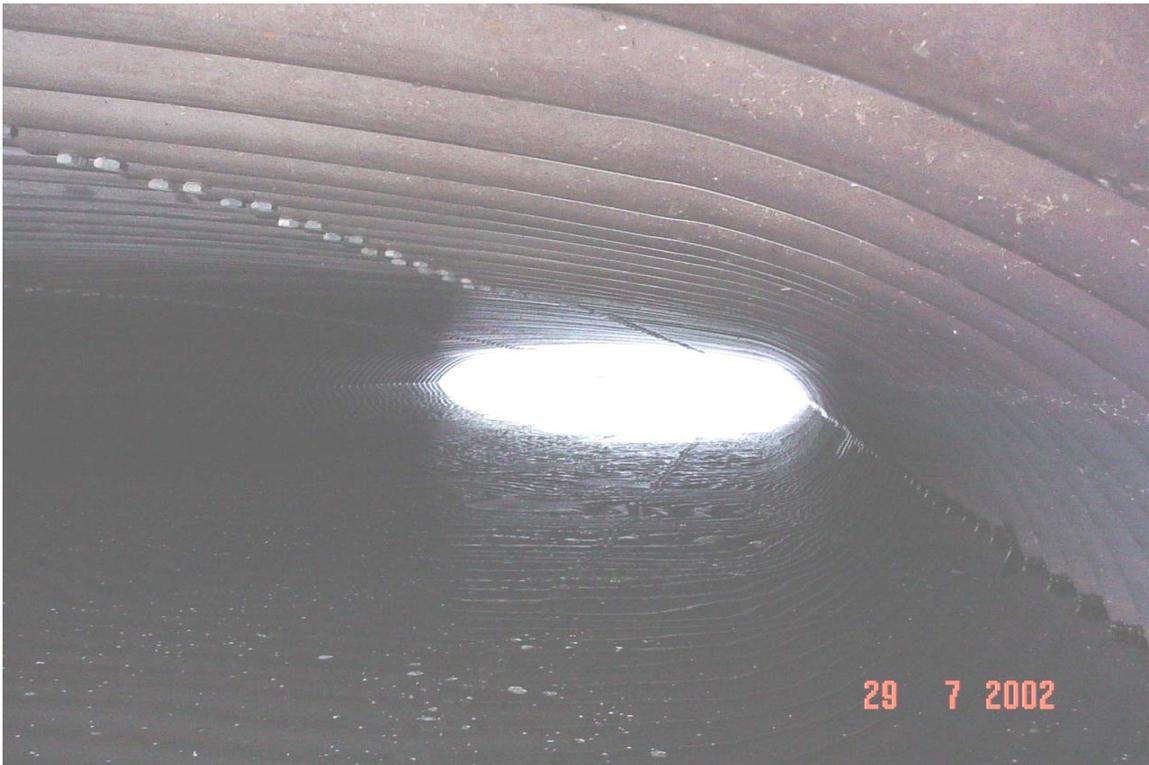
Photograph 2. View of Interior Top of Culvert, Looking South.

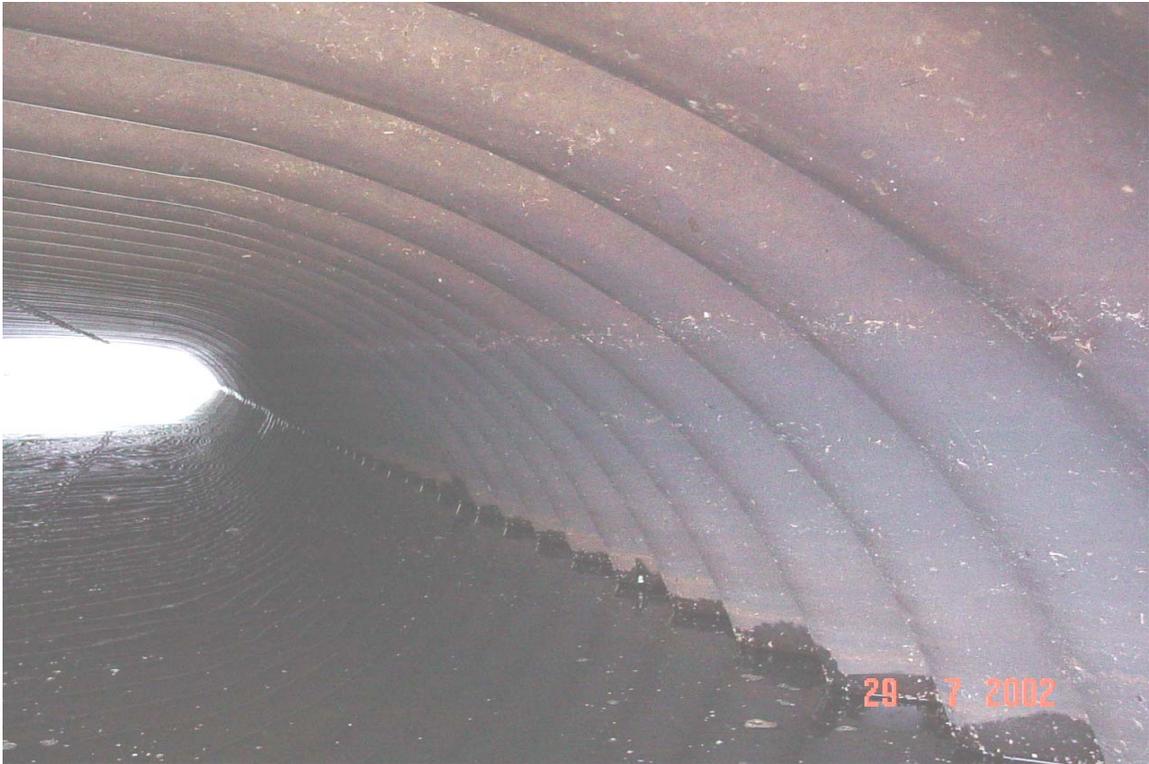
Photograph 3. View of the West Side of the Culvert, Looking Southwest.

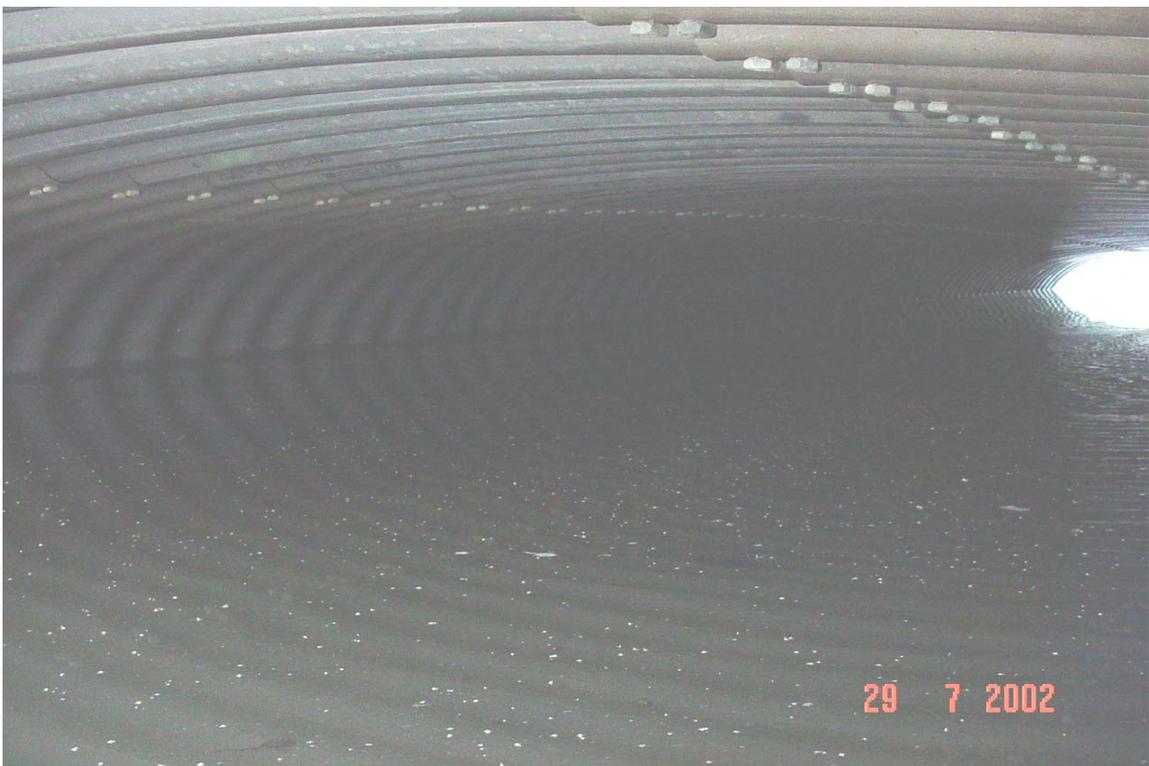
Photograph 4. View of the East Side of the Culvert, Looking Southeast.
