UNDERWATER BRIDGE INSPECTION REPORT

STRUCTURE NO. 15505
CR 23 OVER THE
CLEARWATER RIVER
DISTRICT 2 - CLEARWATER COUNTY

PREPARED FOR THE
MINNESOTA DEPARTMENT OF TRANSPORTATION
BY
COLLINS ENGINEERS, INC.
JOB NO. 5221 (CEI 33)

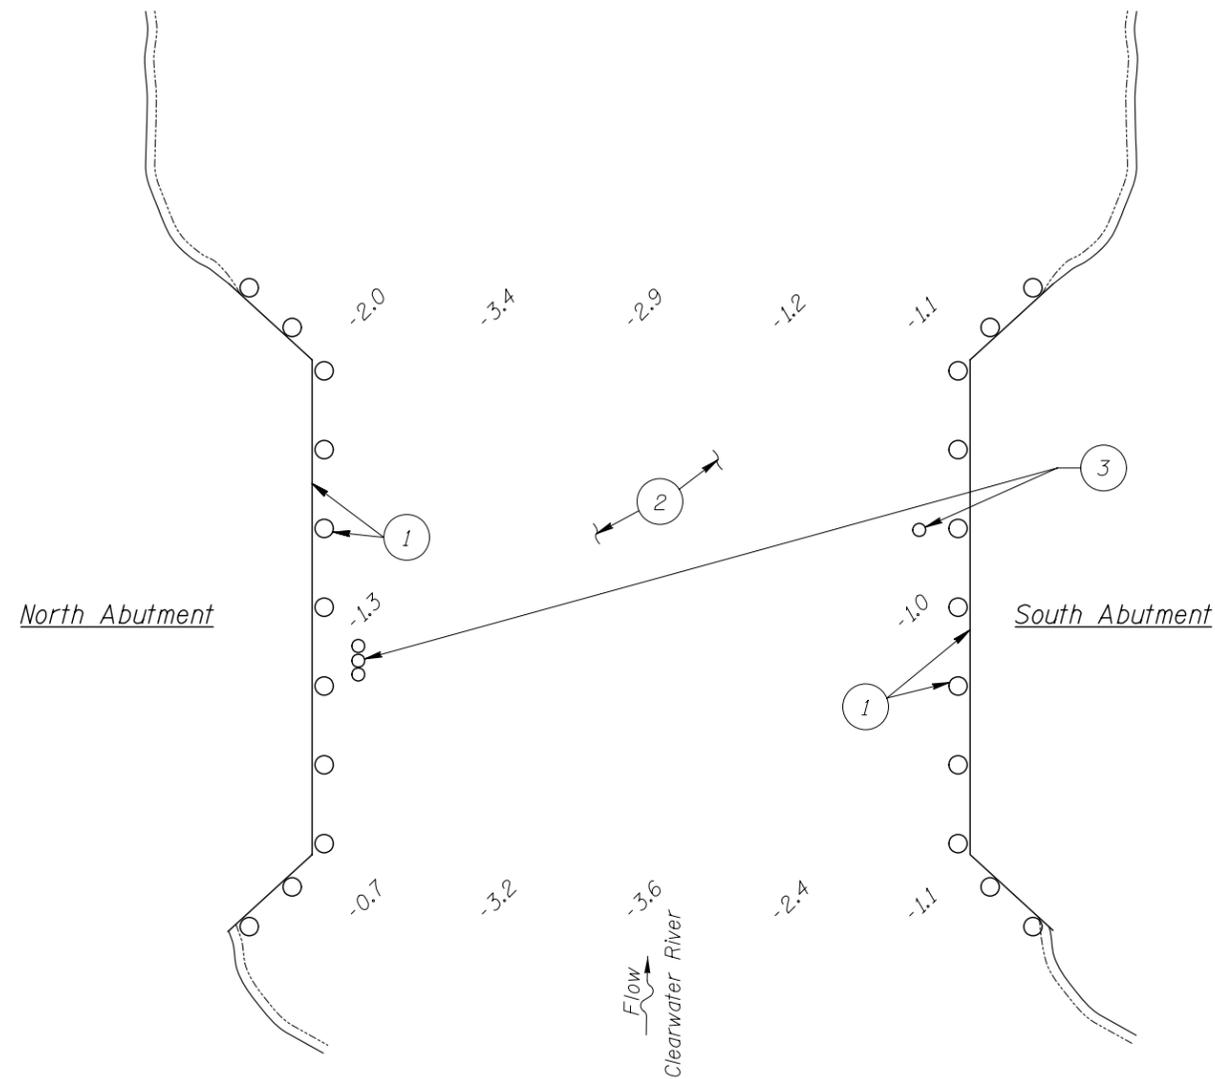
INSPECTION AND SOUNDING PLAN

- 1 The timber piles, pile caps and backwall plank (sheeting) checked up to 1/4 inch wide and typical awl penetrations between 1/4 inch and 1/2 inch deep. The galvanized connection hardware exhibited minor surface corrosion on the lower connections with no appreciable loss of section.
- 2 The channel bottom consisted of silty sand with up to 2 feet of probe rod penetration.
- 3 Abandoned timber piles cut off approximately 1 foot above the waterline.
