UNDERWATER BRIDGE INSPECTION REPORT

STRUCTURE NO. 57502  
CSAH NO. 24  
OVER THE  
RED LAKE RIVER  
DISTRICT 2 - PENNINGTON COUNTY

PREPARED FOR THE  
MINNESOTA DEPARTMENT OF TRANSPORTATION  
BY  
COLLINS ENGINEERS, INC.  
JOB NO. 5221 (CEI 163)

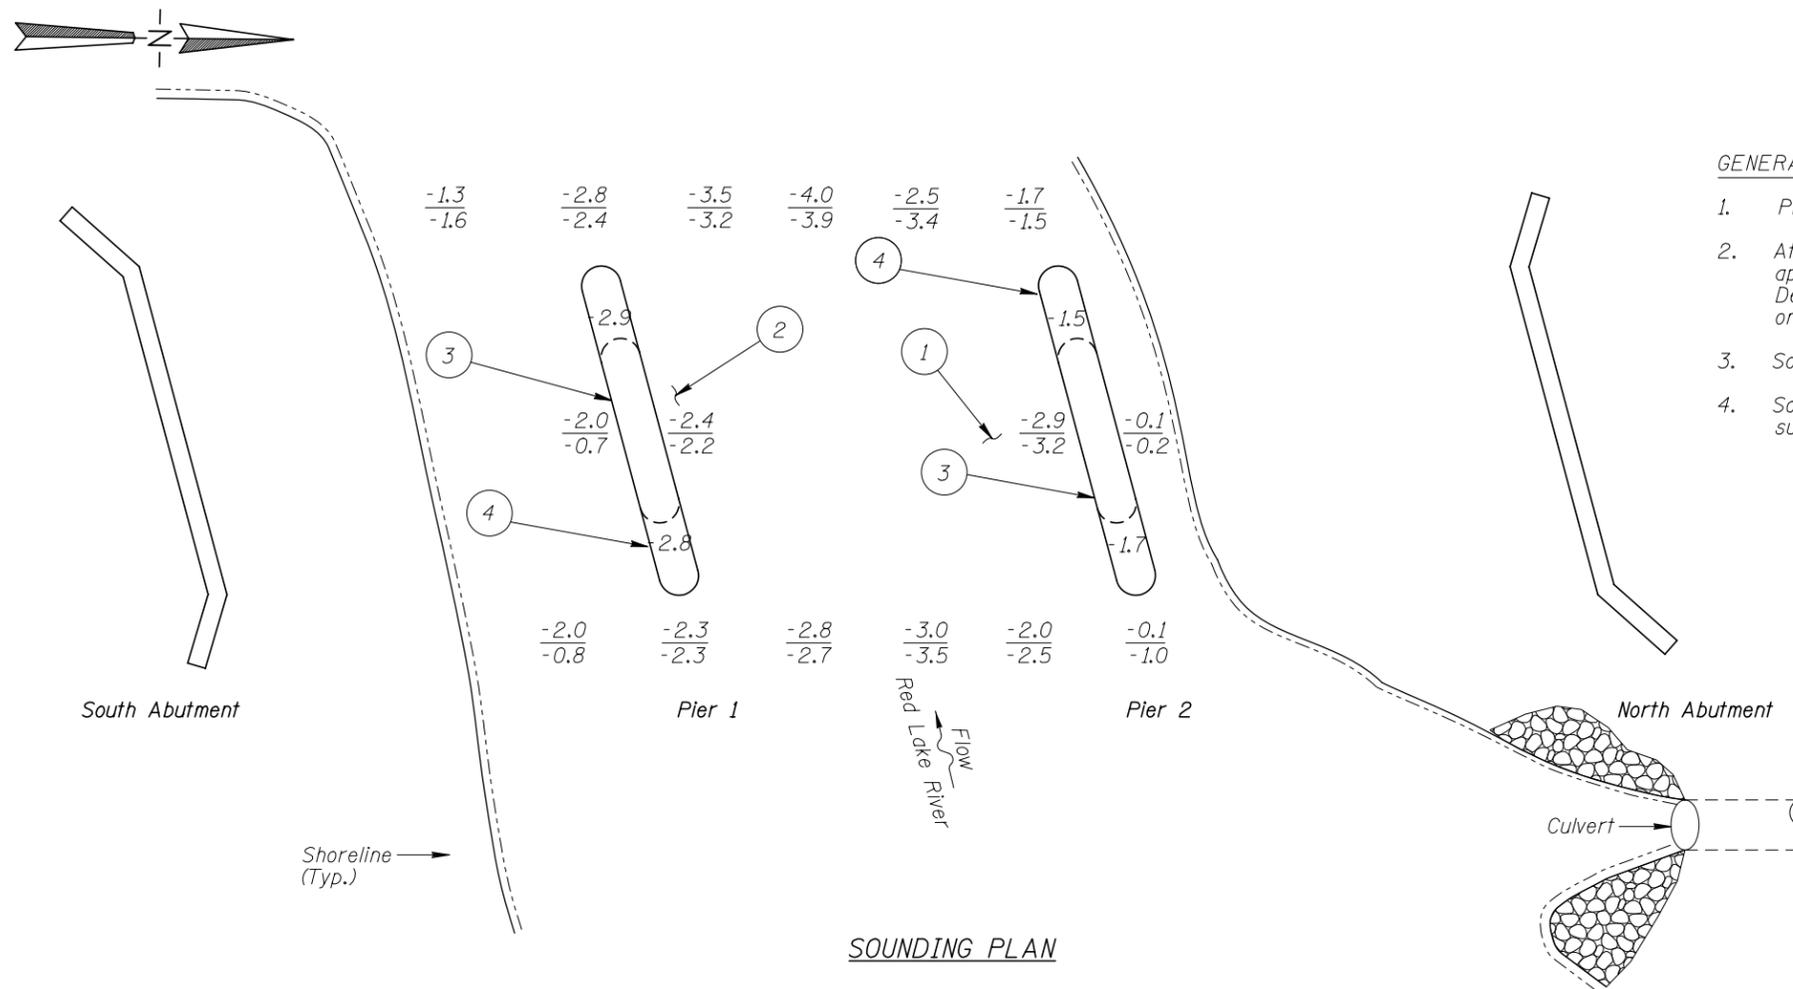
**TYPICAL END VIEW OF PIERS**

- 1 The channel bottom material around Pier 2 consisted of silty sand with up to 12 inches maximum probe rod penetration.
- 2 The channel bottom material around Pier 1 consisted of sand with 3 inches of maximum probe rod penetration.
- 3 The concrete was typically smooth and sound with random minor areas of poor consolidation with up to 1/4 inch penetration on the faces of both piers.
- 4 Minor scaling was observed from the channel bottom to 5 feet above the waterline (bottom of hammerhead pier cap) with up to 1/4 inch maximum penetration on the upstream noses of Piers 1 and 2.
