UNDERWATER BRIDGE INSPECTION REPORT

STRUCTURE NO. 57504

THIEF RIVER

DISTRICT 2 - PENNINGTON COUNTY

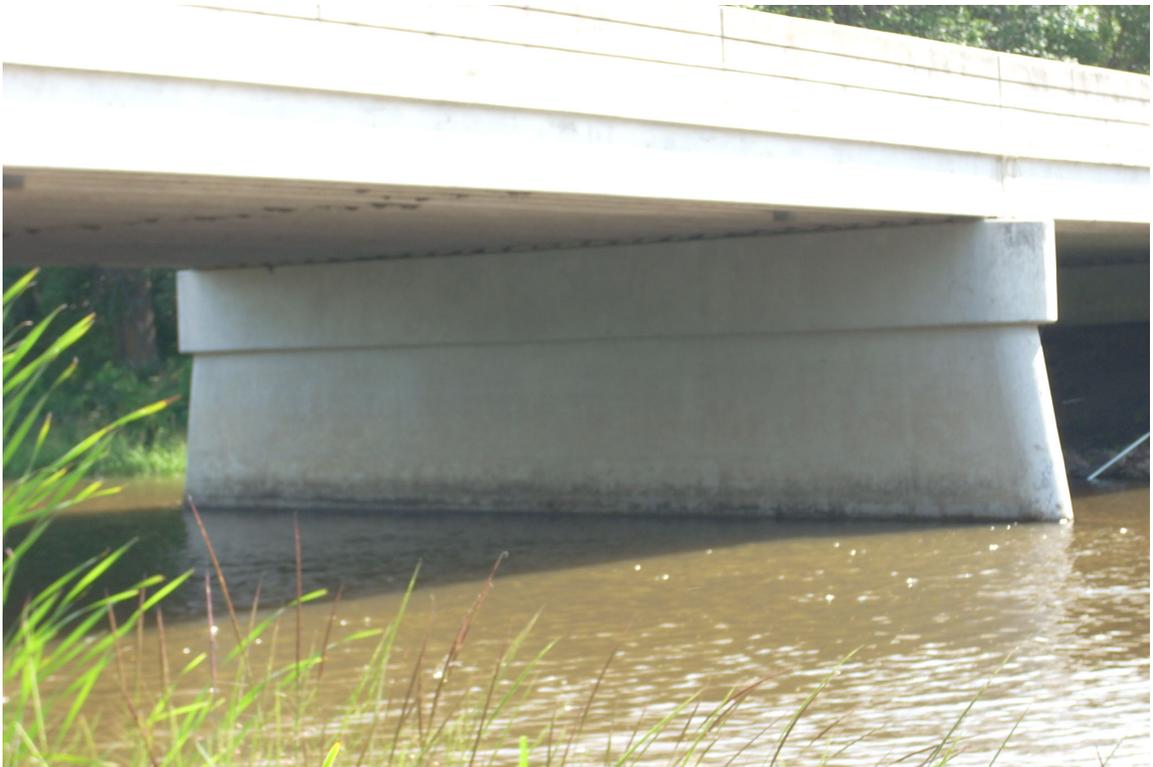
Photograph 2. View of Pier 1, Looking Southeast.

- (A) A light accumulation of timber debris consisting of 6-inch-diameter or smaller branches was observed around the entire pier shaft from the channel bottom up 2 feet and extending up to 3 feet off of Pier 1 noses and faces.
- (B) Similar accumulation of timber debris was observed from the upstream quarter point on the north face around the upstream nose to the upstream quarter point on the south face of Pier 2. The debris extended from the channel bottom up 4 feet and up to 2 feet off of the pier faces and 6 feet off of the pier nose.
- (B) Overall, the concrete piers were in good condition with no significant defects observed.

- 3 A light accumulation of timber debris consisting of 6 inch in diameter or smaller branches was observed around the entire Pier 1 shaft from channel bottom up 2 feet and up to 3 feet off the pier faces and noses.

- (A) Remove accumulations of timber debris at both piers and from within the channel to alleviate further accumulation, scour influence, and any excessive lateral force on the piers.

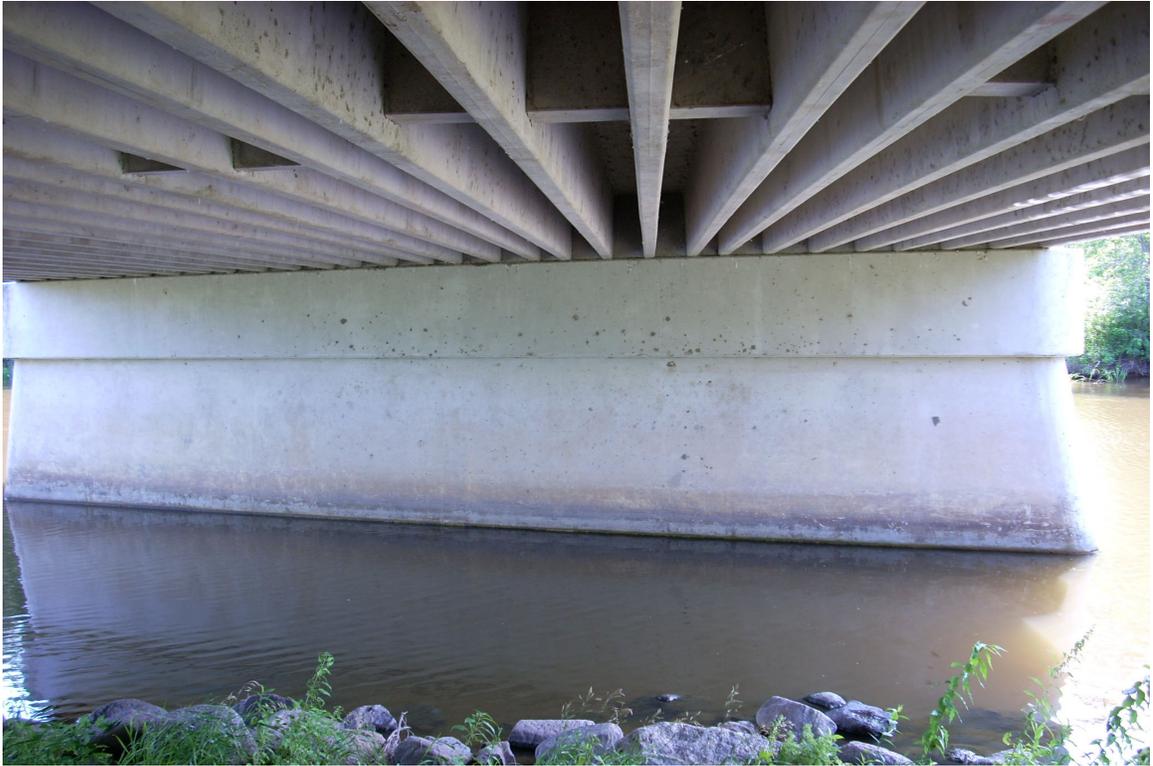
Photograph 3. View of Pier 2, Looking South.

- 4 A light accumulation of timber debris consisting of 12 inches in diameter or smaller logs and branches was observed from the upstream 1/4 point on north face around the upstream nose to the upstream 1/4 point on the south face of Pier 2. The debris extended from channel bottom up 4 feet and up to 2 feet off pier faces and 6 feet off pier nose.

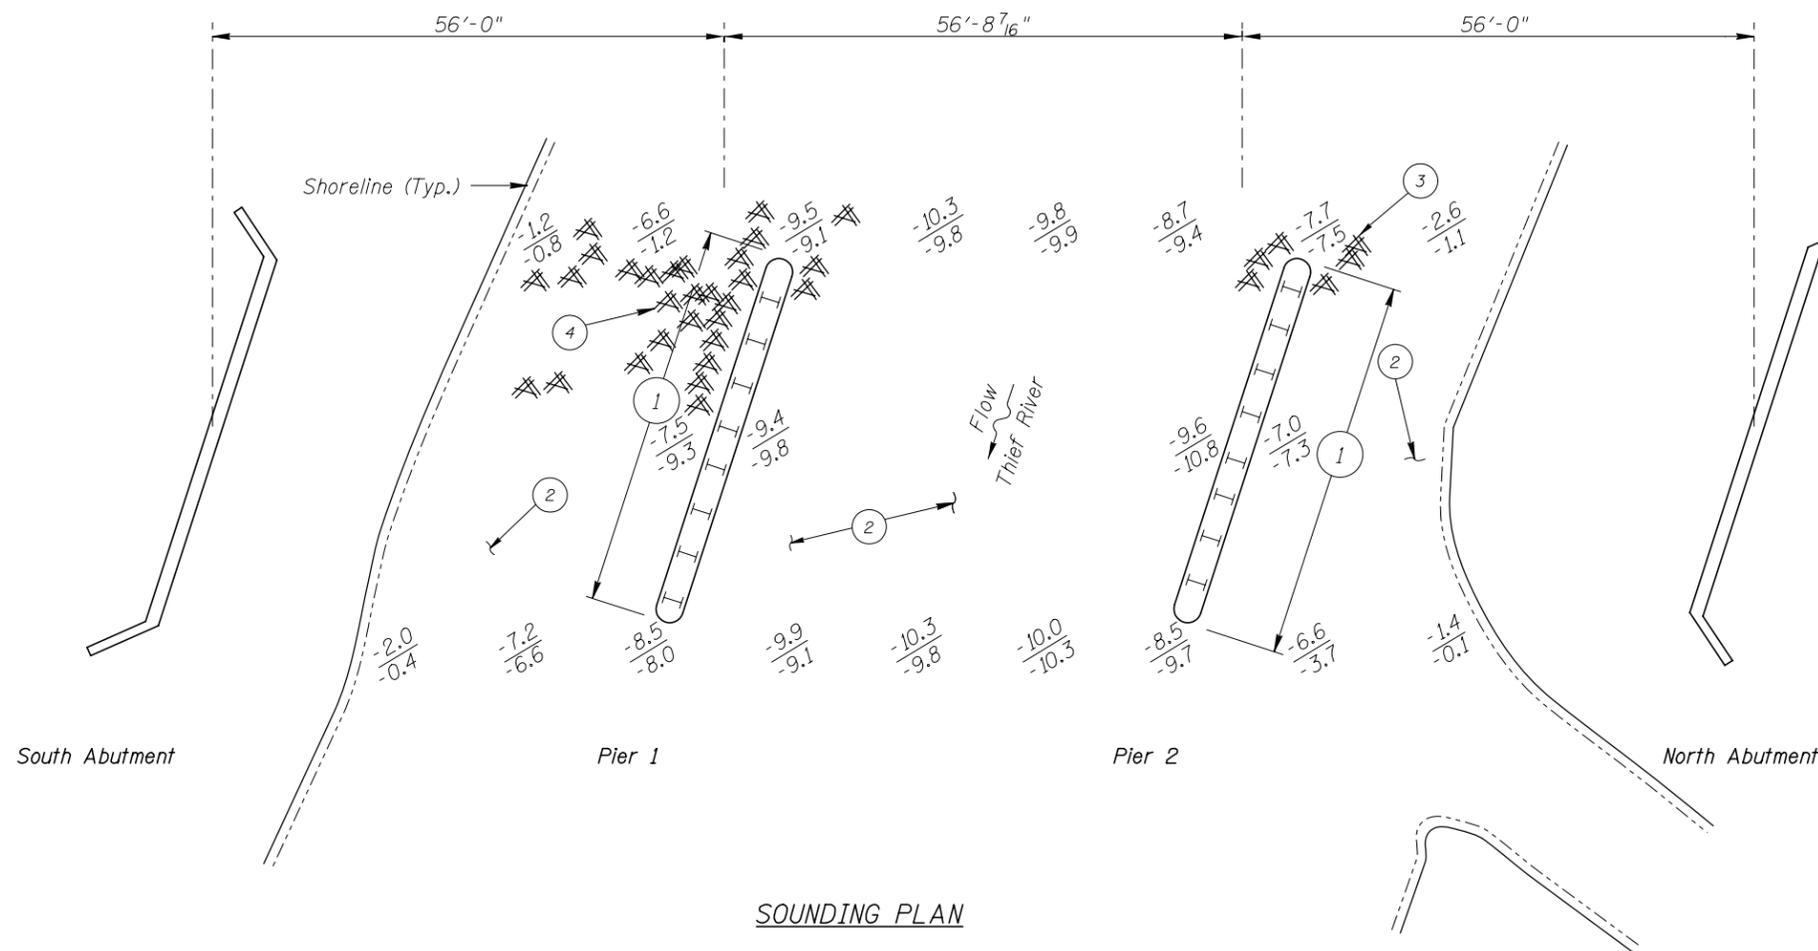
INSPECTION AND SOUNDING PLAN

- 1 Overall, the concrete of piers was smooth and sound. Minor areas of impact damage were observed on the upstream nose of Pier 1 from the waterline to 4 feet above waterline with up to 1/2 inch penetration.

- 2 The channel bottom around the entire perimeter of Pier 1 and 2 consisted of 1 to 6 inches of soft silt over firm gravel, cobbles and scattered riprap.
