UNDERWATER BRIDGE INSPECTION REPORT

STRUCTURE NO. 57517

THIEF RIVER

MINNESOTA DEPARTMENT OF TRANSPORTATION
UNDERWATER BRIDGE INSPECTION

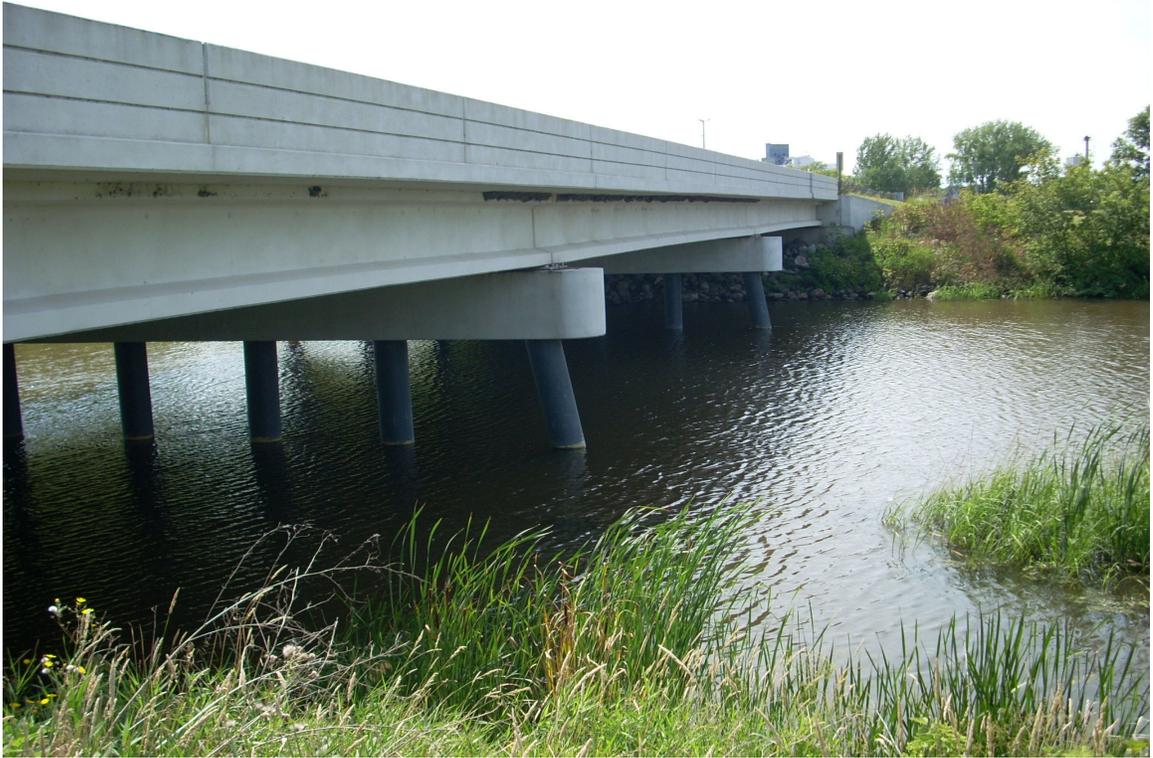
Photograph 1. Overall View of the Structure, Looking South.

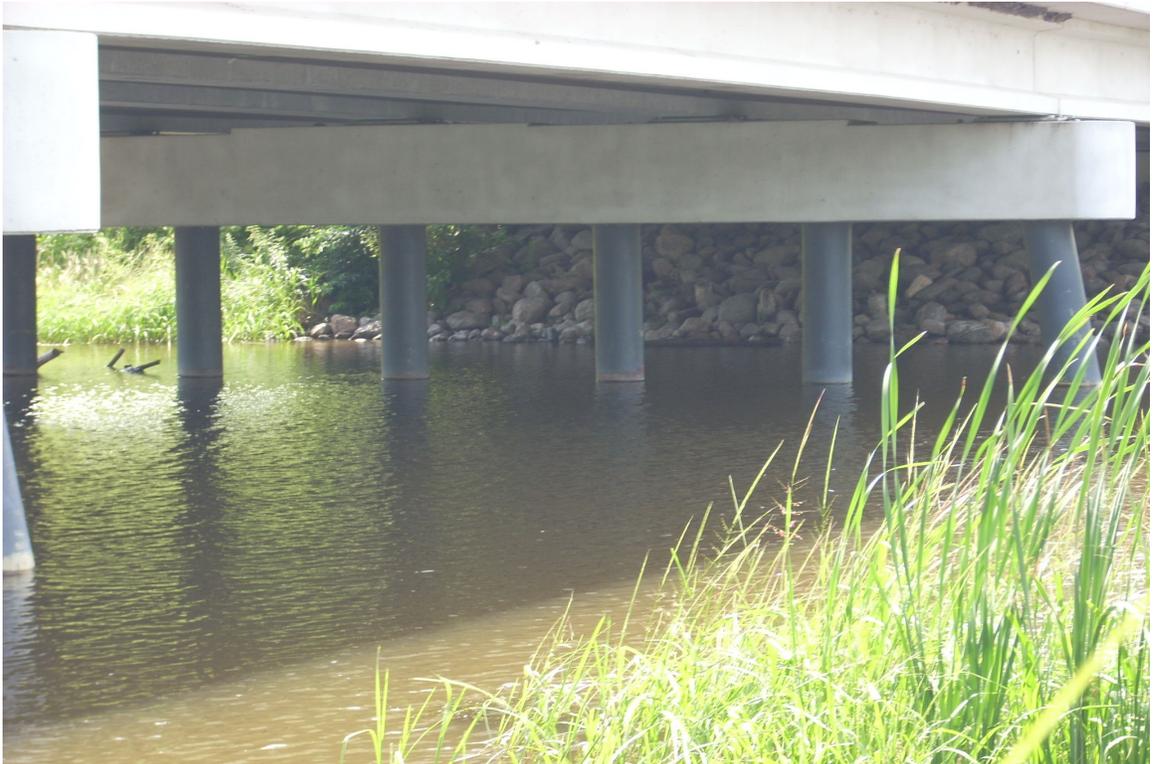
- (D) A moderate accumulation of timber debris consisting of 1 foot diameter and smaller branches was observed along both sides and in between all piles at Pier 1.

Photograph 2. View of Pier 1, Looking Southeast.

- (A) Monitor the timber debris, and if found to be increasing in the future, removal operations may become warranted.

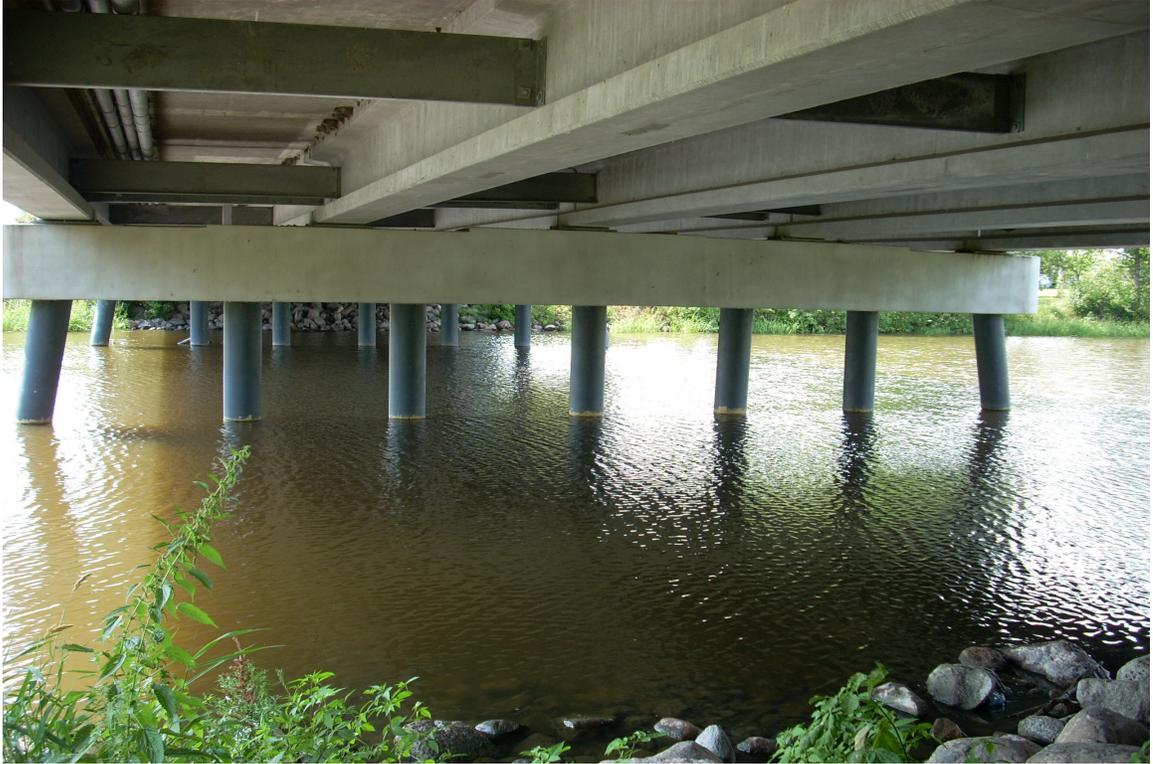
- (C) A light accumulation of timber debris consisting of 3 inch diameter and smaller branches was observed along both sides and in between all piles at Pier 2.

Photograph 3. View of Pier 2, Looking South.
