UNDERWATER BRIDGE INSPECTION REPORT

STRUCTURE NO. 57521

CR 27 OVER THE

RED LAKE RIVER

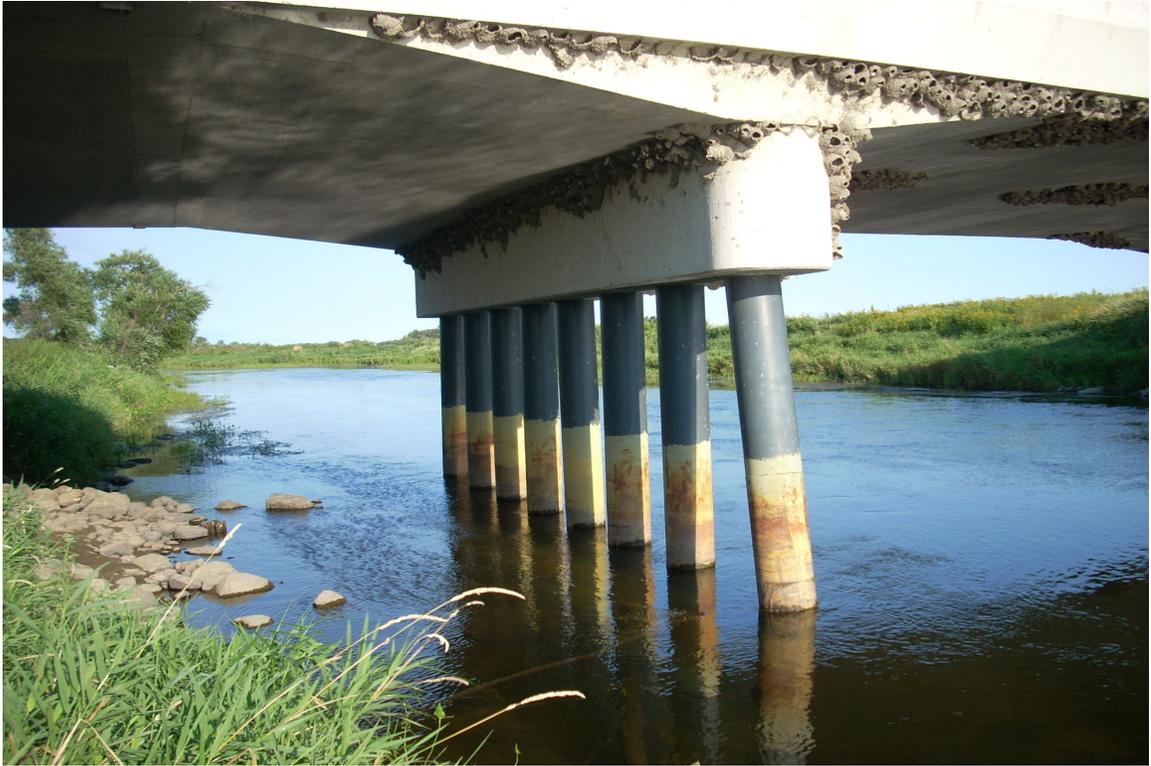
Photograph 1. View of Pier 1, Looking Northwest.

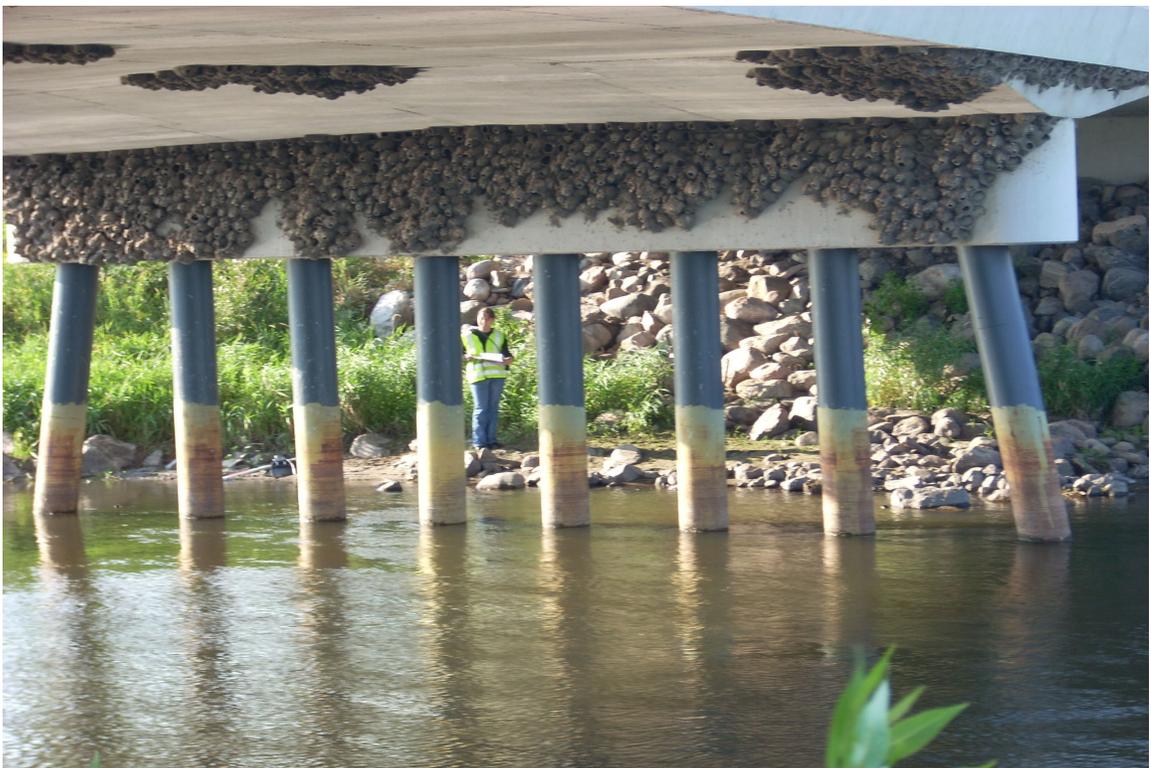
- (B) A minor accumulation of timber debris consisting of logs and branches up to 6 inches in diameter and a steel I-beam were observed extending from south shoreline to easternmost pile of Pier 1. The debris accumulation extended from the channel bottom to the waterline and was approximately 10 feet long (N/S) by 5 feet wide (E/W).

Photograph 2. View of Pier 1 and South Abutment, Looking Southeast.

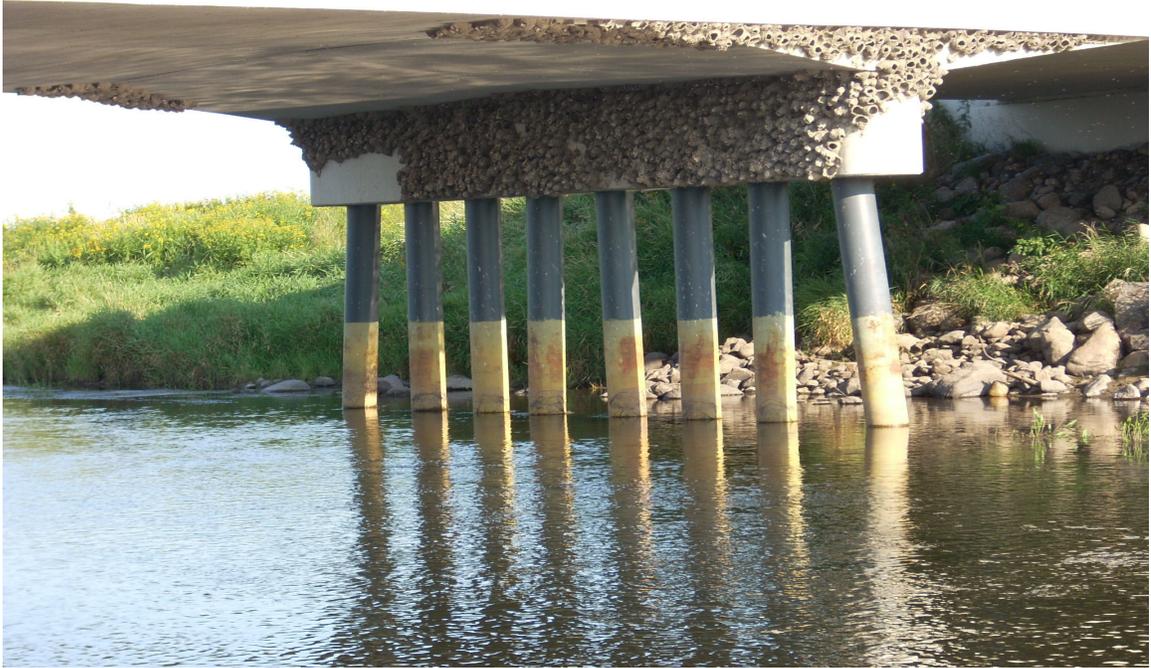
Photograph 3. View of Pier 2, Looking Northwest.

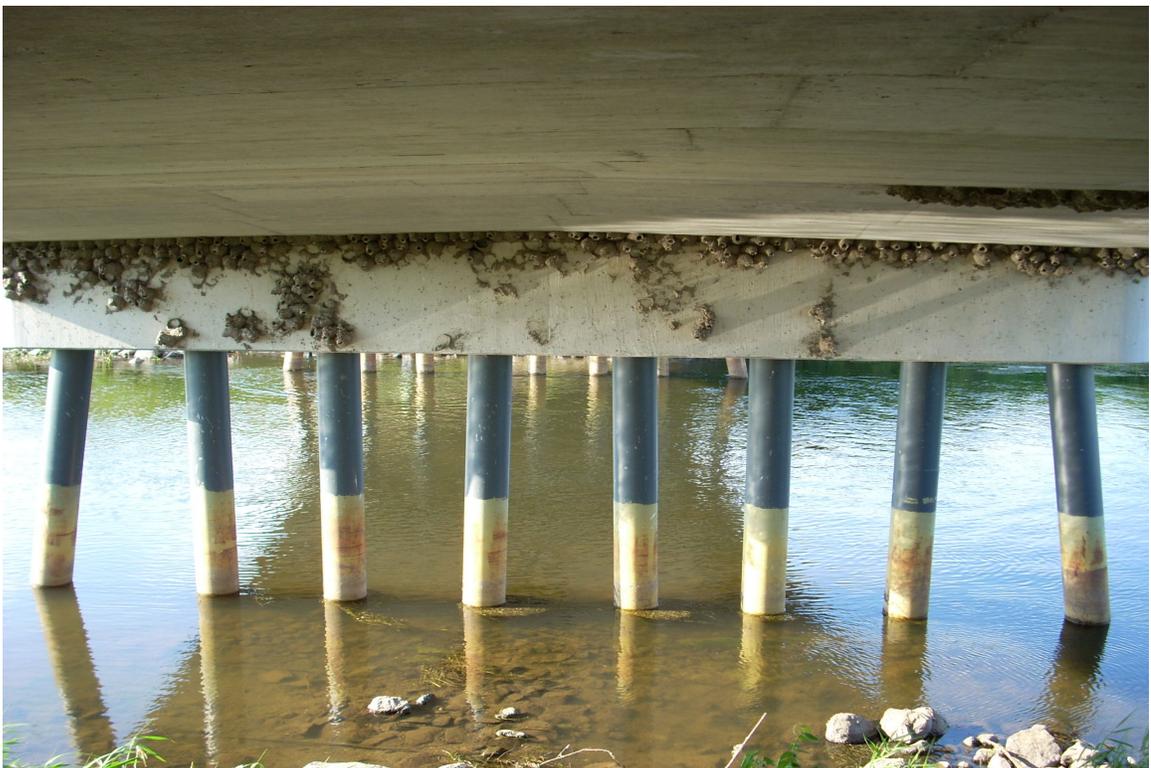
Photograph 4. View of Pier 2, Looking South.

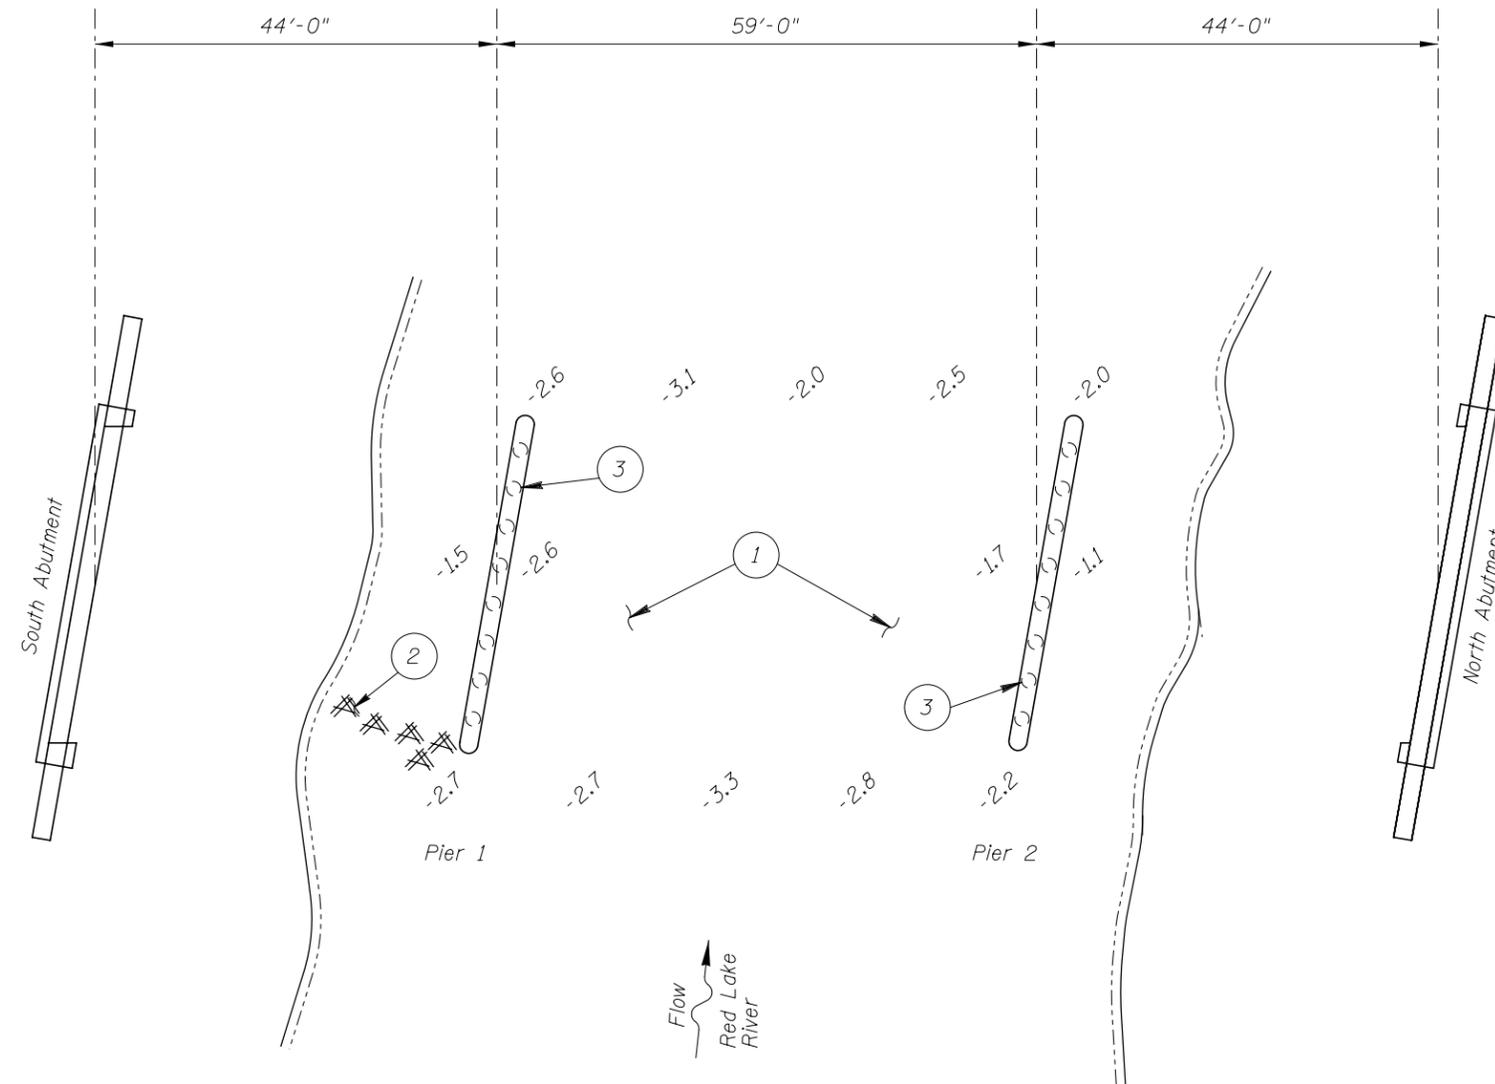
SOUNDING PLAN

- ① The channel bottom consisted of sand, gravel, cobbles up to 6 inches in size, and riprap up to 2 feet in diameter with up to 3 inches probe rod penetration.
- ② A minor accumulation of timber debris consisting of 6-inch-diameter and smaller logs and branches and a steel I-beam were observed extending from the shoreline to the upstream pile of Pier 1 and from the channel bottom to the waterline.
- ③ The steel pipe pile encasements exhibited random minor areas of coating failure from the top of the piles down 5 feet. The piles were uncoated (primer only) from 5 feet below the top of the pile to the channel bottom, with minor surface corrosion observed on over 75 % of the surface area with up to 1/4-inch-diameter rust nodules and minor pitting up to 1/32 inch deep.
