UNDERWATER BRIDGE INSPECTION REPORT

STRUCTURE NO. 5767

RED RIVER OF THE NORTH

MINNESOTA DEPARTMENT OF TRANSPORTATION
UNDERWATER BRIDGE INSPECTION

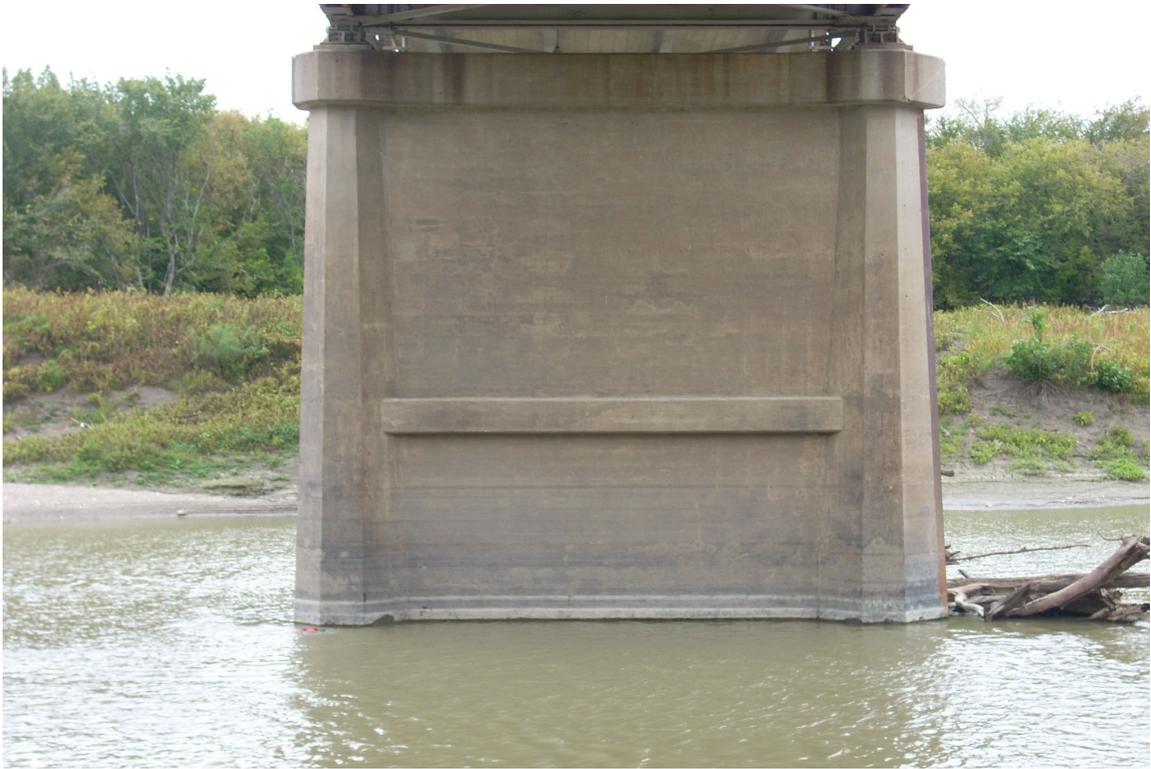
Photograph 1. View of the Pier 1, Looking East.

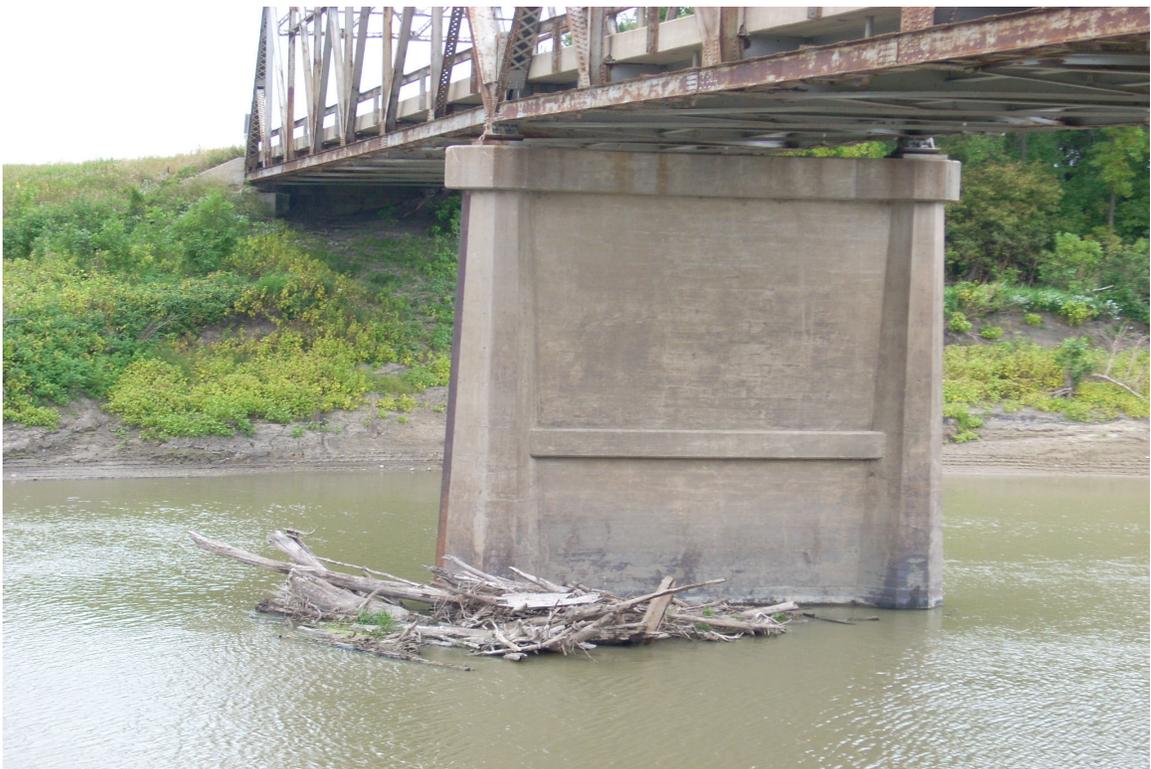
Photograph 2. View of Pier 1, Looking Northwest.

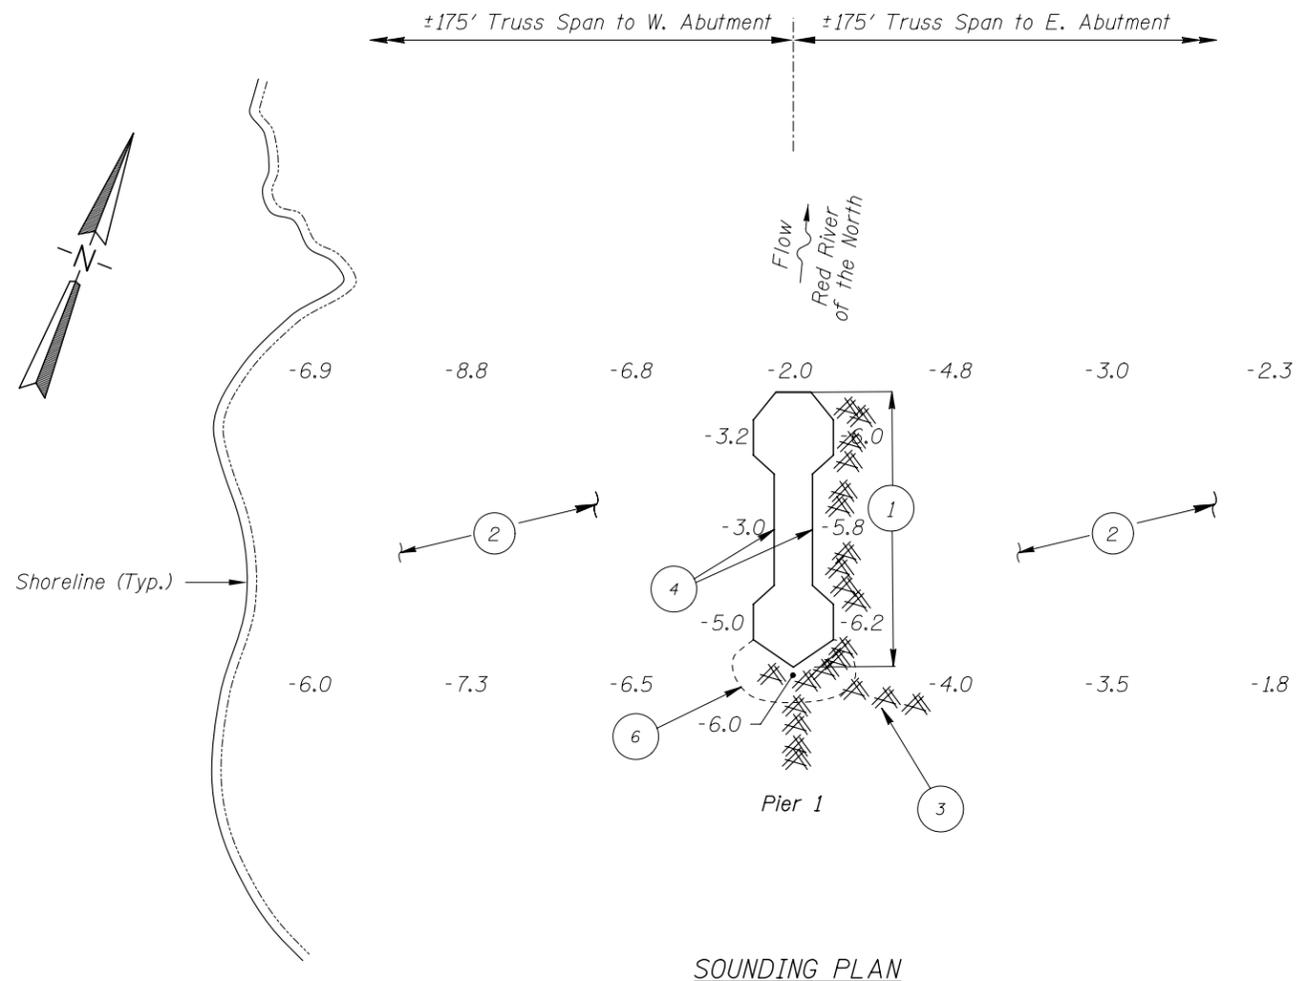
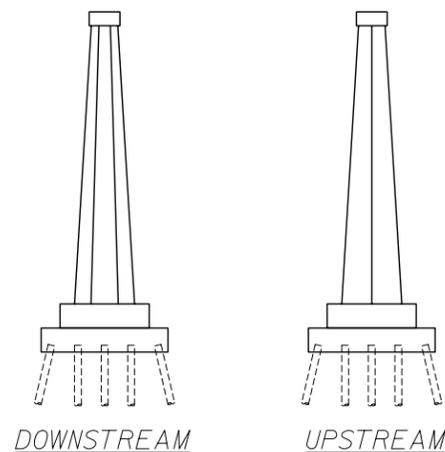
- ① Overall, concrete was smooth and sound with no significant defects.
- ② The channel bottom consisted of sandy silt.
- ③ Timber debris consisting of logs and branches 3 feet in diameter and smaller was observed at the south end of Pier 1. The debris extended from channel bottom up 3 feet 6 feet off the upstream nose towards east. On east face, debris extended above water from upstream nose to midpoint, and from midpoint to downstream nose, it was present from waterline to channel bottom.
- ④ Vertical crack up to 1/8 inch wide was located on both faces of Pier 1 at midpoint extending from strut to channel bottom.
- ⑤ Light scaling was observed at waterline along the entire perimeter of Pier 1 with 1/8 inch of maximum penetration.
- ⑥ A scour depression 1 foot deep by 4 foot radius was observed at upstream column of Pier 1 underneath the debris.

- (A) Monitor the timber debris accumulation, and if found to be increasing in the future, removal operations may become warranted.
