UNDERWATER BRIDGE INSPECTION REPORT

STRUCTURE NO. 5816
CSAH NO. 3
OVER THE
RED RIVER OF THE NORTH
DISTRICT 2 - NORMAN COUNTY

PREPARED FOR THE
MINNESOTA DEPARTMENT OF TRANSPORTATION
BY
COLLINS ENGINEERS, INC.
JOB NO. 5221 (CEI 41)

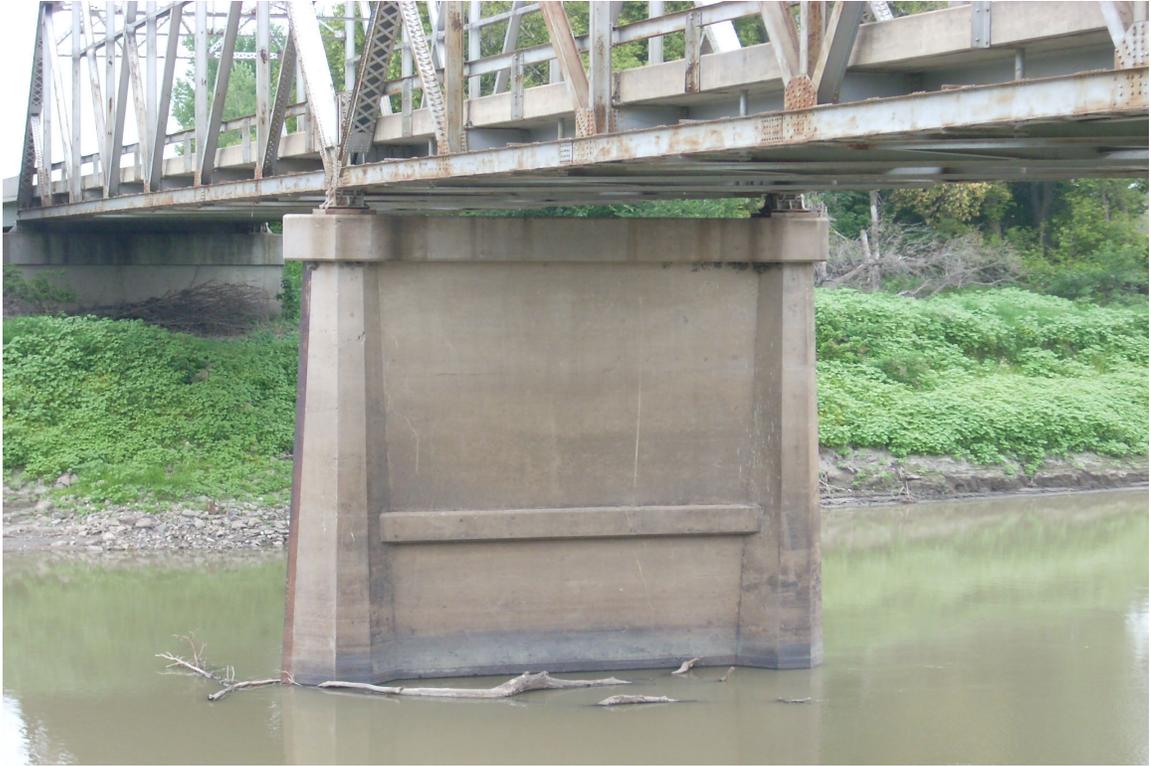
Photograph 3. View of Pier 2, Looking Northwest.

- 3 Light scaling was observed at both noses of Pier 2 from 2 feet above the waterline to 0.5 feet below the waterline with a maximum penetration of 1/8 inch.

- 4 A crack up to 1/16 inch wide was observed at the midpoint of Pier 2 on both sides, extending from the top of the cap to the channel bottom.
- 5 Formed openings, measuring 8 inches wide by 8 inches high, were observed along both faces of Pier 2 at 6 feet below the waterline at 1/4 point intervals along the shaft.

- 6 A moderate accumulation of timber debris, consisting of logs and branches up to 18 inches in diameter, was observed from channel bottom to the waterline at the upstream nose and out from both pier faces. The debris extended up to 8 feet off the faces and nose.

Monitor the timber debris, and if found to be increasing in the future, removal operations may become warranted.

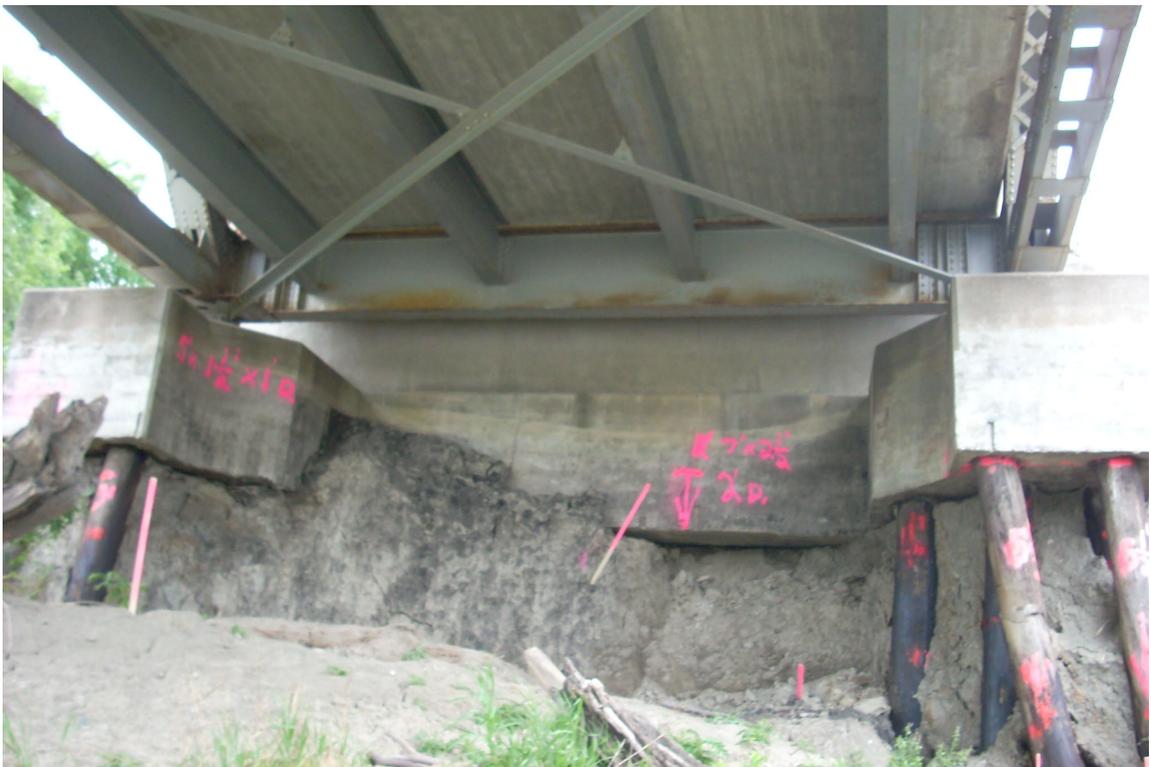
Photograph 4. View of the Bank Erosion and Undermining at the East Abutment, Looking East.

- 7 The east bank exhibited heavy erosion at the East Abutment with undermining up to 8 feet high and exposed piling. One of the five exposed piles that support the abutment was broken (see Photo in report text).

Replace or structurally jacket broken East Abutment pile and repair erosion with properly sized/placed riprap bank protection.

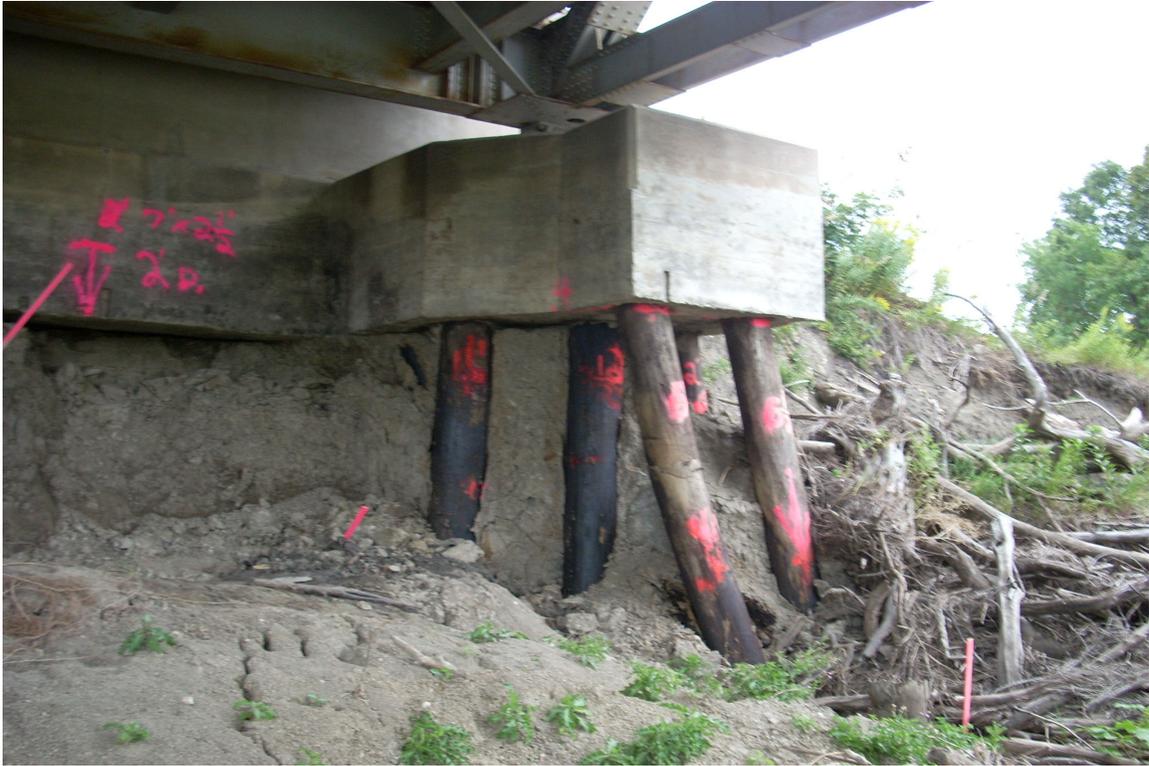
Photograph 5. View of the Undermining at the East Abutment, Looking Southeast. (Piles at upstream end)

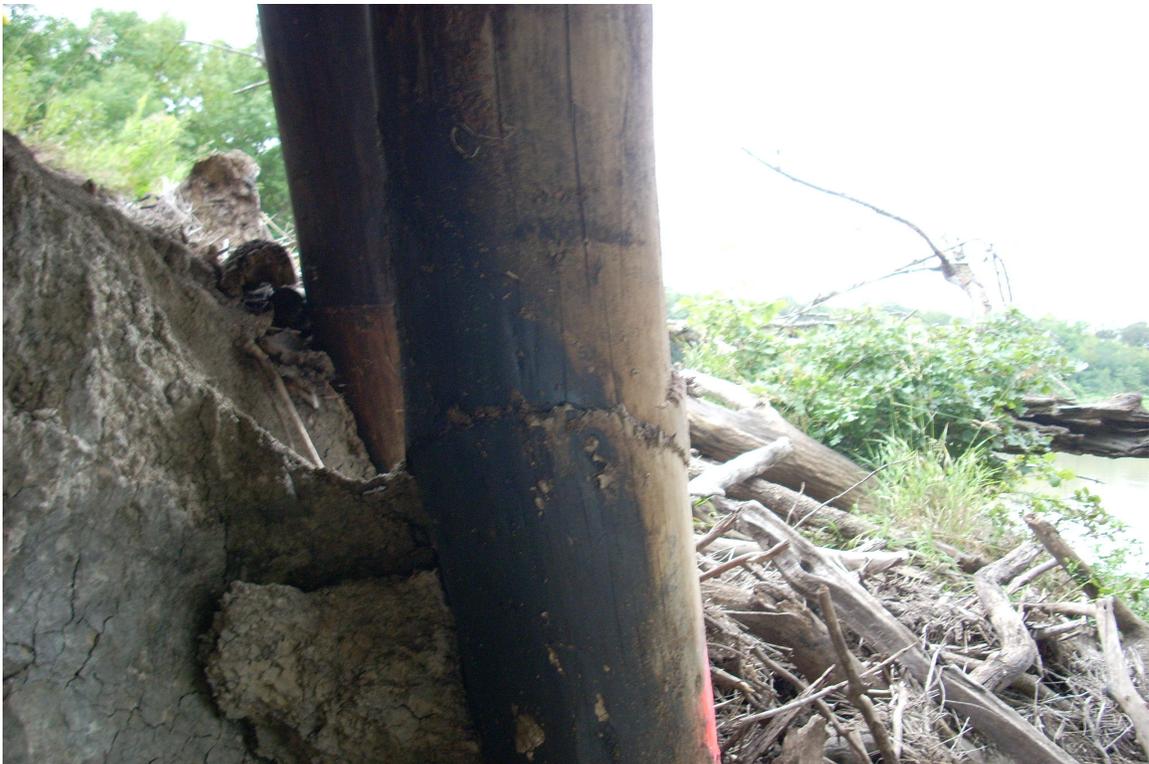
Photograph 6. View of the Undermining at the East Abutment, Looking South. (Broken pile at upstream end)

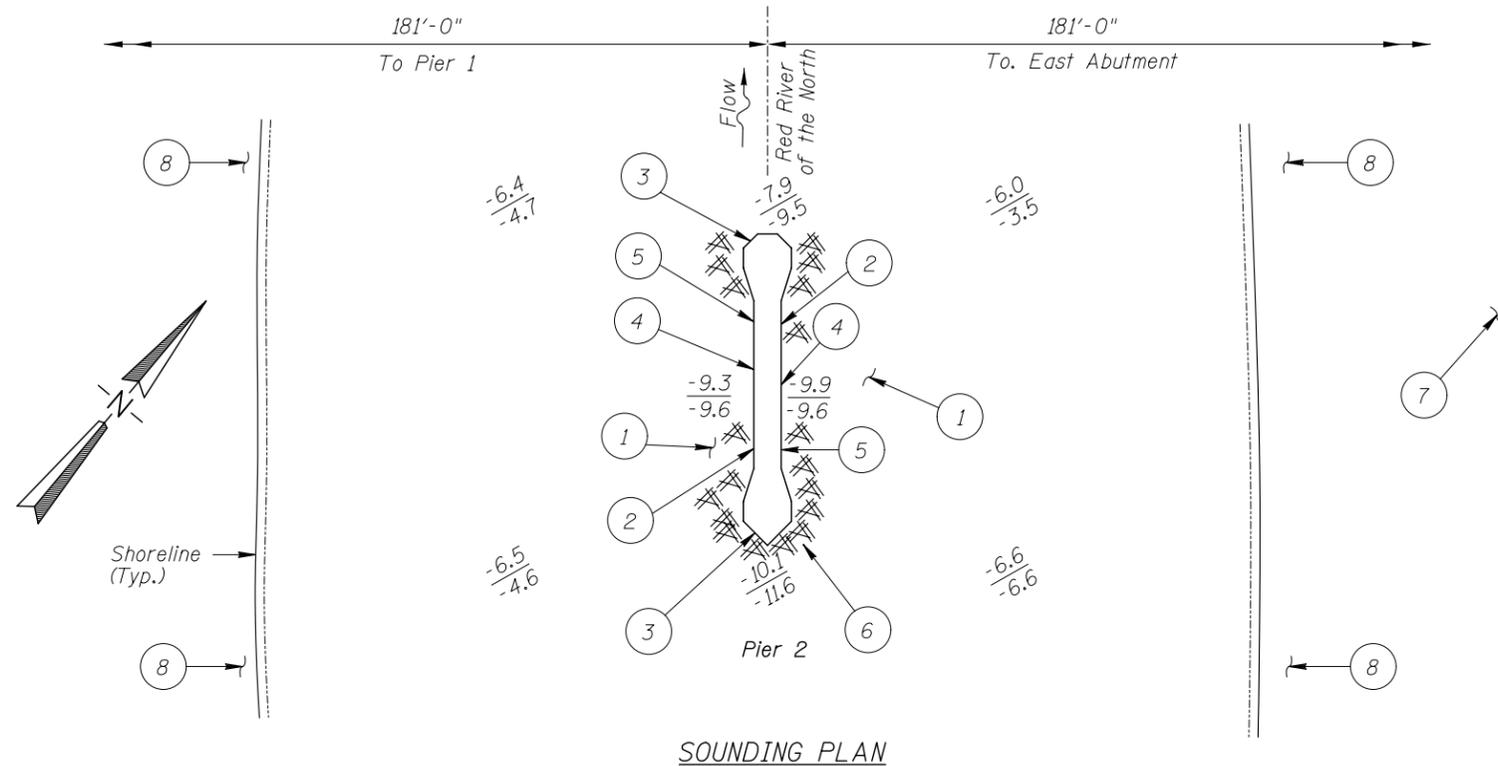
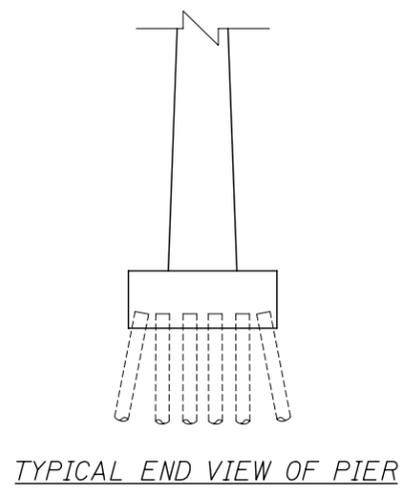
- 1 The channel bottom material around Pier 2 consisted of gravel with up to 2 inches of probe rod penetration.
- 2 In general, the concrete surfaces of Pier 2 above and below the water line were smooth and sound with random minor areas of poor consolidation with up to 1/4 inch penetration.

- 8 Heavy bank erosion was observed along the banks of the channel upstream and downstream of the bridge with steeply cut banks up to 20 feet high.
