UNDERWATER BRIDGE INSPECTION REPORT

STRUCTURE NO. 5824

CLEARWATER RIVER

DISTRICT 2 - RED LAKE COUNTY

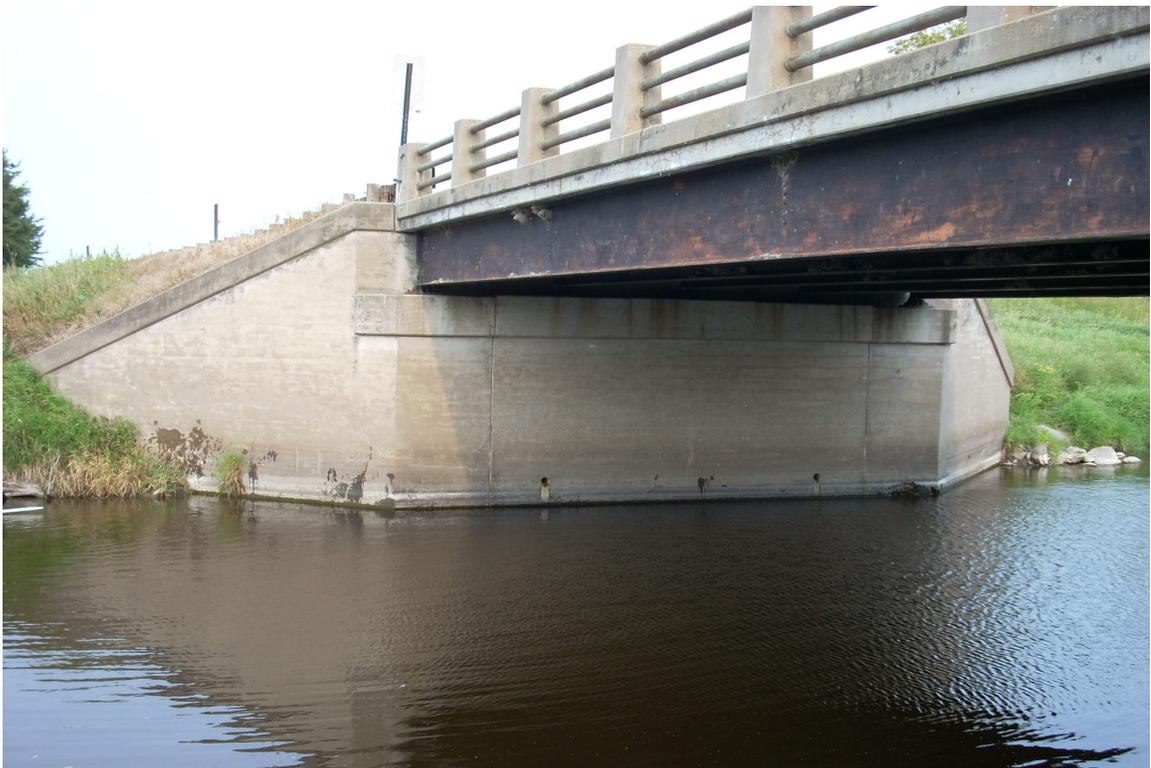
- (A) A void was observed 1 foot below the waterline with 2 inches of maximum penetration located 2.5 feet north of the downstream end of the West Abutment. Spalling and poor consolidation with up to 6 inches of maximum penetration was observed 3 feet along the wingwall and 4 feet along the breastwall at the north end of the abutment, exposing lightly corroded steel reinforcing at the corner.

- (B) Random hairline map cracking was observed on the West Abutment wingwalls from 1 to 4 feet above the waterline.
- (C) A 6-inch-diameter void and area of poor consolidation was located at 1 foot above the waterline with 2 inches of penetration at the downstream end of the West Abutment.

- (D) Vertical cracking was observed on both abutments, extending from the top of seat down to 1 foot above the waterline on the East Abutment, and all the way down to the channel bottom on the West Abutment.

Photograph 2. View of West Abutment, Looking Northwest.

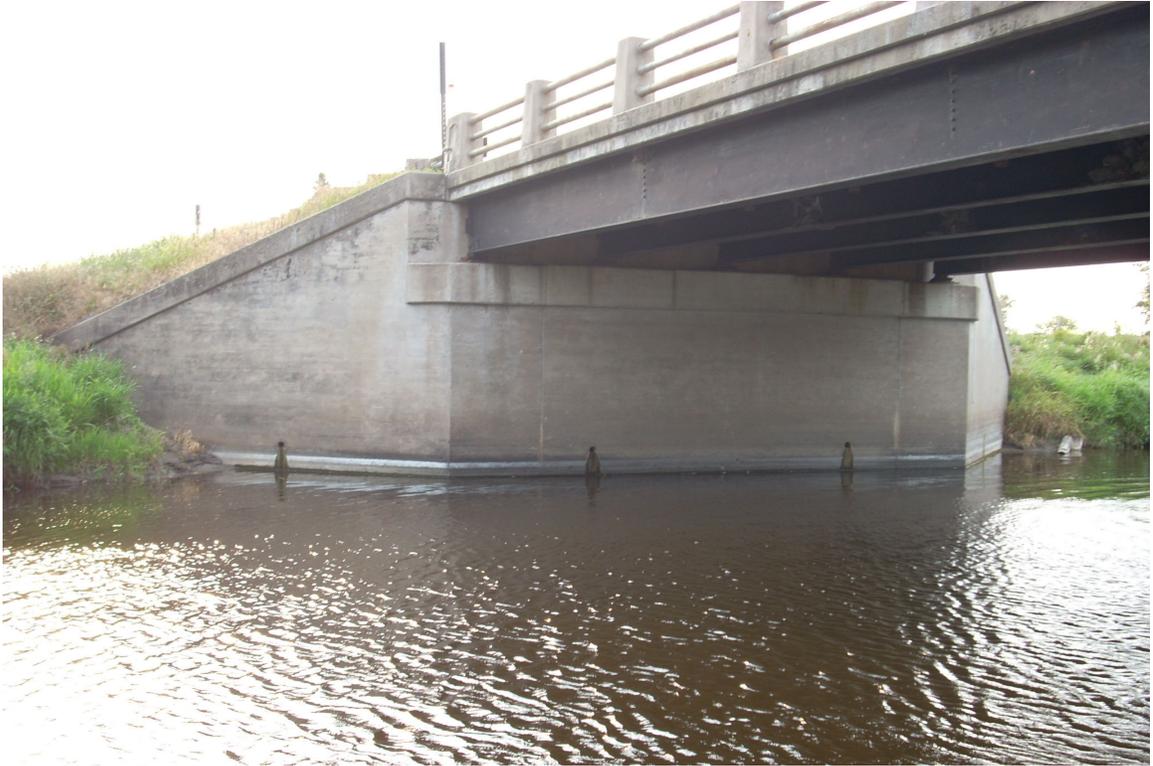
Photograph 3. View of East Abutment, Looking Northeast.

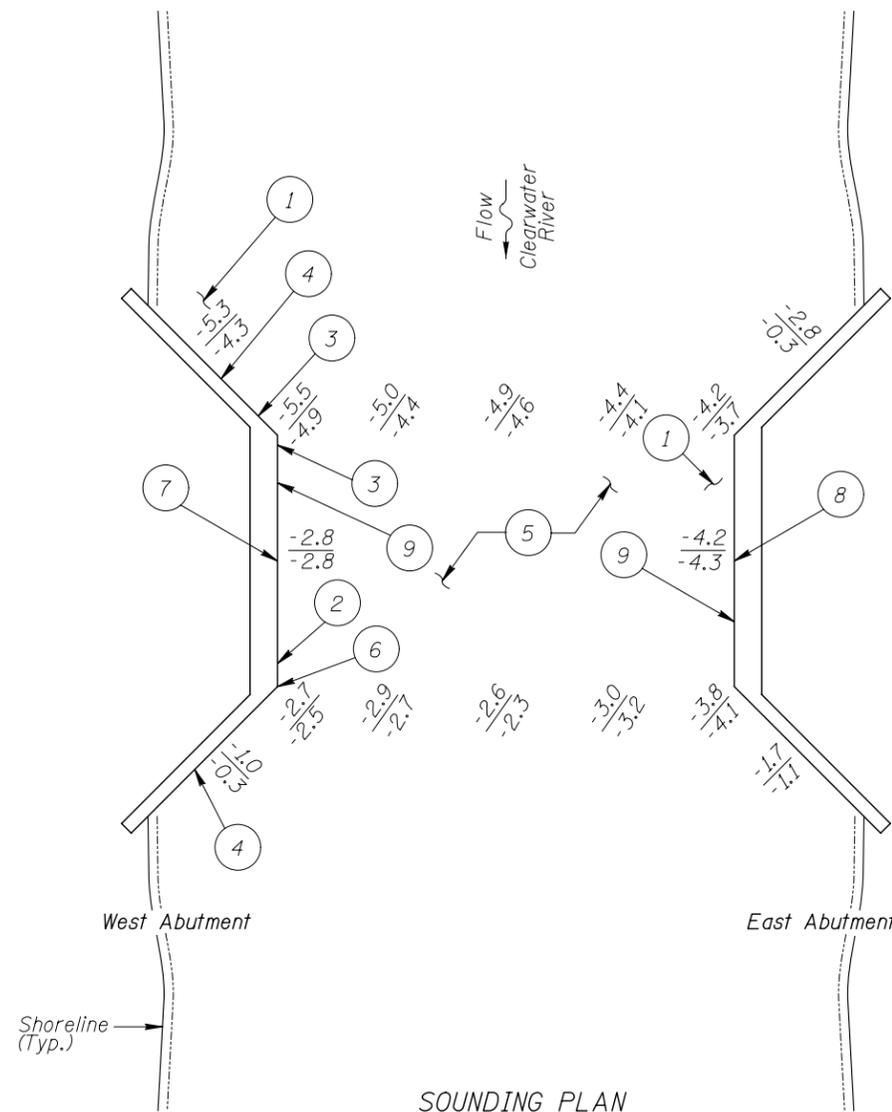
INSPECTION AND SOUNDING PLAN

1. The channel bottom material along both abutments consisted of silty sand with up to 1 foot of probe rod penetration.
2. 1-foot-diameter void at 0.5 feet below the waterline with 2 inches of maximum penetration was located 2.5 feet north of the downstream end of the West Abutment.

3. 3 feet along the wingwall and 4 feet along the breastwall, spalling and poor consolidation was observed from 1 foot above the waterline to 3 feet below the waterline with 6 inches of maximum penetration and lightly corroded exposed steel reinforcing with no appreciable loss of section at the north end of the West Abutment.

4. Random hairline map cracking was observed on the West Abutment wingwalls from 1 to 4 feet above the waterline.
5. The channel bottom in the center of the river consisted of up to 1-foot-diameter riprap.

6. 6-inch-diameter void and area of poor consolidation located at 1 foot above the waterline with 2 inches of penetration at the downstream end of the West Abutment.

7. Vertical crack starting at the top of the seat extending down to the channel bottom, 1/16 inch wide, was located at the midpoint of the West Abutment.

8. Vertical crack starting at the top of the seat extending down to 1 foot above the waterline, 1/16 inch wide, was located at the midpoint of the east abutment.

9. Overall the concrete was smooth and sound.

- (A) Although the channel bottom appears to have remained stable since the last inspection, according to Item 113, the bridge is rated as scour critical, and therefore, it is recommended that the channel bottom be closely monitored after major flood events and during future biennial and underwater inspections.
- (B) Reinspect the submerged substructure units at the normal maximum recommended (NBIS) interval of five (5) years.
