UNDERWATER BRIDGE INSPECTION REPORT

STRUCTURE NO. 5871

RED RIVER OF THE NORTH

MINNESOTA DEPARTMENT OF TRANSPORTATION
UNDERWATER BRIDGE INSPECTION

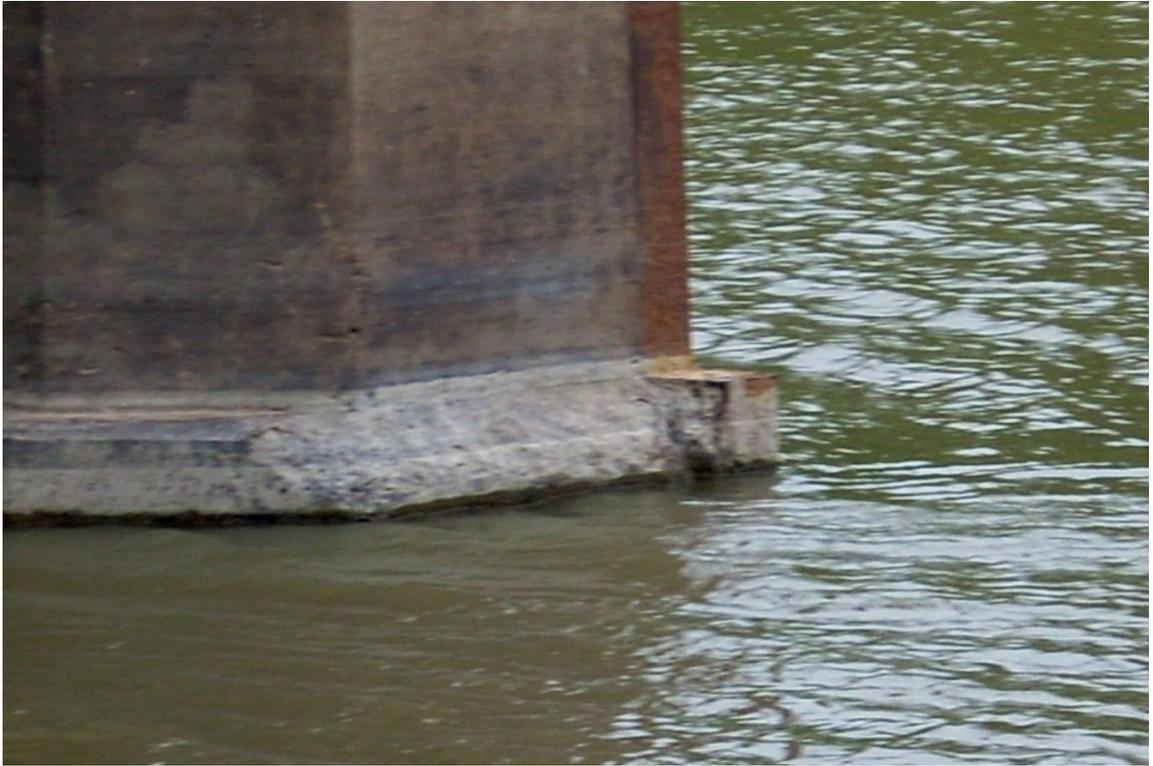
- (A) Light scaling was observed extending from 1 foot above the waterline to 1 foot below the waterline, with 1/8 inch maximum penetration.
- (B) Section loss was observed at ledge in shaft along the south end at 1 foot above the waterline, with 6 inches of maximum penetration.
- (C) Moderate accumulation of timber debris, consisting of logs and branches 2 feet in diameter and smaller, was observed around the entire perimeter of Pier 1 extending from the channel bottom to between 4 and 8 feet above the channel bottom and off the pier faces and noses by up to 6 feet.

Photograph 3. View of the south end of Pier 1, Looking East.

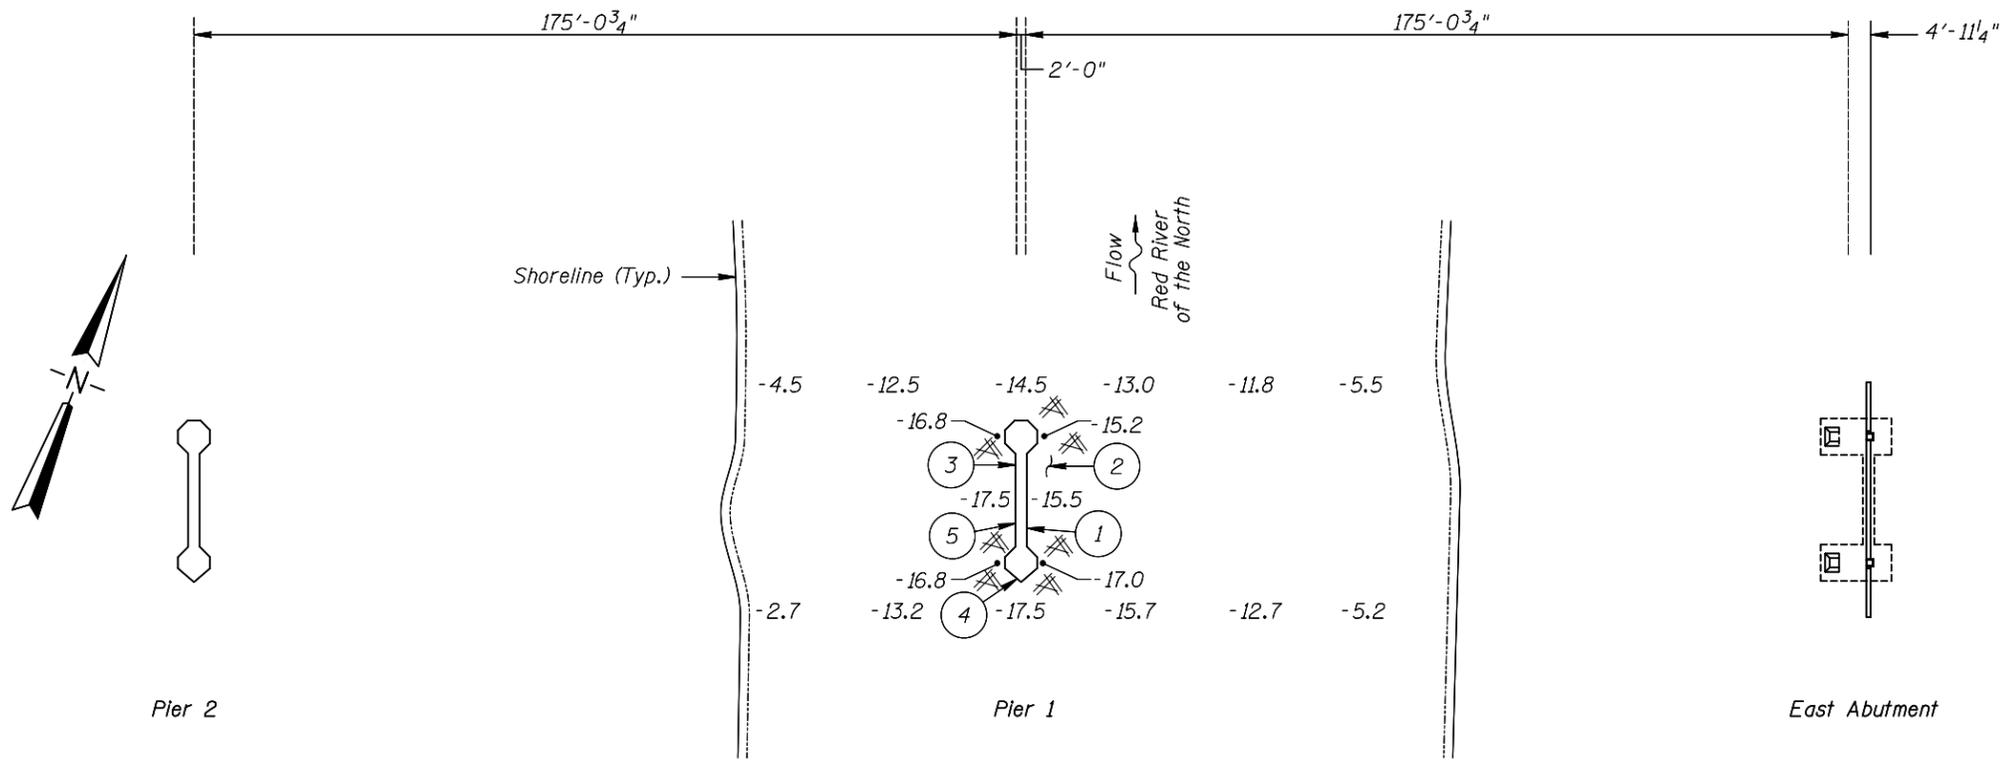
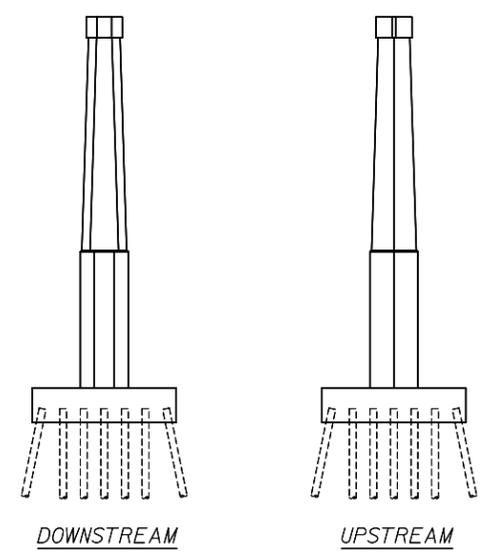
TYPICAL END VIEWS OF PIER 1

- INSPECTION NOTES:**
- 1 Overall, concrete was smooth and sound with no significant defects.
 - 2 The channel bottom consisted of soft silt, sand and gravel with 2 feet maximum probe rod penetration.
 - 3 Light scaling around pier shaft extending 1 foot above waterline to 1 foot below waterline, 1/8 inch maximum penetration.
 - 4 Section loss at ledge at south end at 1 foot above waterline with 6 inches maximum penetration.
 - 5 Moderate timber debris consisting of logs and branches 2 feet in diameter and smaller was observed around the entire perimeter of Pier 1. The debris extended 4 to 8 feet above the channel bottom and 5 to 6 feet off the faces and noses of the pier.
