UNDERWATER BRIDGE INSPECTION REPORT

STRUCTURE NO. 6676

RED RIVER OF THE NORTH

MINNESOTA DEPARTMENT OF TRANSPORTATION
UNDERWATER BRIDGE INSPECTION

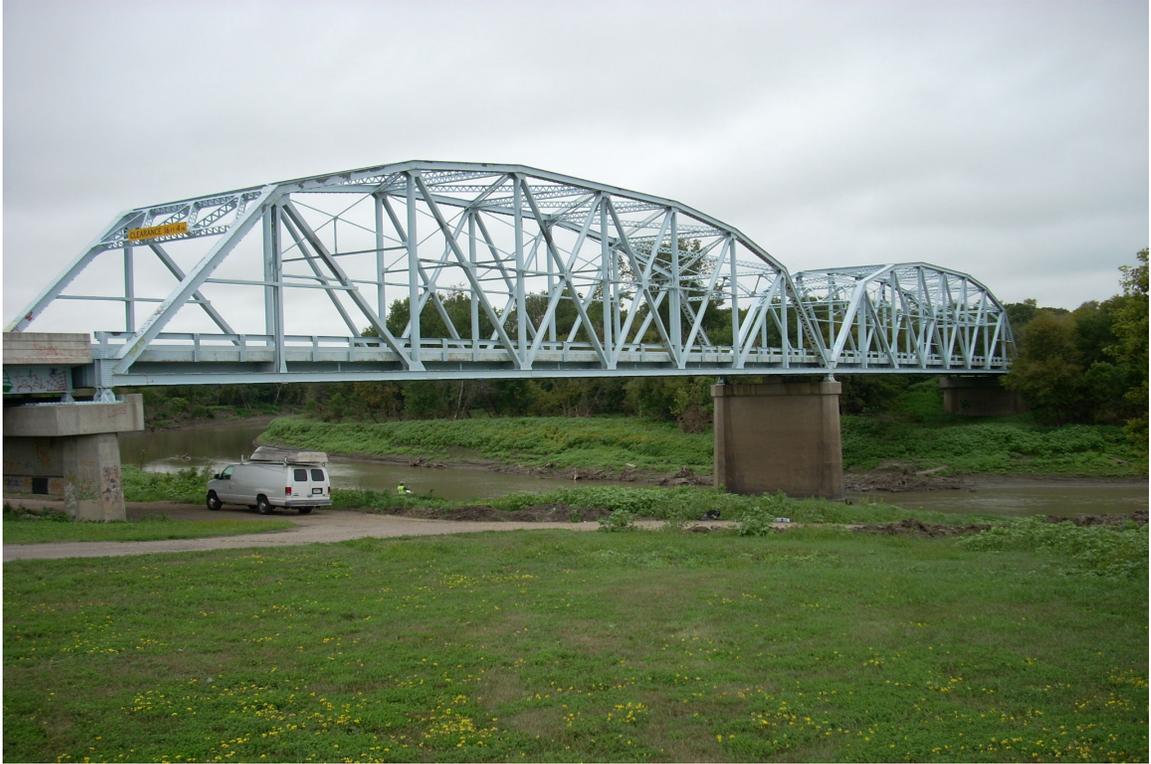
Photograph 1. Overall View of the Structure, Looking Southwest.

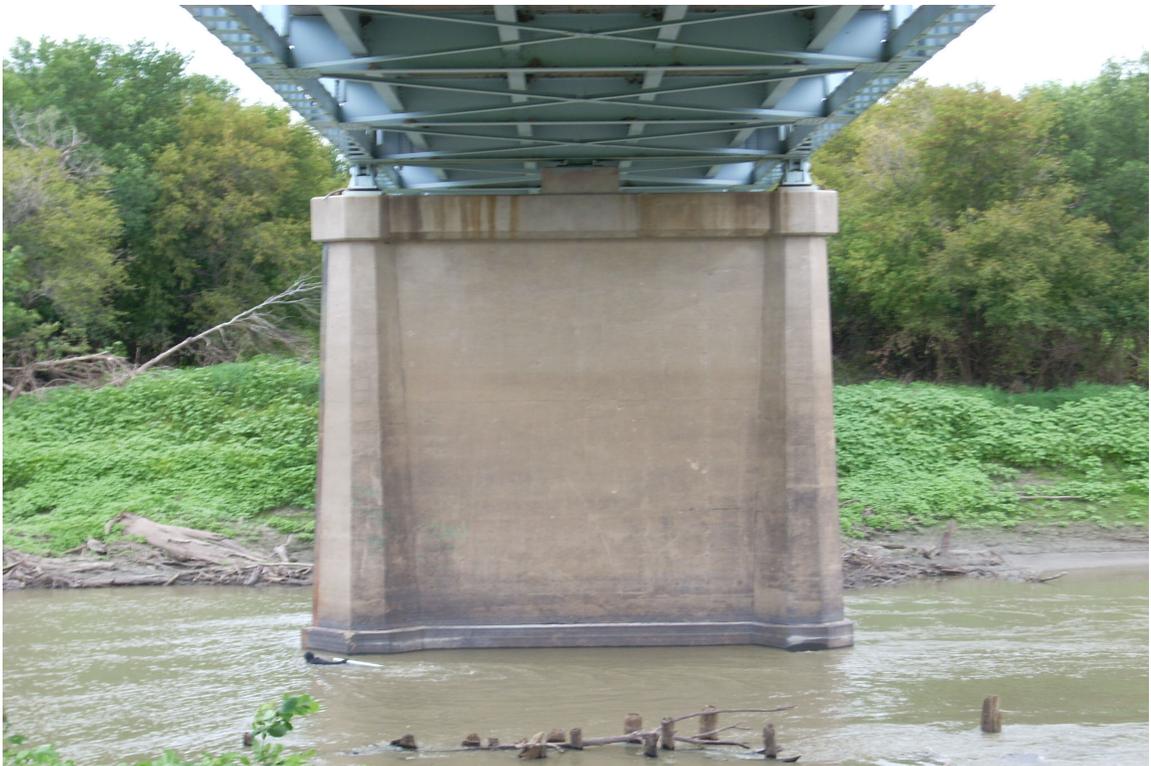
Photograph 2. View of Pier 2 and Abandoned Timber Piles along East Shore, Looking West.

- 6 Heavy bank erosion was located along the entire eastern shoreline in the vicinity of the bridge, exhibiting 10 foot vertical banks, loss of soil, and exposed tree roots.

- 7 Abandoned timber piles cut off at up to 3 feet above the waterline with scattered accumulated timber drift, with pieces up to 1.5 foot in diameter, hung up on and throughout piles.

- (A) Ideally, the moderate accumulation of timber debris located around Pier 2 and the abandoned timber piles should be removed. In addition, consideration could be given to removing or cutting down the abandoned piles to prevent future accumulations. Until removal operations are accomplished, future inspections should particularly monitor the drift accumulations.
- (B) Design plans with footing information for Pier 2 should be obtained, if possible, for the next underwater inspection.
- (C) Reinspect the submerged substructure unit at the normal maximum recommended (NBIS) interval of five (5) years.

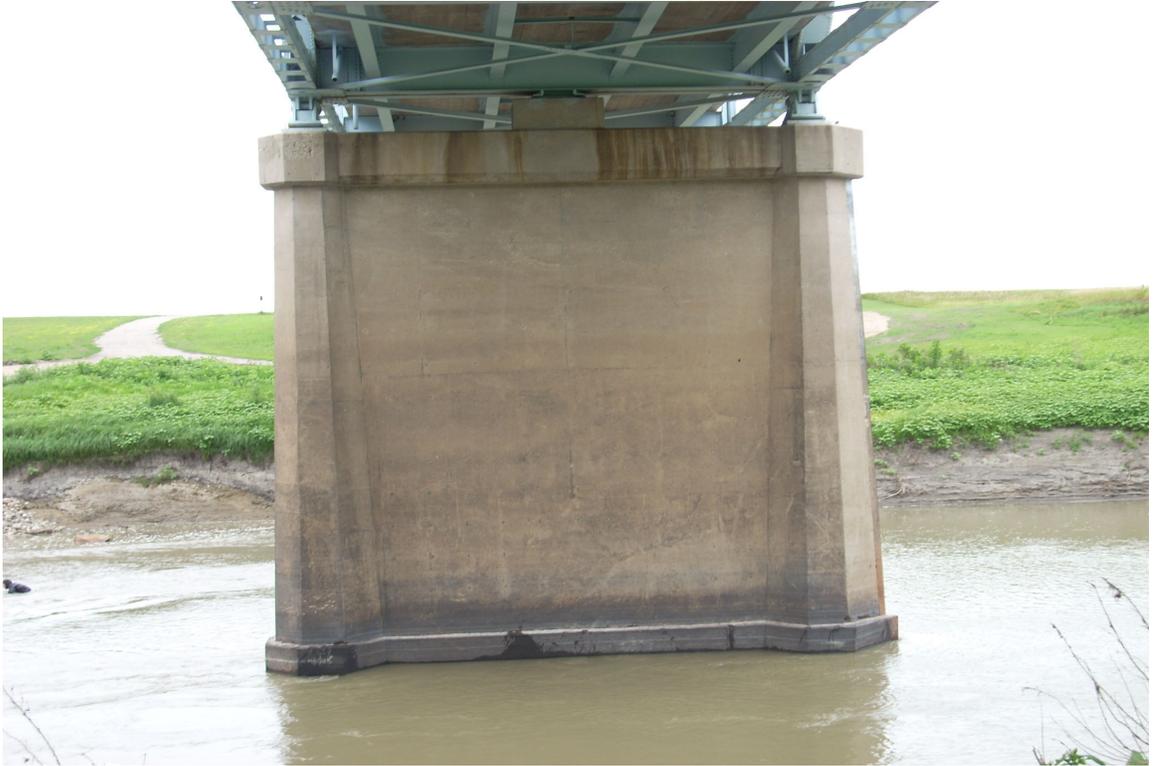
Photograph 3. View of Pier 2, Looking East.

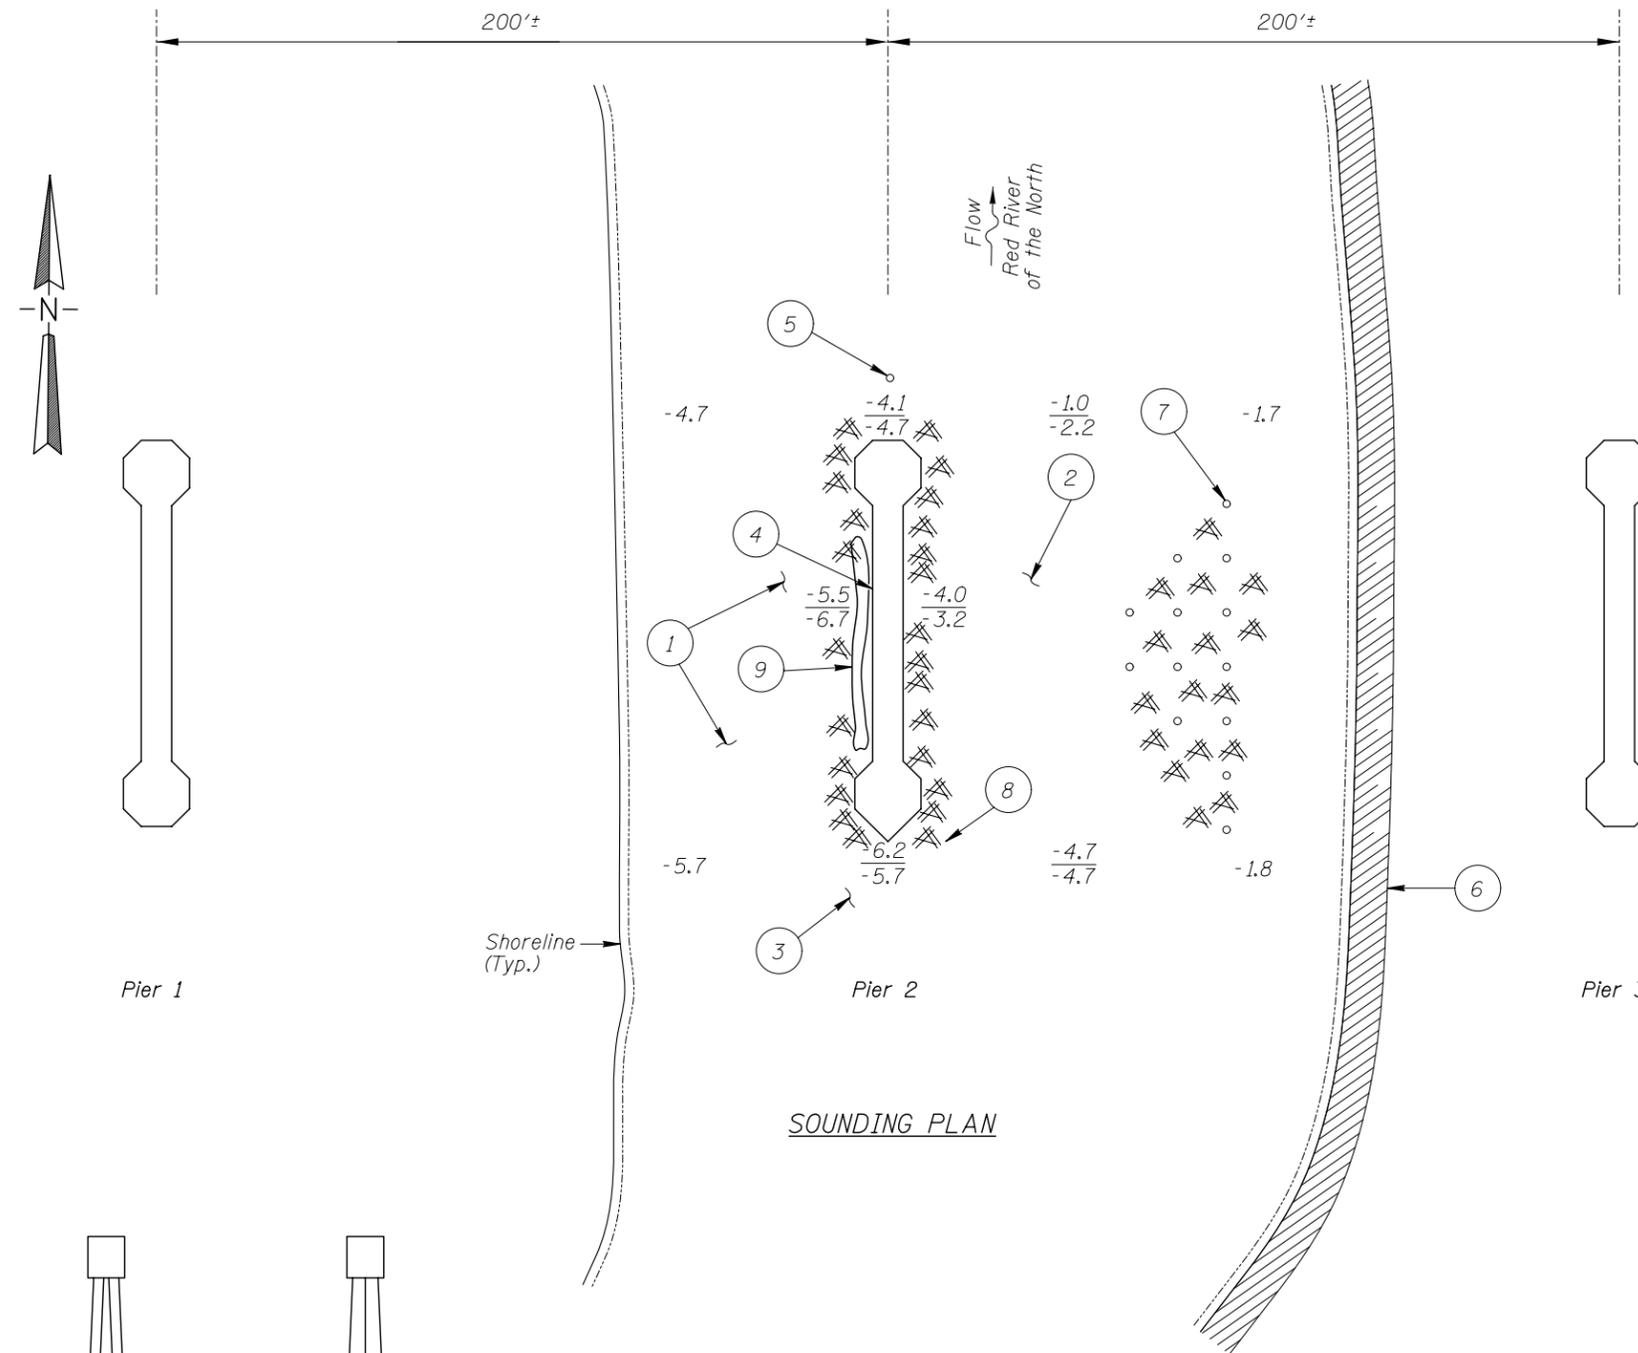
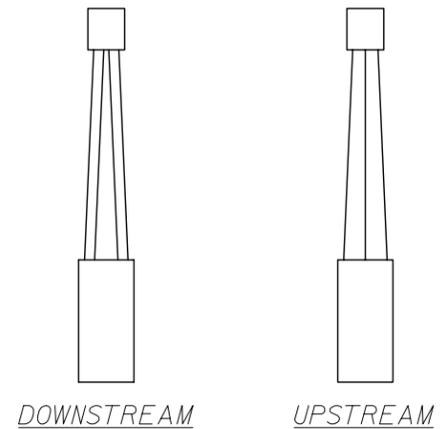
- 1 The channel bottom material along the west side of Pier 2 consisted of silt and gravel with up to 6 inches of maximum probe rod penetration.
- 2 The channel bottom material along the east side of Pier 2 consisted of clayey silt with up to 12 inches of maximum probe rod penetration.

- 3 The channel bottom material at the upstream nose of Pier 2 consisted of hard clay with 2 to 4 inches of maximum probe rod penetration.
- 4 The concrete surfaces of Pier 2 were smooth and sound. Random minor areas of poor consolidation and section loss with up to 1/2 inch maximum penetration and no exposed reinforcing steel were present.

- 5 An abandoned timber pile was observed 2 feet north of the downstream nose of Pier 2, extending from 2 feet below the waterline into the channel bottom.

- 8 A light accumulation of timber debris, consisting of 8 to 10 inch diameter branches, was observed around the entire perimeter of Pier 2 extending from channel bottom up 2 feet and off faces and noses by up to 3 feet.

- 9 A log, 1.5 feet in diameter, extended along the west face of the pier shaft on the channel bottom.

Ideally, both the moderate accumulation of timber debris located around Pier 2 and the abandoned timber piles should be removed. In addition, consideration could be given to removing or cutting down the abandoned piles to prevent future accumulations. Until removal operations are accomplished, future inspections should particularly monitor the drift accumulations.

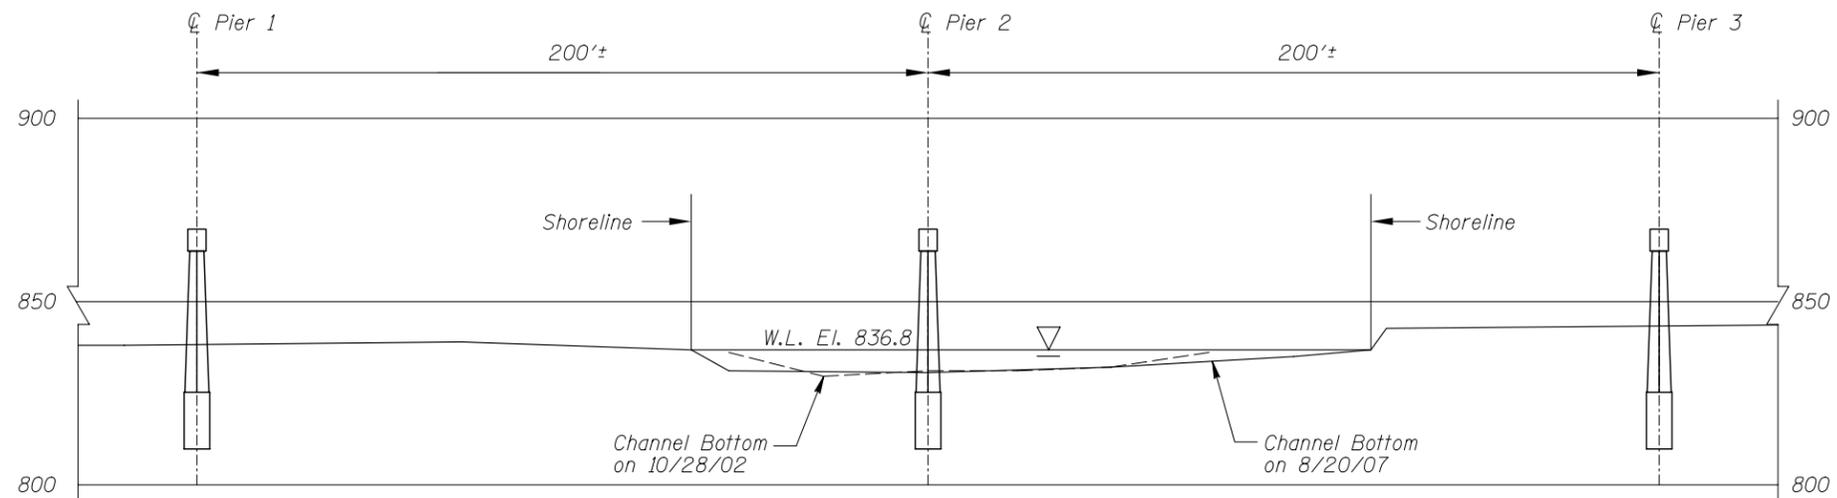
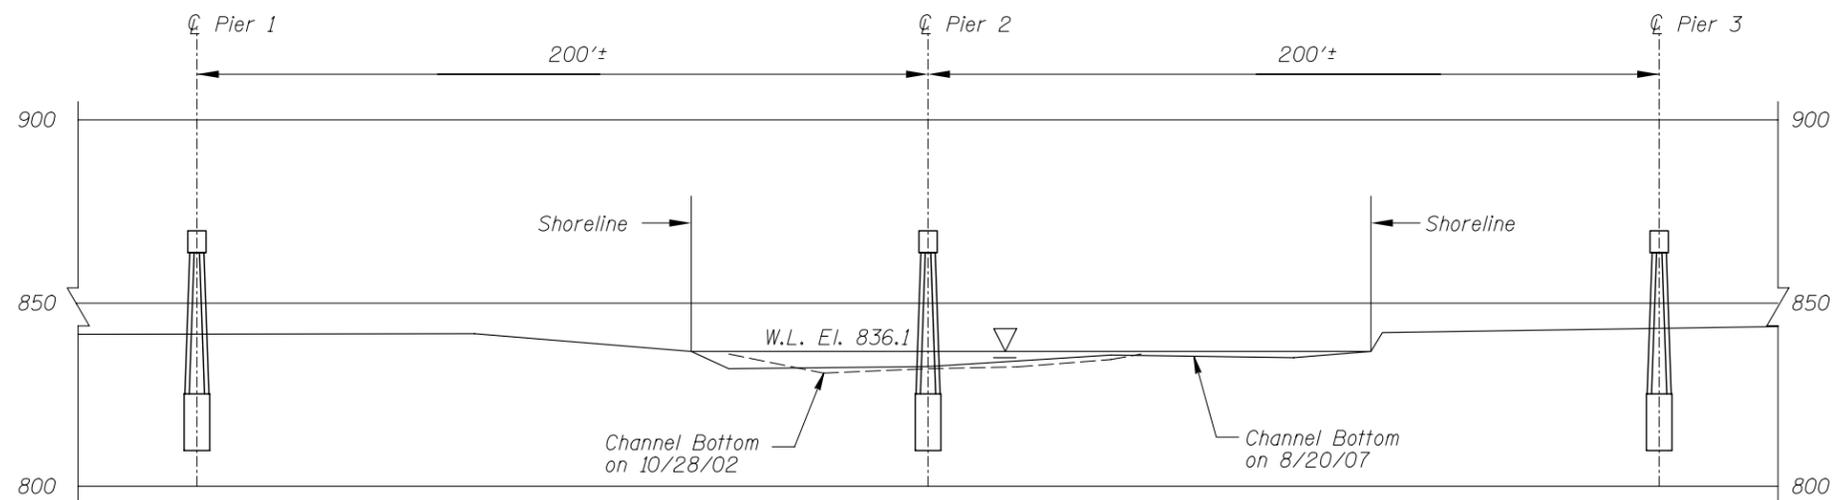
UPSTREAM FASCIA PROFILE
Vertical Scale: 1"=50'-0"

DOWNSTREAM FASCIA PROFILE
Vertical Scale: 1"=50'-0"
