UNDERWATER BRIDGE INSPECTION REPORT

STRUCTURE NO. 97373
CSAH 37
OVER
HEIR CREEK
DISTRICT 2 - CLEARWATER COUNTY

PREPARED FOR THE
MINNESOTA DEPARTMENT OF TRANSPORTATION
BY
COLLINS ENGINEERS, INC.
JOB NO. 5221 (CEI 35)

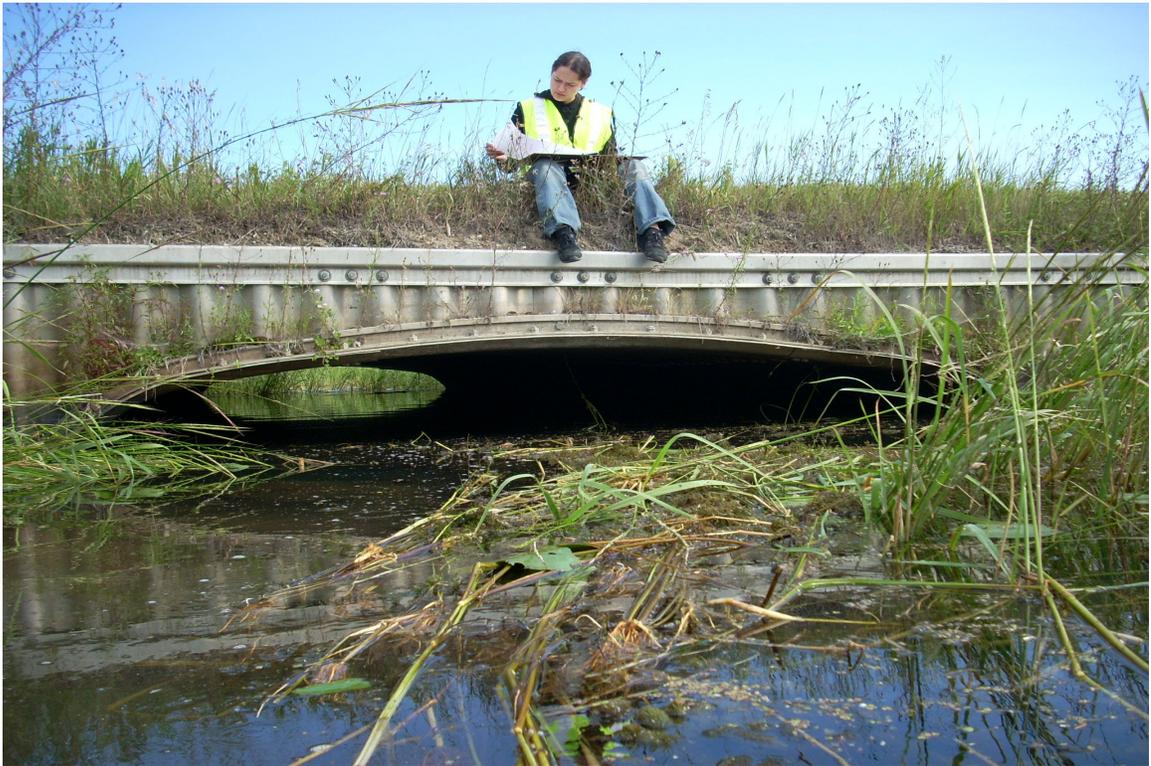
Photograph 1. Overall View of Structure, Looking North.

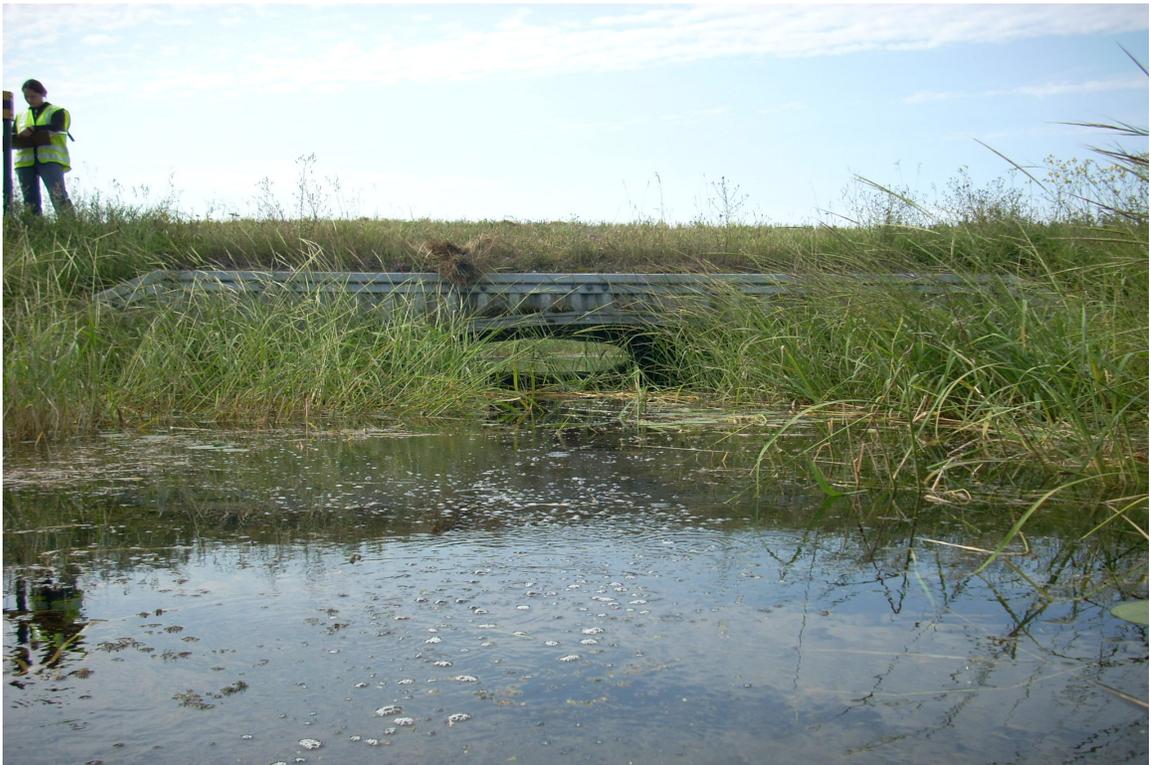
Photograph 2. Overall View of Structure, Looking South.

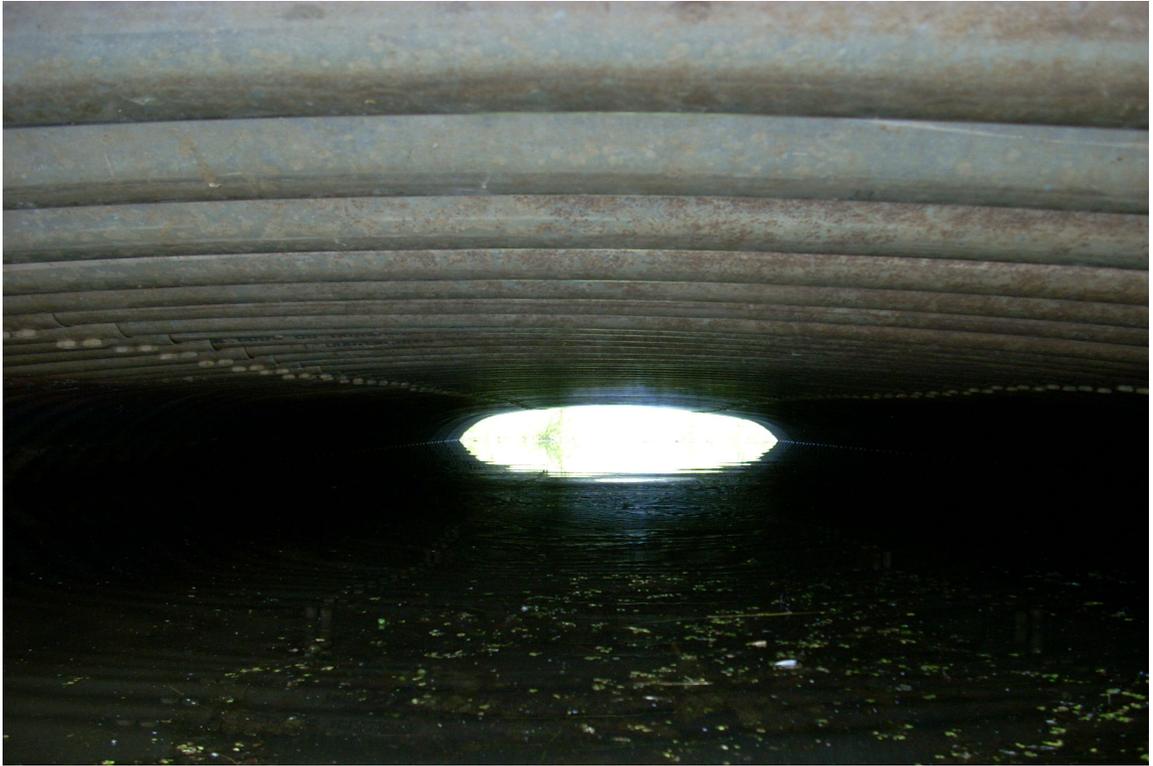
Photograph 3. View of Interior Top of Culvert, Looking North.

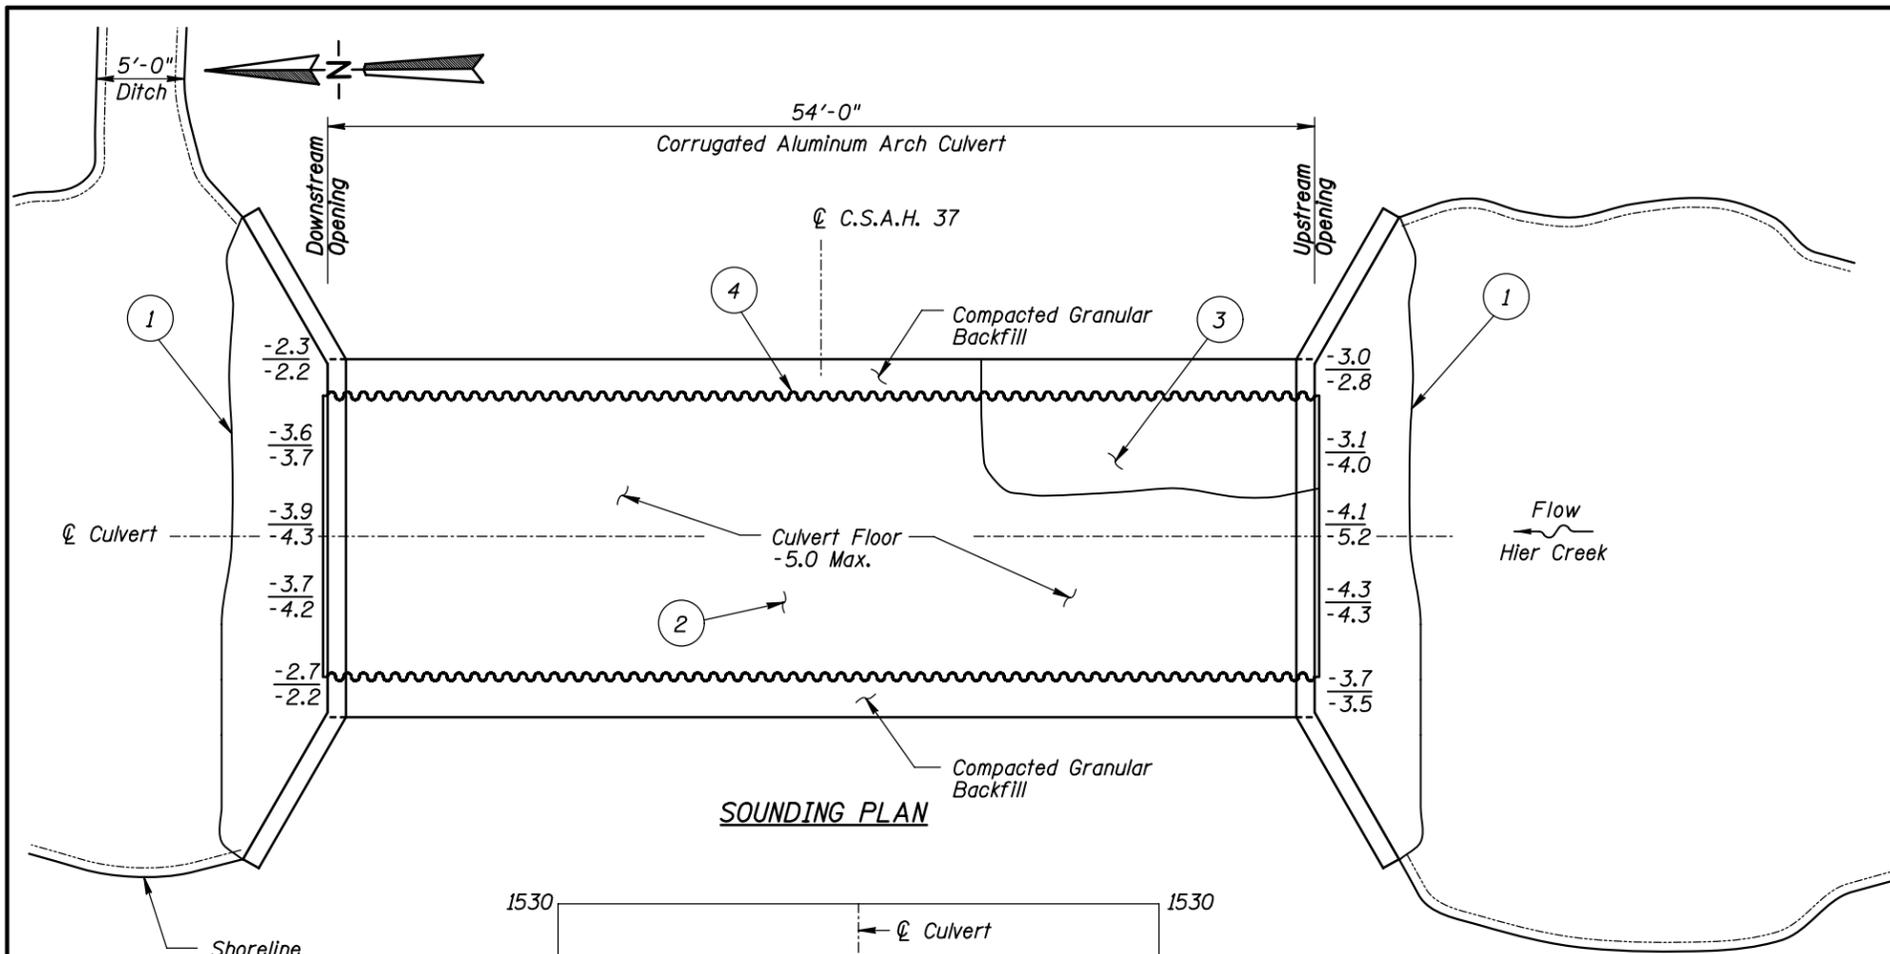
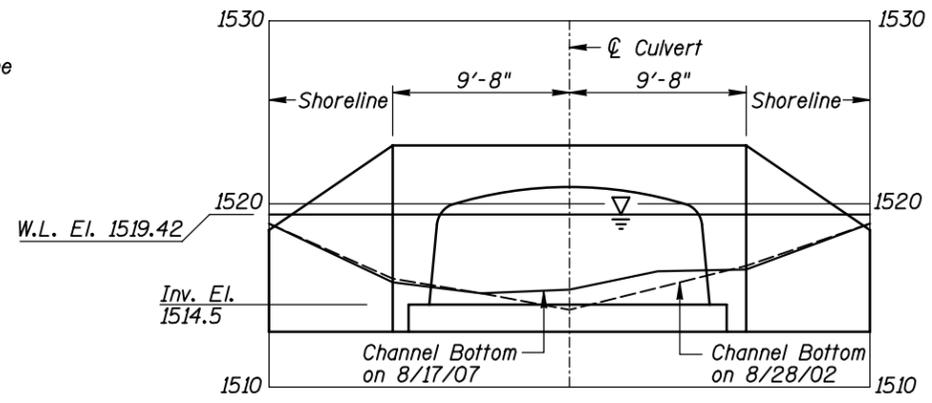
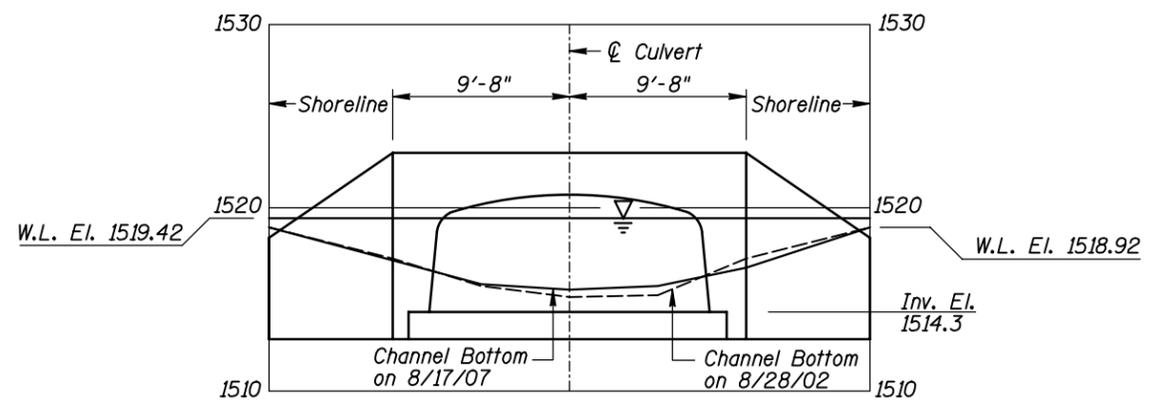
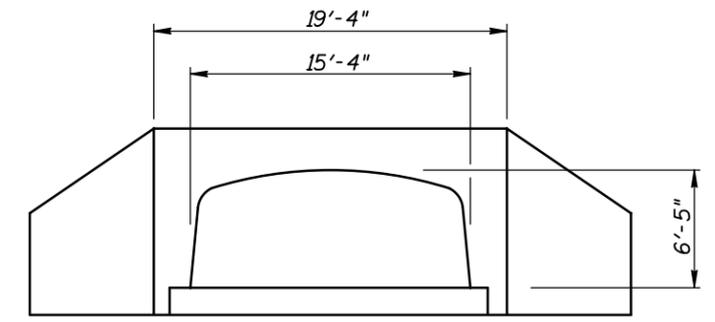
SOUNDING PLAN

- ① The channel bottom consisted of riprap covered with silty sand with 6 inches of probe rod penetration.
- ② Culvert floor was occasionally covered with up to 3 inches of silty, sandy gravel.
- ③ Area of culvert floor covered with a 6-inch layer of silty, sandy gravel located on the east side of the culvert floor from the upstream opening to the upstream quarter point of the culvert.
- ④ The corrugated aluminum arch culvert was sound with all joints secure and properly fitted with no gaps and no deficiencies observed.
