UNDERWATER BRIDGE INSPECTION REPORT

STRUCTURE NO. 04511

MISSISSIPPI RIVER

AUGUST 13, 2012

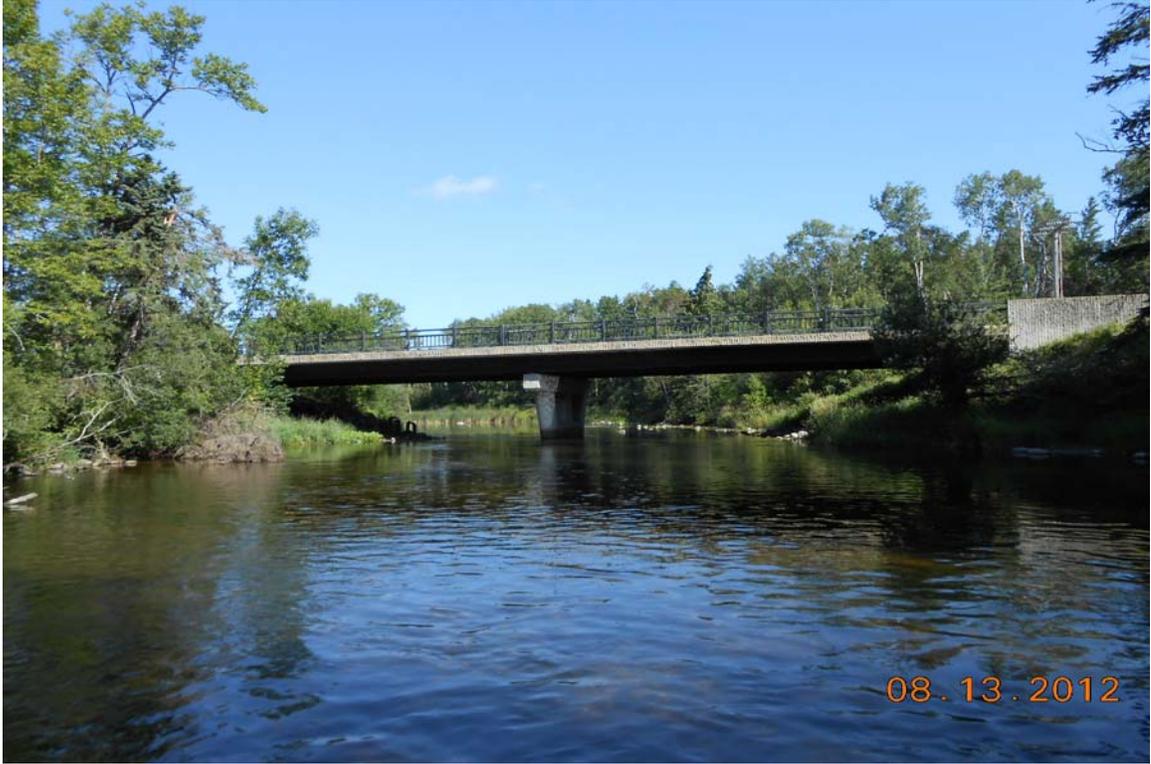
Photograph 1. Overall View of Downstream Fascia, Looking North.

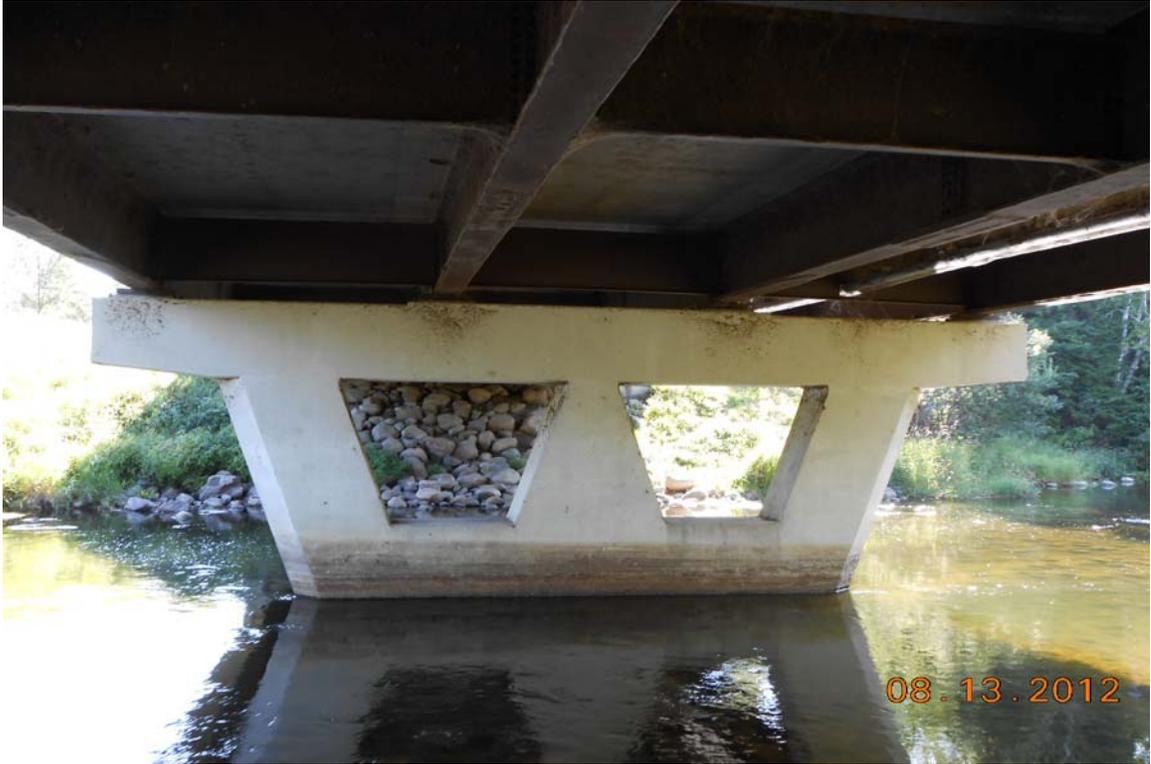
- (A) Minor timber debris consisting of twigs was observed at the upstream nose of Pier 1.
- (B) A minor scour depression, 3 foot radius and 1 foot deep, was observed at the downstream nose of Pier 1.
- (C) The streambed material consisted of cobbles.
- (D) The west and east embankments had sparse riprap, 2 foot to 3 foot in diameter, with signs of erosion observed.
- (E) Overall, the concrete of Pier 1 was smooth and sound.

Photograph 2. Overall View of Pier 1, Looking East.

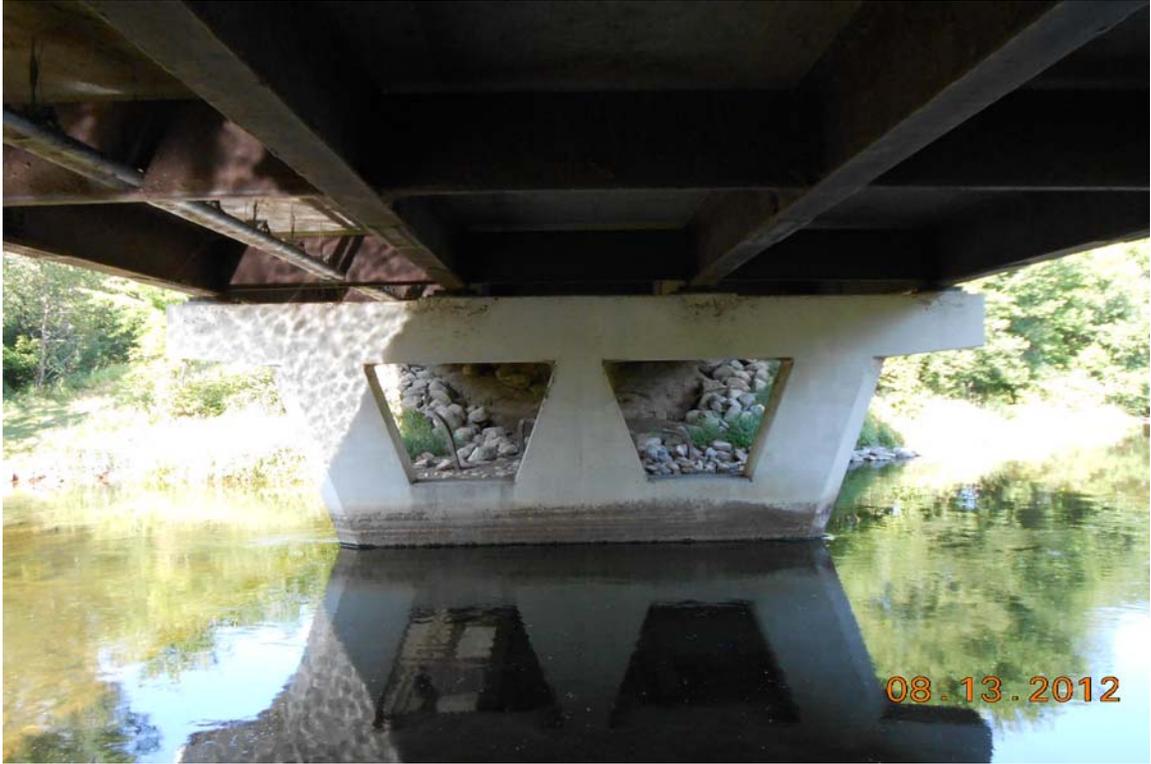
Photograph 3. View of Pier 1, Looking West.

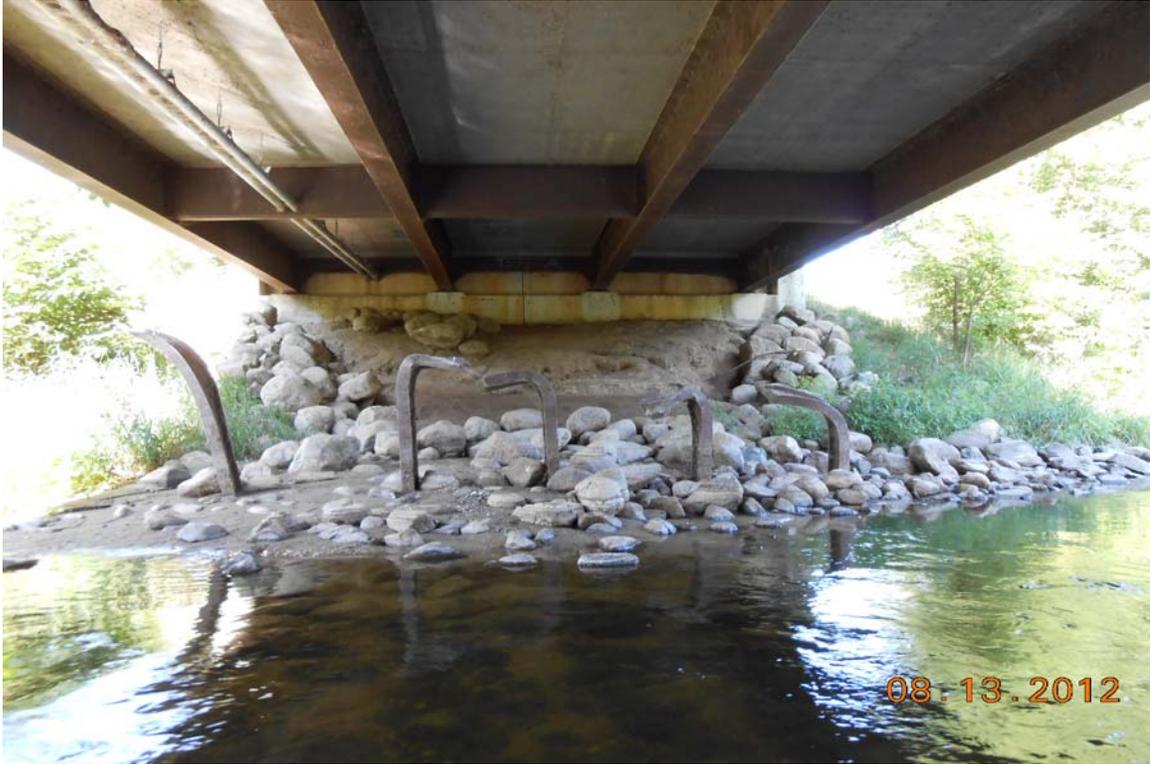
Photograph 4. View of the West Abutment, Looking West

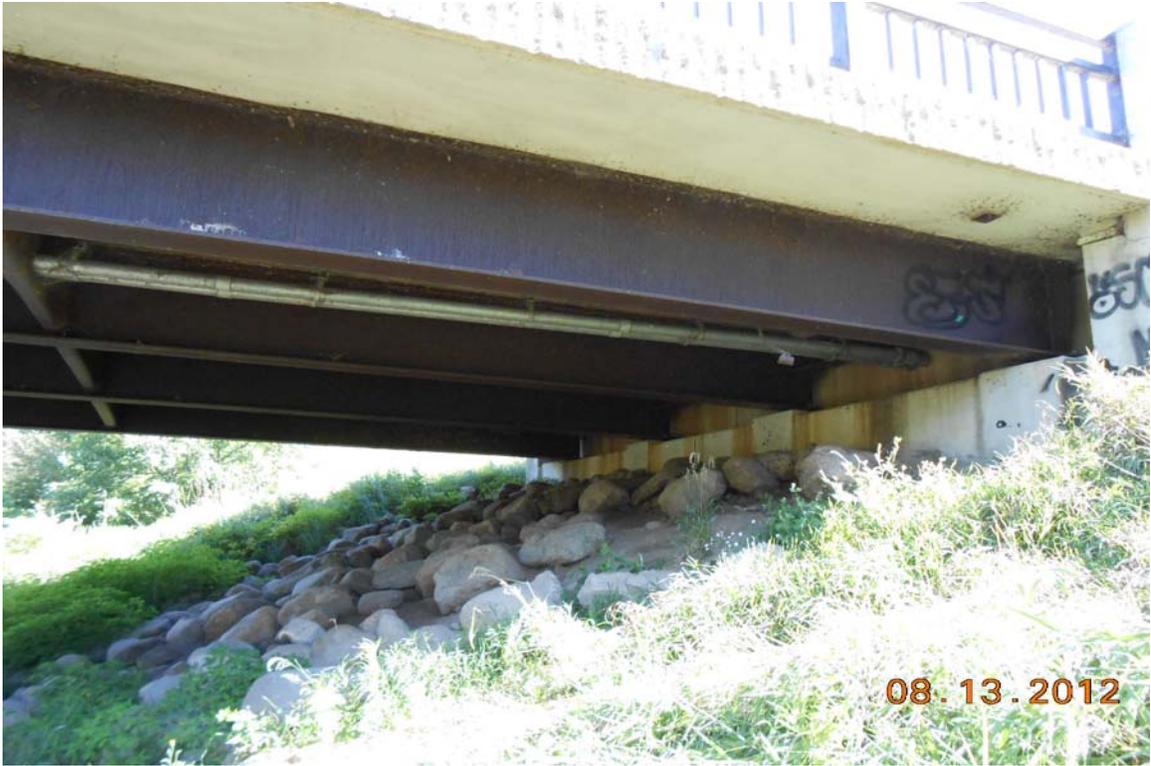
Photograph 5. View of the East Abutment, Looking Northeast.

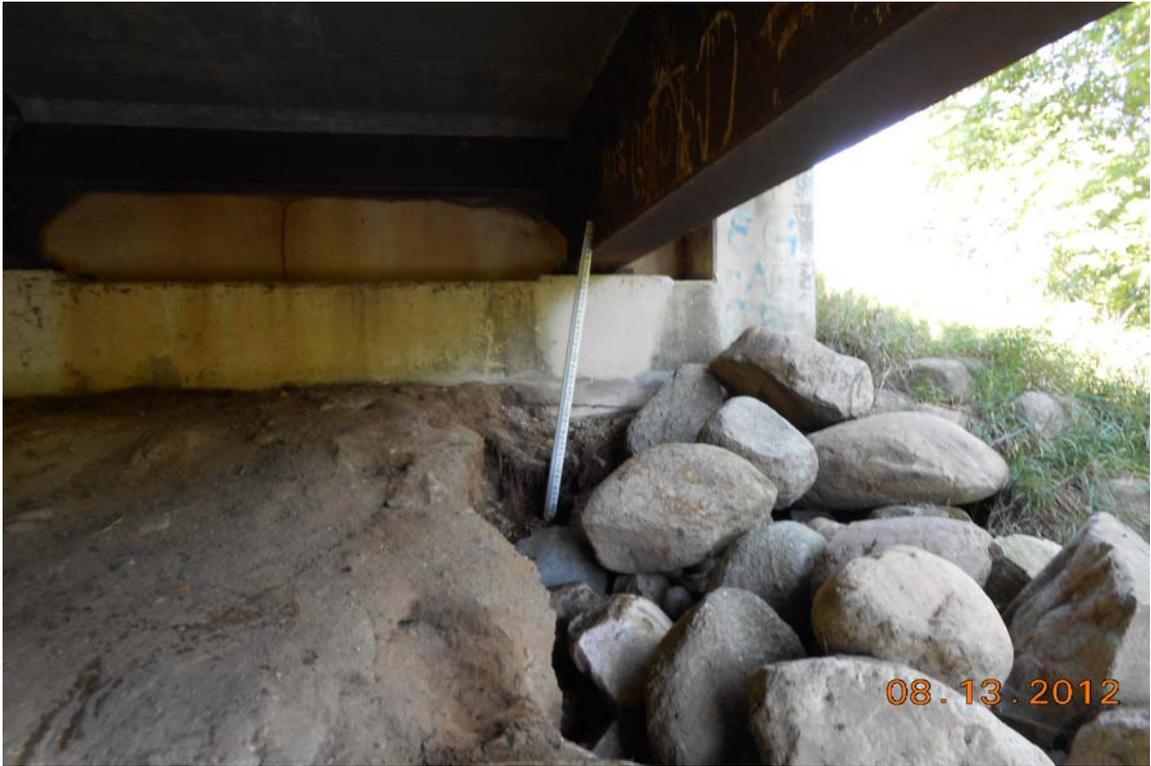
Photograph 6. View of Typical Embankment Erosion and Missing Riprap.

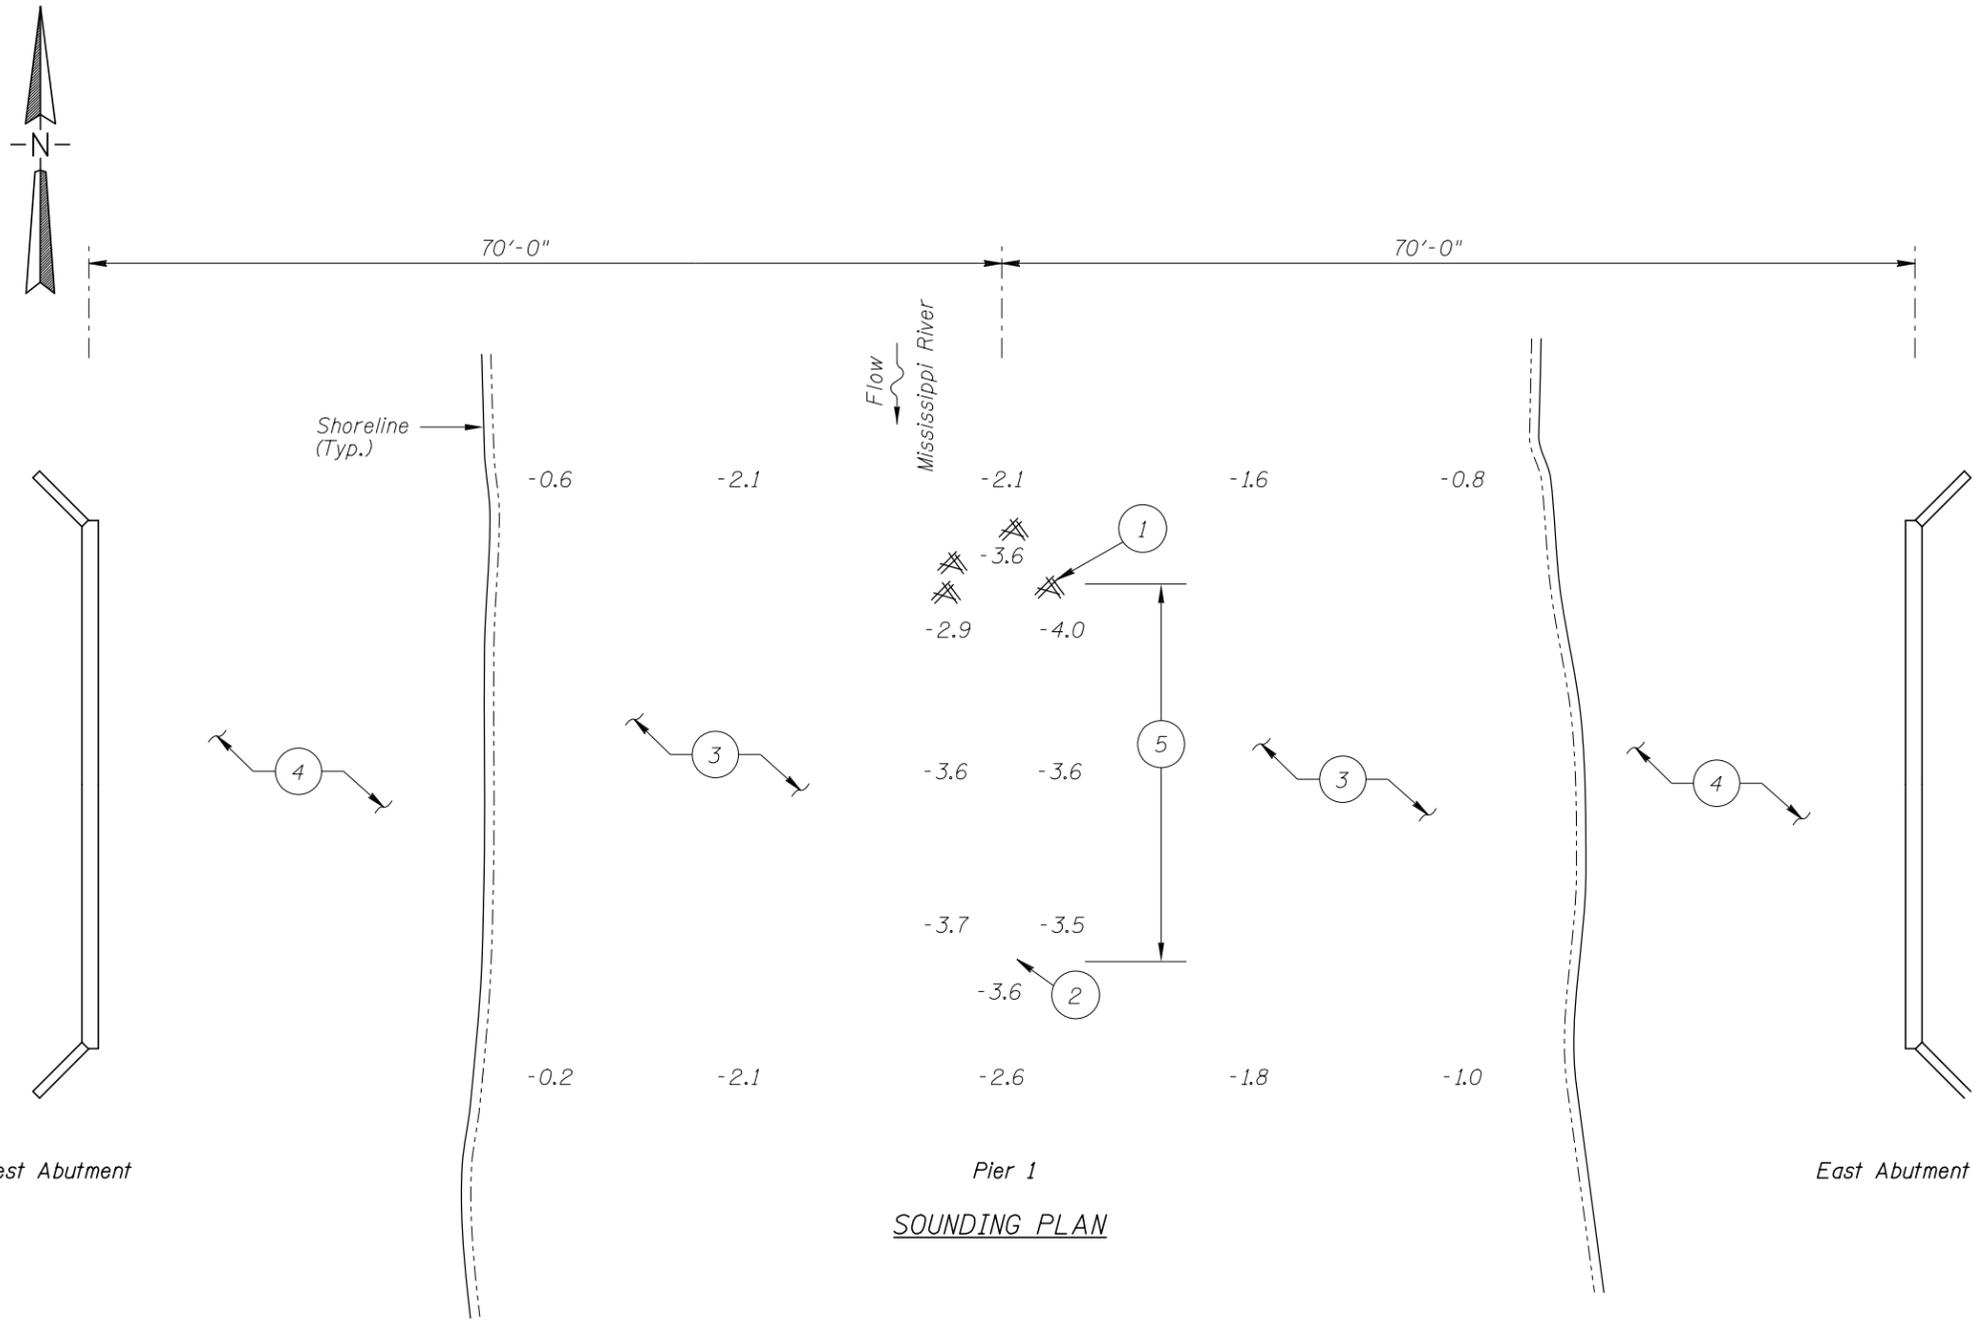
SOUNDING PLAN

- ① Minor timber debris consisting of twigs was observed at the upstream nose of Pier 1.
- ② A minor scour depression, 3 foot radius and 1 foot deep, was observed at the downstream nose of Pier 1.
- ③ The streambed material consisted of cobbles.
- ④ The west and east embankments had sparse riprap, 2 foot to 3 foot in diameter, and signs of erosion were observed.
- ⑤ Overall, the concrete of Pier 1 was smooth and sound.
