UNDERWATER BRIDGE INSPECTION REPORT

STRUCTURE NO. 15505  
CR 23 OVER THE  
CLEARWATER RIVER  
DISTRICT 2 - CLEARWATER COUNTY

AUGUST 13, 2012  
PREPARED FOR THE  
MINNESOTA DEPARTMENT OF TRANSPORTATION  
BY  
AYRES ASSOCIATES & COLLINS ENGINEERS, INC.  
JOB NO. 7423

MINNESOTA DEPARTMENT OF TRANSPORTATION  
UNDERWATER BRIDGE INSPECTION

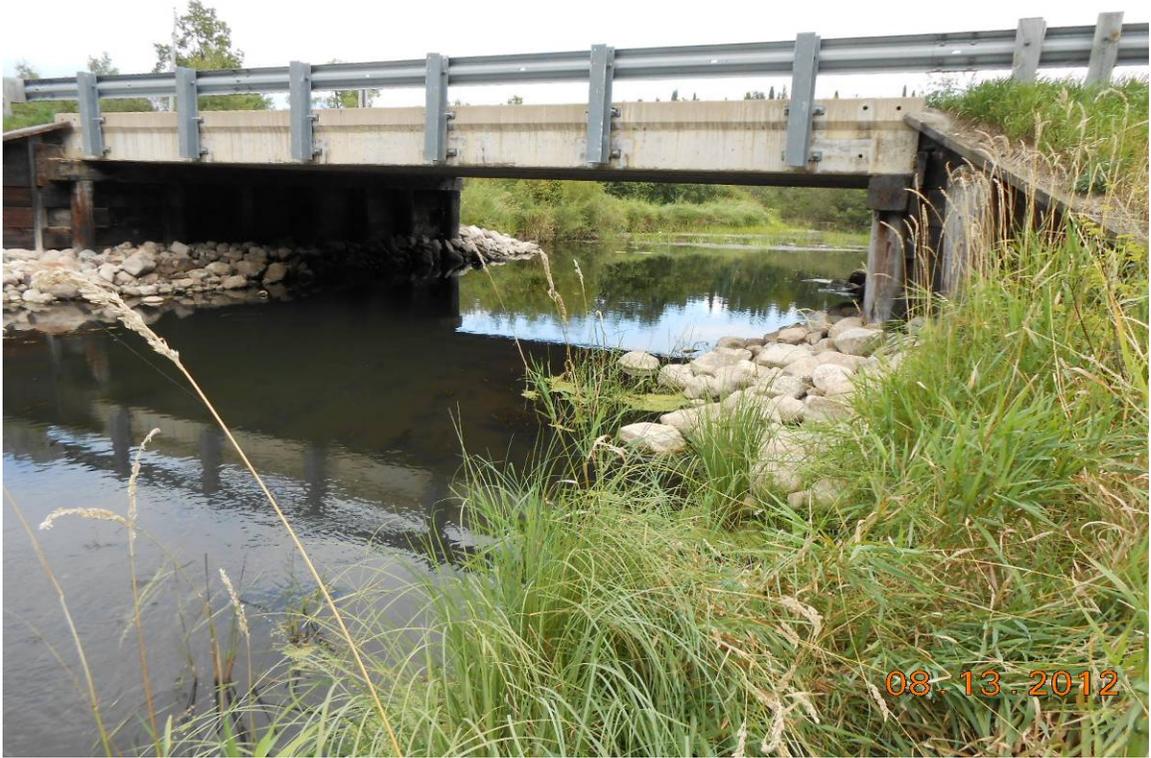
Photograph 1. Overall View of Bridge, Looking Northeast.

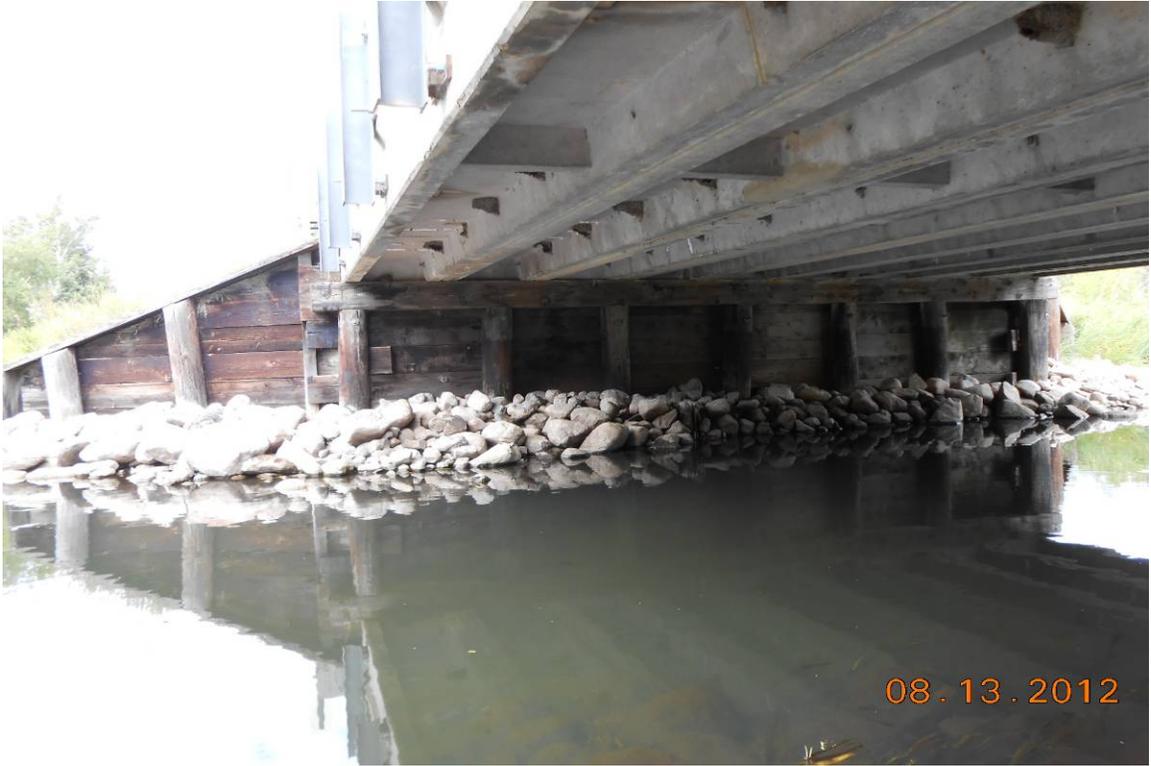
- (A) The timber piles, pile caps, and sheeting exhibited checking up to ¼ inch wide and allowed typical awl penetrations between ¼ inch and ½ inch in depth. The pile to sheeting connection hardware was galvanized steel with minor surface corrosion and no appreciable loss of section on the lower connections (1 foot above waterline). The joints between the wall sheeting were tight with no appreciable loss of fill observed.

Photograph 2. View of North Abutment, Looking North.

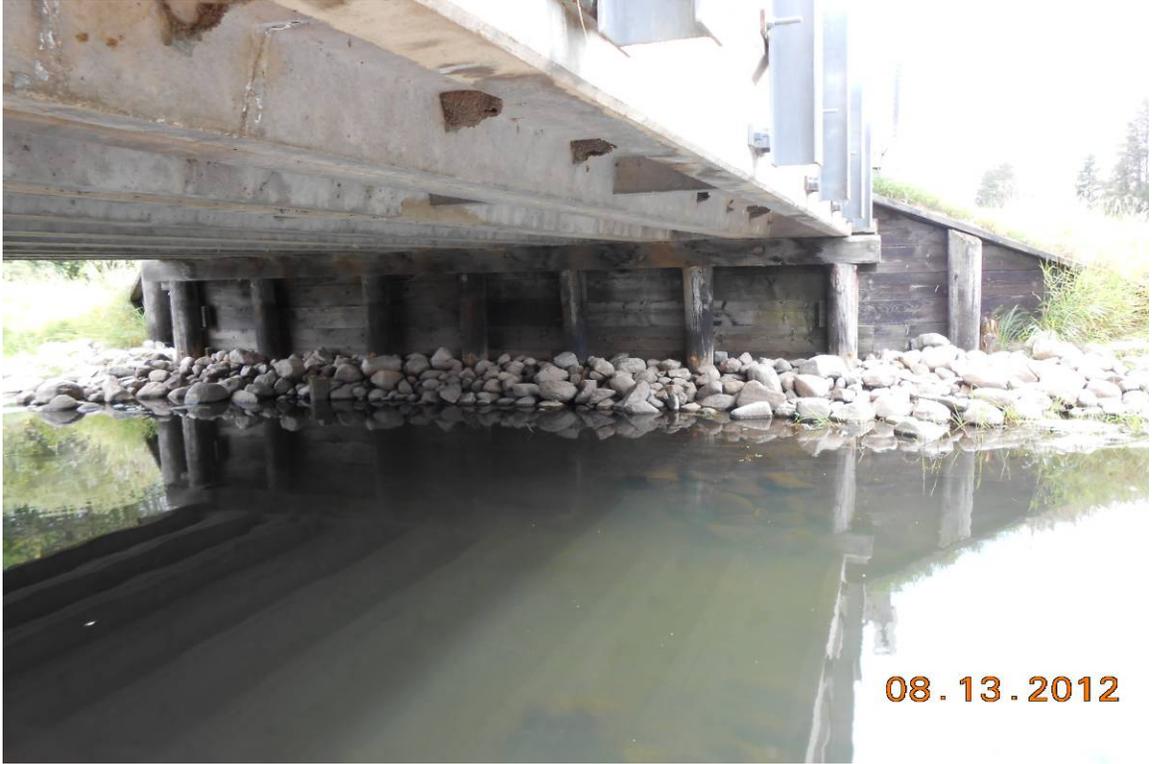
Photograph 3. View of South Abutment, Looking South.

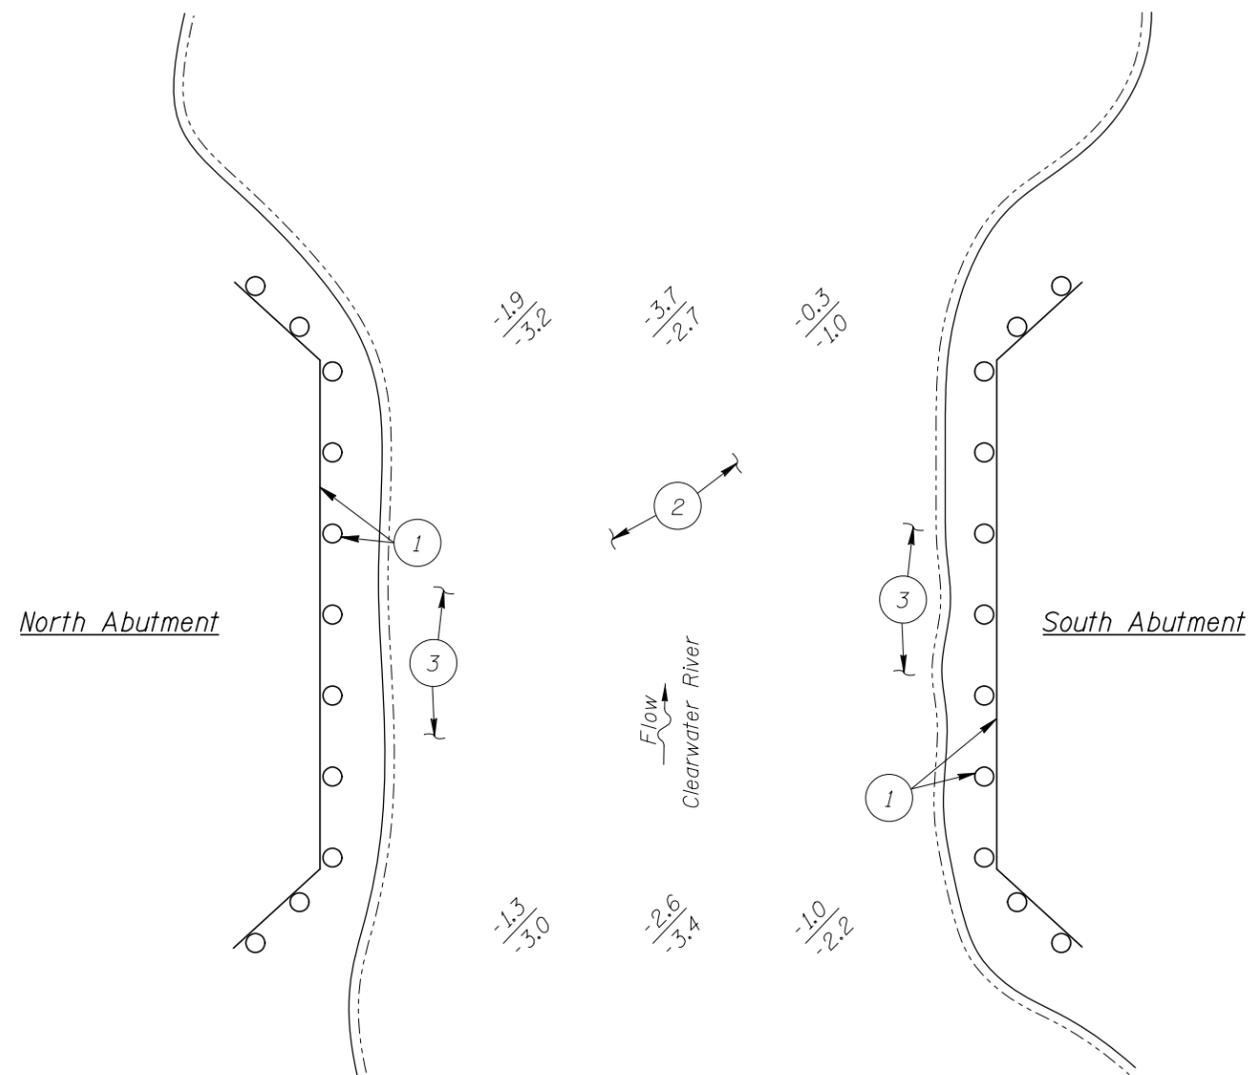
INSPECTION AND SOUNDING PLAN

- 1 The timber piles, pile caps and backwall plank (sheeting) checking up to 1/4 inch wide and typical awl penetrations between 1/4 inch and 1/2 inch deep. The galvanized connection hardware exhibited minor surface corrosion on the lower connections with no appreciable loss of section.
- 2 The channel bottom consisted of silty sand with up to 2 feet of probe rod penetration.
- 3 Riprap was present at the North and South Abutments, extending 4 feet past the face of the abutments.
