UNDERWATER BRIDGE INSPECTION REPORT

STRUCTURE NO. 4886

CLEARWATER RIVER

AUGUST 13, 2012

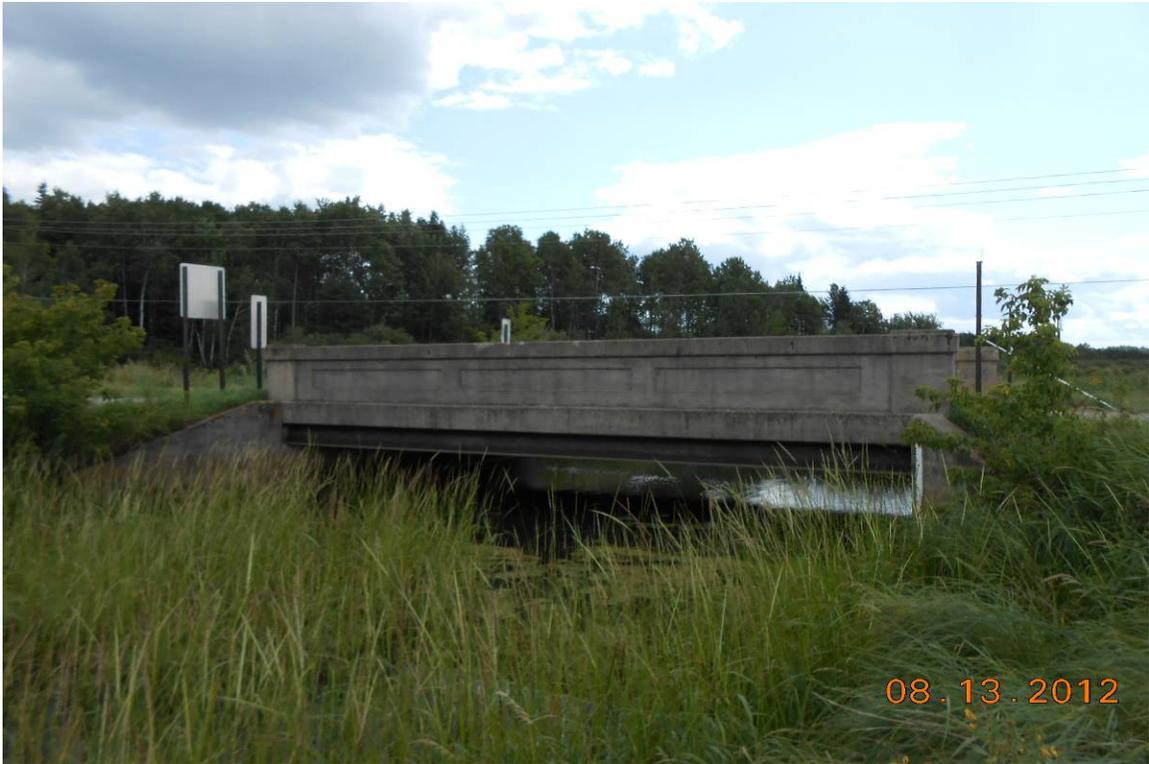
Photograph 1. Overall View of Bridge, Looking Southeast.

The substructure units inspected at Bridge No. 4886, East and West Abutments, were found to generally be in satisfactory condition with no defects of structural significance. The channel bottom around the substructure units appeared stable with no evidence of significant scour. There was, however, partial footing exposure observed at both abutments with up to 6 inches of vertical face exposure.

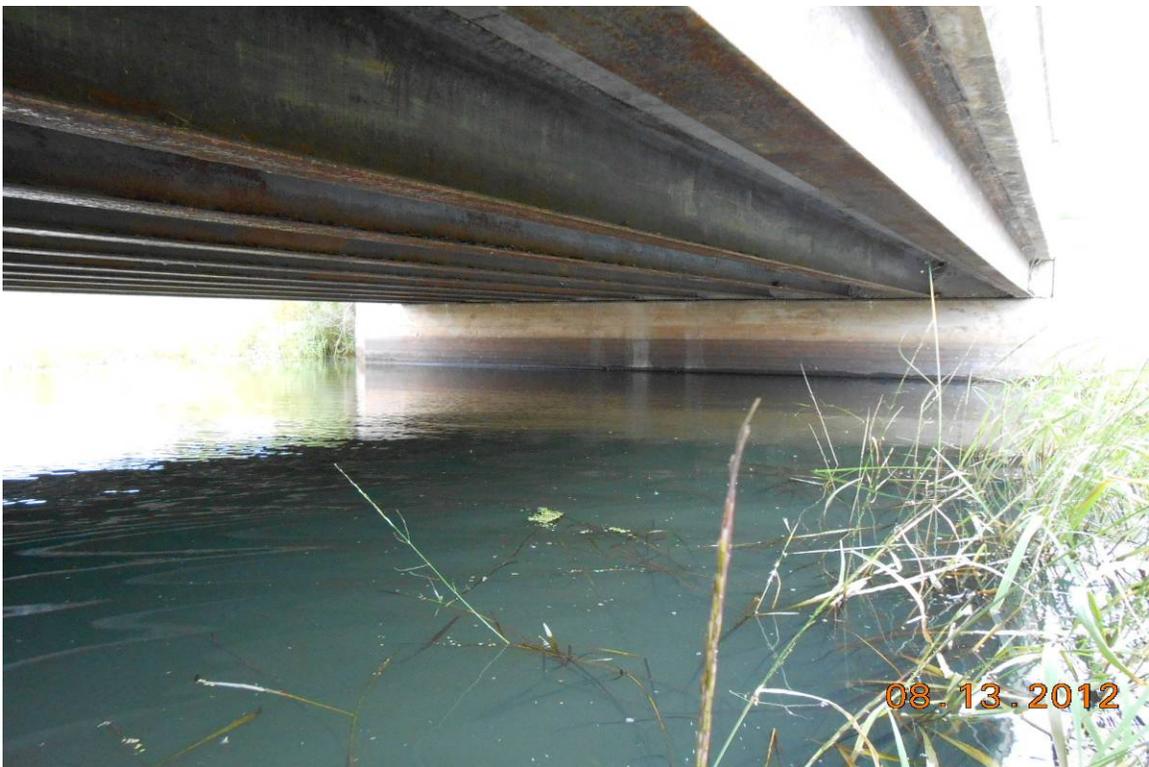
Photograph 2. View of East Abutment, Looking Northeast.

- (B) Loss of section along the joint between southeast wingwall and East Abutment was located 4.8 feet below top of wingwall, measuring 1 foot in diameter with a maximum penetration of 1.5 inches.

- (C) Spalling was observed at East Abutment below northernmost beam seat, 8 inches in diameter with a maximum penetration of 1 inch.
- (D) The south end of southwest wingwall had delaminated areas measuring 1 foot wide, 3 feet high and 6 inches deep.

- (F) Footing exposure was observed along a 15 foot section of the East Abutment near the midpoint with maximum vertical exposure of 6 inches.

- (A) Monitor footing exposure at East and West Abutments during future inspections.
- (B) Reinspect the submerged substructure units at the normal maximum recommended (NBIS) interval of sixty (60) months.

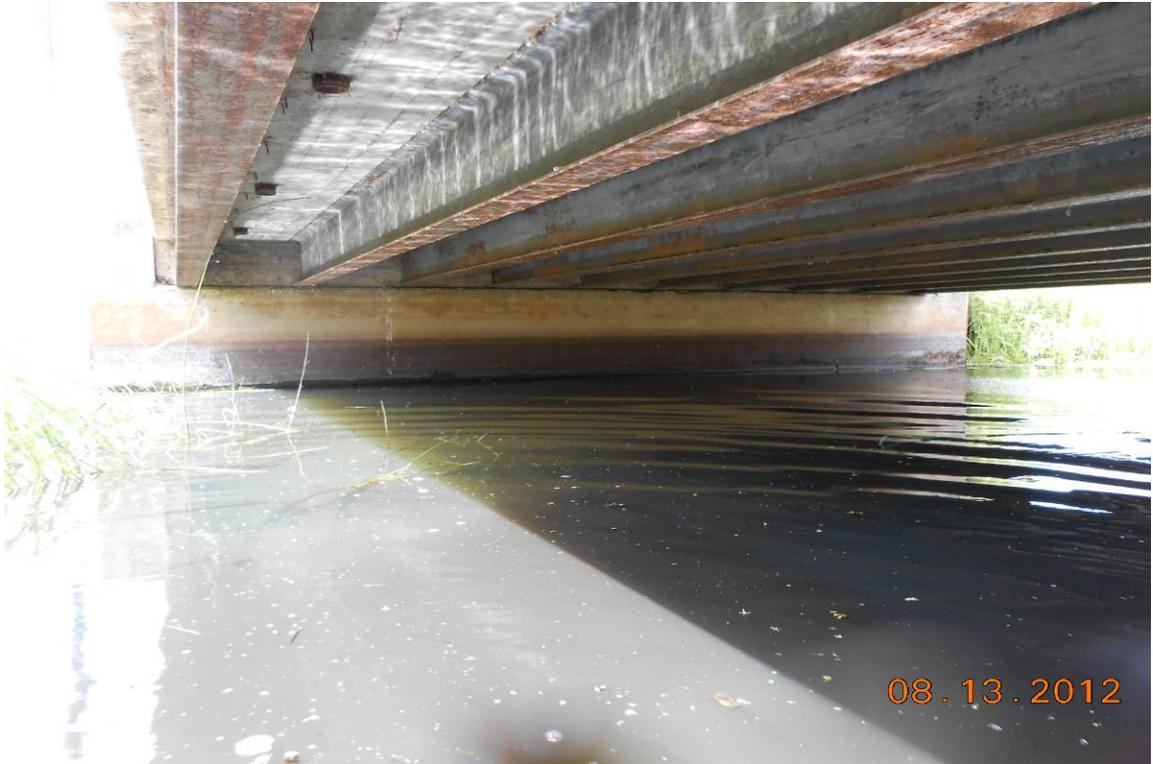
Photograph 3. View of West Abutment, Looking Northwest.

- (G) Footing exposure was observed along a 10 foot section of the West Abutment near the midpoint with no vertical exposure.

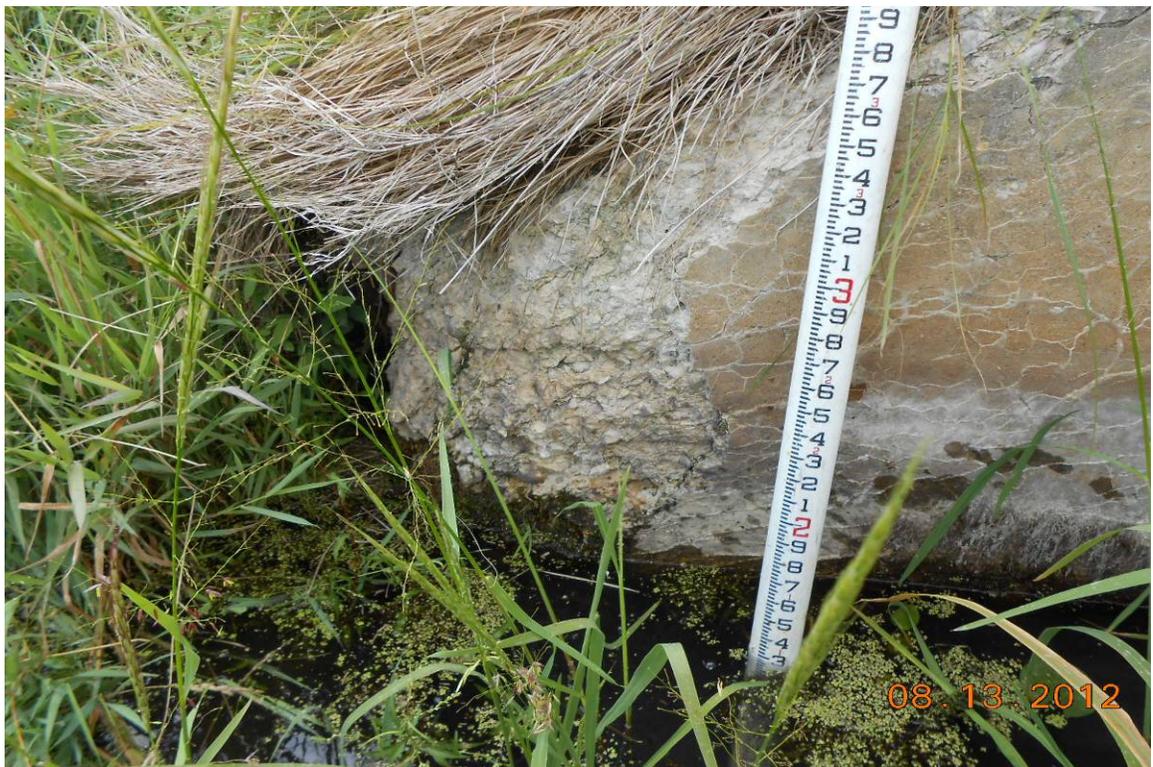
Photograph 4. View of Deteriorate Concrete at South end of Southwest Wingwall.

- 7 The end of Southwest wingwall was delaminated. The area measured 1 foot wide, 3 feet high, with 6 inches of penetration, with no exposed reinforcing steel.

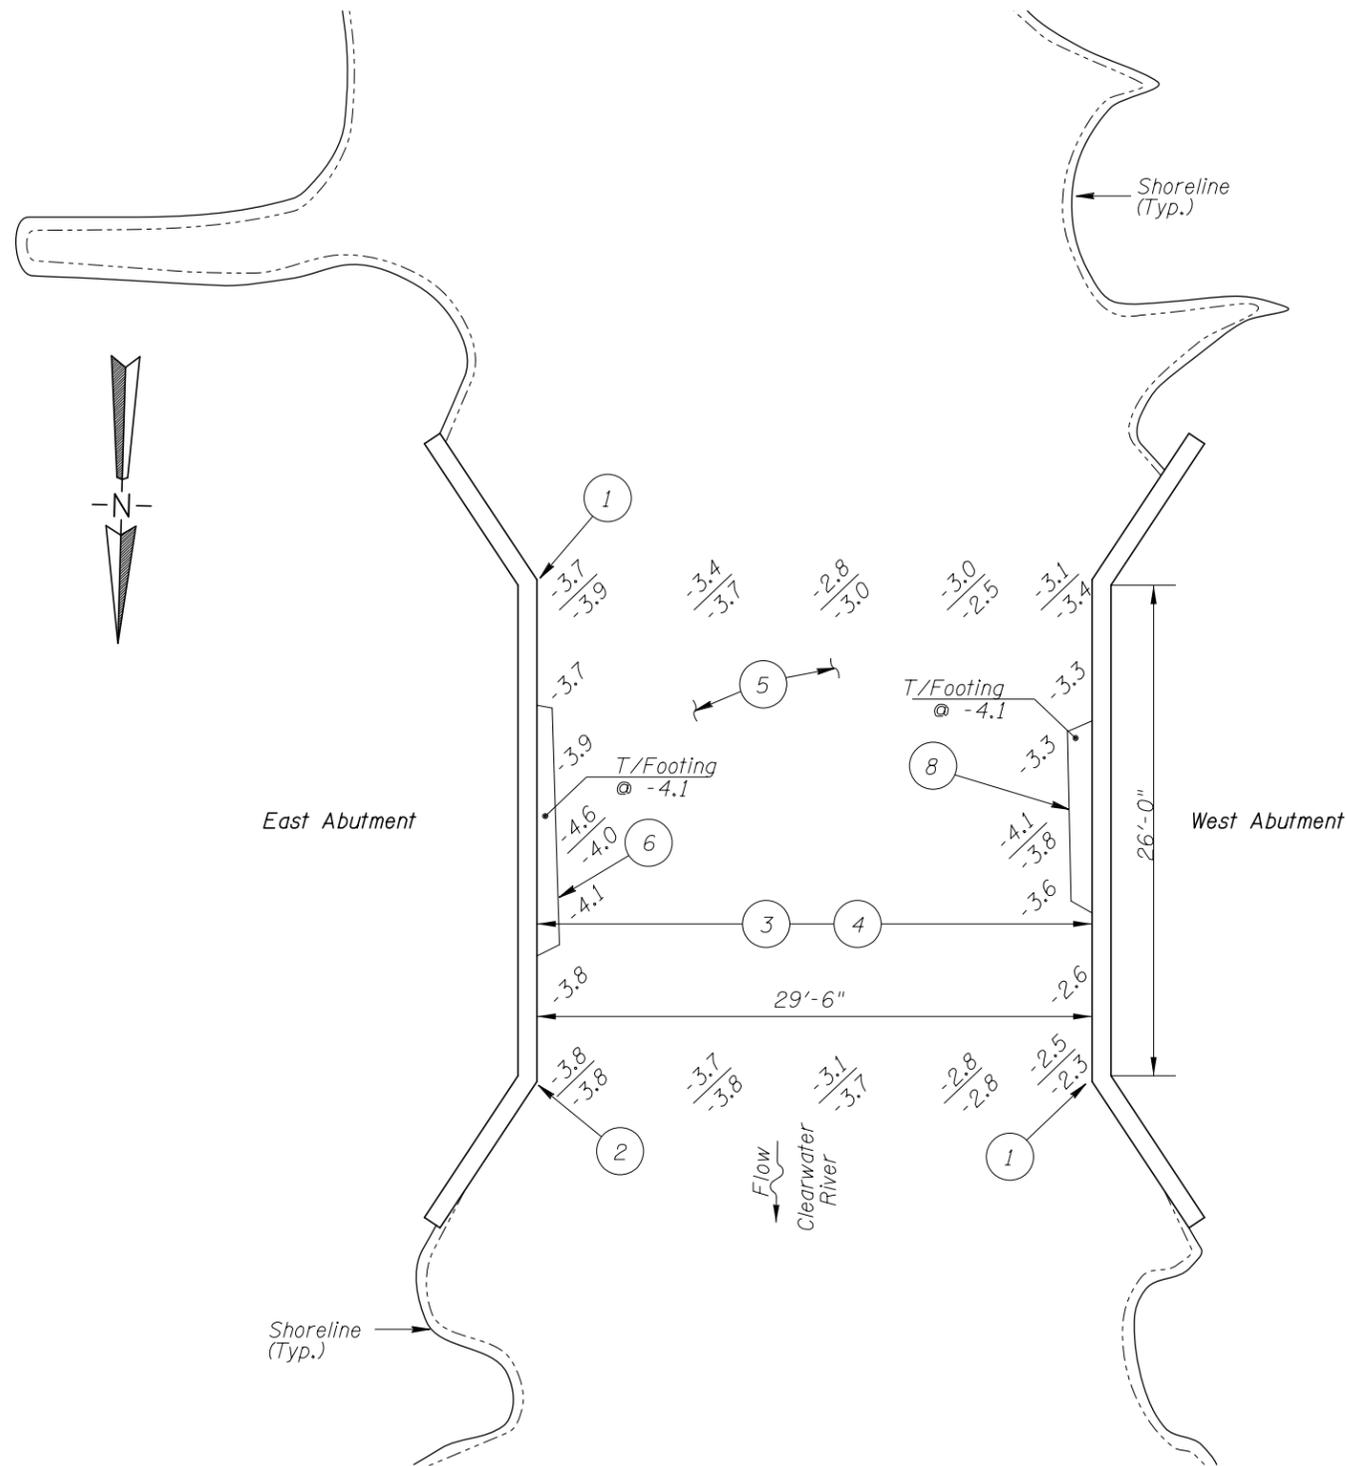
TYPICAL ELEVATION VIEW OF EACH ABUTMENT

- 1 Loss of section at the joint between the southeast wingwall and East Abutment. It was located 4.8 feet below the top of the wing wall measuring 1 foot in diameter with a maximum penetration of 1.5 inches with no exposed reinforcing steel.

- 2 Spall was observed at East Abutment below northernmost beam seat measuring 8 inches in diameter, with a maximum penetration of 1 inch with no exposed reinforcing steel.

- 3 Random vertical cracks extending from the bridge seat down 4 feet measuring from hairline to 1/16 inches wide located approximately every 5 feet along both abutment faces.

- 4 Above and below the waterline the concrete was typically smooth and sound with areas of hairline map cracking on the wingwalls and on the abutment faces.

- 5 The channel bottom consisted of silty sand with 1 foot of probe rod penetration.
- 6 Footing exposure was observed along a 15 foot section at the East Abutment near the midpoint with 6 inches of maximum vertical exposure.

- 8 Footing exposure was observed along a 10 foot section at the West Abutment near the midpoint with no vertical face exposure.
