UNDERWATER BRIDGE INSPECTION REPORT

STRUCTURE NO. 4992  
CSAH NO. 4  
OVER THE  
CLEARWATER RIVER (DAM)  
DISTRICT 2 - CLEARWATER COUNTY

AUGUST 14, 2012  
PREPARED FOR THE  
MINNESOTA DEPARTMENT OF TRANSPORTATION  
BY  
AYRES ASSOCIATES & COLLINS ENGINEERS, INC.  
JOB NO. 7423

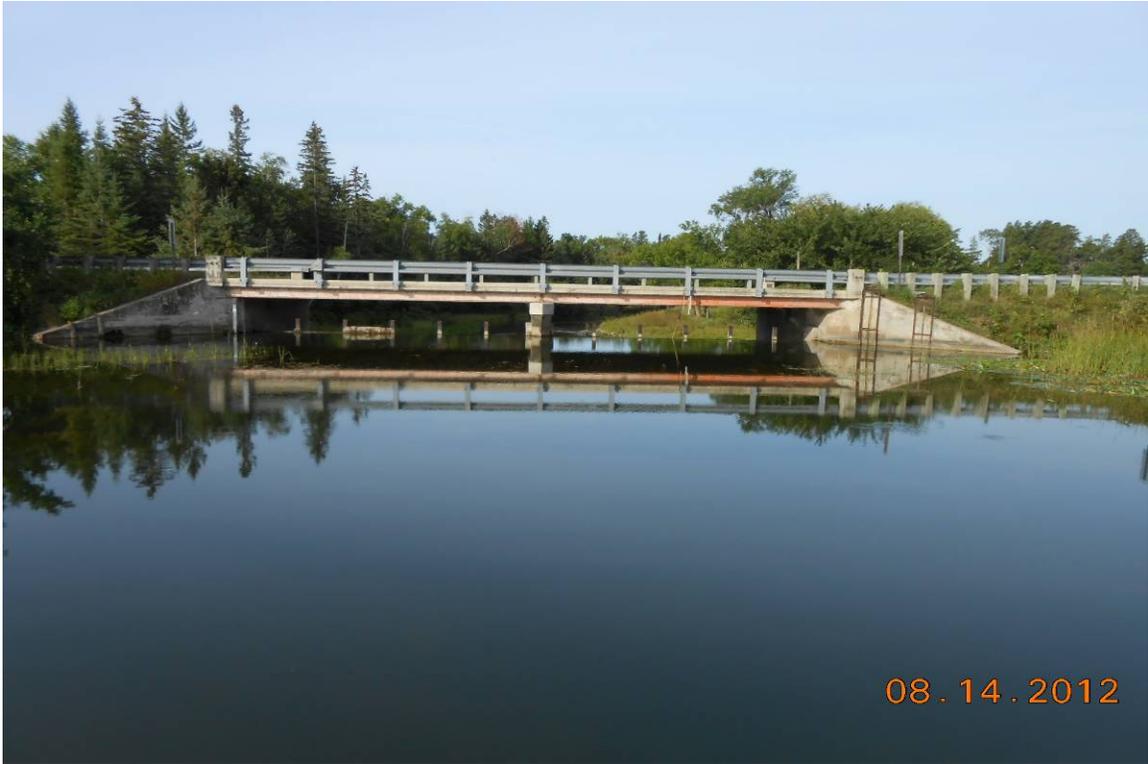
Photograph 1. Overall View of the Upstream Fascia of the Structure, Looking West.

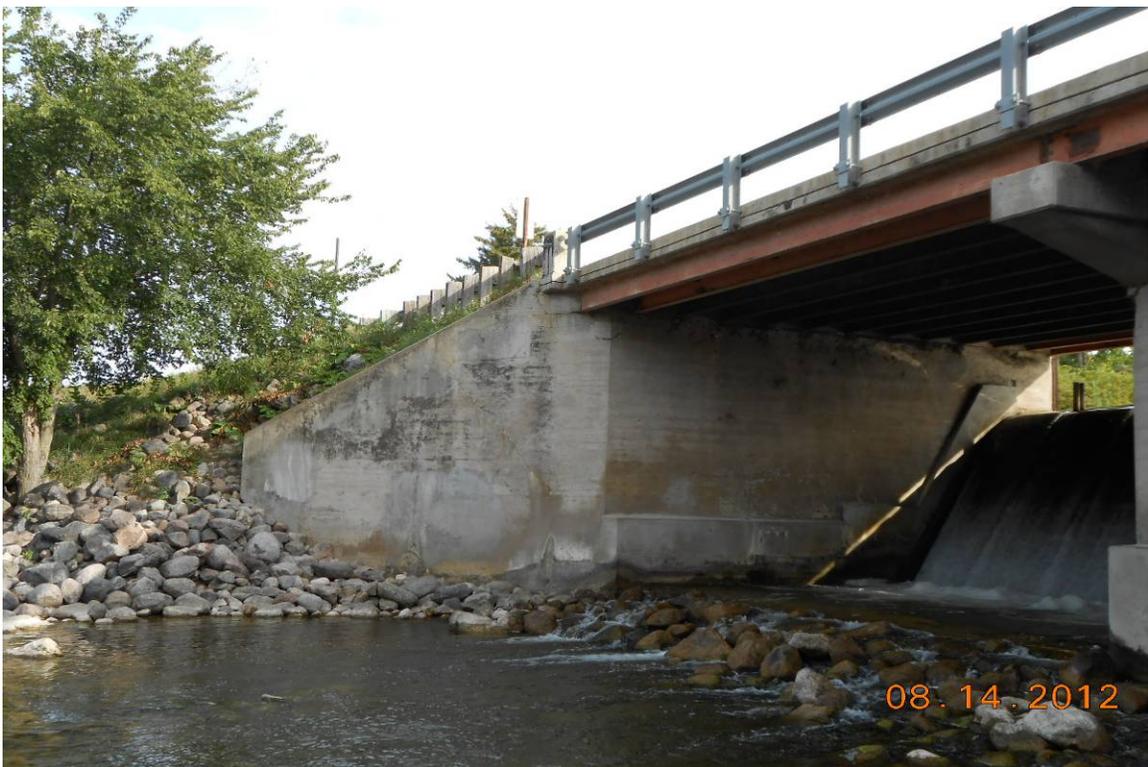
Photograph 2. View of the West Wingwall and North Abutment, Looking North.

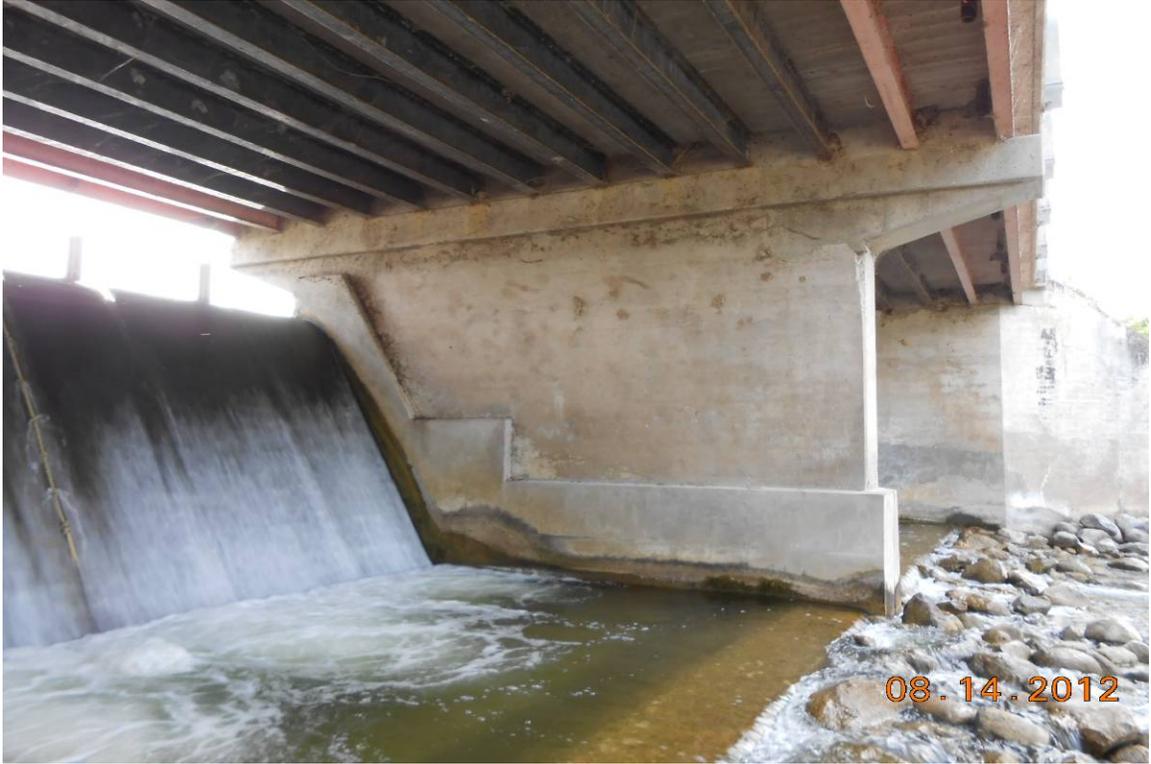
Photograph 3. View of Pier 1, Looking Southeast.

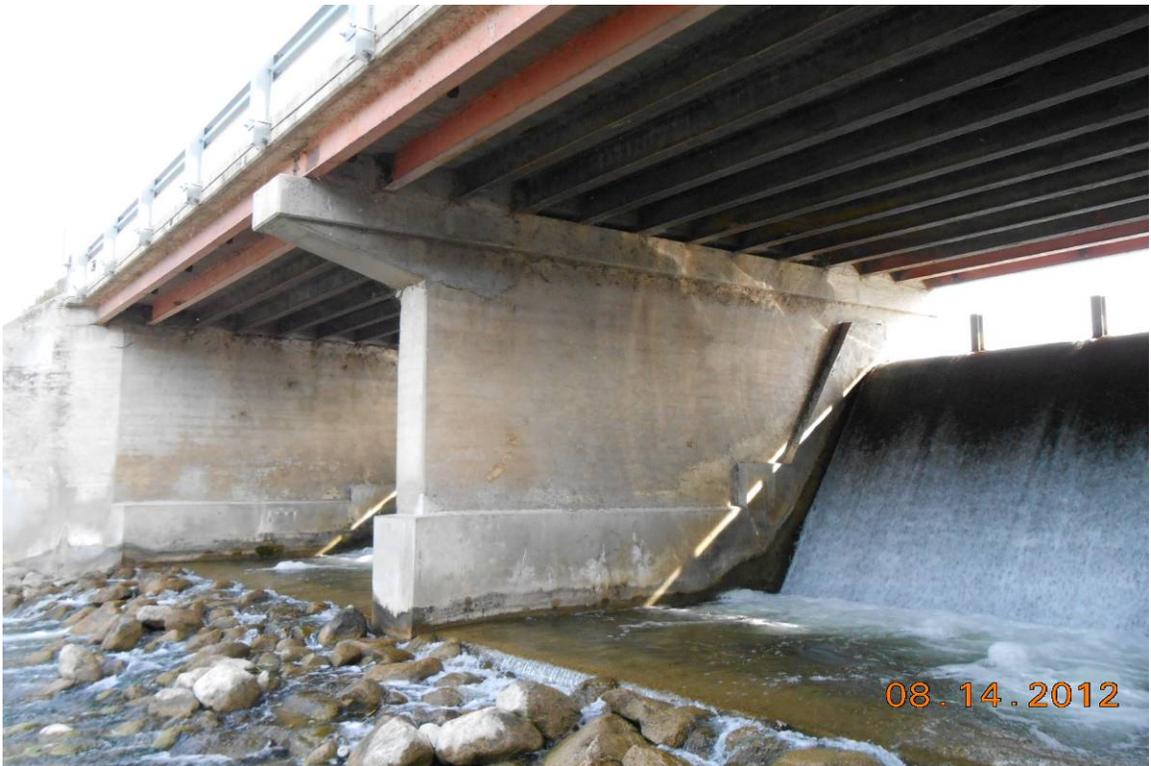
Photograph 4. View of Pier 1, Looking Northeast.

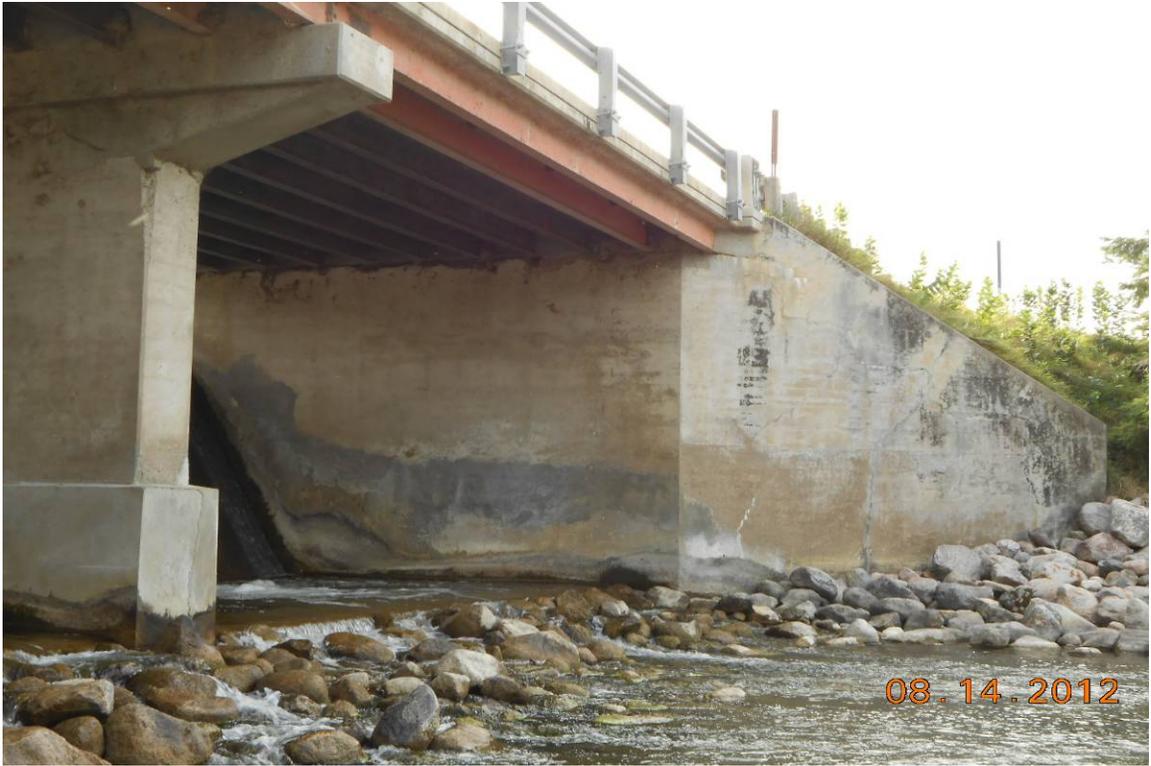
Photograph 5. View of the West Wingwall and South Abutment, Looking South.

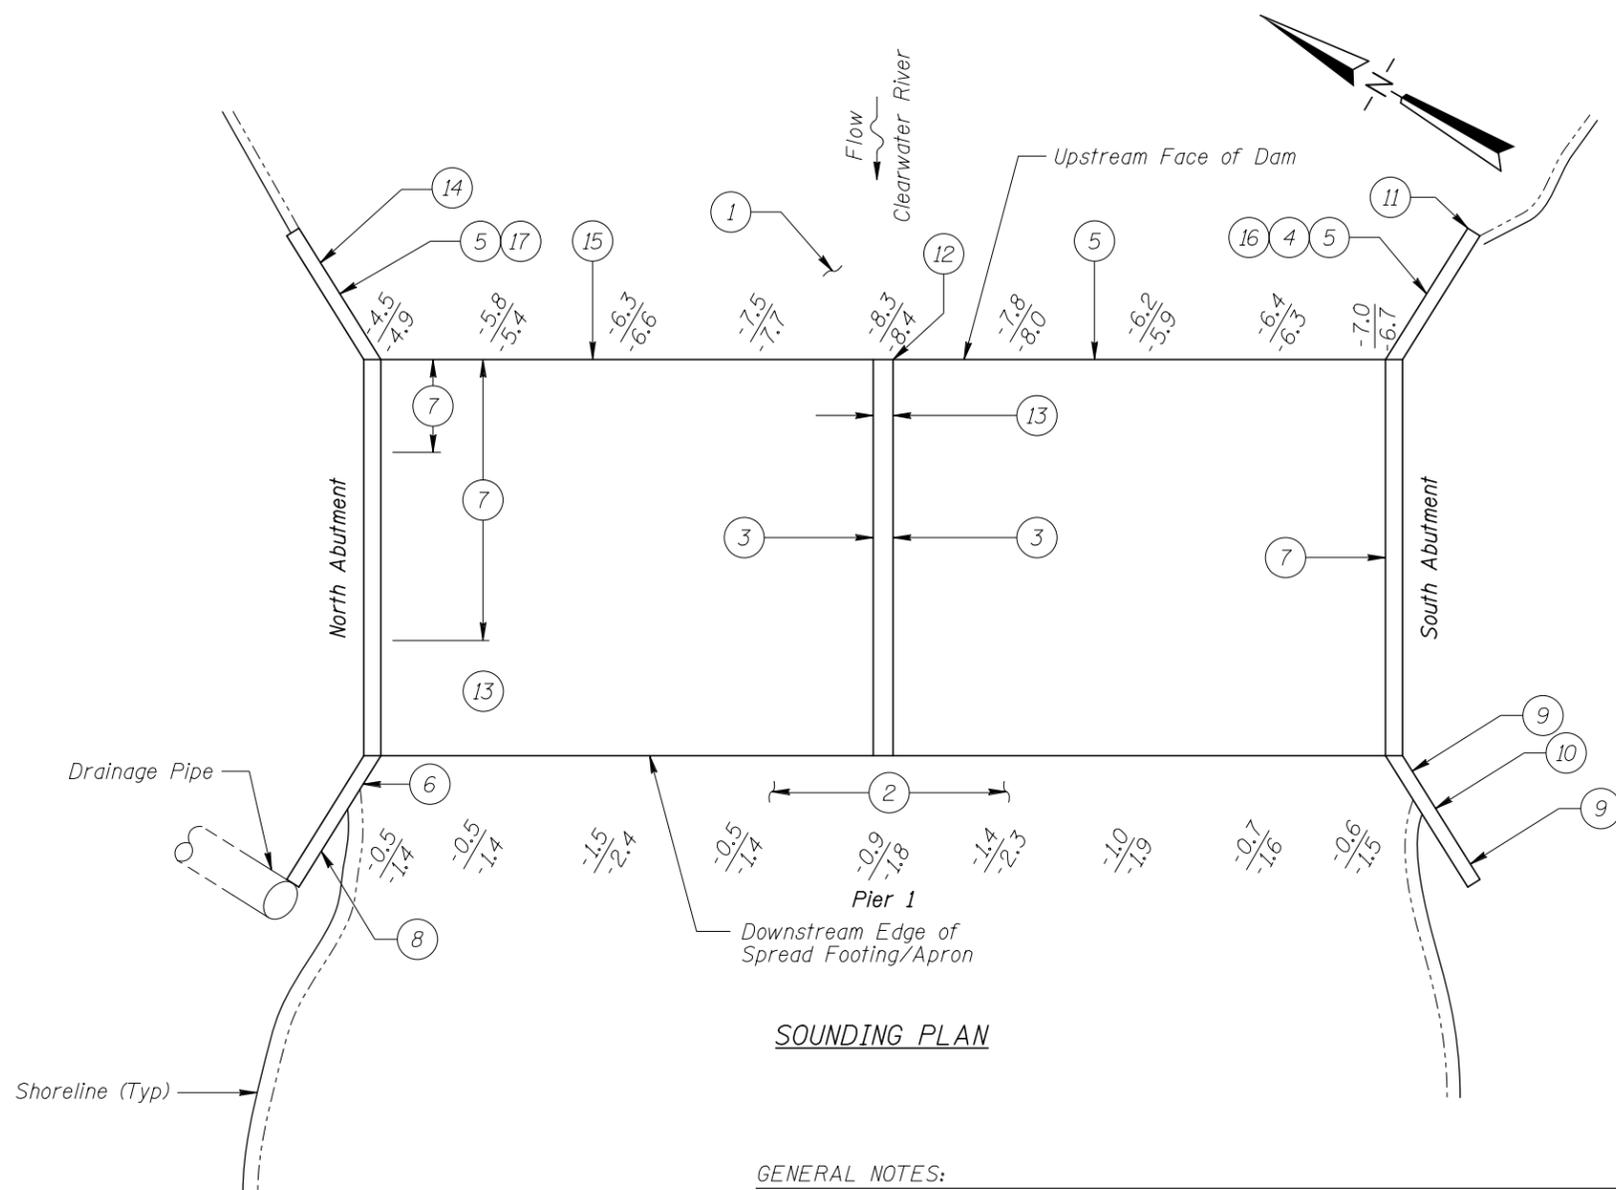
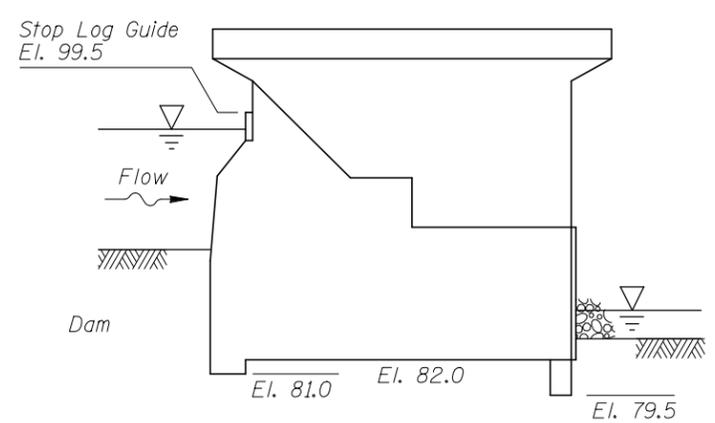
**SOUNDING PLAN**

- 1 The channel bottom material consisted of sandy gravel with random riprap and up to 2 inches of probe rod penetration.
- 2 The channel bottom material consisted of 6 to 18 inch diameter riprap with no probe rod penetration.

- 3 Three diagonal 1/16 inch wide cracks on both sides of Pier 1 extending from the the bottom of pier cap to the top of concrete pier encasement.
- 4 Spalled, cracked, and unsound concrete area centered at the waterline, 2 feet wide by 2 feet high, with exposed aggregate and up to 2 inches maximum penetration.

- 5 Random light scaling of below water concrete surfaces with up to 1/8 inch penetration.
- 6 Vertical 1/16 inch wide crack extending from the footing slab up 8 feet through a failing repair patch with a 6 inch diameter spall 2.5 feet above the channel bottom.

- 7 Two vertical 1/16 inch wide cracks extending from 3 to 4 feet above the waterline to the bottom of the wall.
- 8 Vertical 1/16 inch wide crack extending from the top of footing slab up 8 feet through a failing repair patch with 1 foot diameter spall at the footing.

- 9 Vertical 1/16 inch wide crack extending up from the top of footing 8 feet and continuing diagonally to the top of the wingwall.
- 10 Vertical 1/8 inch wide crack extending up from the top of footing 8 feet and continuing diagonally to the top of the wingwall.

- 11 Area of minor section loss 1 1/2 inch by 6 inch with maximum penetration of 6 inches located at the end of the southeast wingwall.
- 12 Corner spall, 6 inches wide by 6 inches high, with 1 inch maximum penetration was observed at the upstream nose of Pier 1 at the waterline.

- 13 In addition to repairs, the North Abutment and Pier 1 have concrete encasements extending from the channel bottom to 4 feet to 5 feet above the waterline. The concrete encasements exhibited minor hairline shrinkage cracking, but were smooth and sound.

- 14 Deterioration of skin coat grout facing, with 1/4 inch penetration near waterline.
- 15 Random 1/16 inch wide cracks in upstream face of dam.
- 16 A 1/4 inch wide crack, 8 feet long with 1 inch of displacement in the southeast wingwall.

- 17 A 1/8 inch wide crack, 8 feet long with 1/8 inch of displacement in the northeast wingwall.
