UNDERWATER BRIDGE INSPECTION REPORT

STRUCTURE NO. 57501
CSAH NO. 22
OVER THE
RED LAKE RIVER
DISTRICT 2 - PENNINGTON COUNTY

AUGUST 27, 2012
PREPARED FOR THE
MINNESOTA DEPARTMENT OF TRANSPORTATION
BY
AYRES ASSOCIATES & COLLINS ENGINEERS, INC.
JOB NO. 7423

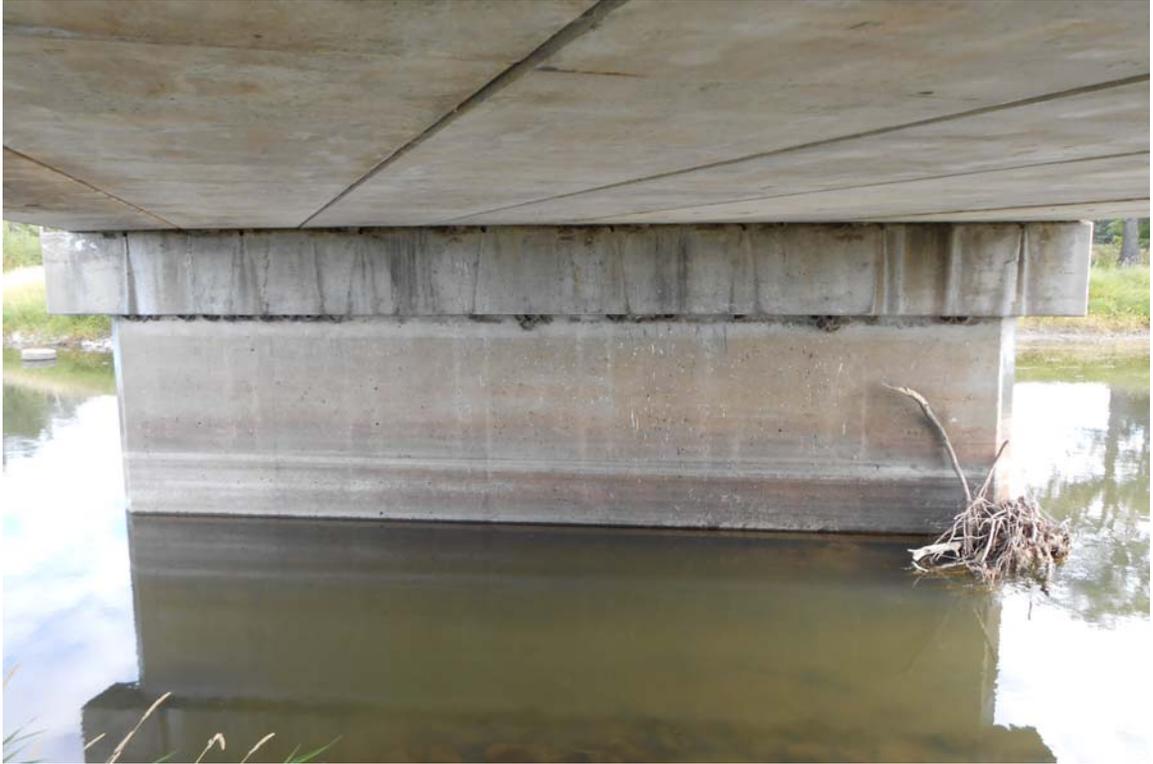
Photograph 1. View of Pier 1, Looking North.

3. The bottom portion of the shaft/footing was broken off at the downstream end of Pier 1 exposing three corroded horizontal steel reinforcing bars. The broken piece of the footing was lying on the channel bottom and was approximately 3 feet long (E/W).

9. The bottom portion (stepout) of concrete shaft was exposed around the entire shaft of Pier 1 with up to full height (1 foot) vertical exposure around the entire pier. Undermining was observed in the location of full height vertical exposure with a maximum of 0.8 feet height at the upstream nose. All of the H-Piles were exposed in the area of undermining with light surface corrosion.

- (A) Monitor the undermining and pile exposure during future inspections and if it continues to increase, scour countermeasures may be warranted at that time.

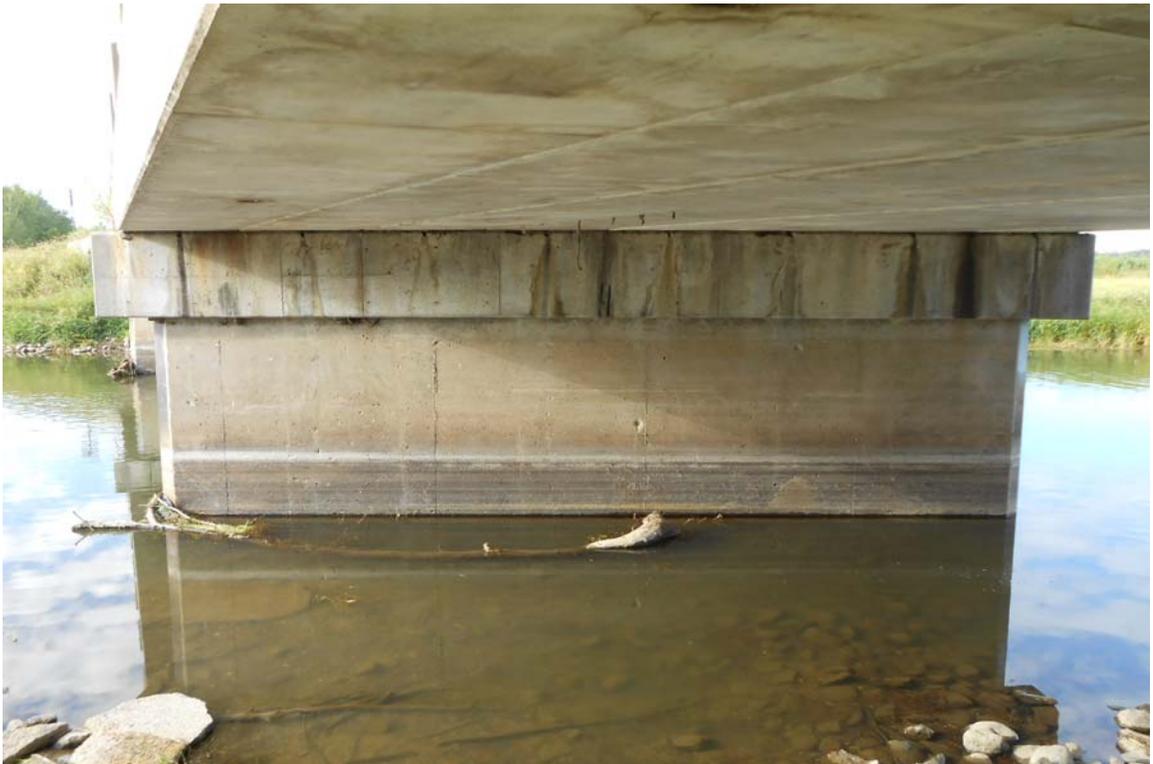
Photograph 2. View of Pier 2, Looking South.

5. Riprap was observed on the channel bottom measuring 1 to 2 feet in diameter at the upstream nose of Pier 2.
6. The shaft bottom step of Pier 2 was cracked and detached at the south eastern corner of Pier 2 with an approximate length of 2.5 feet (E/W) and an approximate width of 8 inches (N/S) and also at the downstream end for a length of 3 feet.

7. The bottom portion (stepout) of the concrete shaft was exposed around the entire shaft of Pier 2 with up to full height (1 foot) vertical exposure from the upstream 1/4 point of the south face, around upstream nose to the upstream 1/4 point on the north face. Undermining was observed in the location of full height vertical exposure with a maximum of 0.4 foot height at the upstream nose. The eastern most steel H-Pile was exposed in the area of undermining with light surface corrosion.

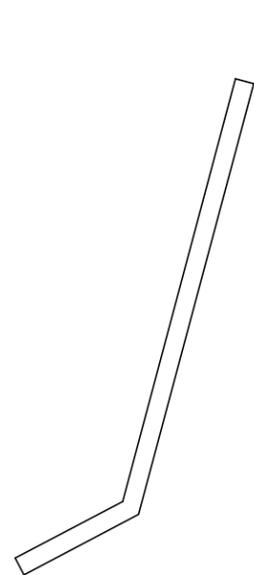
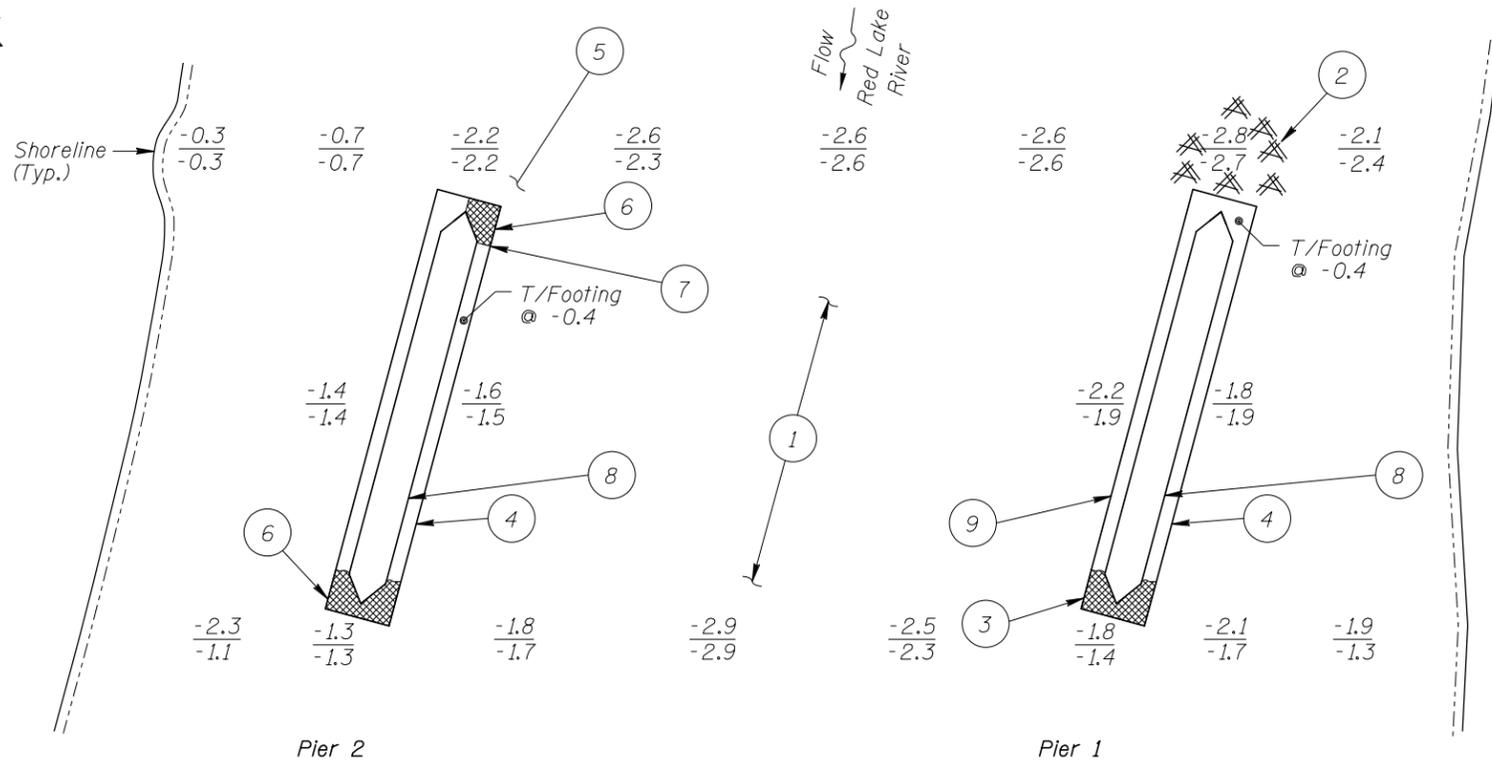
INSPECTION AND SOUNDING PLAN

1. The channel bottom material consisted of silty sand and gravel with scattered 6 to 8 inch diameter cobbles and up to 3 inches of probe rod penetration.

2. A light to moderate accumulation of 6 inch diameter timber debris was observed from 1 foot above the waterline to the channel bottom and 5 feet from the upstream nose of Pier 1.

4. The concrete of the bottom portion of the shaft/footing at Piers 1 and 2 was frequently soft on the surface with random irregularities and section losses having up to 5 inches of penetration.

8. The concrete of the pier cap and shaft for Pier 1 and 2 was typically smooth and sound with random minor areas of poor consolidation with 1/4 inch maximum penetration and with minor vertical hairline to 1/16 inch wide cracks extending the full height of the pier.
