UNDERWATER BRIDGE INSPECTION REPORT

STRUCTURE NO. 57502
CSAH NO. 24
OVER THE
RED LAKE RIVER
DISTRICT 2 - PENNINGTON COUNTY

AUGUST 27, 2012
PREPARED FOR THE
MINNESOTA DEPARTMENT OF TRANSPORTATION
BY
AYRES ASSOCIATES & COLLINS ENGINEERS, INC.
JOB NO. 7423

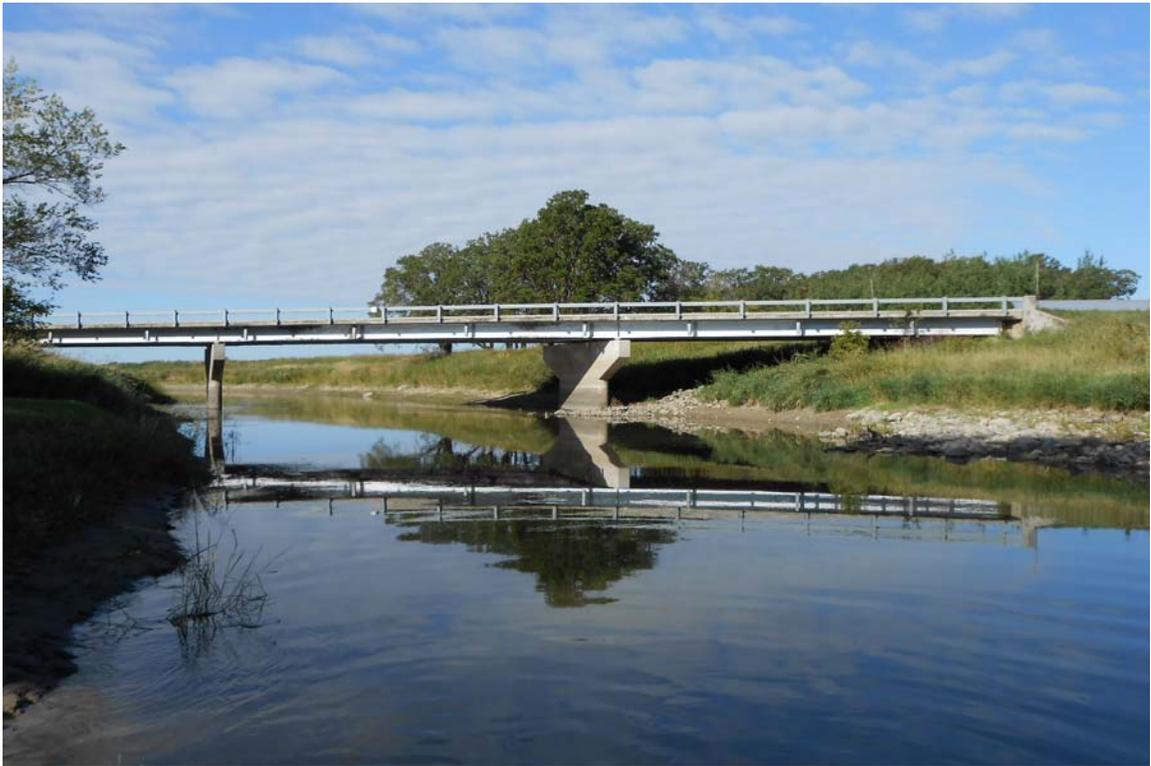
Photograph 1. Overall View of the Structure, Looking East.

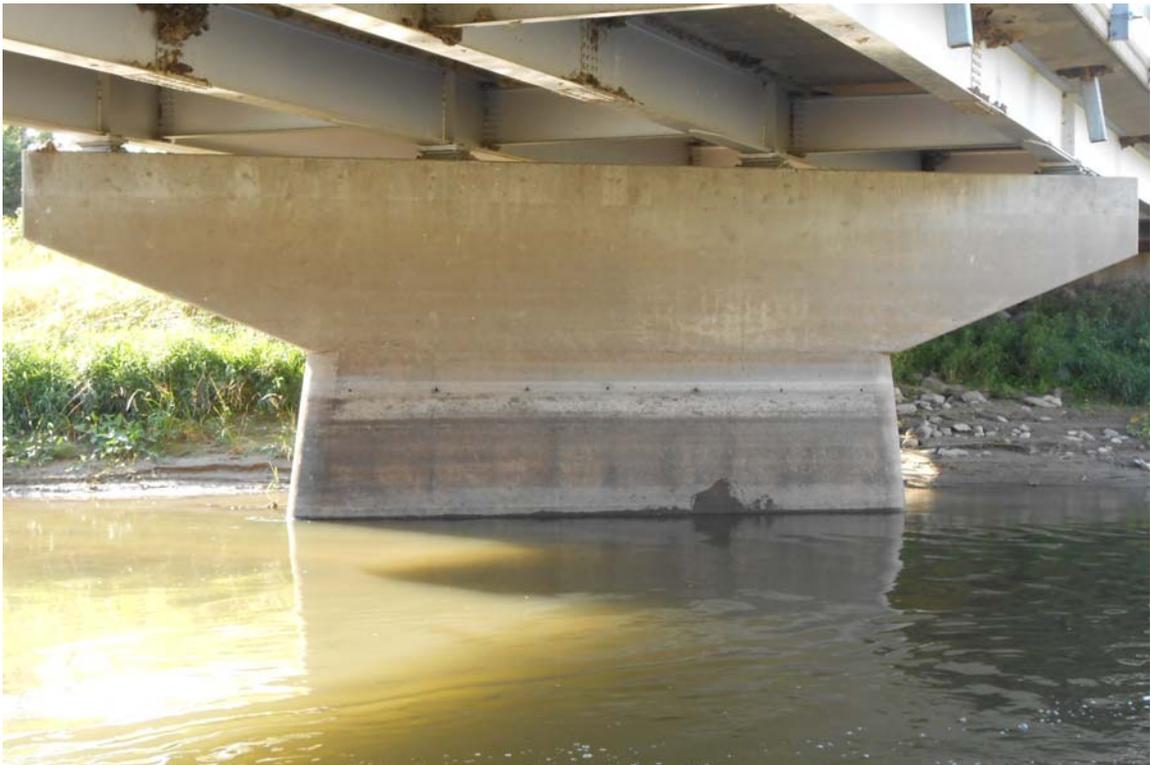
Photograph 2. View of Pier 1, Looking South.

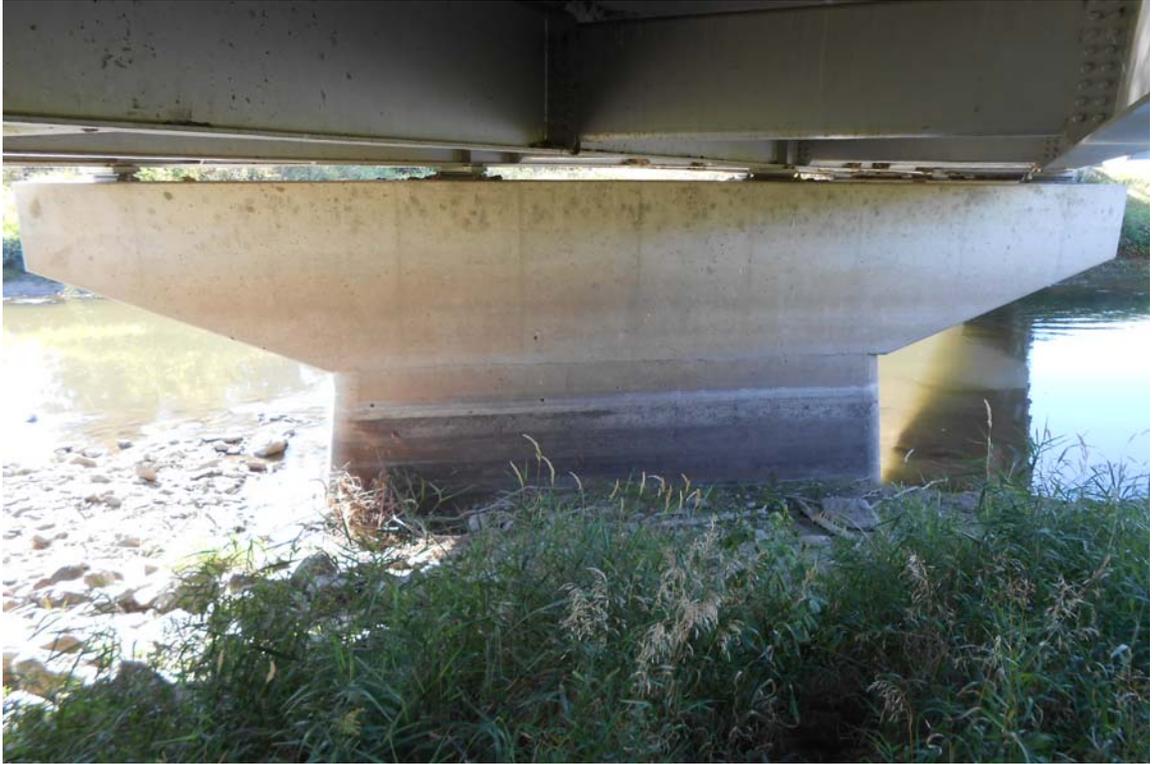
Photograph 3. View of Pier 2, Looking South.

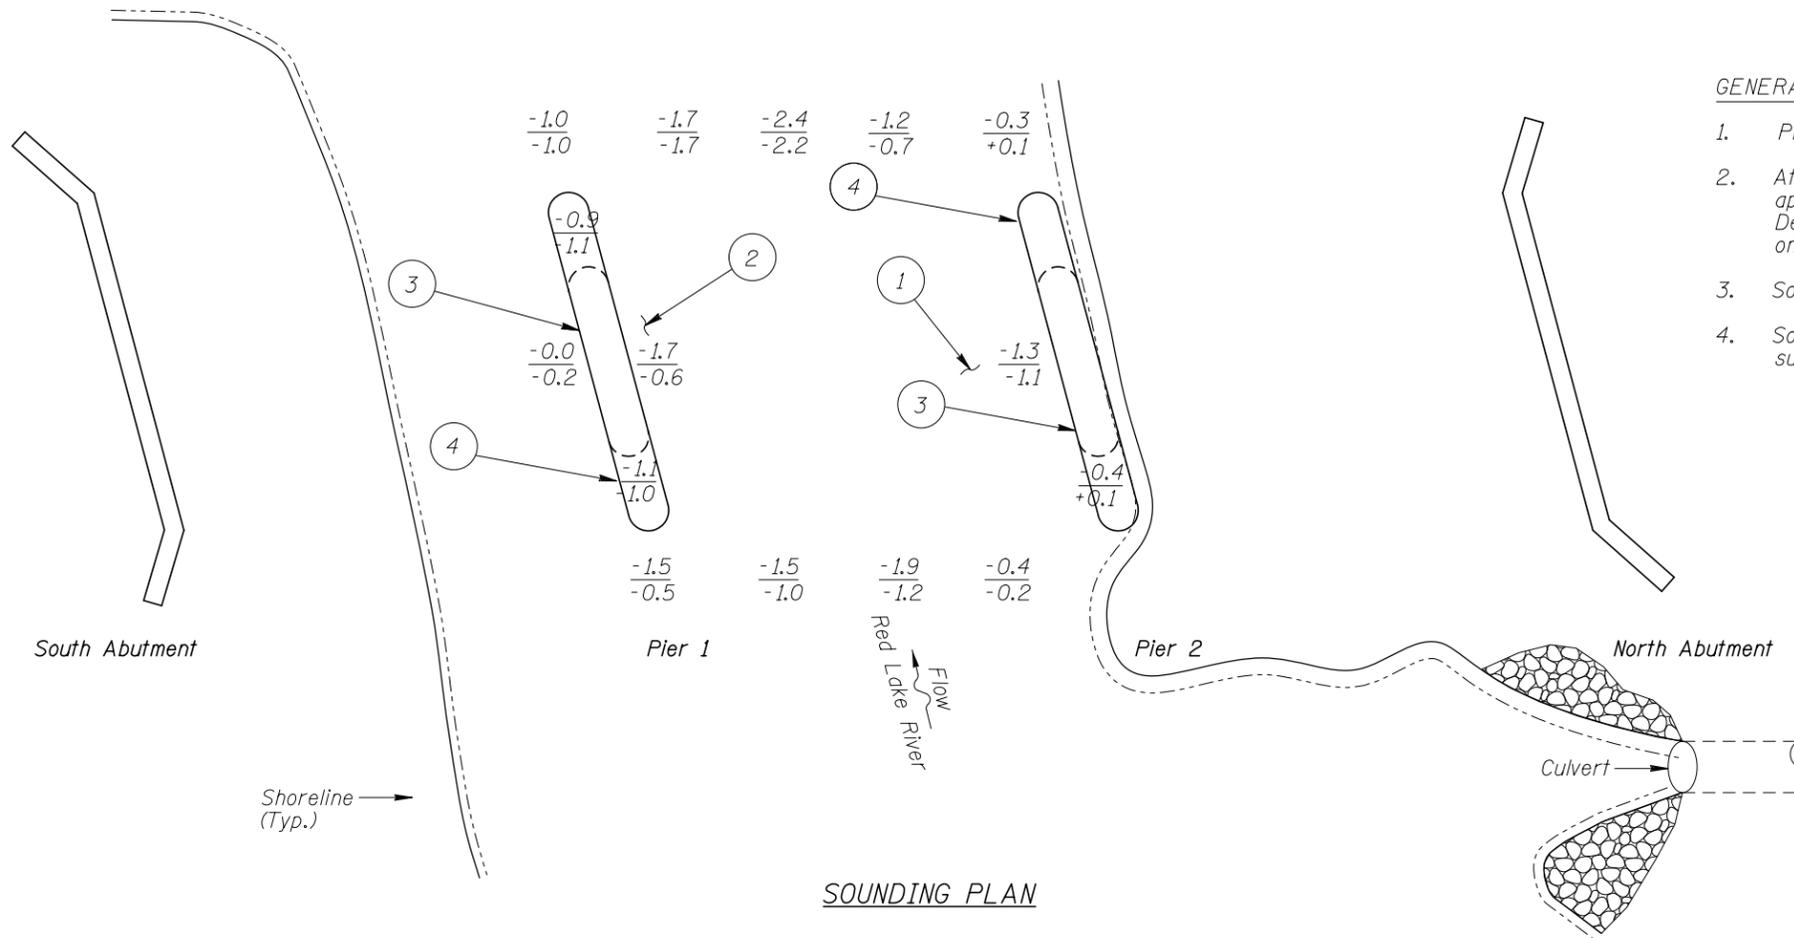
- 1 The channel bottom material around Pier 2 consisted of silty sand with up to 12 inches maximum probe rod penetration.
- 2 The channel bottom material around Pier 1 consisted of sand with 3 inches of maximum probe rod penetration.
- 3 The concrete was typically smooth and sound with random minor areas of poor consolidation with up to 1/4 inch penetration on the faces of Piers 1 and 2.
- 4 Minor scaling was observed from the channel bottom to 5 feet above the waterline (bottom of hammerhead pier cap) with up to 1/4 inch maximum penetration on the upstream noses of Piers 1 and 2.
