UNDERWATER BRIDGE INSPECTION REPORT

STRUCTURE NO. 57503
CSAH NO. 7
OVER THE
RED LAKE RIVER
DISTRICT 2 - PENNINGTON COUNTY

AUGUST 28, 2012
PREPARED FOR THE
MINNESOTA DEPARTMENT OF TRANSPORTATION
BY
AYRES ASSOCIATES & COLLINS ENGINEERS, INC.
JOB NO. 7423

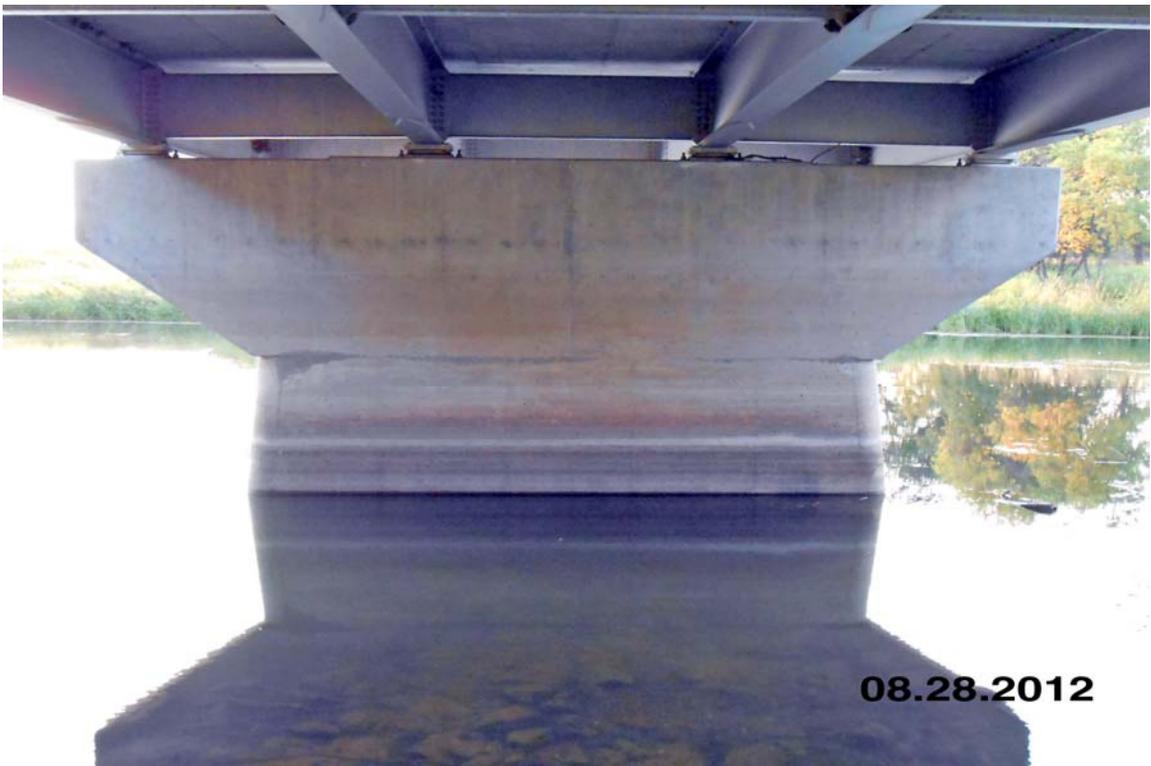
- (A) An 8-inch length of exposed reinforcing steel was observed at the waterline at the upstream end of Pier 1.
- (B) A minor scour depression 3 feet in diameter and 1 foot deep, was observed at the upstream end of Pier 2.
- (C) A moderate accumulation of timber debris, which included drift up to 1 foot in diameter, was observed around the upstream nose from the channel bottom to the waterline and extending 10 feet off the faces and noses of Pier 1.
- (D) A minor accumulation of timber debris build-up was observed at the upstream nose of Pier 2.

Photograph 2. View of Pier 1, Looking East.

- ② A minor scour depression, 1 foot deep with a radius of 3 feet, was observed at the upstream end of Pier 2.
- ③ A moderate accumulation of timber debris, which included drift up to 1 foot in diameter, was observed around the entire perimeter of Pier 1 from the channel bottom to the waterline and up to 10 feet off the pier faces and noses.

- (A) The timber debris accumulation at Pier 1 did not significantly affect the channel flow, and as a result, does not require removal at this time. If the debris accumulation increases in size or density, it may be necessary to remove the debris to reduce excessive lateral loads on the pier, limit further debris accumulation, and reduce the likelihood of channel bottom degradation resulting from obstructed flow.

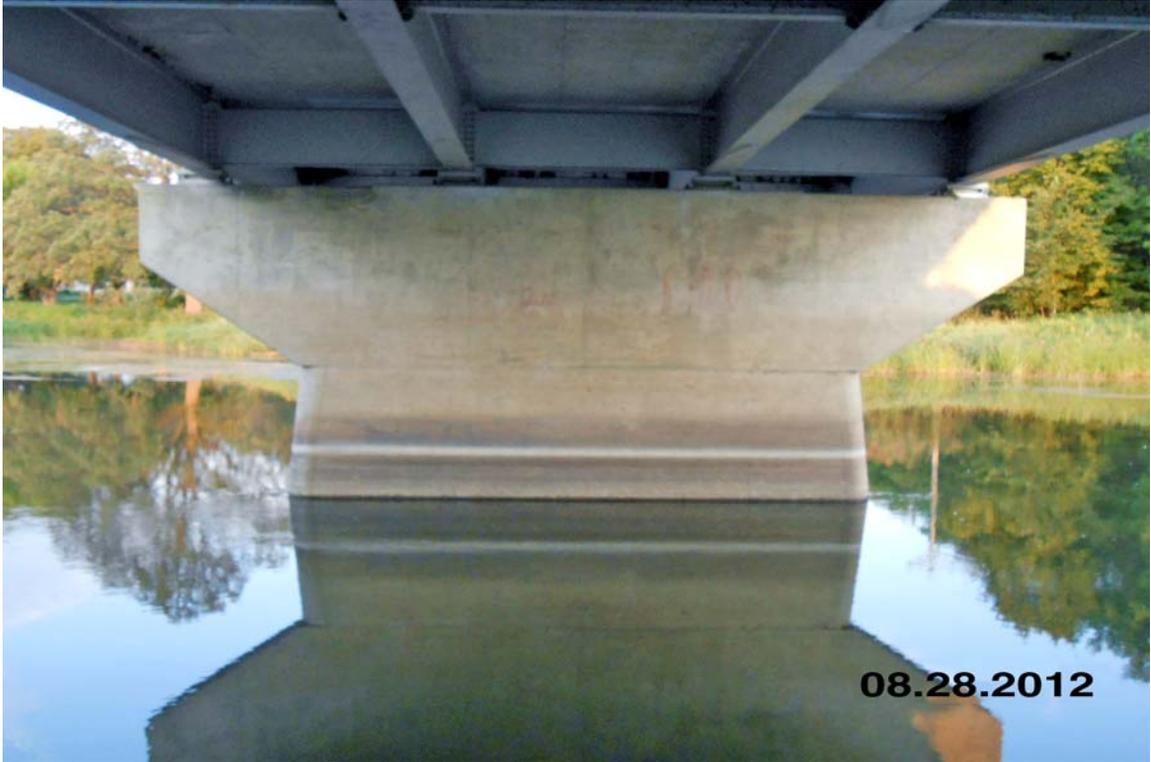
Photograph 3. View of Pier 2, Looking West.

- ④ A minor accumulation of timber debris build-up was observed at the upstream nose of Pier 2.
- ⑤ The channel bottom around the entire perimeters of Piers 1 and 2 consisted of sand and gravel and random rip rap up to 1 foot in diameter with up to 6 inches of probe rod penetration.

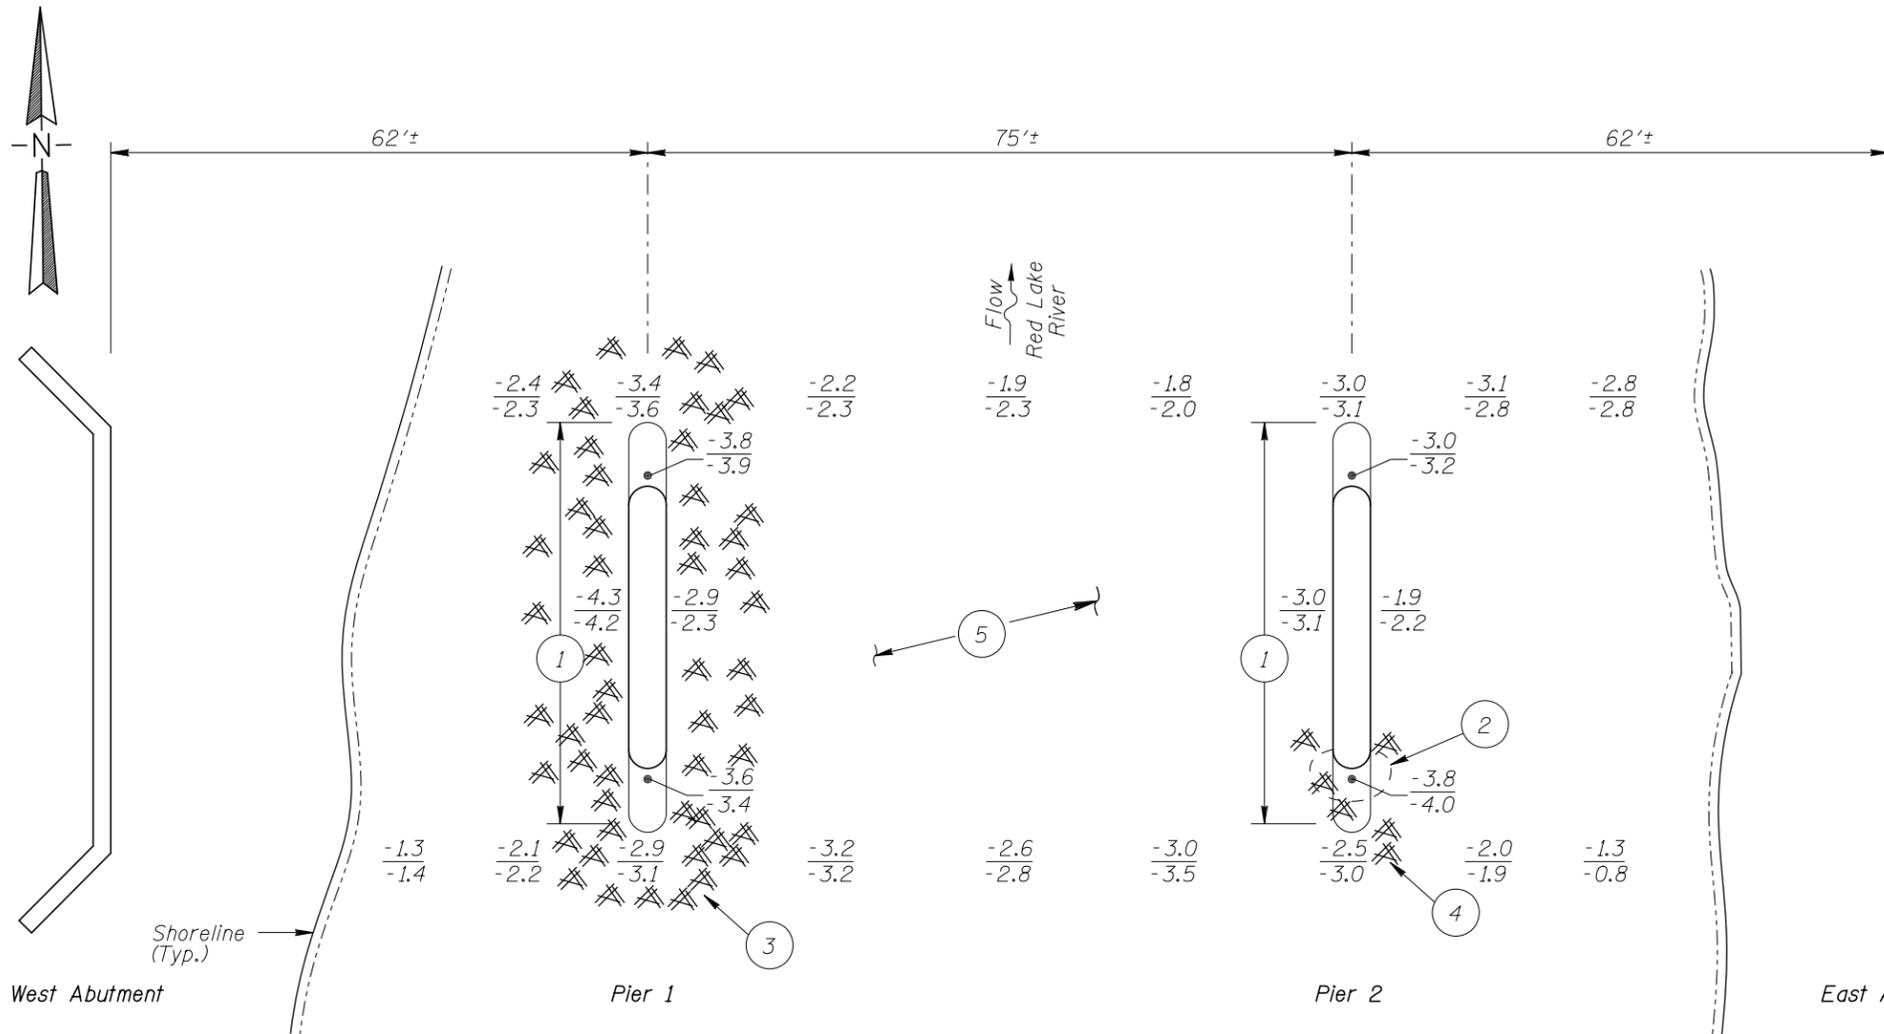
INSPECTION AND SOUNDING PLAN

- ① Overall, the concrete piers were smooth and sound with an 8-inch length of exposed reinforcing steel located at the waterline at the upstream end of Pier 1. In addition, minor scaling was observed at the upstream nose of Piers 1 and 2 from channel bottom to 4 feet above the waterline.
