UNDERWATER BRIDGE INSPECTION REPORT

STRUCTURE NO. 57504

THIEF RIVER

AUGUST 16, 2012

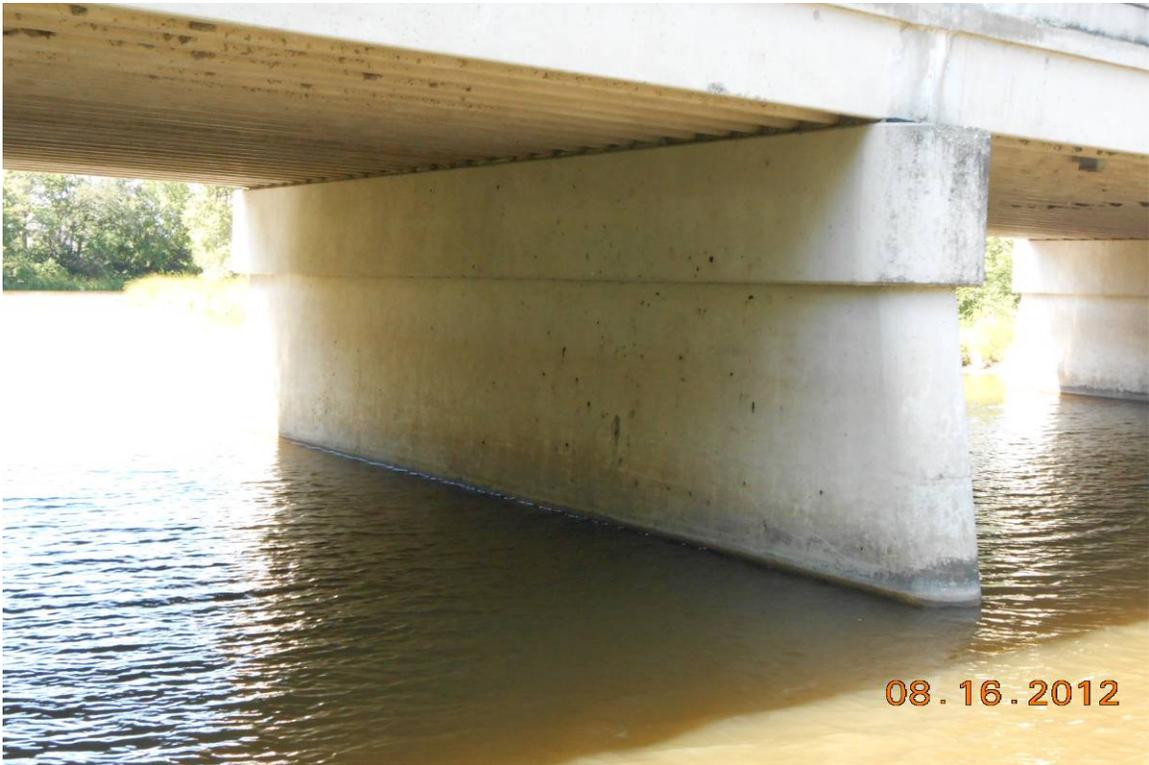
- (A) A light accumulation of timber debris consisting of twigs and small branches was observed at the upstream half of the south face from the channel bottom up 1 foot and extending up to 3 feet off of Pier 1 noses and faces.
- (B) Similar accumulation of timber debris was observed around Pier 2. The debris extended from the channel bottom up 1 foot and up to 2 feet off of the pier faces and noses.
- (C) Overall, the concrete piers were in good condition with no significant defects observed.

Photograph 2. View of Pier 1, Looking Northwest.

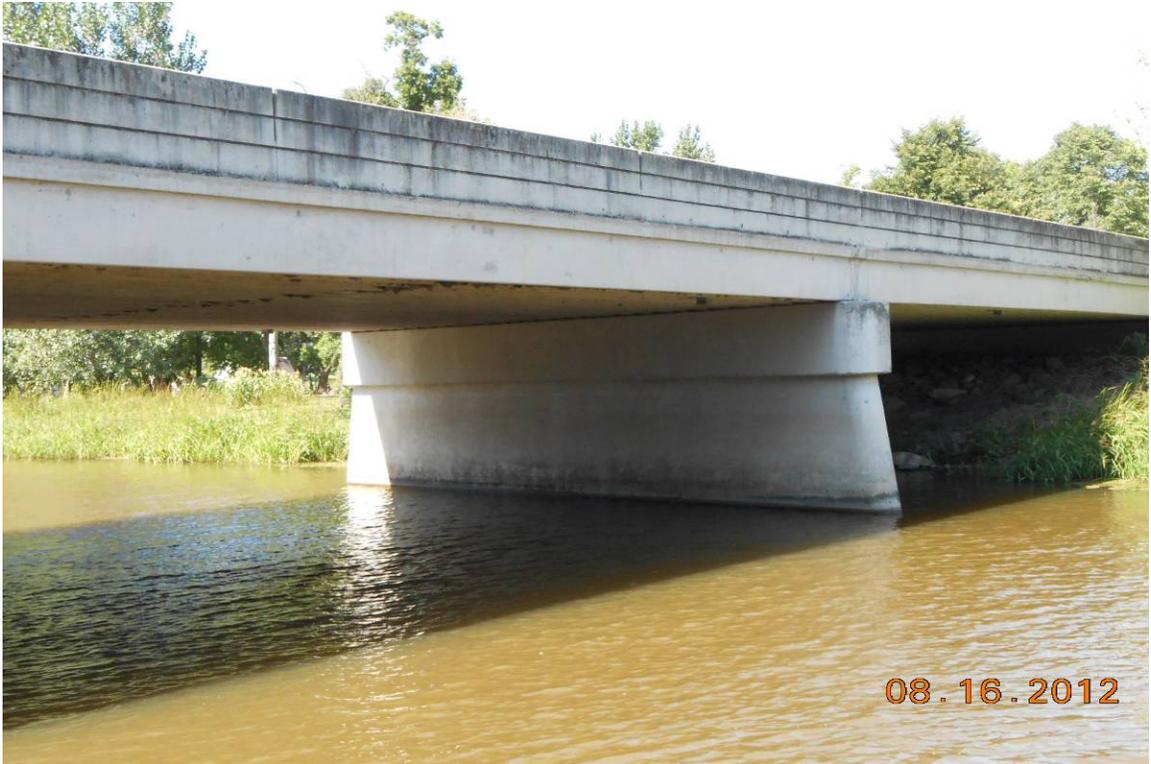
Photograph 3. View of Pier 2, Looking Northwest.

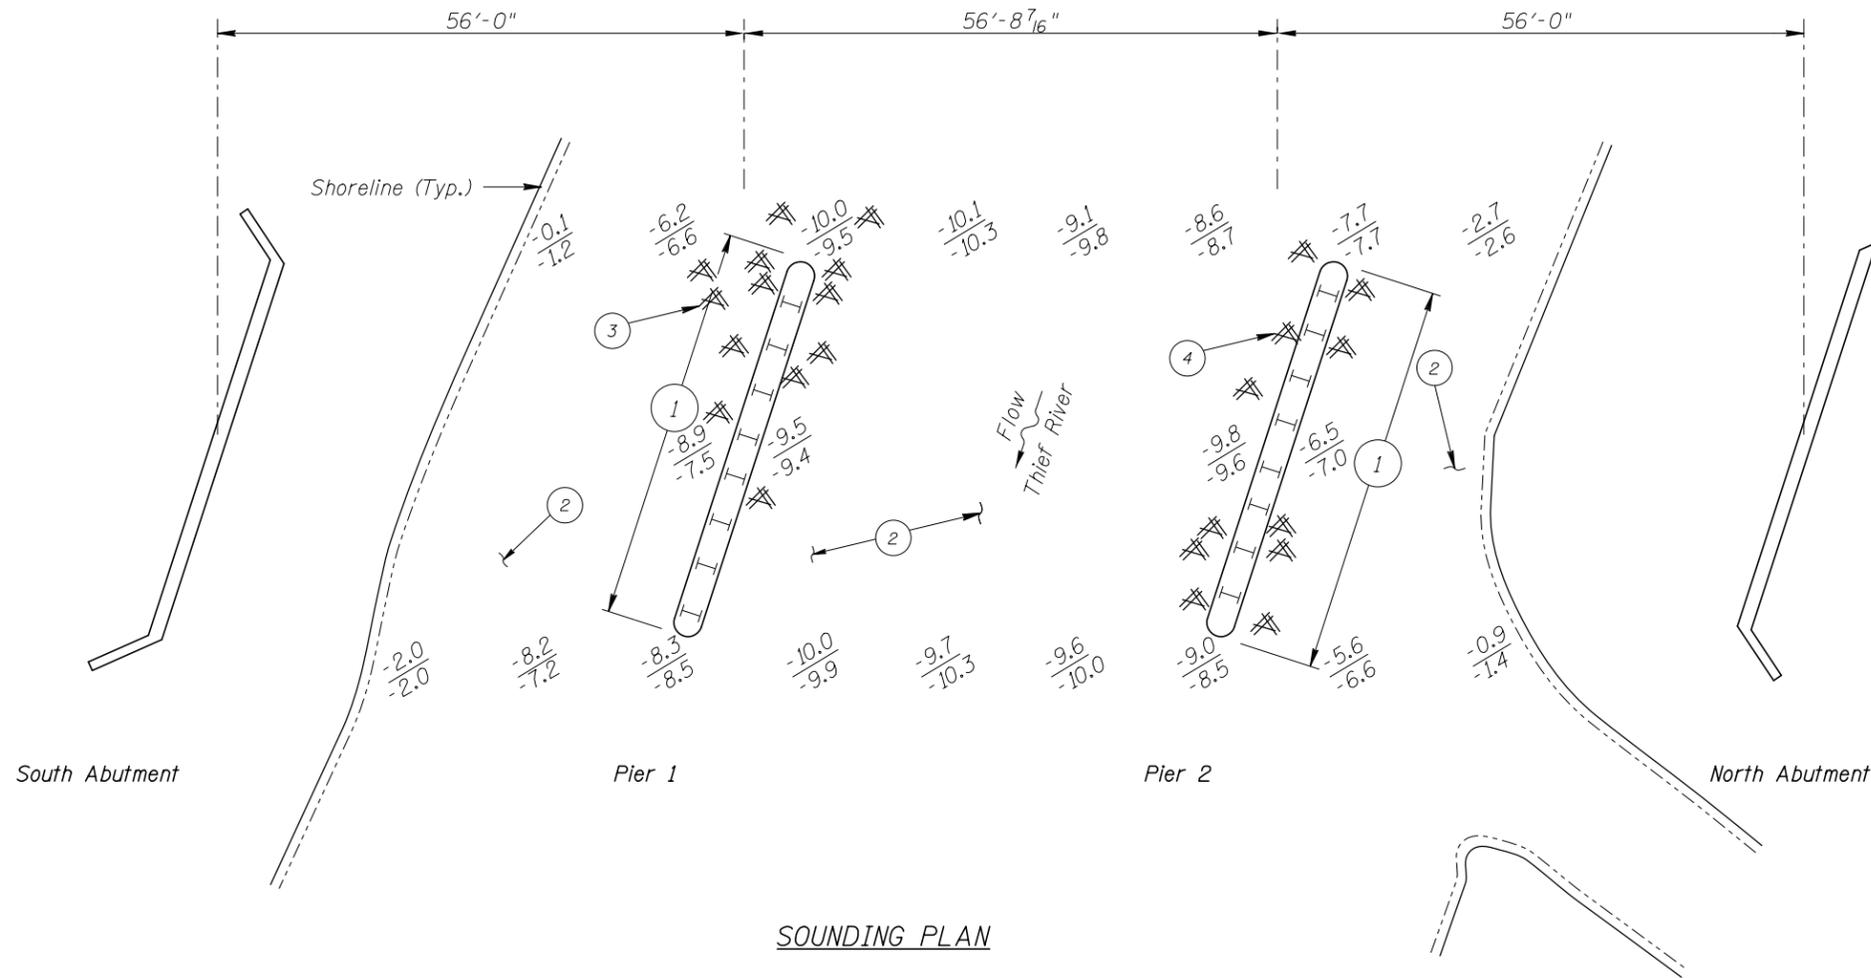
Date: AUG. 2012  
Scale: NTS  
Figure No.: 1

- ① Overall, the concrete of piers was smooth and sound. Minor areas of impact damage were observed on the upstream nose of Pier 1 from the waterline to 4 feet above waterline with up to 1/2 inch penetration.
- ② The channel bottom around the entire perimeter of Pier 1 and 2 consisted of 1 to 6 inches of soft silt over firm gravel, cobbles and scattered riprap.
- ③ A light accumulation of timber debris consisting of twigs and small branches was observed around at the upstream half of the south face from the channel bottom up 1 foot and extending up to 3 feet off Pier 1 noses and faces.
- ④ A light accumulation of timber debris consisting of twigs and small branches was observed around Pier 2 extending from the channel bottom up 1 foot and up to 2 feet off the pier faces and noses.

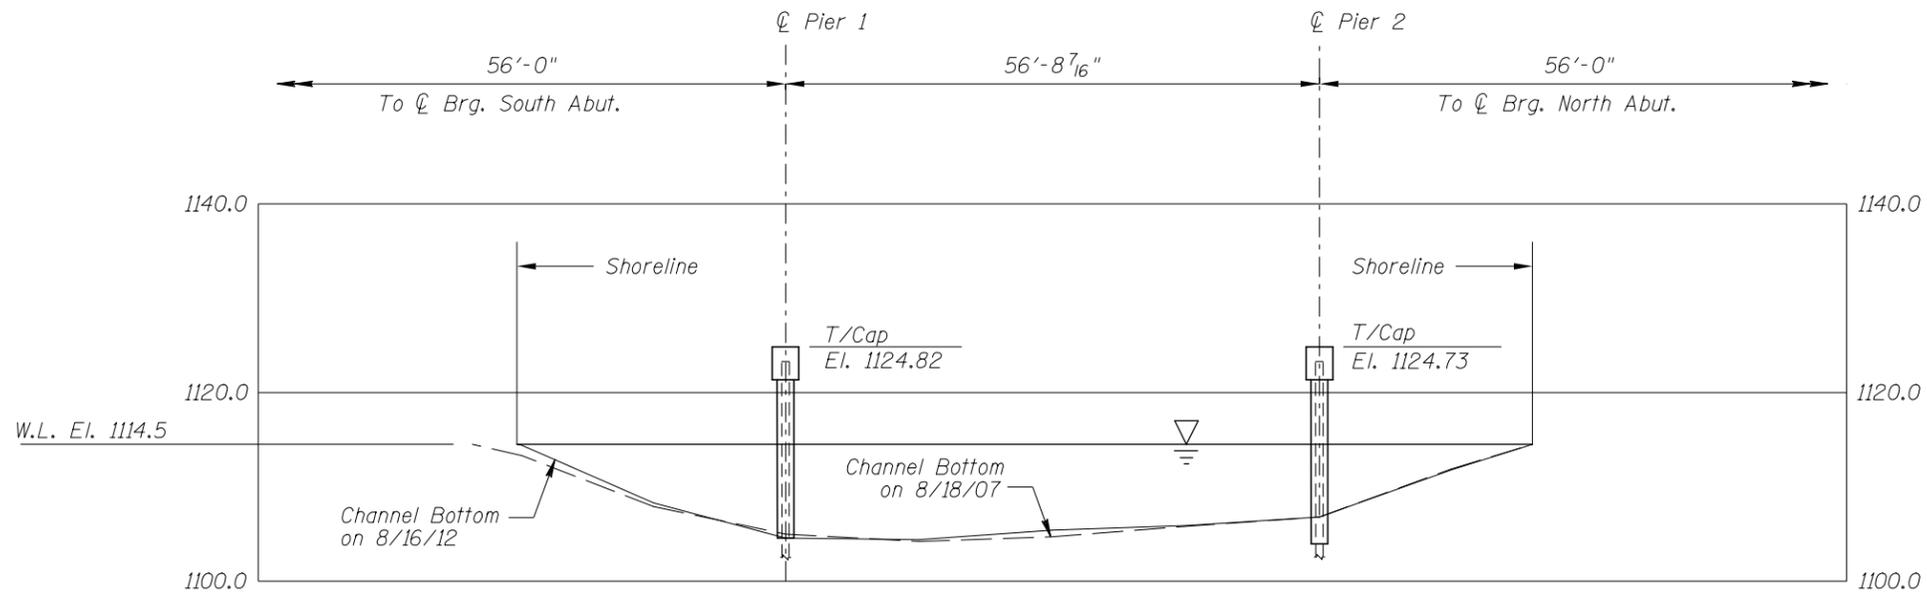
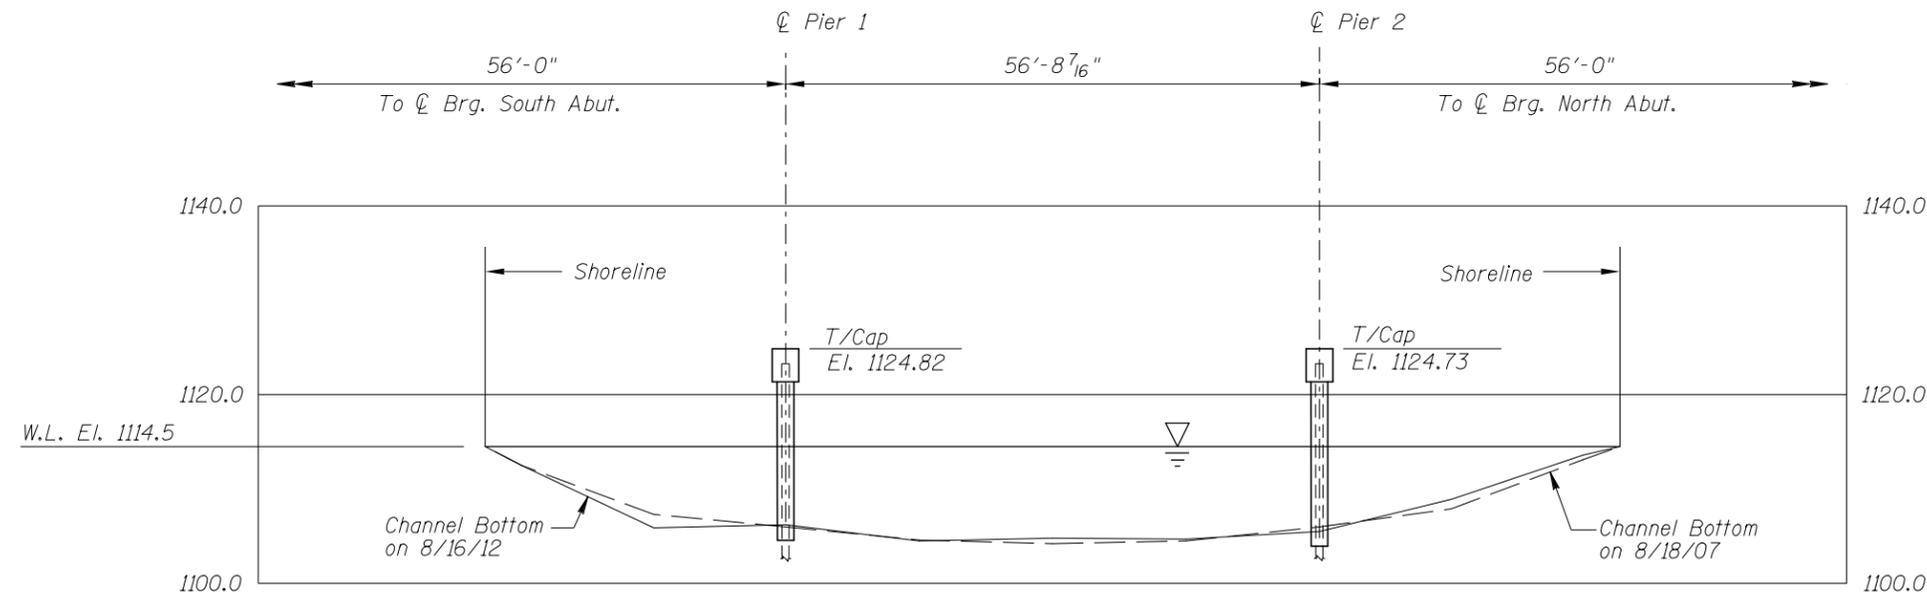
<b>MINNESOTA DEPARTMENT OF TRANSPORTATION UNDERWATER BRIDGE INSPECTION</b>	
STRUCTURE NO. 57504 OVER THE THIEF RIVER DISTRICT 2, PENNINGTON COUNTY	
<b>UPSTREAM AND DOWNSTREAM FASCIA PROFILES</b>	
Drawn By: JAC	Date: AUG, 2012
Checked By: BKS	Scale: 1"=20'
Code: 52210038	Figure No.: 2

UPSTREAM FASCIA PROFILE

DOWNSTREAM FASCIA PROFILE
