UNDERWATER BRIDGE INSPECTION REPORT

STRUCTURE NO. 57517

THIEF RIVER

AYRES ASSOCIATES & COLLINS ENGINEERS, INC.

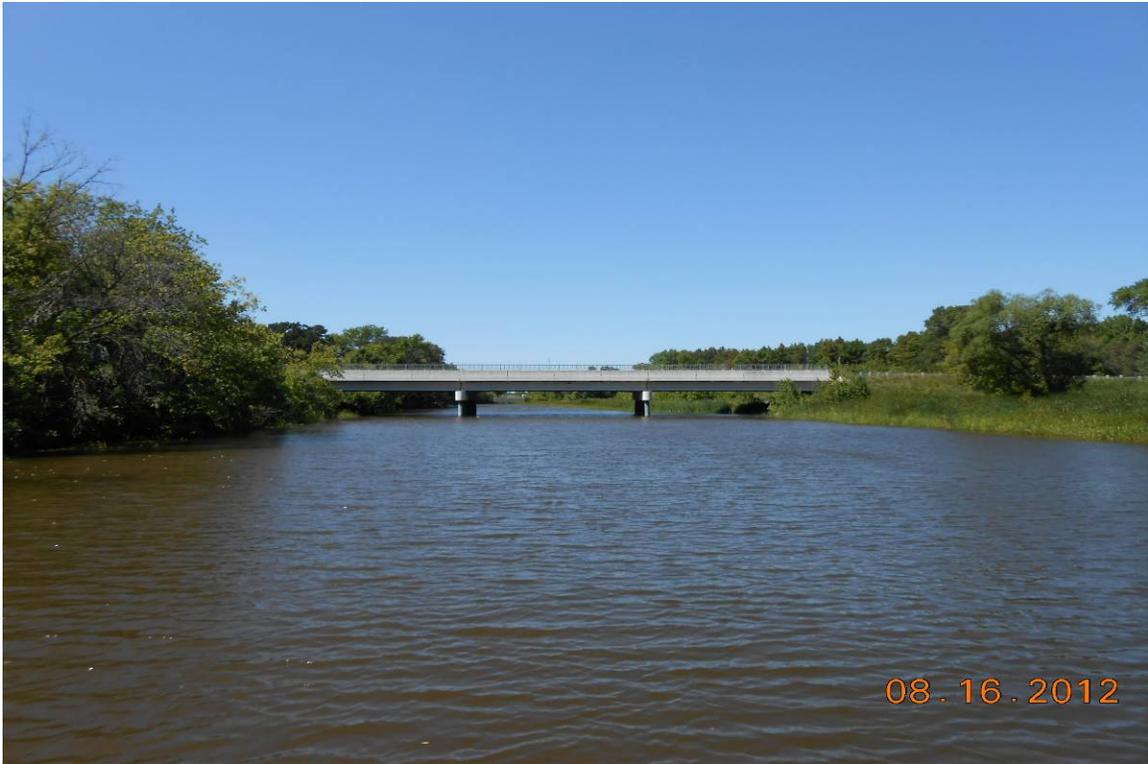
Photograph 1. Overall View of the Structure, Looking Northwest.

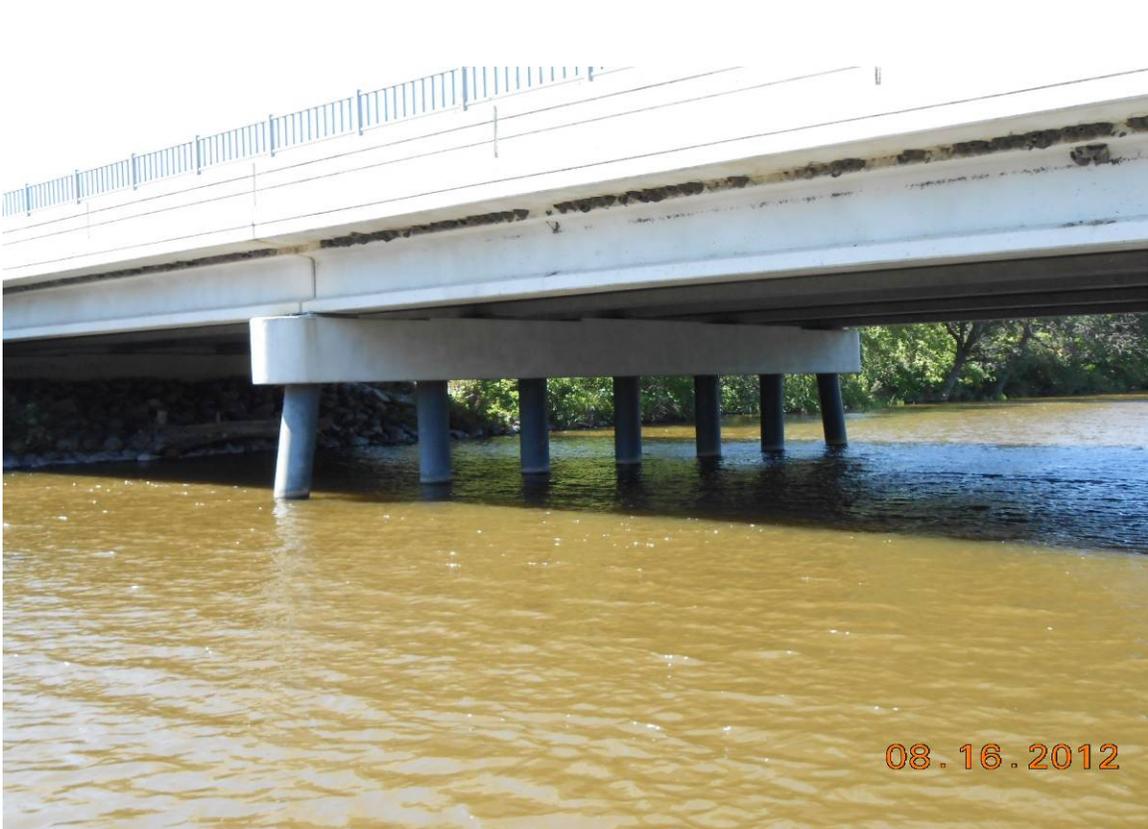
- (D) A moderate accumulation of timber debris consisting of 1 foot diameter and smaller branches was observed along both sides and in between all piles at Pier 1.

Photograph 2. View of Pier 1, Looking West.

- (A) Monitor the timber debris, and if found to be increasing in the future, removal operations may become warranted.
- (B) Reinspect the submerged substructure units at the normal maximum recommended (NBIS) interval of sixty (60) months.

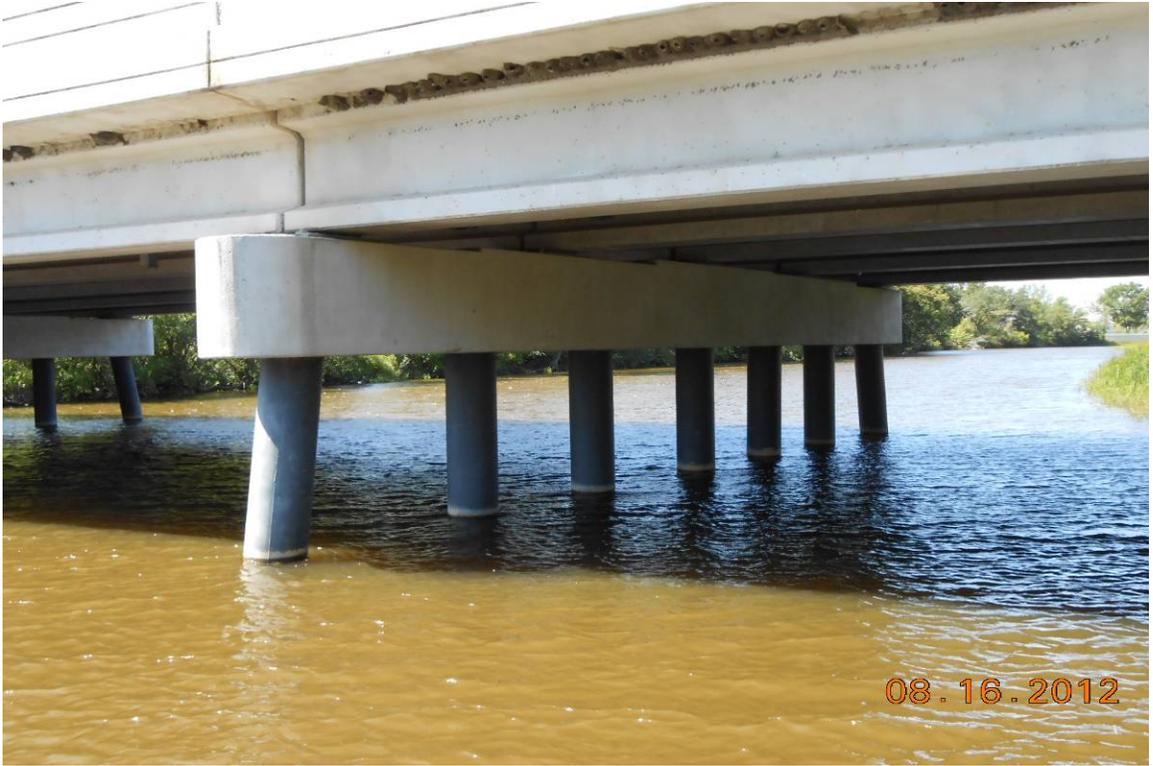
- (C) A light accumulation of timber debris consisting of 3 inch diameter and smaller branches was observed along both sides and in between all piles at Pier 2.

Photograph 3. View of Pier 2, Looking West.

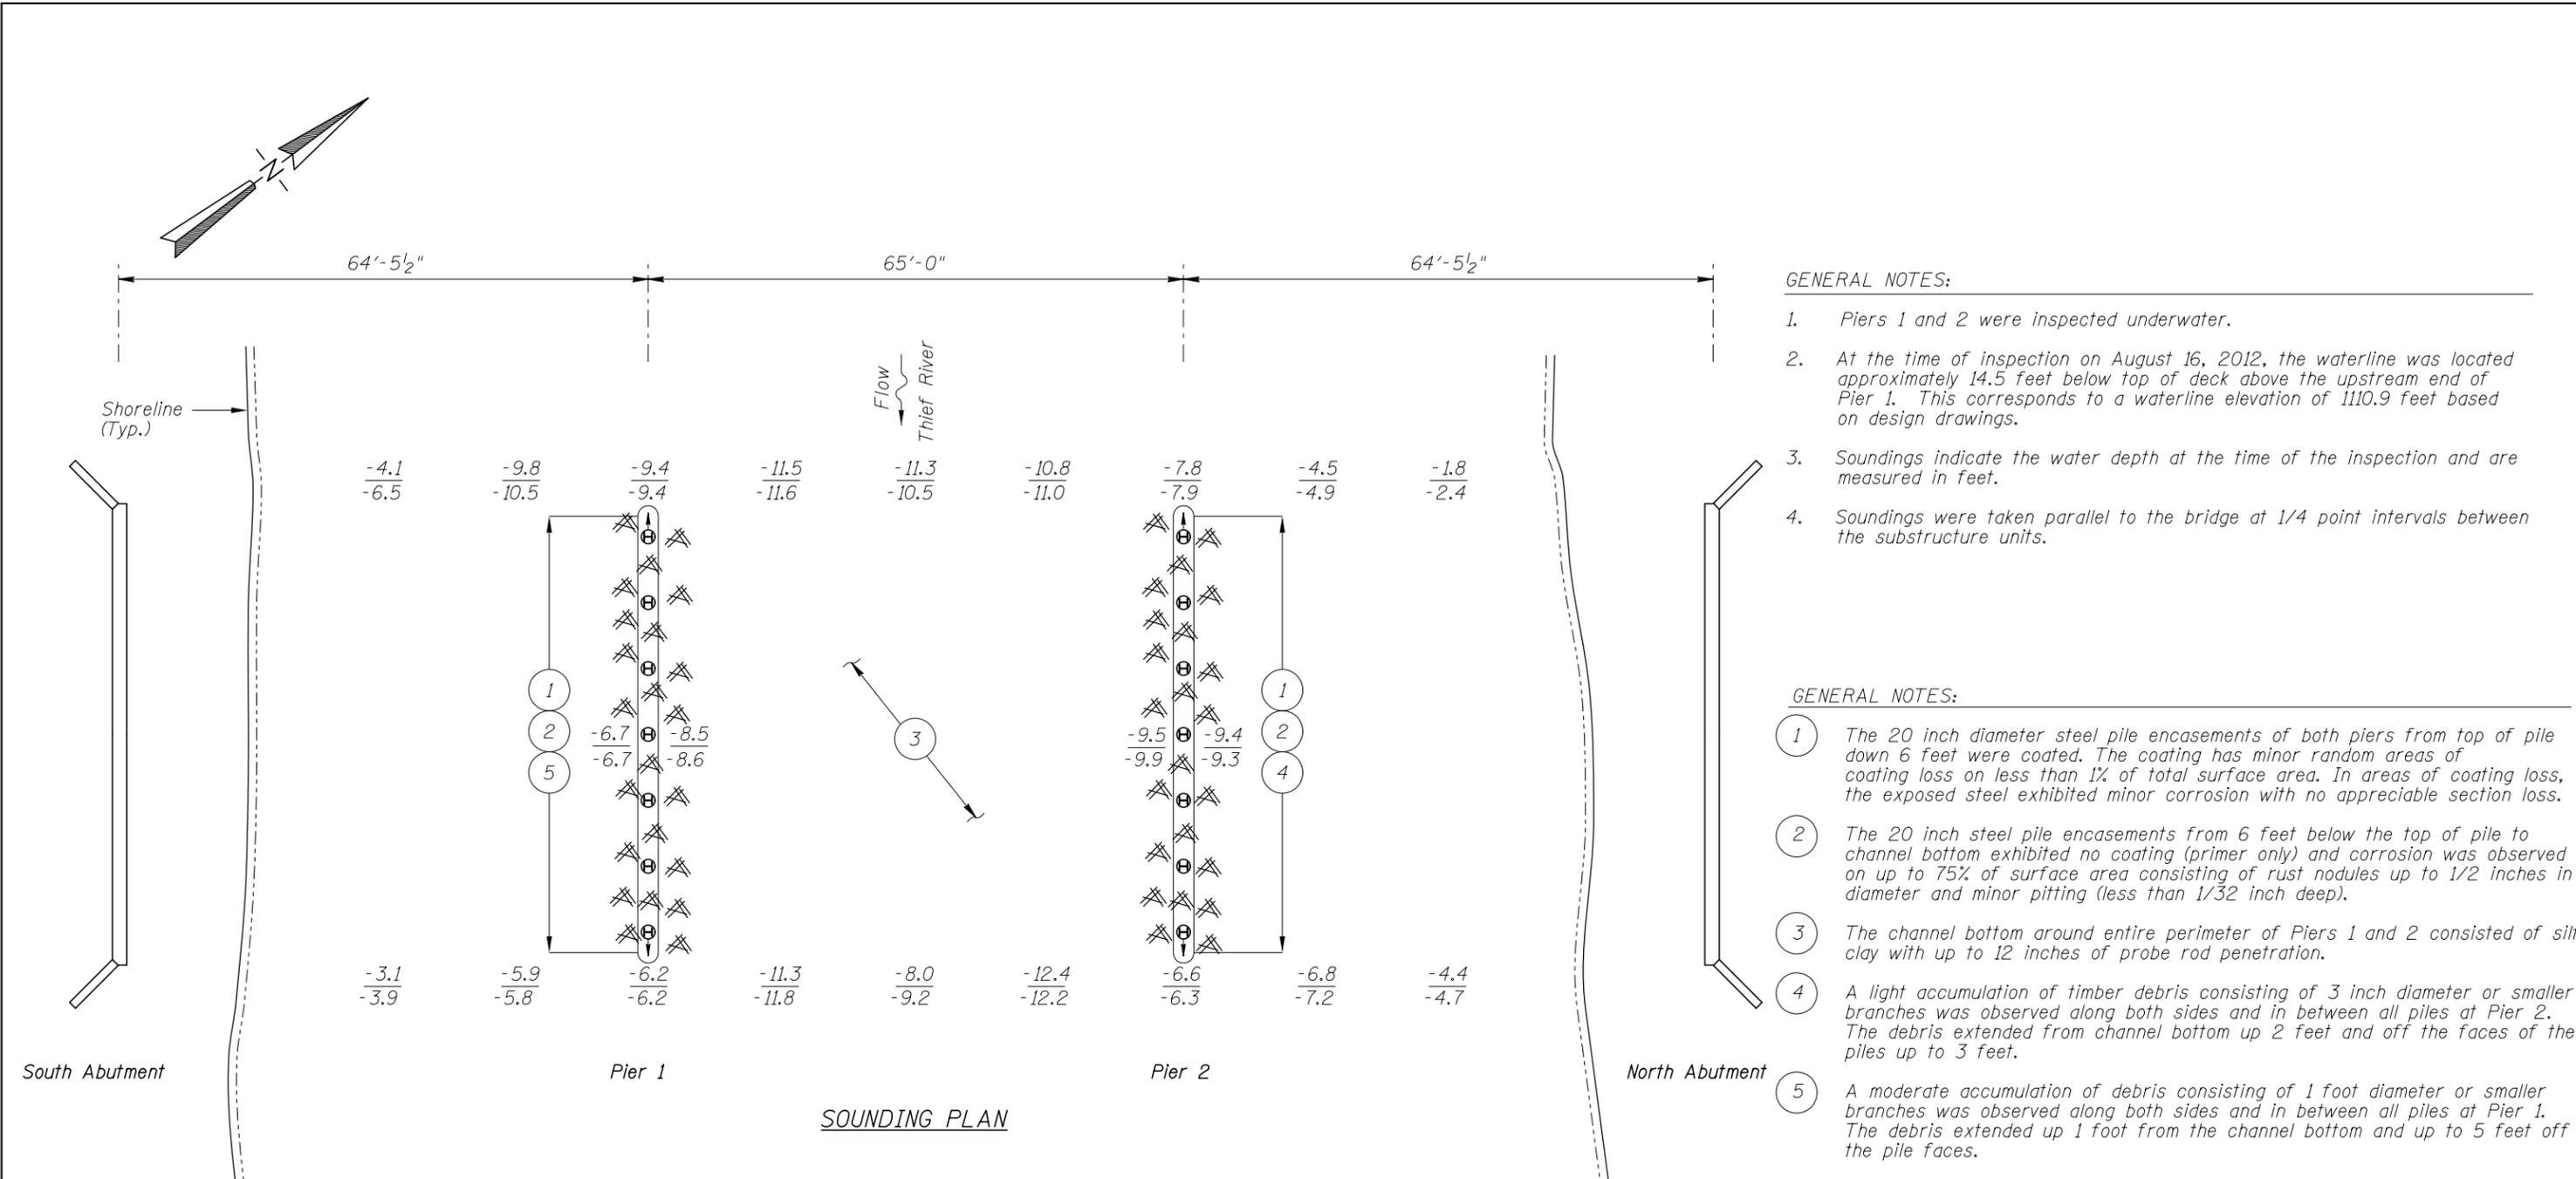
| INSPECTION AND SOUNDING PLAN | |

The substructure units inspected at Bridge No. 57517, Piers 1 and 2, were in good condition with no defects of structural significance observed. The channel bottom appeared to be stable with no evidence of significant scour.
