UNDERWATER BRIDGE INSPECTION REPORT

STRUCTURE NO. 57518  
CSAH NO. 3  
OVER THE  
RED LAKE RIVER  
DISTRICT 2 - PENNINGTON COUNTY

AUGUST 27, 2012  
PREPARED FOR THE  
MINNESOTA DEPARTMENT OF TRANSPORTATION  
BY  
AYRES ASSOCIATES & COLLINS ENGINEERS, INC.  
JOB NO. 7423

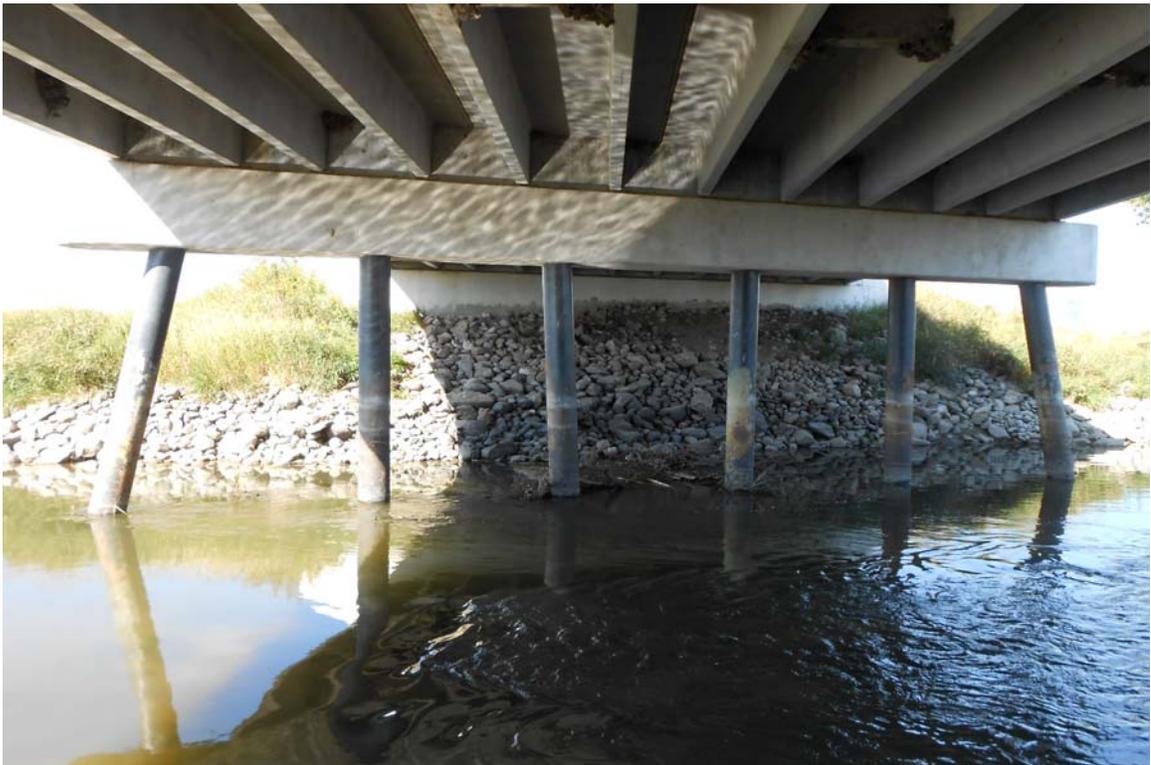
- (B) Pier 1, Pile B (second pile from the south) has hollow sounds at west face, 3 feet high, starting 6 feet below cap. Pier 1, Pile E (second pile from the north) has hollow sounds at west face, 4 feet high, starting 5 feet below cap. Pier 1, Pile F (northern most pile) has hollow sounds at west face, from 6 feet below cap to ground line.

Photograph 2. View of Pier 1 and West Abutment, Looking West.

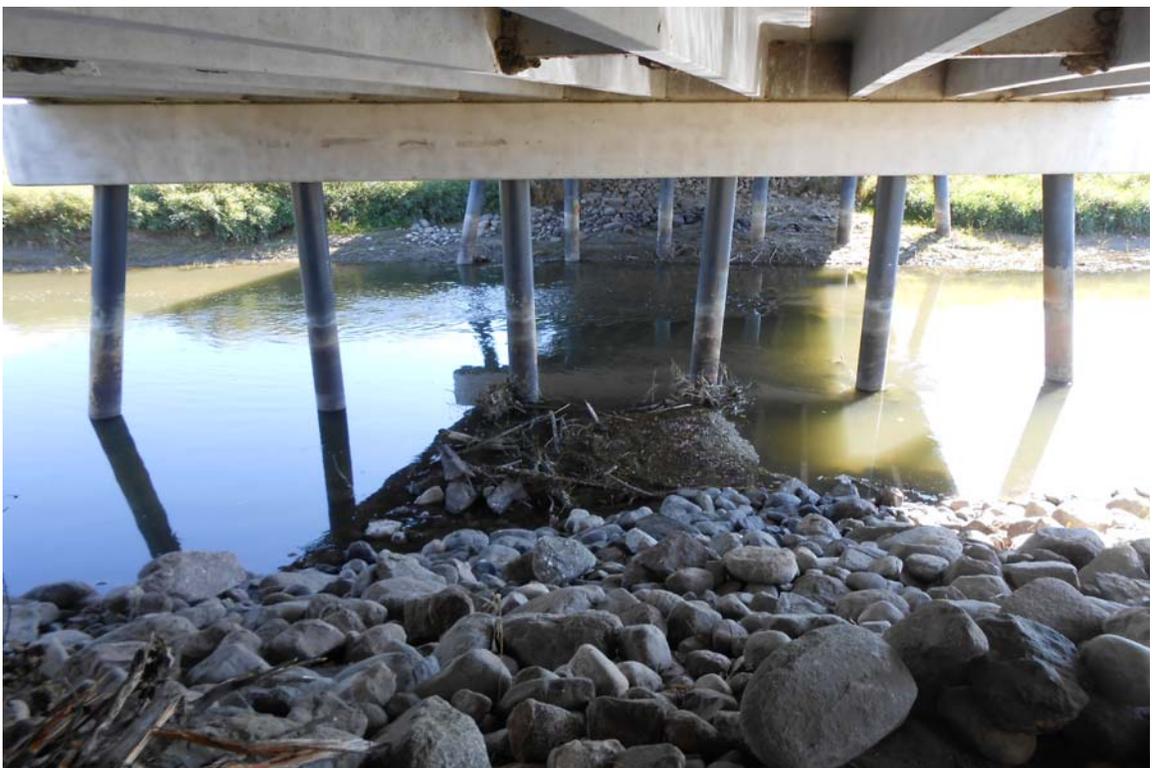
- (C) Light to moderate accumulations of timber debris and organic material were observed around Piles B through D of Pier 1.

Photograph 4. View of Debris near the Middle Piles of Pier 1, Looking East.

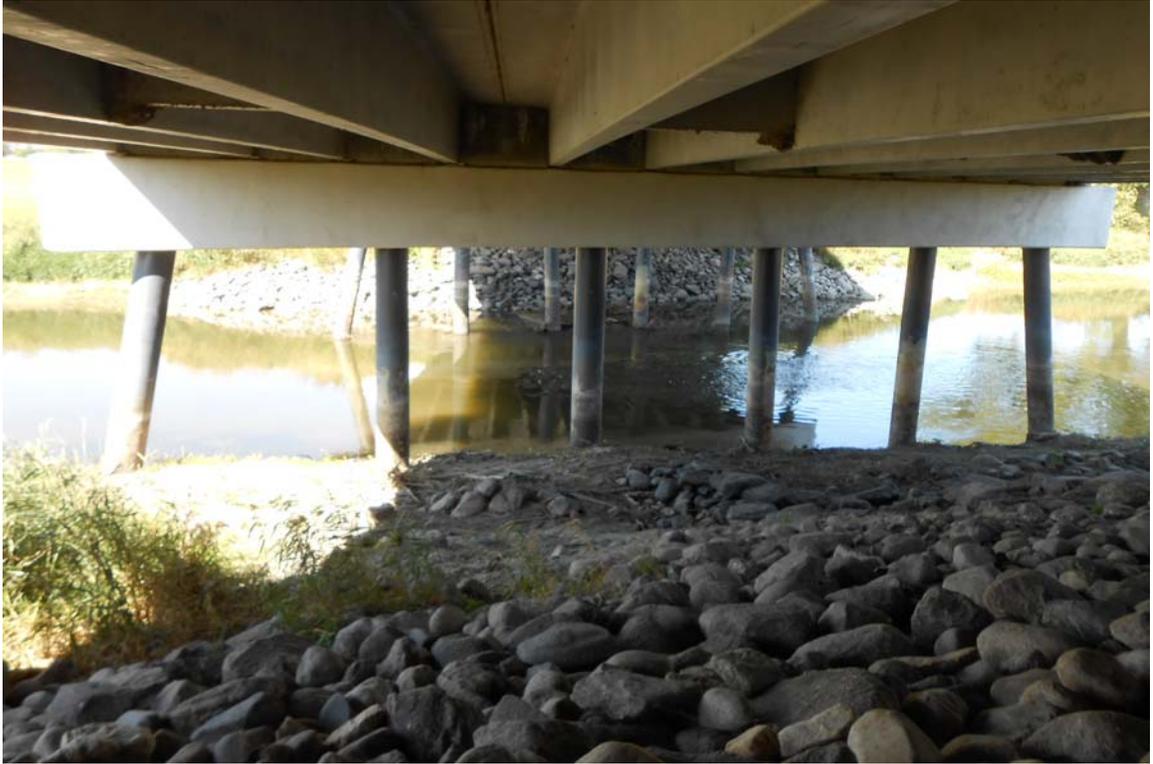
Photograph 5. View of Pier 2, Looking West.

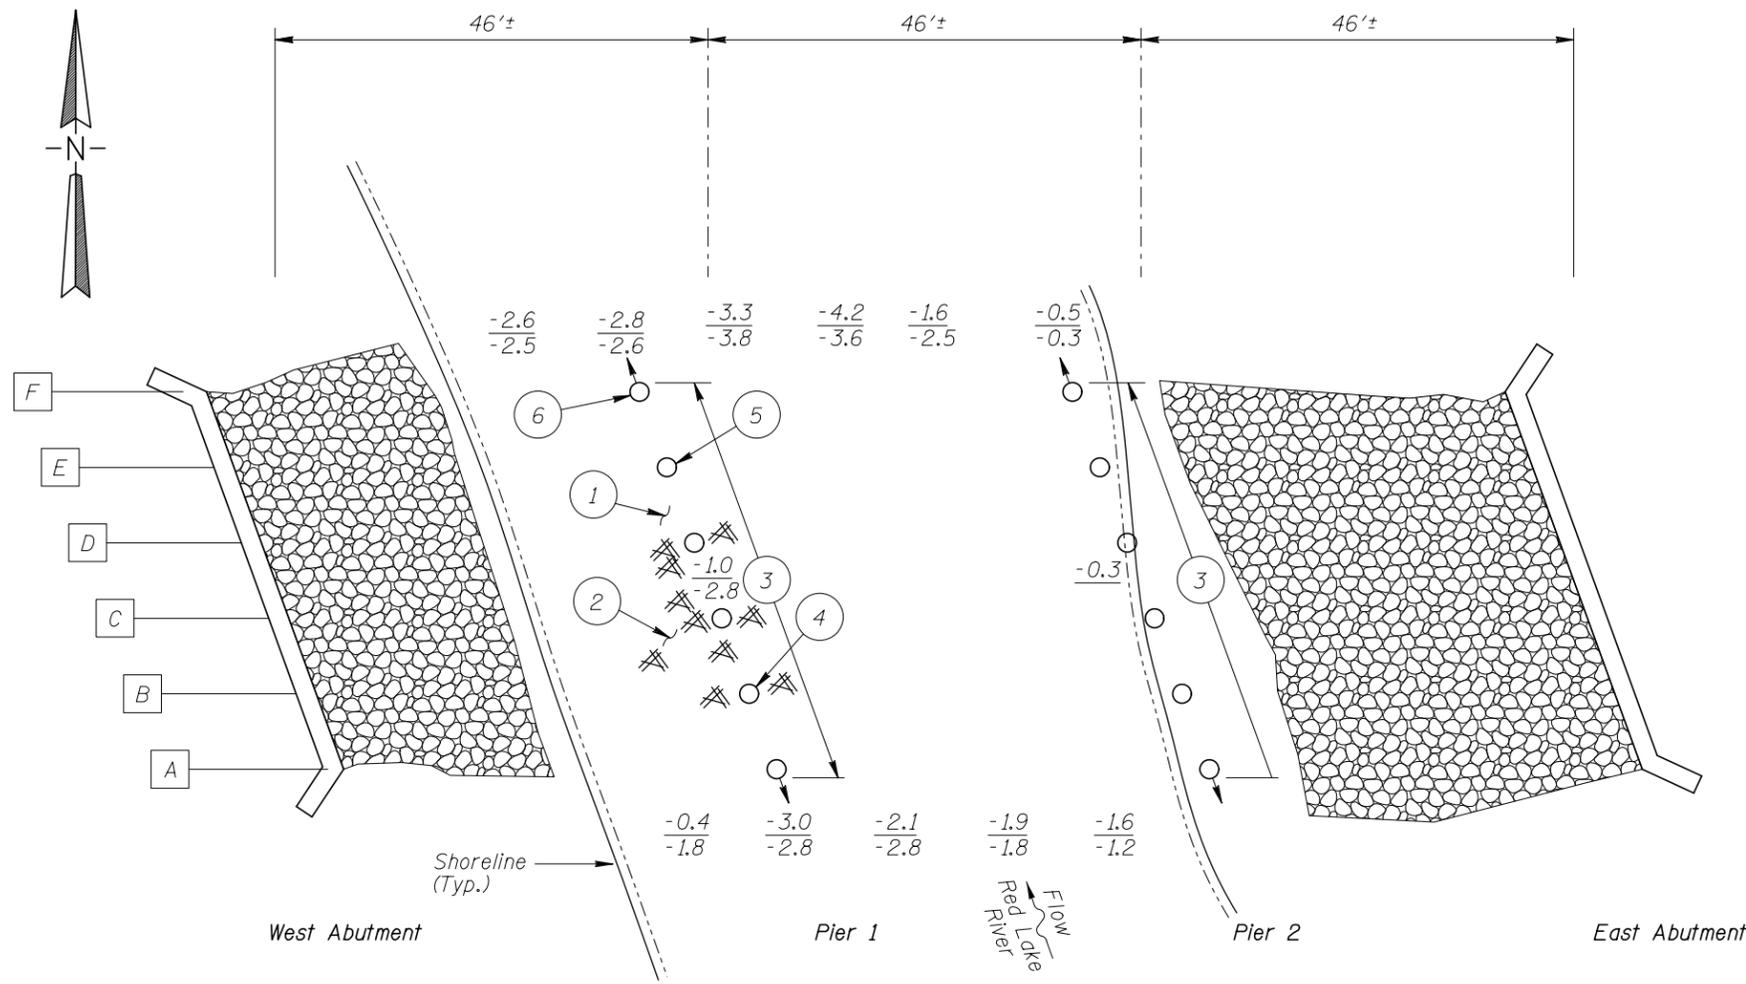
**SOUNDING PLAN**

- 1 The channel bottom material around Piers 1 and 2 consisted of sand with 12 inches of probe rod penetration.
- 2 A light to moderate accumulation of 1-foot-diameter and smaller timber debris and organic material was observed around Piles B through D at Pier 1.
- 3 The steel pipe piles had coating failure and random areas of minor surface corrosion with no appreciable loss of section over approximately 50 percent of the surface area from 5 feet below the top of the piles to the channel bottom.
- 4 Pier 1, Bile B sounded hollow at west face, 3 feet high, starting at 6 feet below the cap.
- 5 Pier 1, Bile E sounded hollow at west face, 4 feet high, starting at 5 feet below the cap.
- 6 Pier 1, Bile F sounded hollow at west face, from 6 feet below cap to ground line.
