UNDERWATER BRIDGE INSPECTION REPORT

STRUCTURE NO. 57521

CSAH 27 OVER THE

RED LAKE RIVER

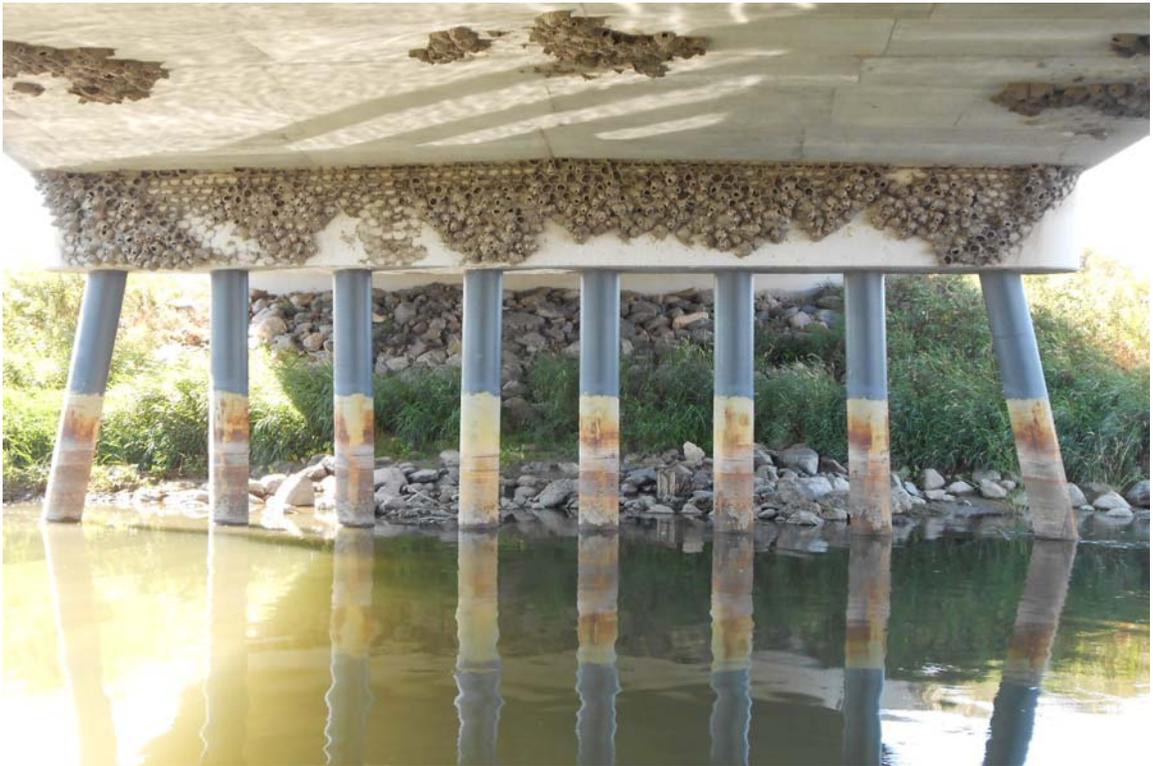
Photograph 1. View of Pier 1 and South Abutment, Looking South.

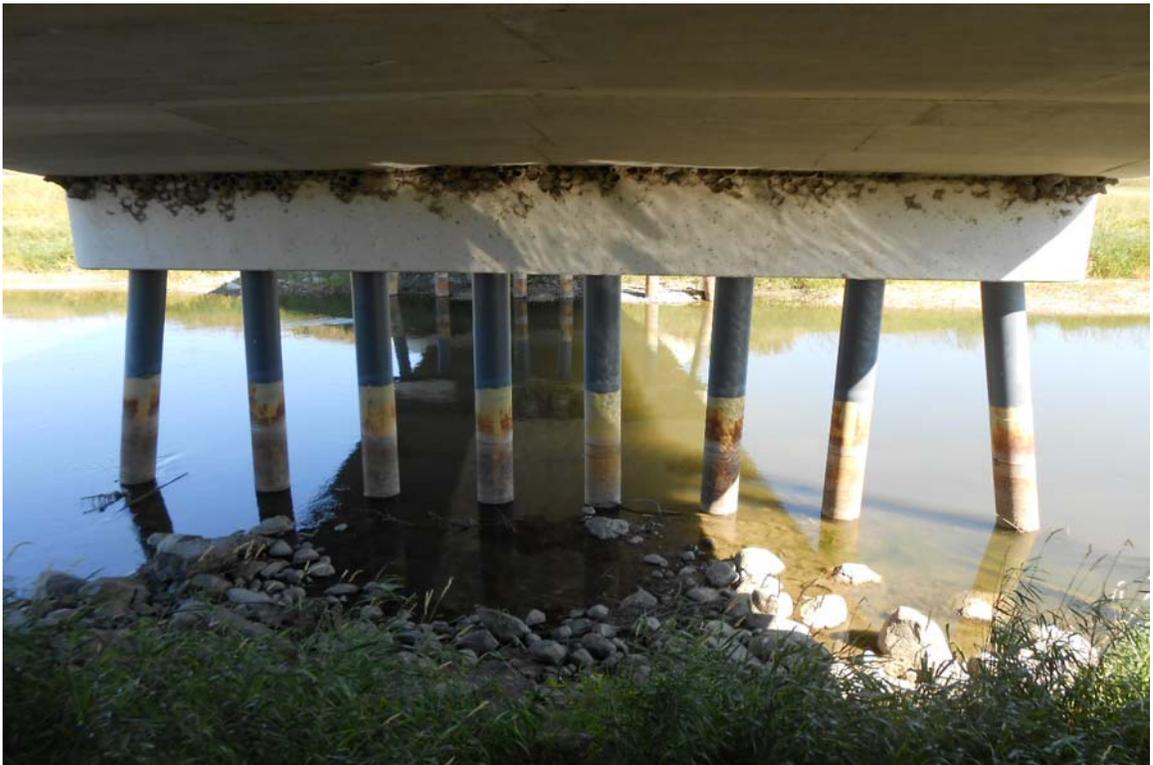
Photograph 2. View of Pier 1, Looking North.

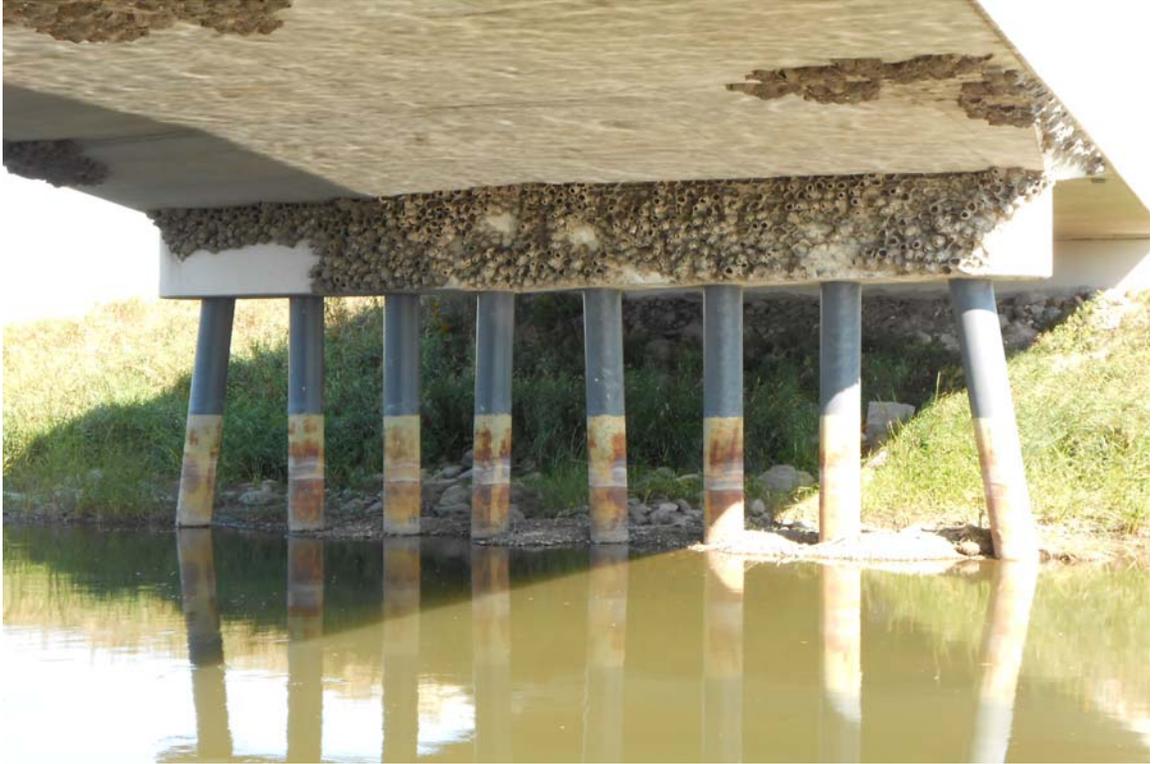
Photograph 3. View of Pier 2 and North Abutment, Looking North.

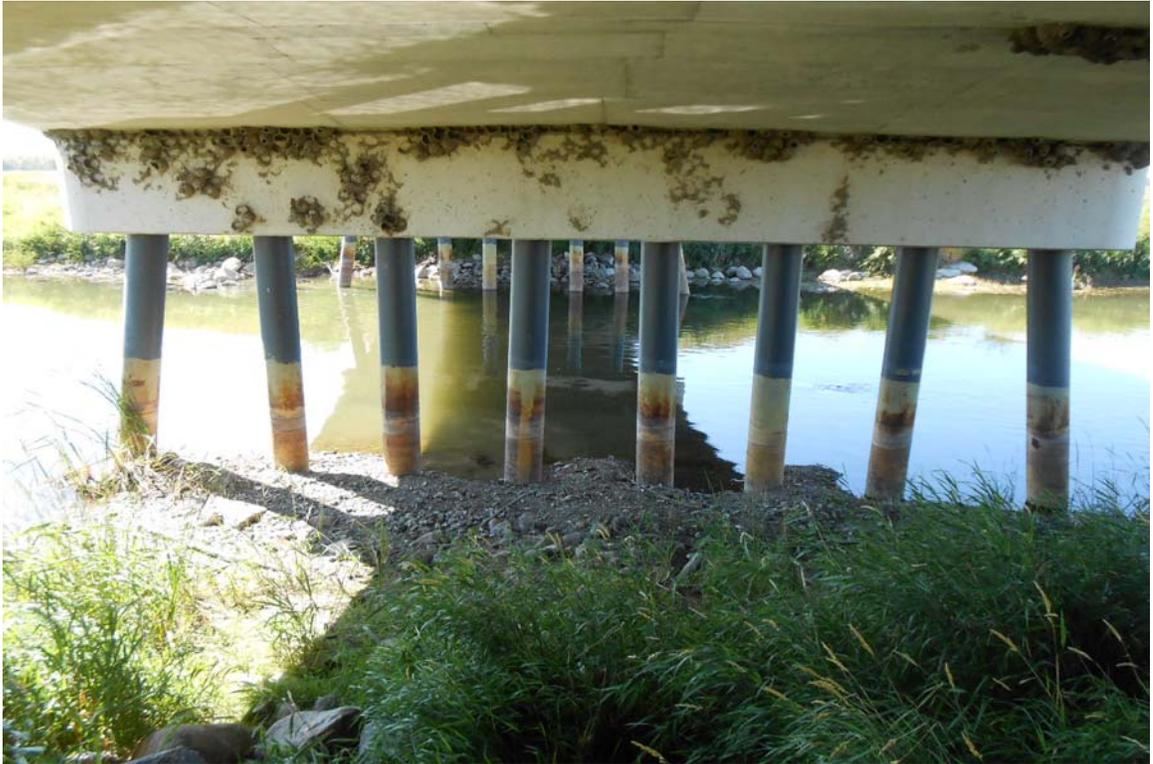
Photograph 4. View of Pier 2, Looking South.

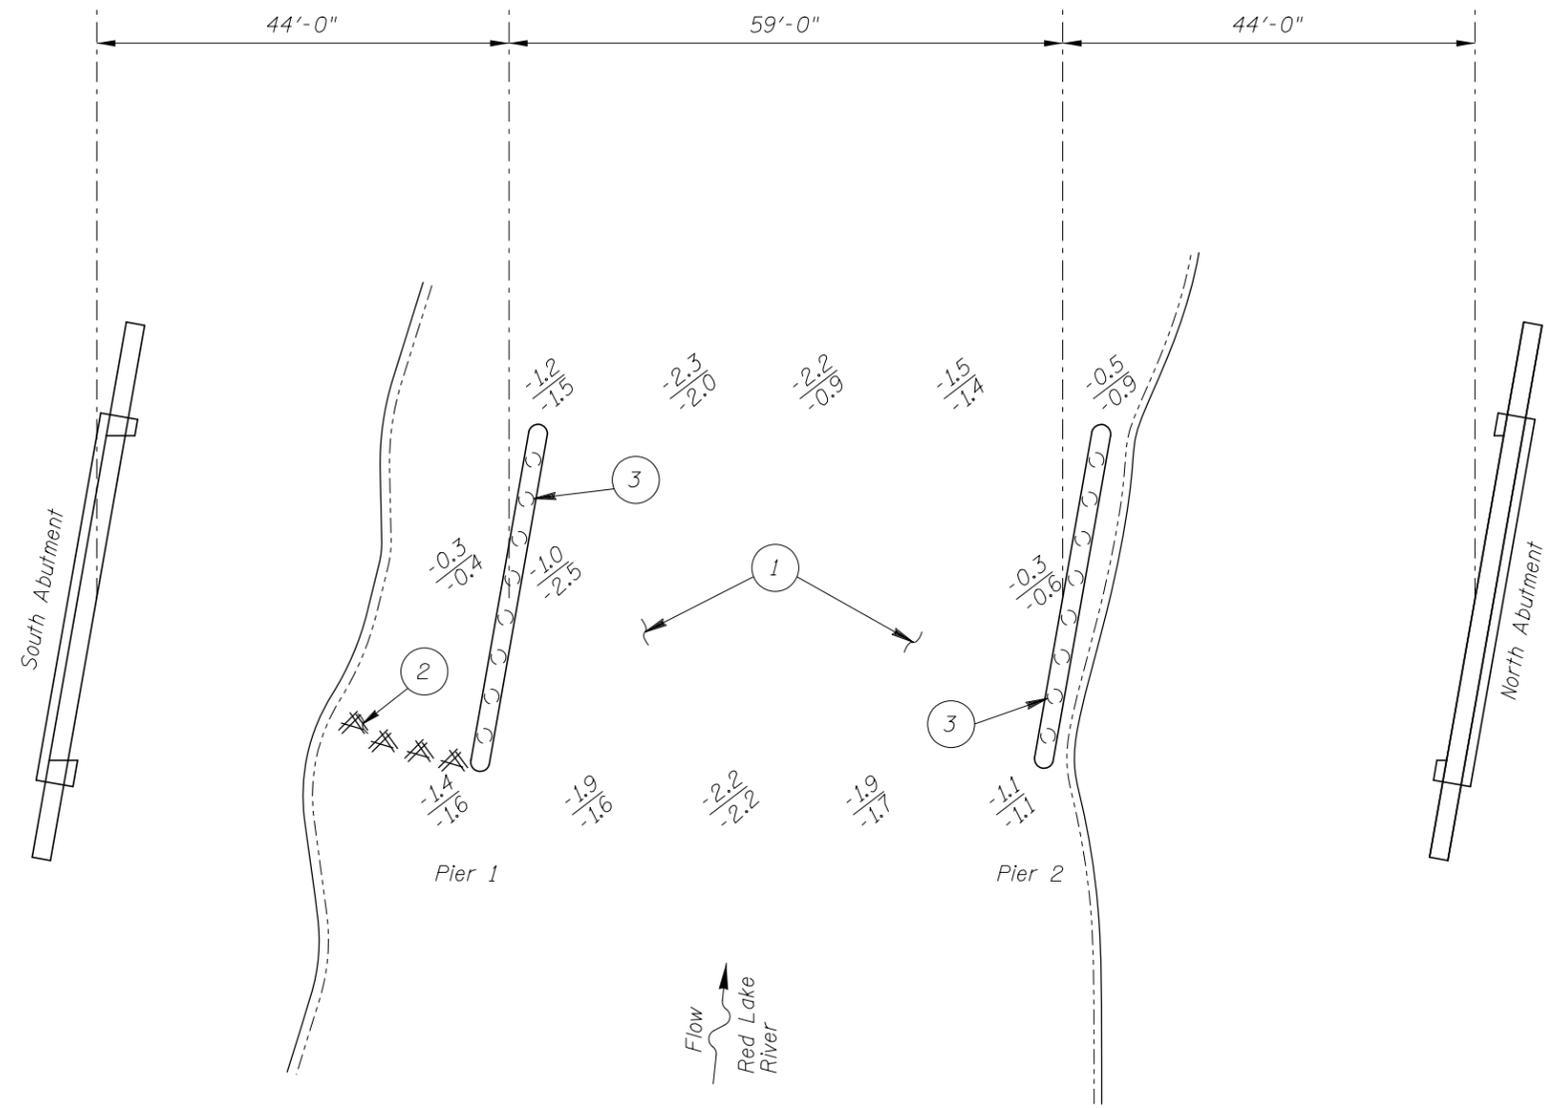
INSPECTION AND SOUNDING PLAN

- 1 The channel bottom material consisted of sand, gravel, cobbles up to 6 inches in size, and riprap up to 2 feet in diameter with up to 3 inches probe rod penetration.
- 2 A minor accumulation of timber debris consisting of 3-inch-diameter and smaller branches and a steel I-beam were observed intermittently extending from the shoreline to the upstream pile of Pier 1 and from the channel bottom to the waterline.
- 3 The steel pipe pile encasements had random minor areas of coating failure from the top of the piles down 5 feet. The piles were uncoated (primer only) from 5 feet below the top of the pile to the channel bottom, with minor surface corrosion observed on over 75 % of the surface area with up to 1/4-inch-diameter rust nodules and minor pitting up to 1/32 inch deep.
