UNDERWATER BRIDGE INSPECTION REPORT

STRUCTURE NO. 5767  
CR NO. 1  
OVER THE  
RED RIVER OF THE NORTH  
DISTRICT 2 - POLK COUNTY, CITY OF NIELSVILLE

AUGUST 30, 2012  
PREPARED FOR THE  
MINNESOTA DEPARTMENT OF TRANSPORTATION  
BY  
AYRES ASSOCIATES & COLLINS ENGINEERS, INC.  
JOB NO. 7423

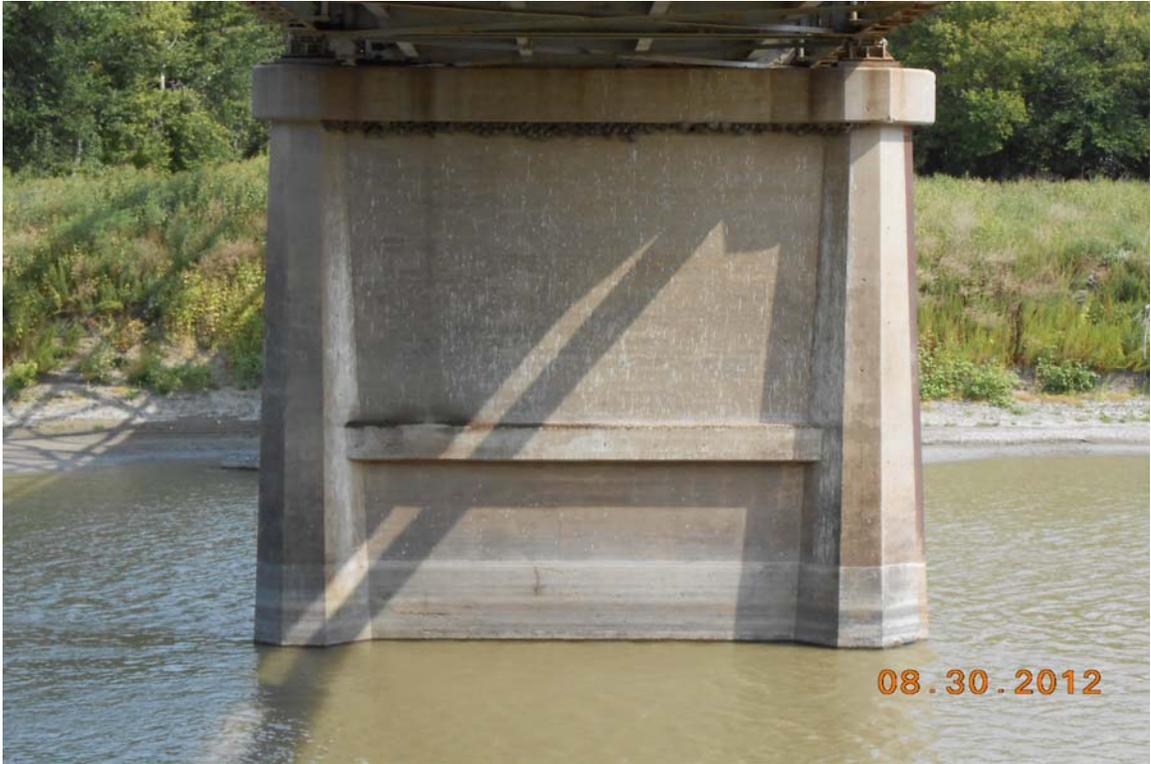
Photograph 1. View of the Pier 1, Looking East.

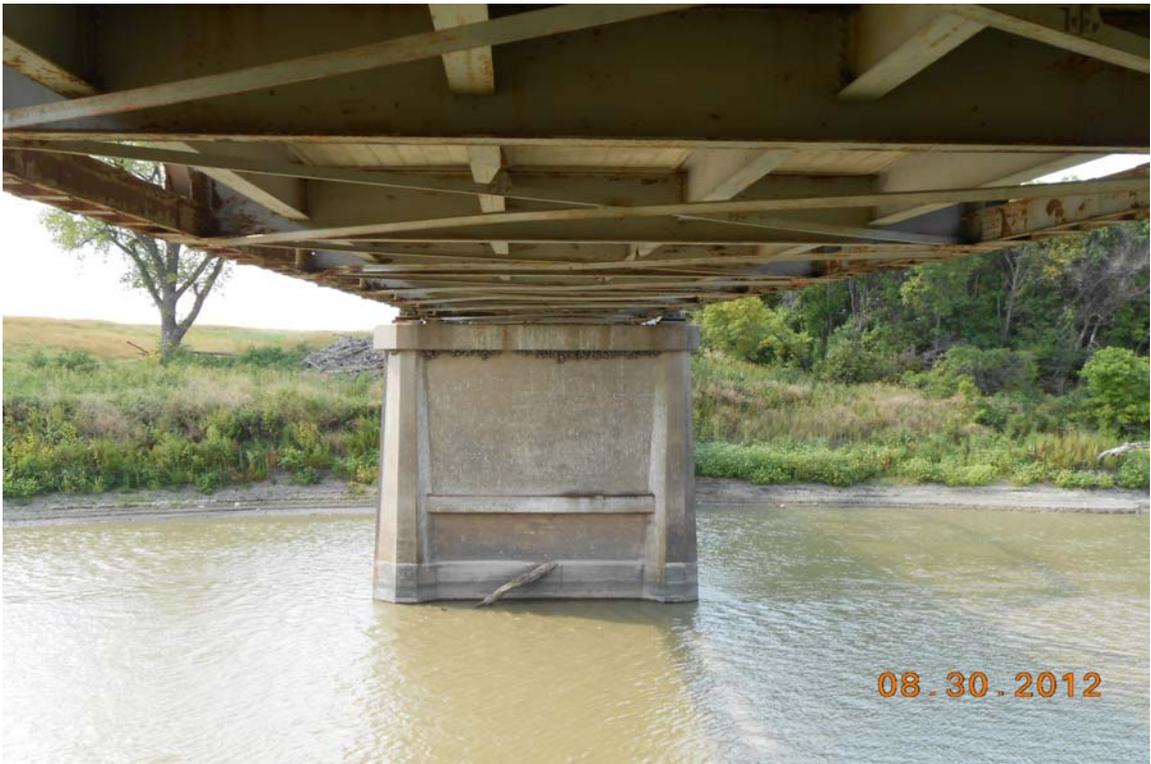
Photograph 2. View of Pier 1, Looking West.

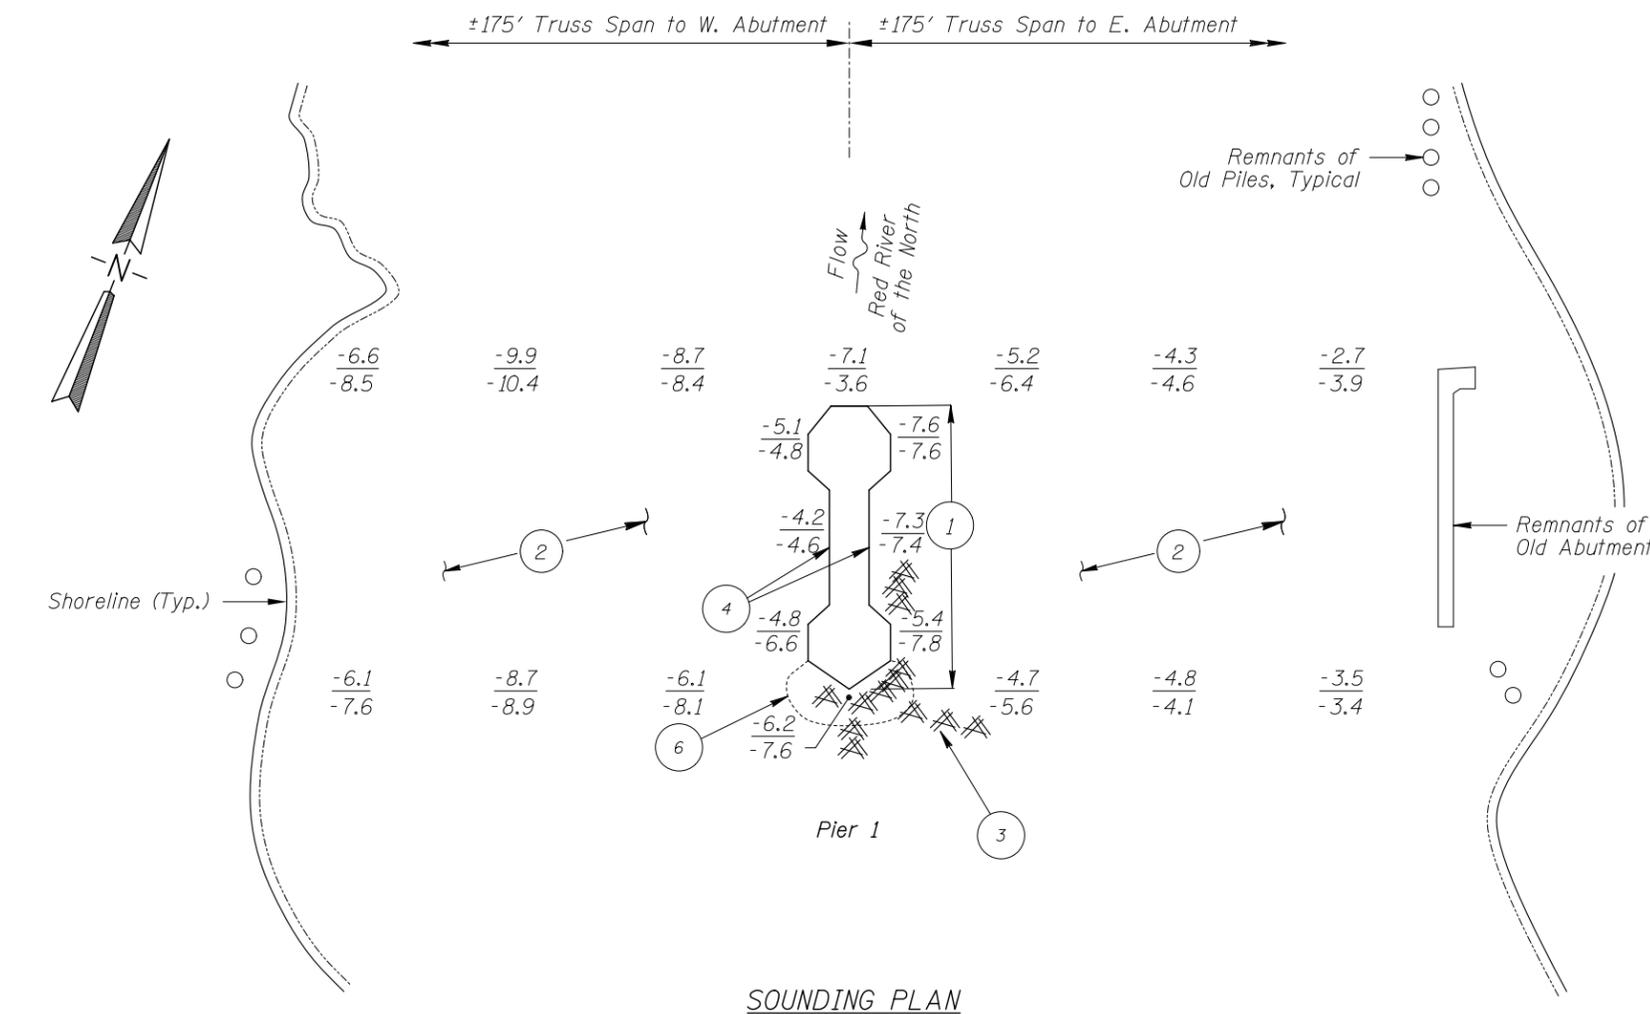
- ① Overall, concrete was smooth and sound with no significant defects.
- ② The channel bottom consisted of sandy silt.
- ③ Timber debris consisting of logs and branches 3 feet in diameter and smaller was observed around the upstream nose and along the upstream half of the east face of Pier 1. The debris extended from channel bottom to the waterline and 6 feet off the pier.
- ④ Vertical crack up to 1/8 inch wide was located on both faces of Pier 1 near the midpoint extending from strut to channel bottom.
- ⑤ Light scaling was observed at waterline along the entire perimeter of Pier 1 with 1/8 inch of maximum penetration.
- ⑥ A scour depression 0.5 feet deep by 4 foot radius was observed at upstream column of Pier 1 underneath the debris.

- (A) Monitor the timber debris accumulation, and if found to be increasing in the future, removal operations may become warranted.
- (B) Reinspect the submerged substructure units at the normal maximum recommended (NBIS) interval of sixty (60) months.
